Stormwater Site Plan

Pierce College Puyallup
New STEM Building
Puyallup, WA
2210810.10

May 2022
Revised August 2022
Revised October 2022

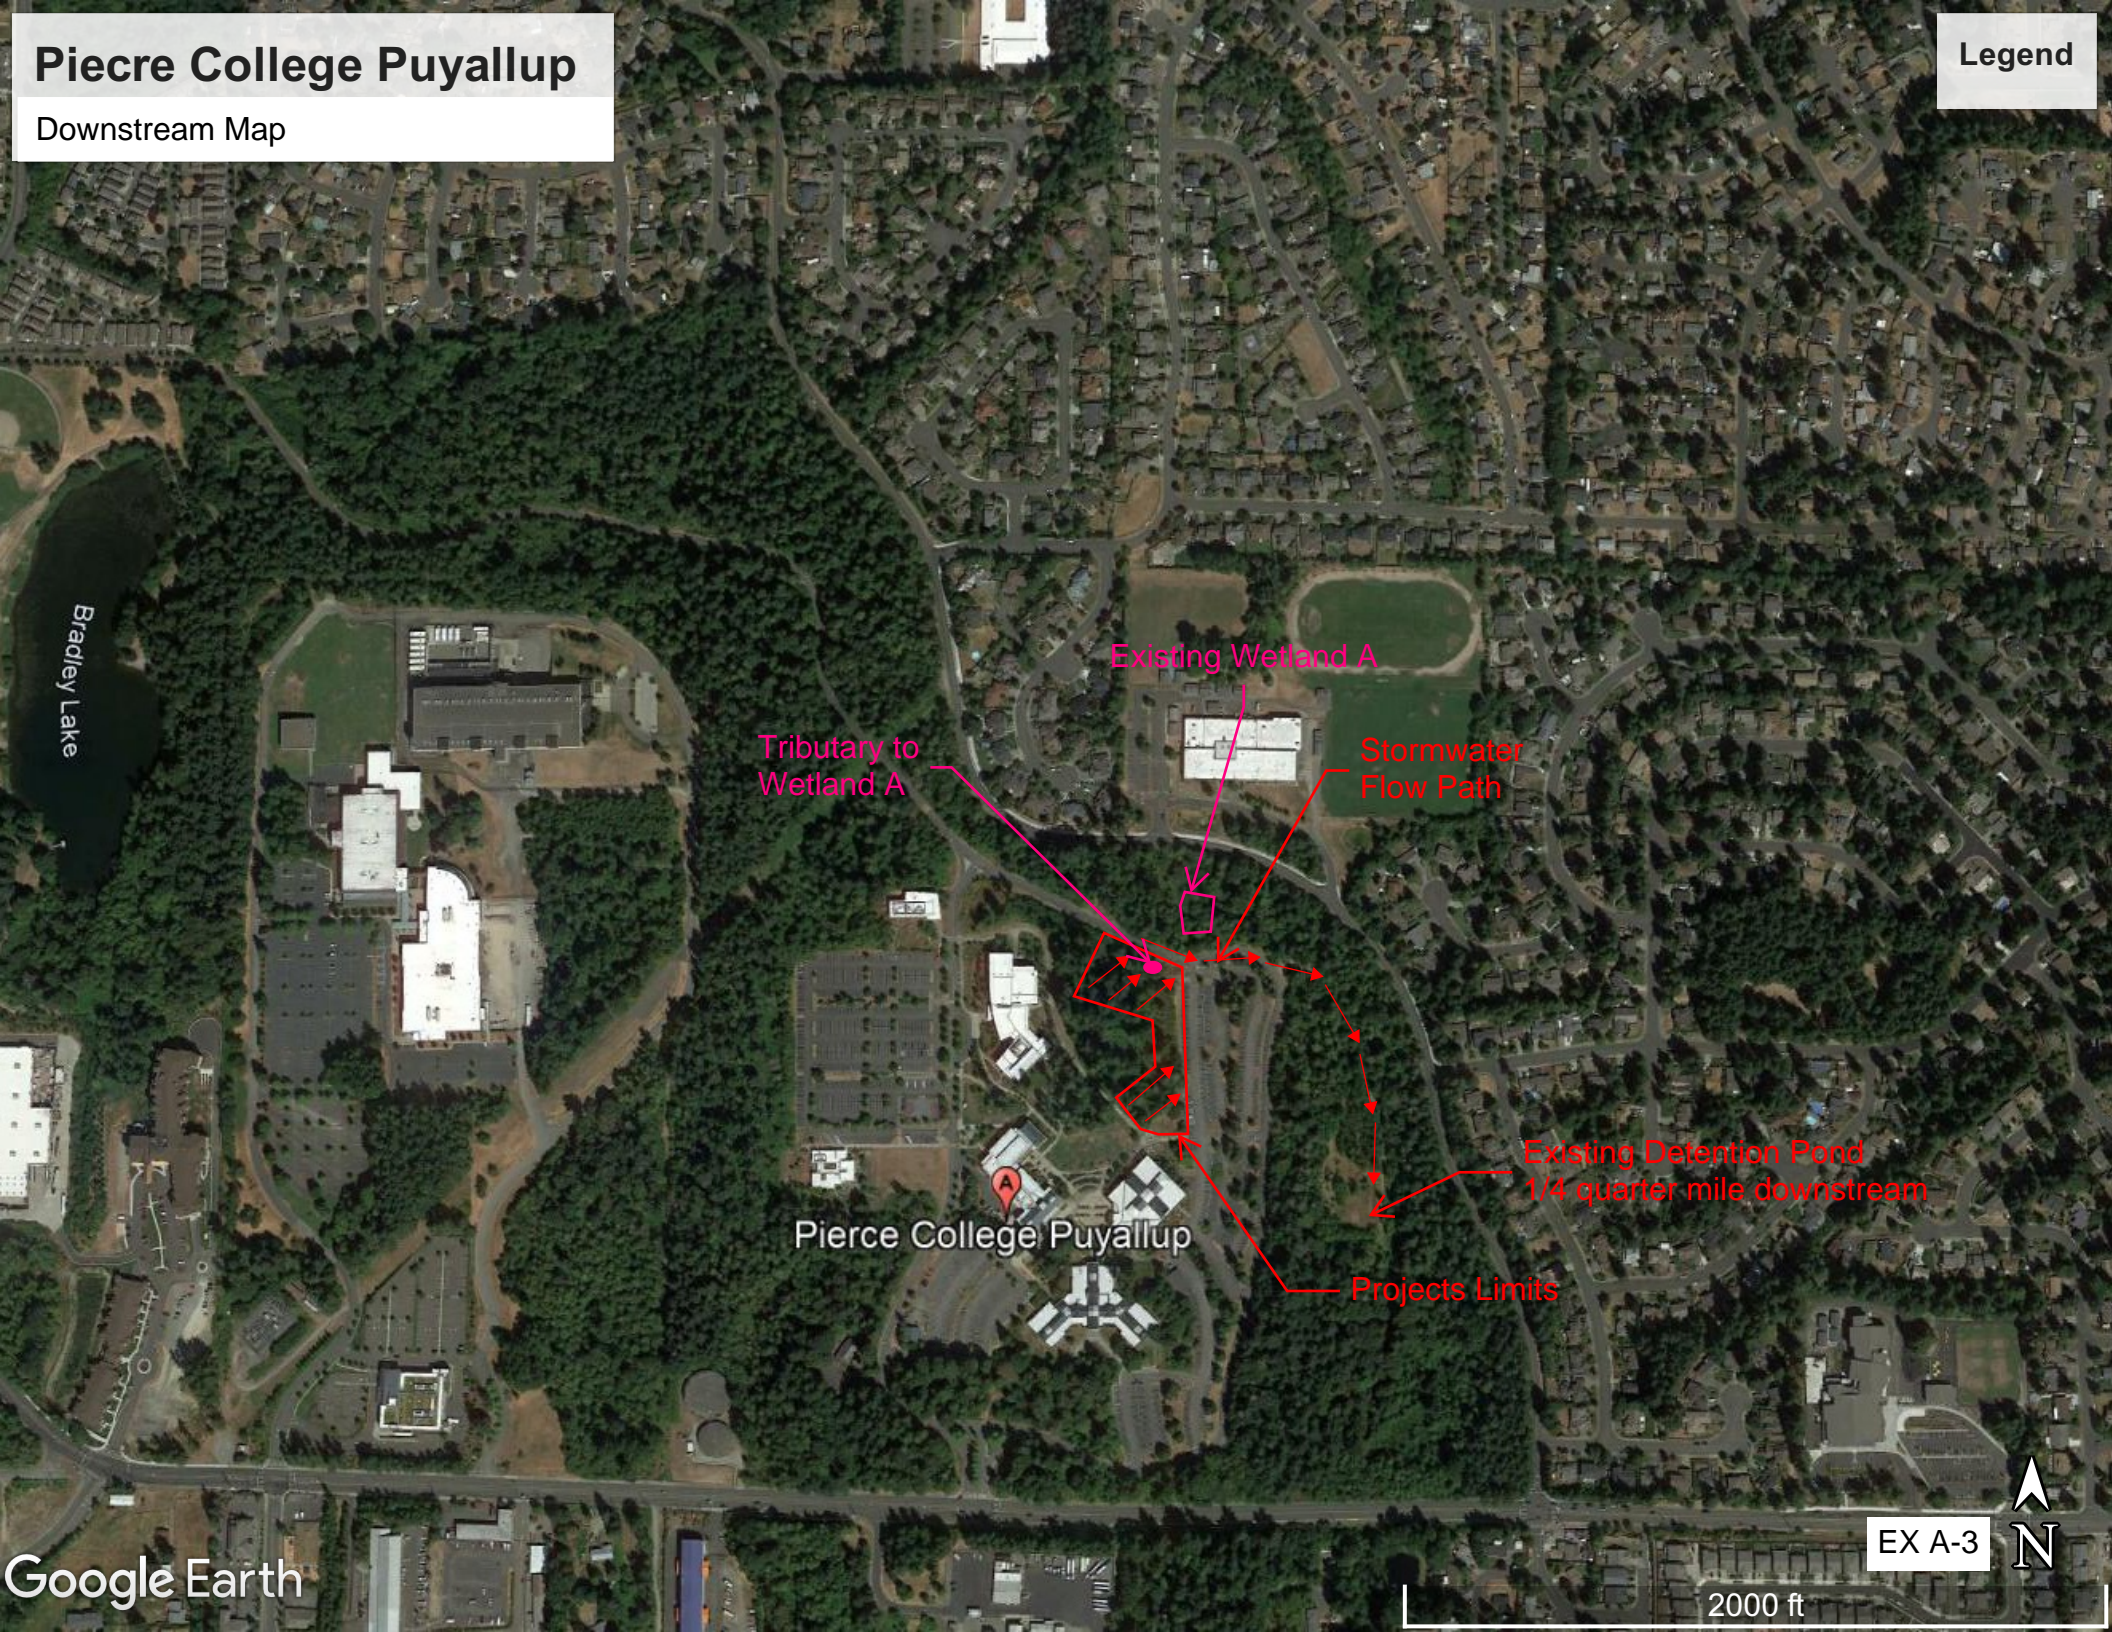
Downstream Map

Tributary to Wetland A

Existing Wetland A

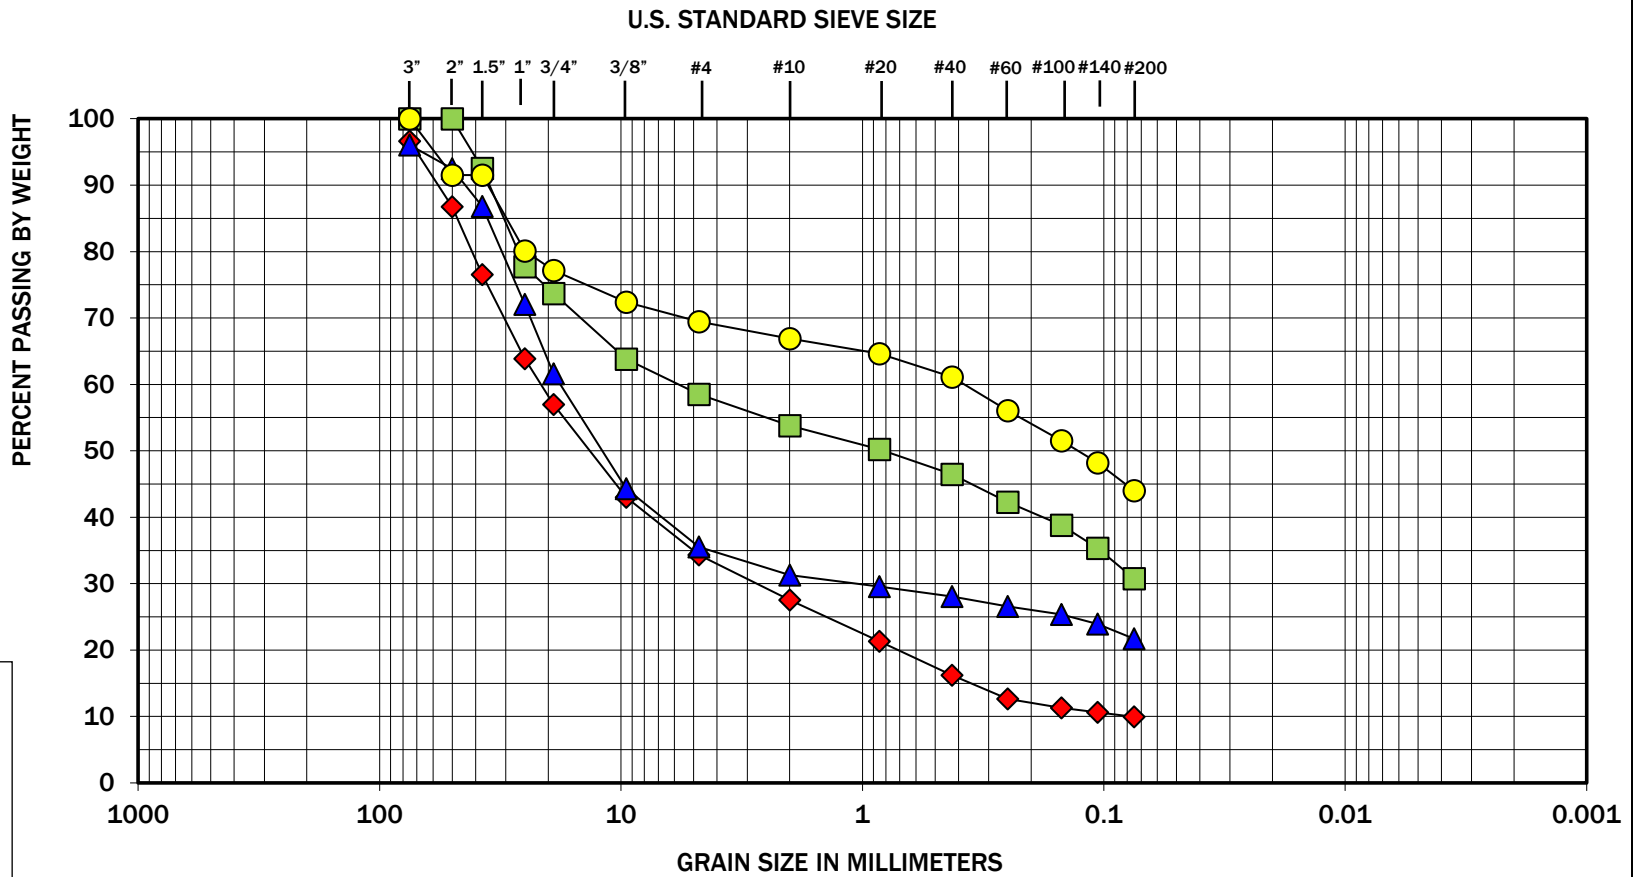
Symbol	Boring Number	Depth (feet)	Moisture (%)	Soil Description
◆	TP-1	13	9	Poorly graded gravel with silt and sand (GP-GM)
■	TP-2	6	10	Silty gravel with sand (GM)
▲	TP-3	12.5	27	Silty gravel (GM)
●	TP-5	8.5	11	Silty gravel with sand (GM)

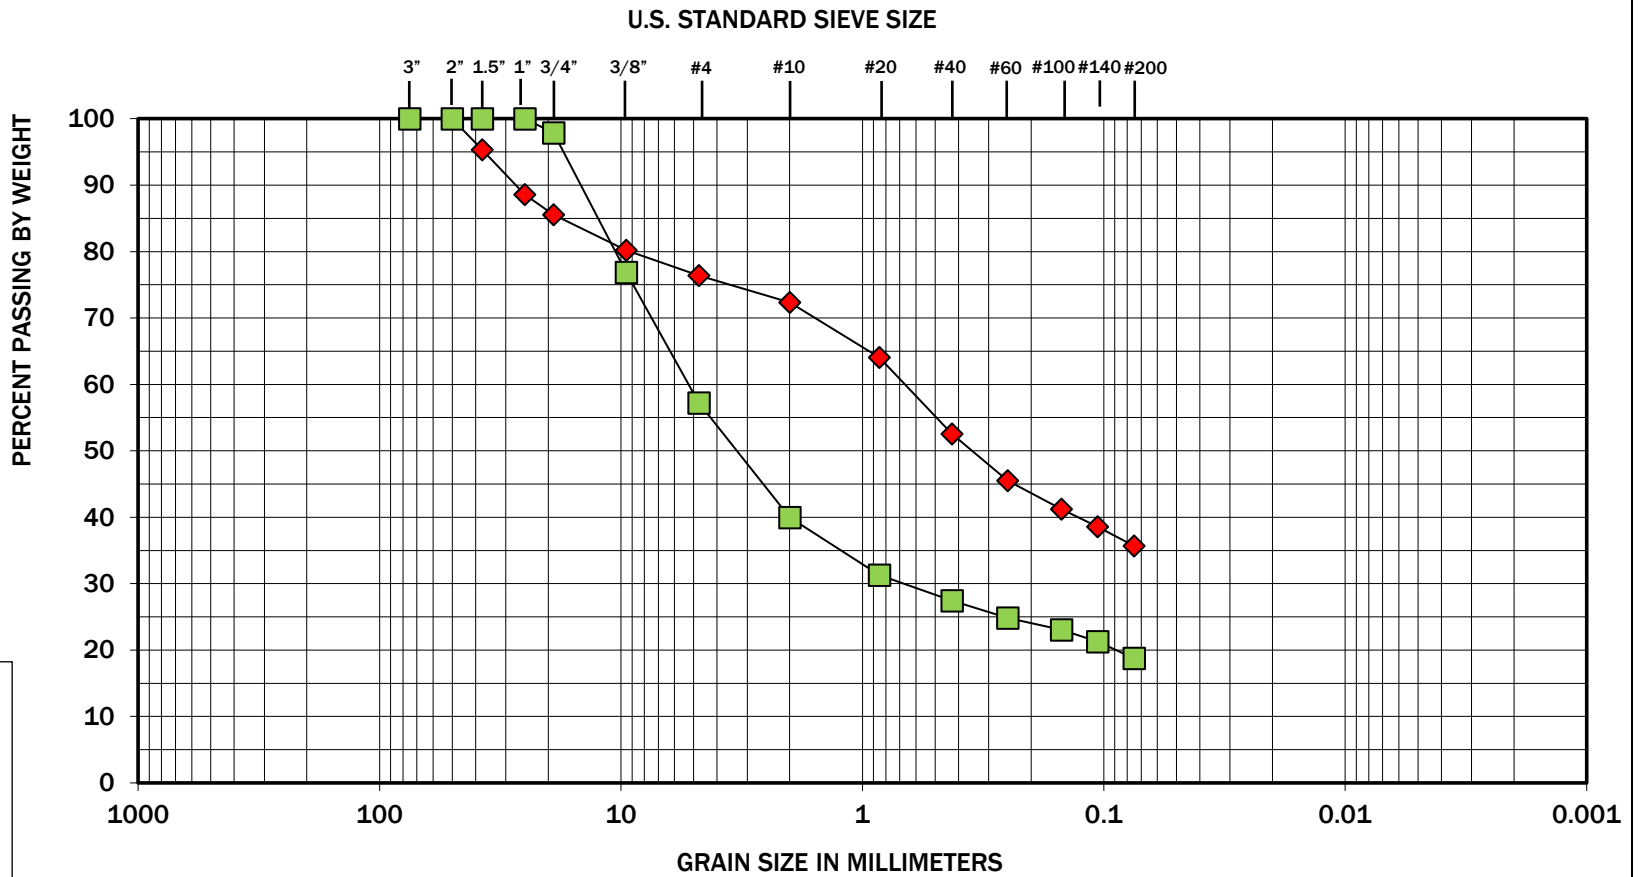
Sieve Analysis Results

Symbol	Boring Number	Depth (feet)	Moisture (%)	Soil Description
◆	TP-6	12	9	Silty sand with gravel (SM)
■	MW-1	15-20	8	Silty gravel with sand (GM)

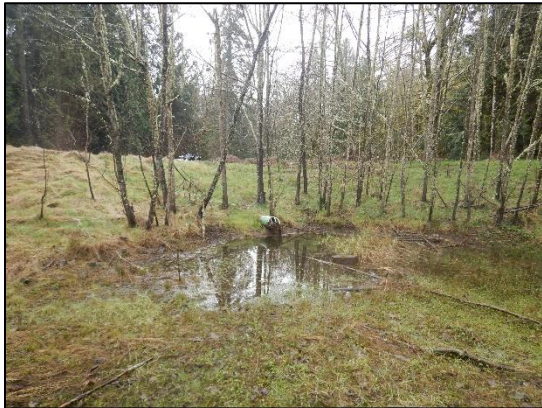
Figure 2. Stormwater Pond Conveyance Features

The photograph on the left captures the stormwater pond outlet pipe located in the southeastern portion of the stormwater pond and the photograph on the right captures a stormwater catch basin located on top of the earthen berm associated with the stormwater pond.

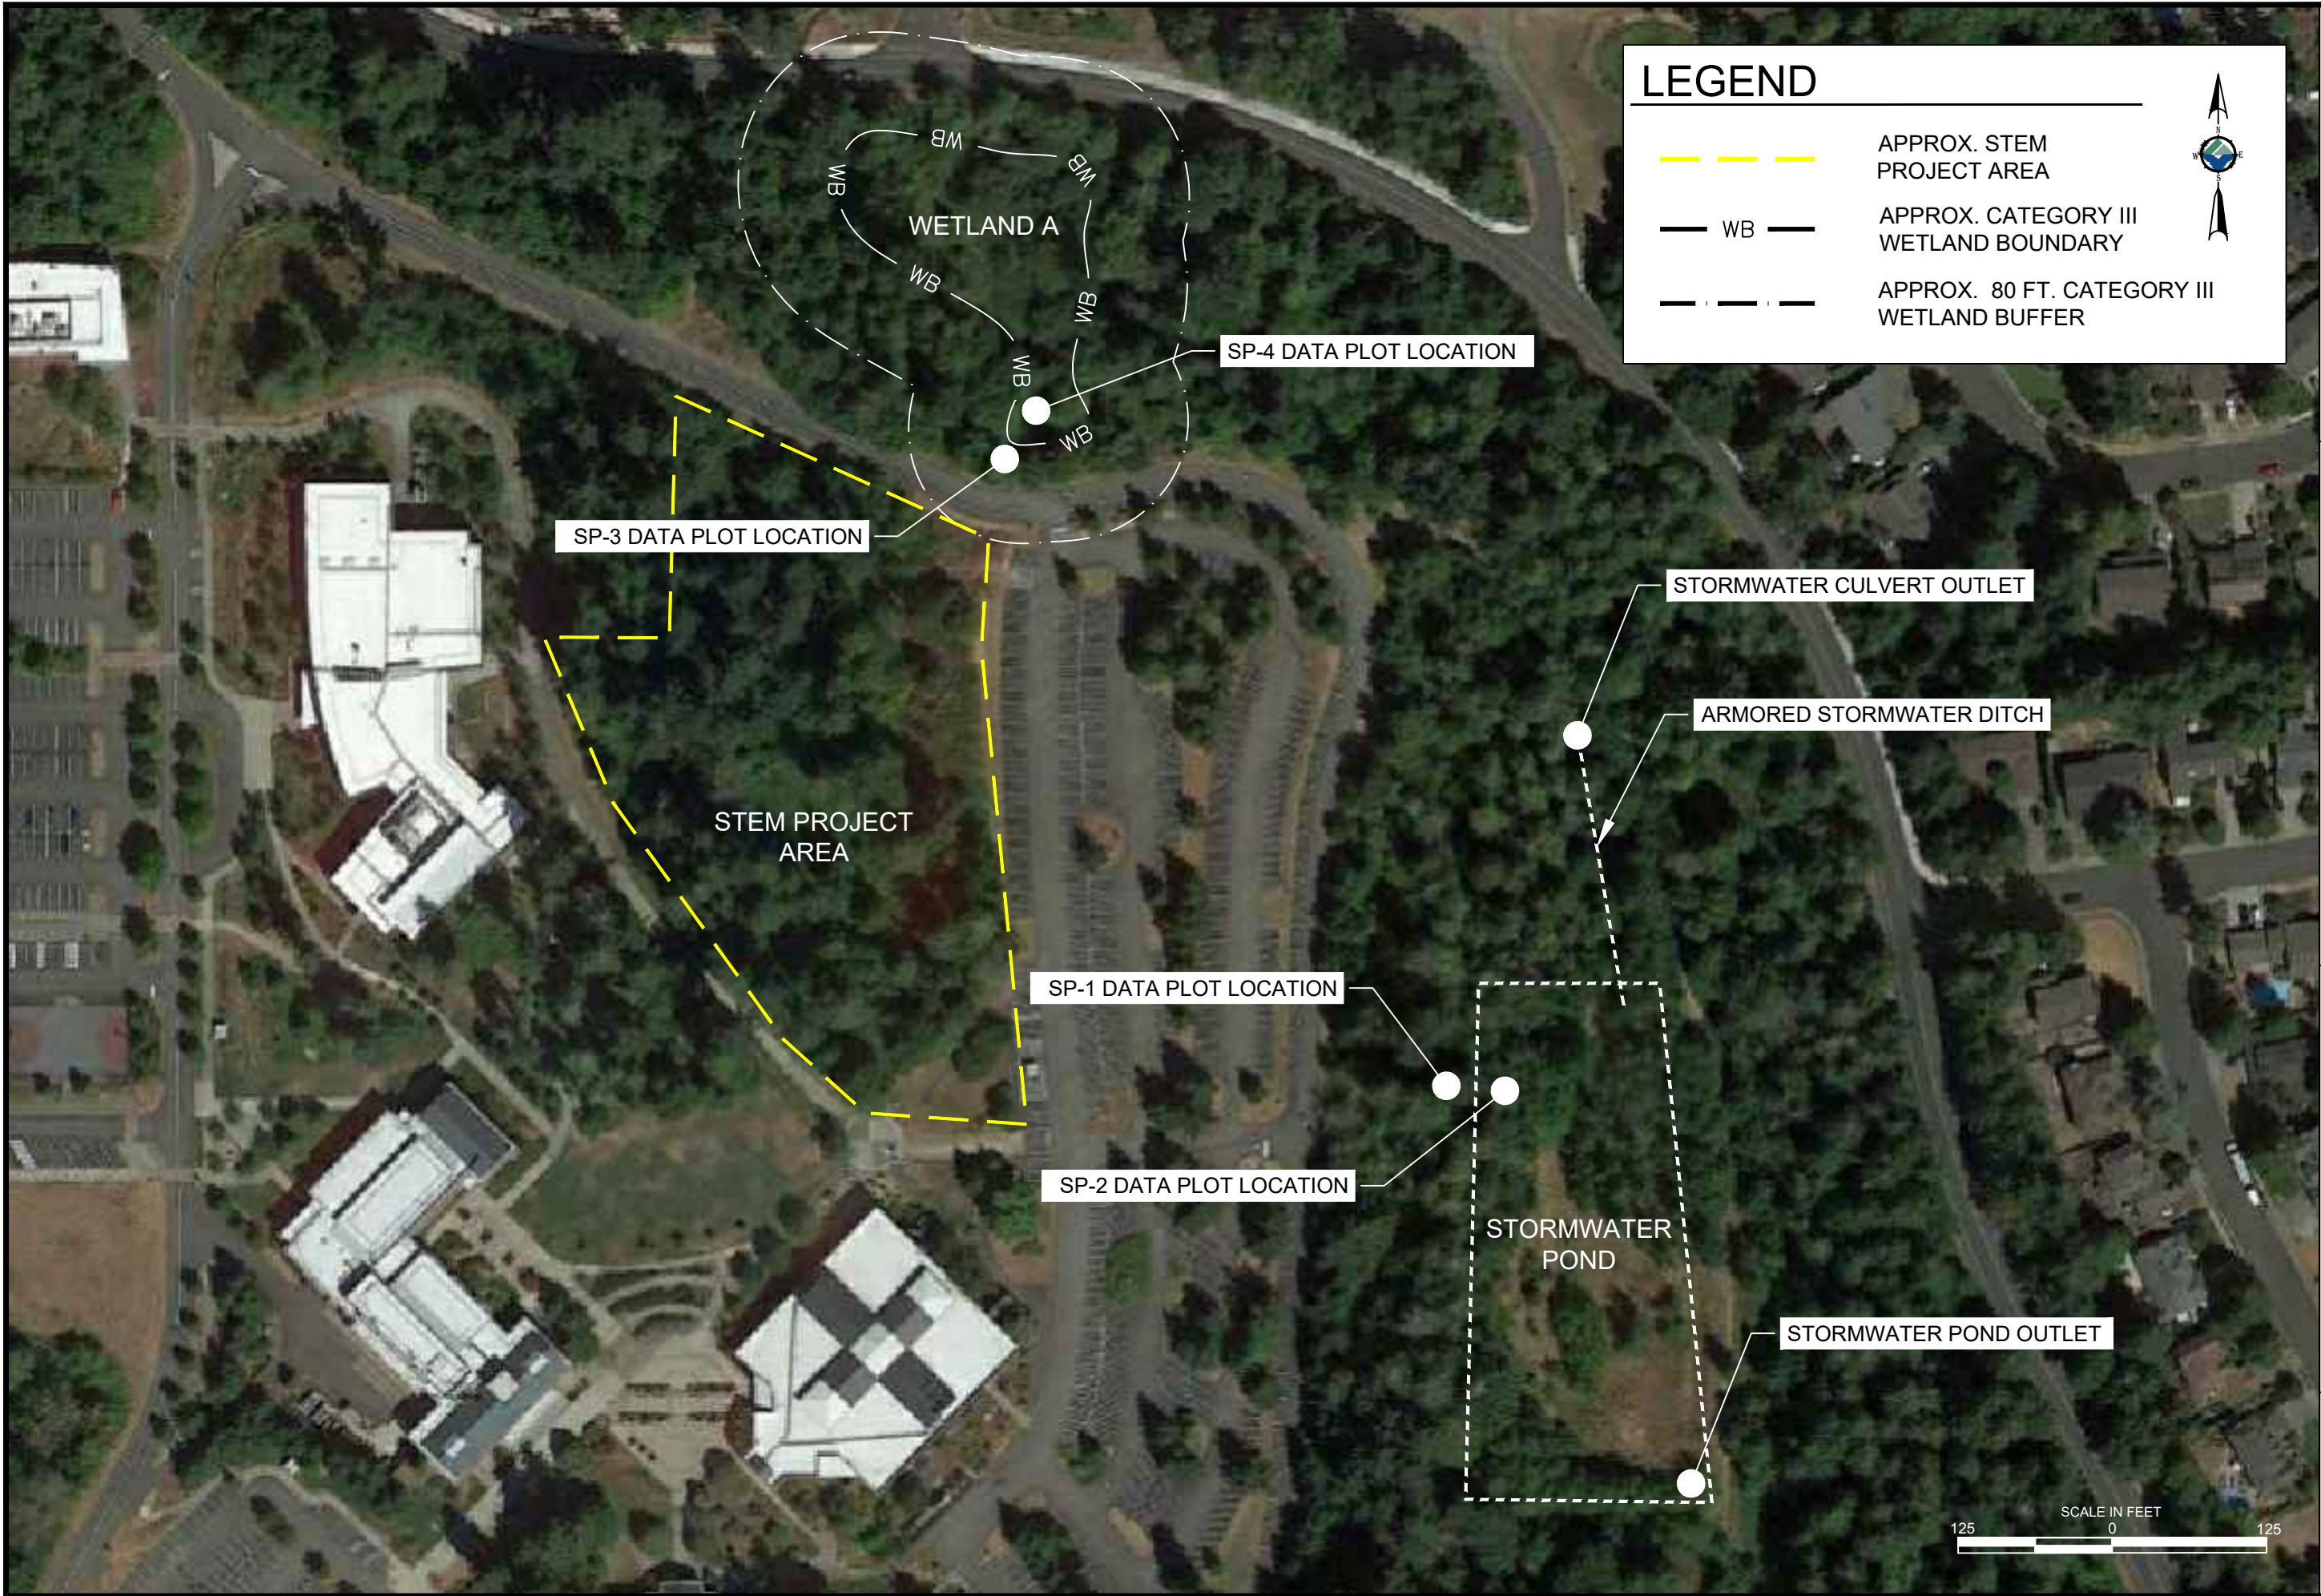
APPENDIX A: WETLAND DELINEATION MAP

- APPROX. STEM PROJECT AREA
- WB APPROX. CATEGORY III WETLAND BOUNDARY
- APPROX. 80 FT. CATEGORY III WETLAND BUFFER

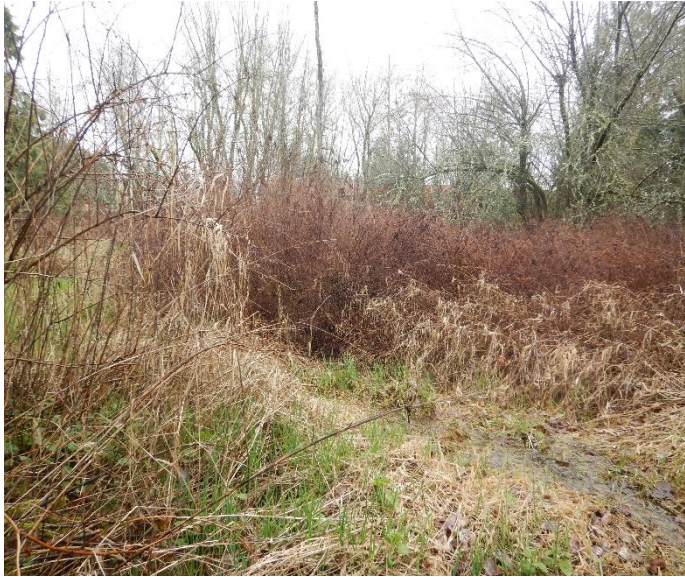
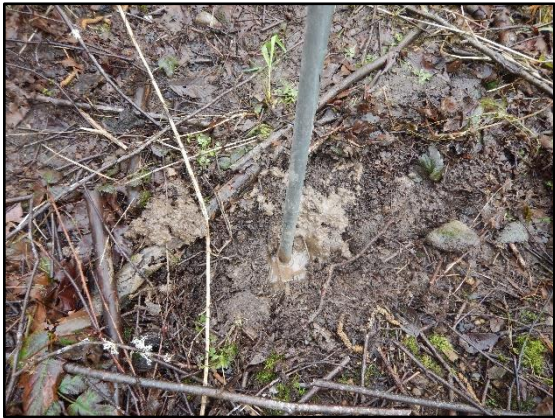
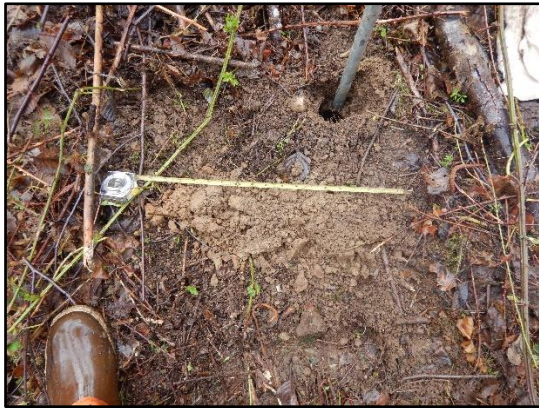
WETLAND A SUMMARY		
Approximate Size (sq. ft.):	-

Cowardin Classification ¹ :	PEM/SS	
HGM Classification ² :	Depressional	
Wetland Category ³ :	III	
Wetland Buffer Width ⁴ :	80 ft.	
Sample Plot Total ⁵ :	2	
Hydrophytic Vegetation Present (Y/N)?	Yes	
Hydric Soil Indicator?	Yes	
Wetland Hydrology Present?	Yes	
Summary of Findings		
Dominant Vegetation:	The scrub-shrub area predominately consists of a spiraea (<i>Spiraea douglasii</i>) with an understory of native and non-native vegetation. The emergent area largely consists of reed canarygrass (<i>Phalaris arundinacea</i>) and skunk cabbage (<i>Lysichiton americanus</i>).	
Soil Profile:	The soils observed in Wetland A were unconsolidated and were not able to be accurately evaluated.	
Primary Hydrological Support:	Hydrologic support for Wetland A is primarily provided by high groundwater table and stormwater discharge.	
Wetland Data Plot:	Upland Data Plot:

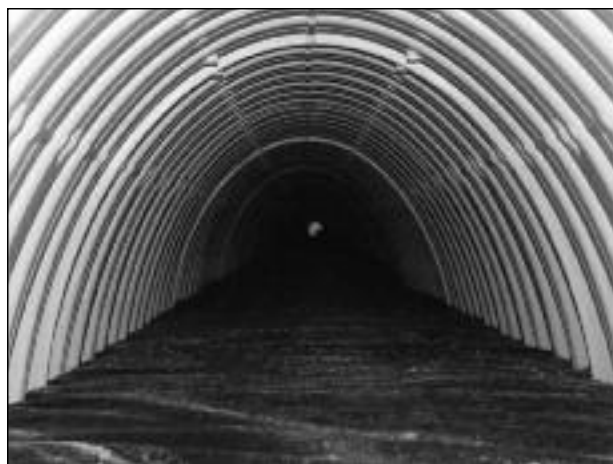
Looking down the Isolator Row.

JetVac maintenance is recommended if sediment has been collected to an average depth of 3" (76 mm) inside the Isolator Row. More frequent maintenance may be required to maintain minimum flow rates through the Isolator Row. The JetVac process utilizes a high pressure water nozzle to propel itself down the Isolator Row while scouring and suspending sediments. As the nozzle is retrieved, a wave of suspended sediments is flushed back into the manhole for vacuuming. Most sewer and pipe maintenance companies have vacuum/ JetVac combination vehicles. Fixed nozzles designed for culverts or large diameter pipe cleaning are preferable. Rear facing jets with an effective spread of at least 45" (1143 mm) are best. The JetVac process shall only be performed on StormTech Rows that have AASHTO class 1 woven geotextile over their foundation stone (ADS 315WTM or equal).

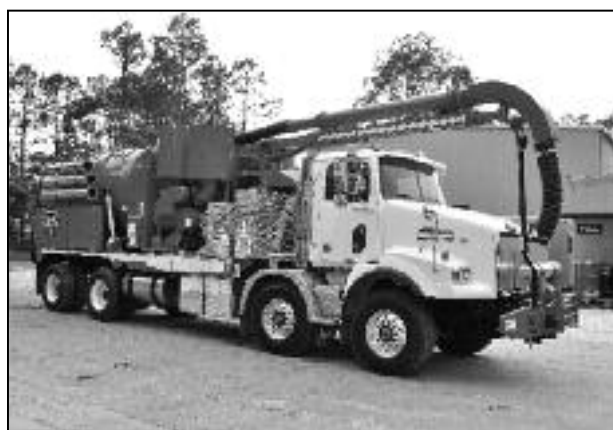
A typical JetVac truck. (This is not a StormTech product.)
