**Stormwater Site Plan  
Puget Sound Energy  
Operational Training Center  
325 Todd Road NW  
Puyallup, Washington**  
Tax Parcel Numbers:  
04202-11030

## STORMWATER SITE PLAN

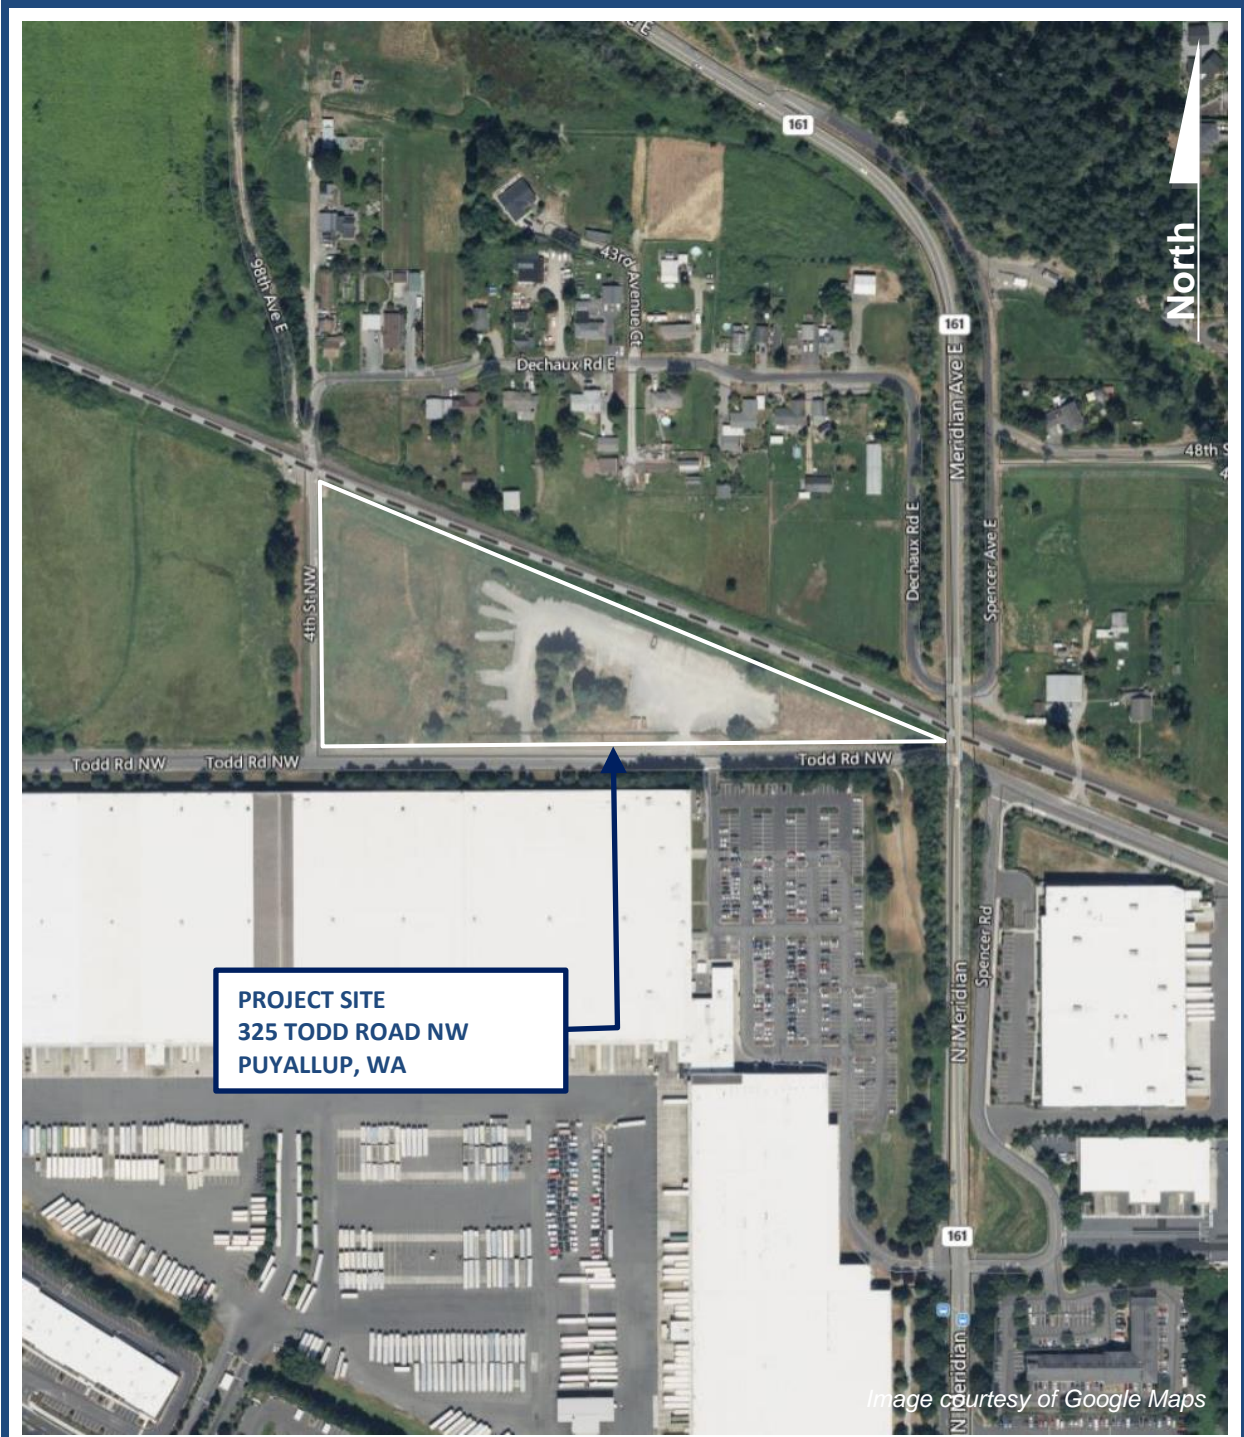
**Fig. 2**

**Aerial Photograph**

Much of the east half of the site is surfaced with gravel and used as an equipment storage yard for PSE vehicles, materials, and equipment. Two gated driveway entrances access the gravel yard from Todd Road NW. For security purposes, the gravel yard is lined with barbed wire fencing. Vegetation in the east half of the parcel consists of evergreen trees, shrubbery, and perimeter grass. The western half of the site is undeveloped and vegetated with grasses and scattered trees. Overall site topography is generally flat. Refer to *Figure 2 – Aerial Photograph* for the existing site conditions.

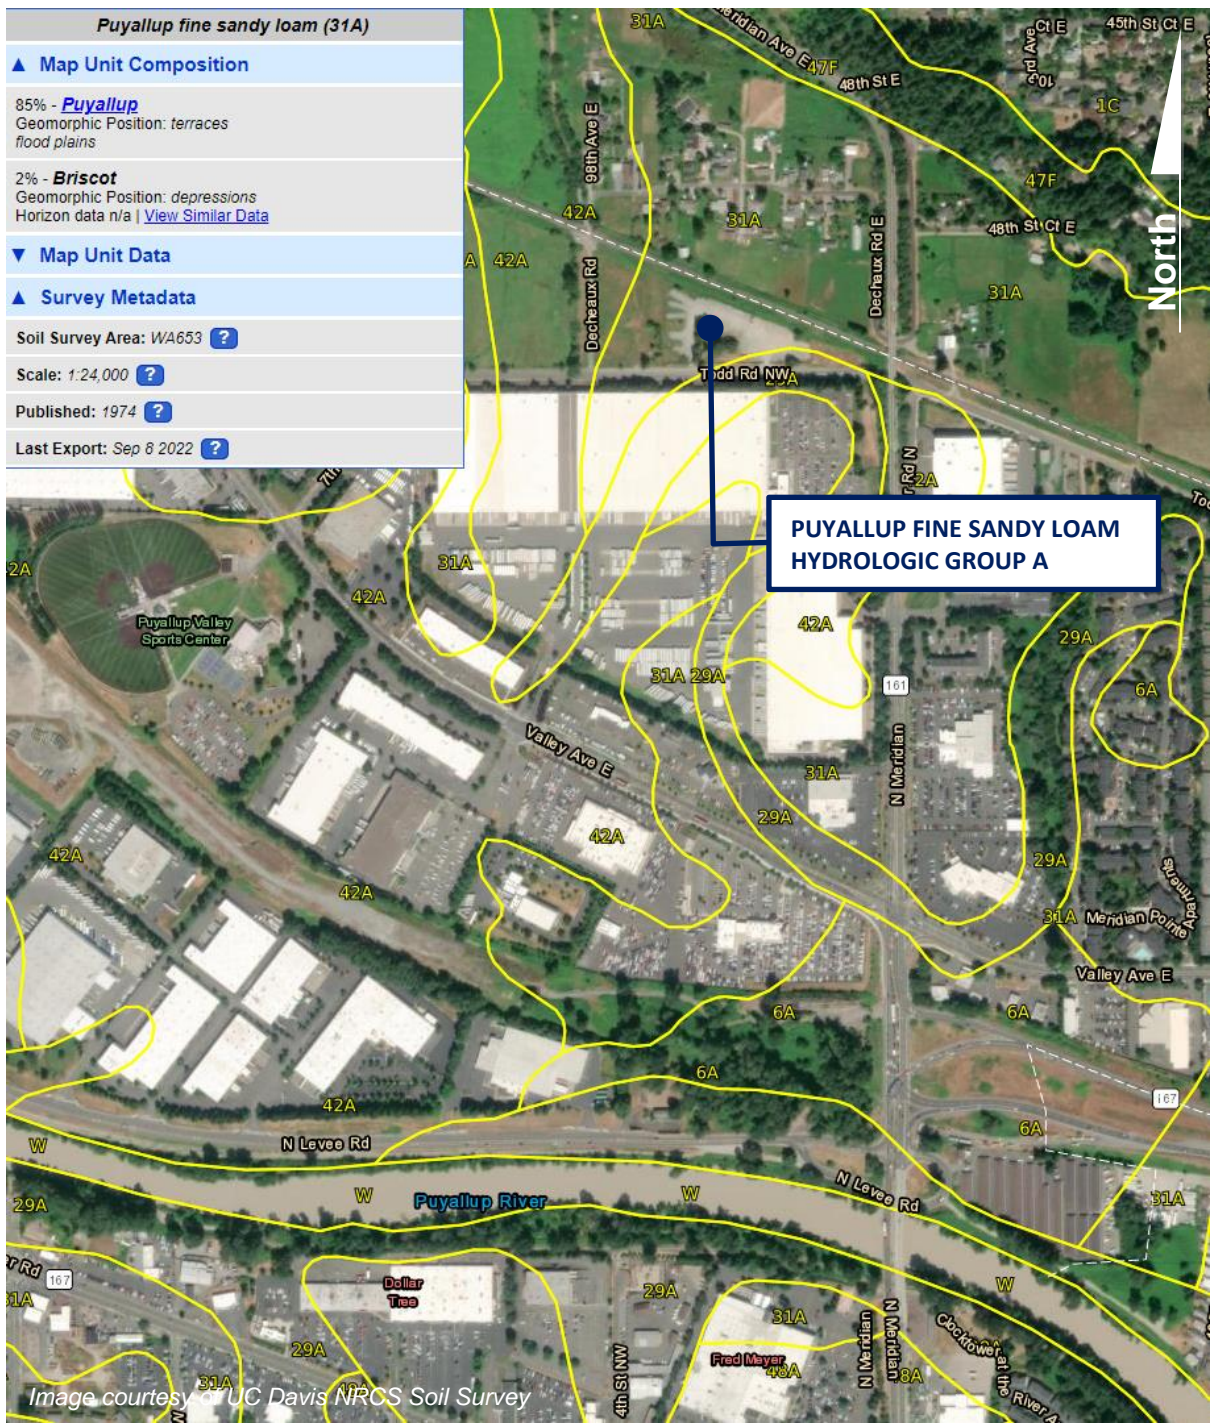
Fig. 3b

Soil Map

Soil horizons, consisting of these soil types, is typically deposited by alluvial processed in the form of floodplains and derived from alluvium deposited by the Puyallup River. The Sultan series is classified as hydrologic group 'C/D' which consists of soils with low infiltration rates and high runoff potential when thoroughly wetted. The Puyallup and Pilchuck series are classified as hydrologic group 'A' which includes soils with high infiltration rates and low runoff potential when thoroughly wetted. Refer to *Figure 3a-c Soils Map* for the regional soil mapping.

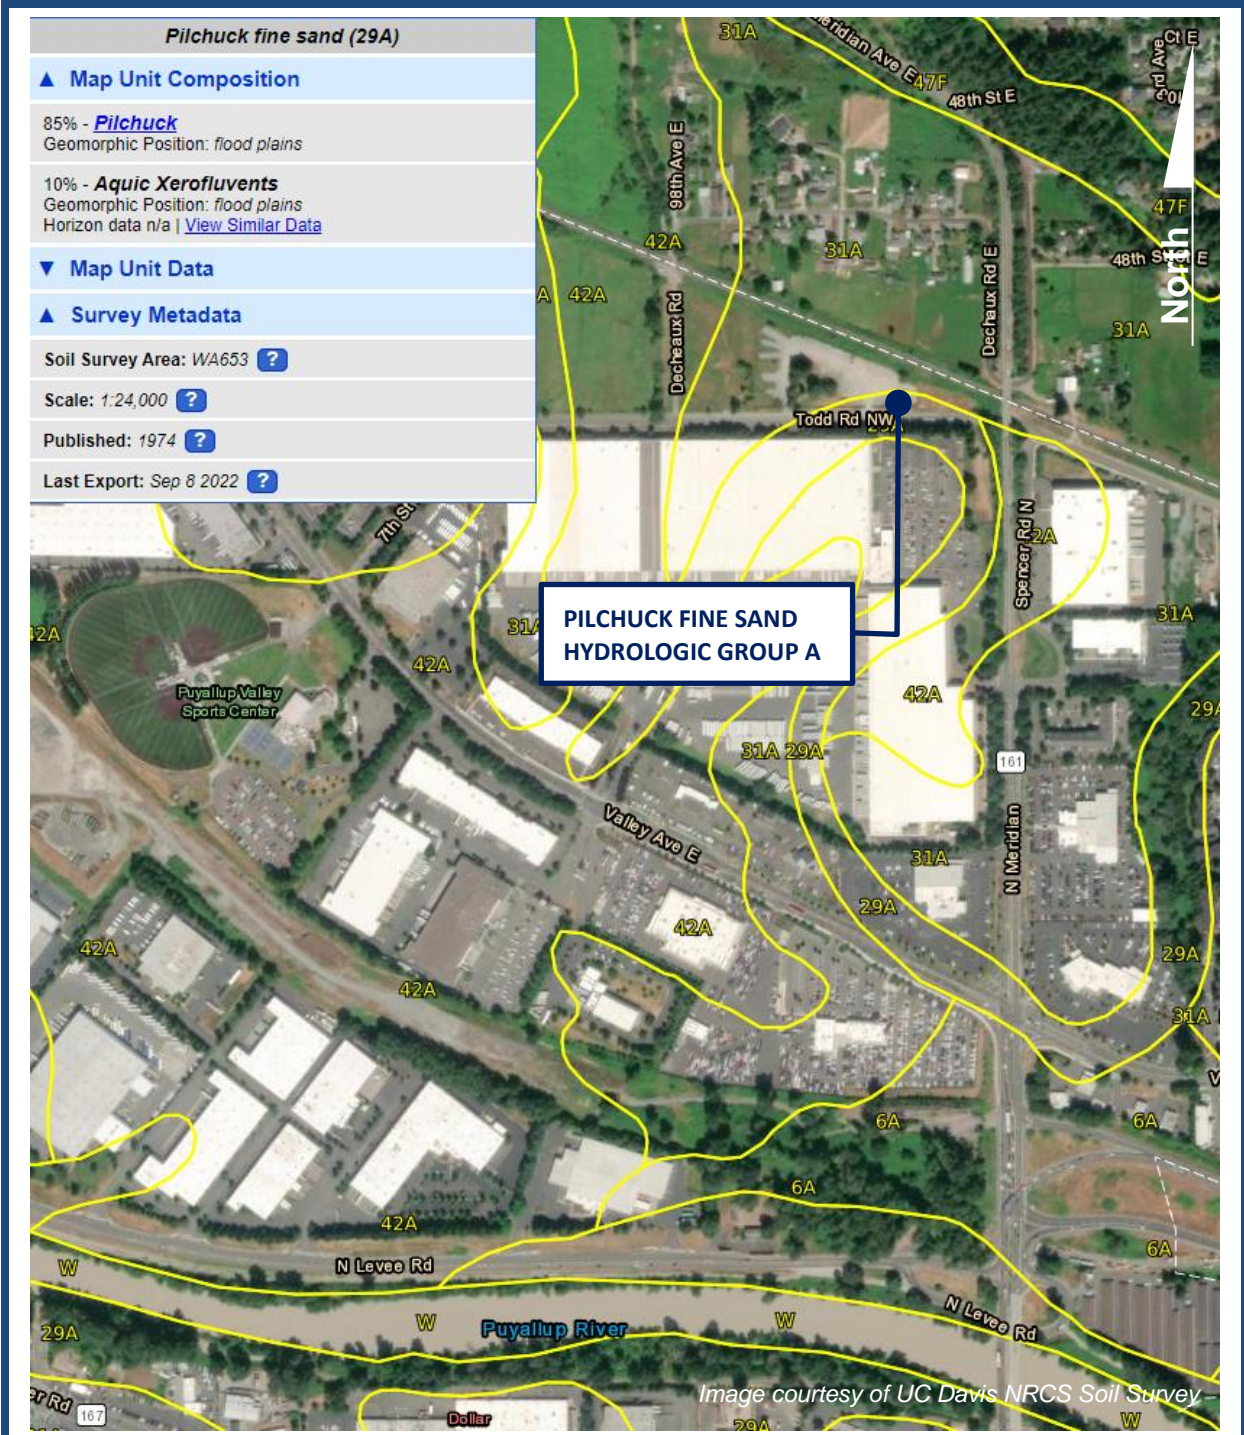
**Fig. 3c**

**Soil Map**

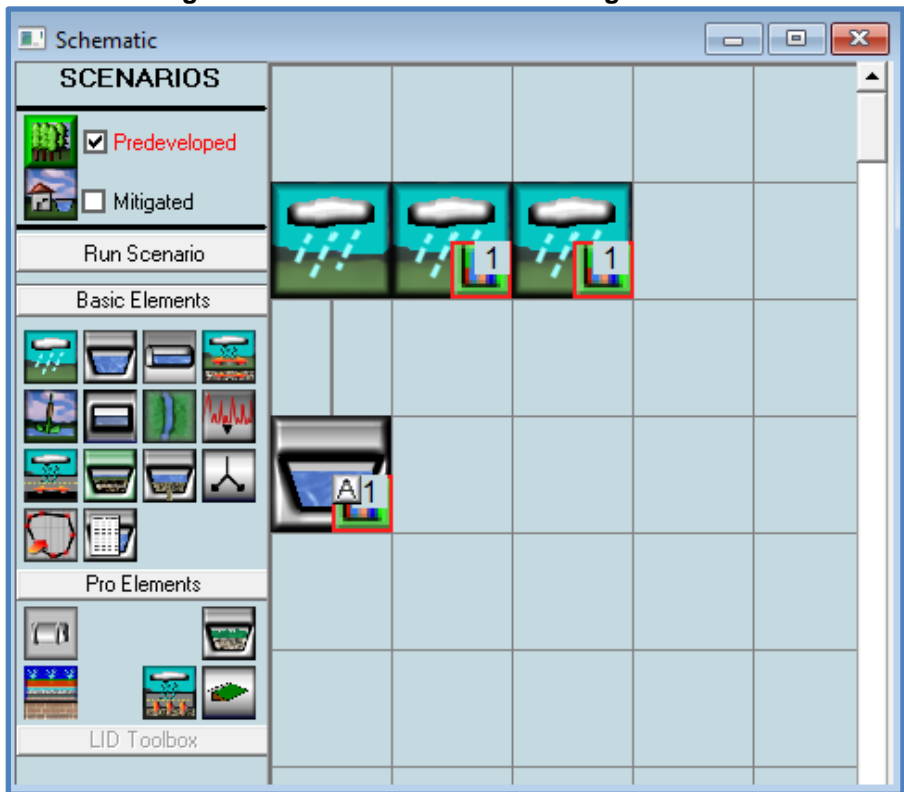
Figure C16 – Wetland Basin Existing Condition

A wetland hydroperiod analysis following Method 2 as outlined in Volume I, Section I-C.4 of the DOE Manual has been prepared for the off-site unmapped wetland. Method 2 compares the wetland's existing condition basin and proposed condition basin using WWHM's Wetland Input Volume analysis. A contributing basin for the off-site wetland was identified using aerial photography, City of Puyallup online mapping, and City Record Drawings. To be conservative, the contributing basin is limited to runoff discharging from the Todd Road NW storm conveyance system that outfalls to the roadside ditch. The analysis does not include Wapato Creek stream flow other basin areas that may contribute to Wapato Creek flow upstream of the project. Refer to Table C3 and C4 below for a summary of basin ground cover conditions and Figure 12 and 13 for a graphical depiction of the pre-development and post-development contributing basin.

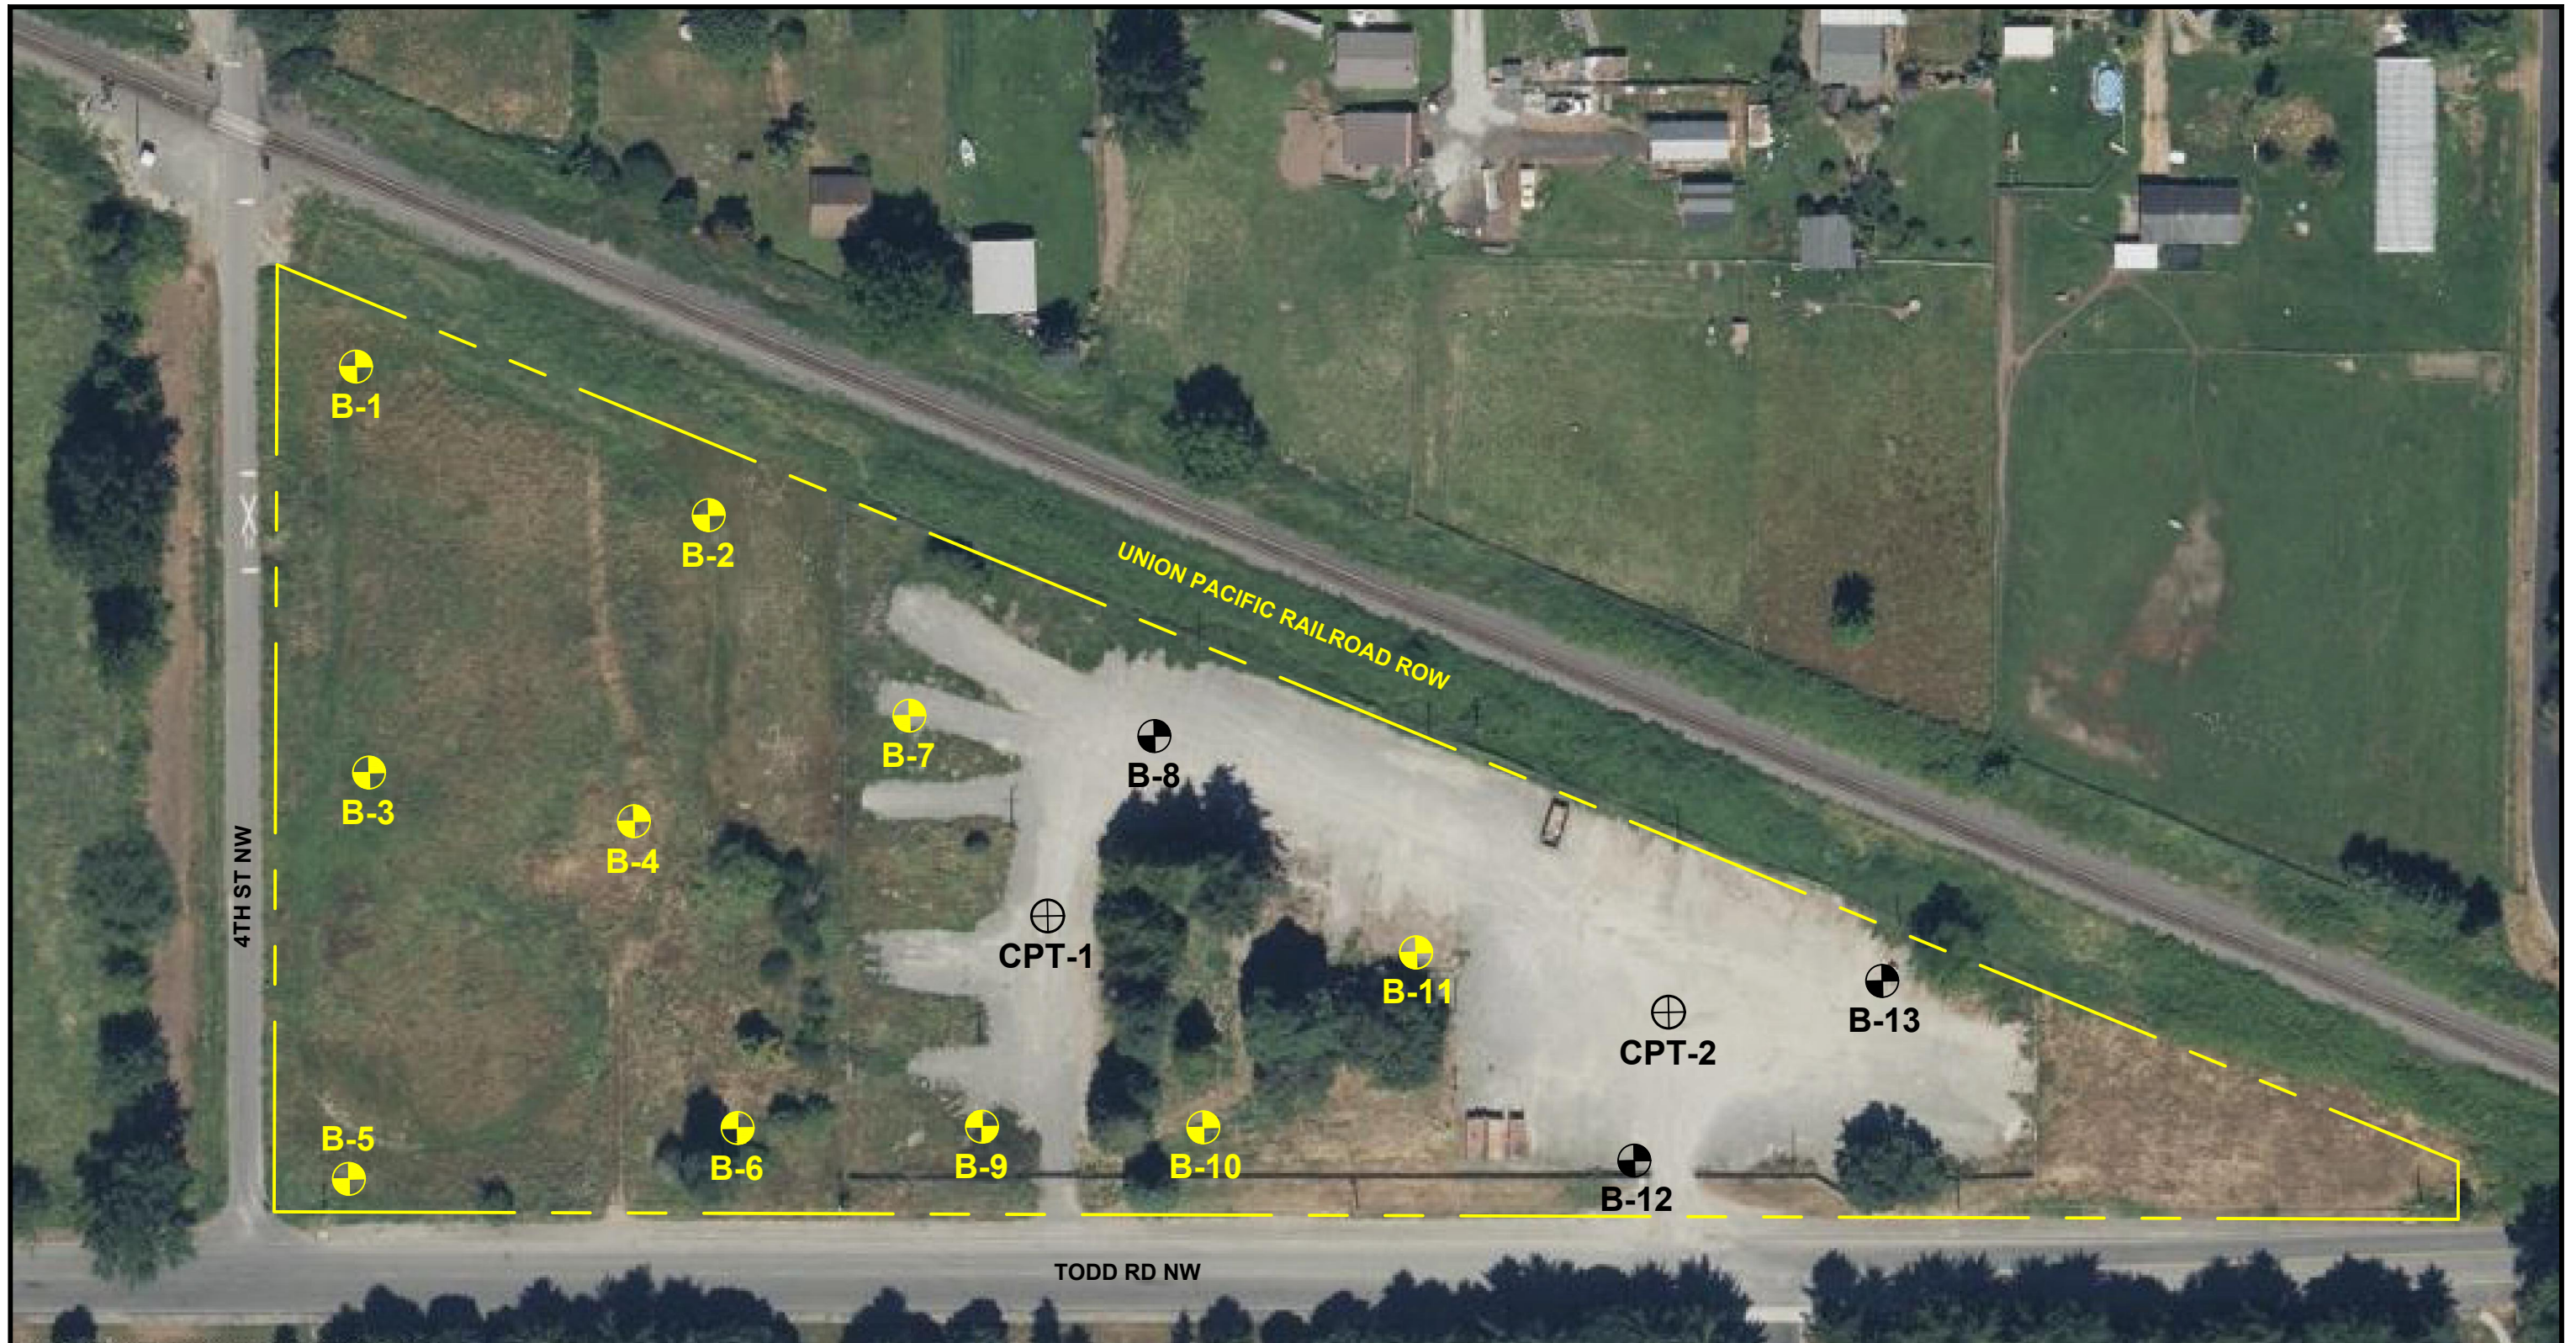
Figure 4

Stormwater runoff will be conveyed to a detention pond located in the eastern portion of the site. Pond elevations are currently not available. The proposed development plan is shown on Figure 4.

We explored subsurface conditions at the site by drilling 13 test borings to depths of 10 to 30 feet with a track-mounted drill rig using hollow-stem auger drilling methods, and by advancing two cone penetration tests (CPTs) to maximum depths of 60 and 70 feet. The boring logs and CPT plots are presented in Appendix A. The approximate boring and CPT locations are shown on Figure 4.

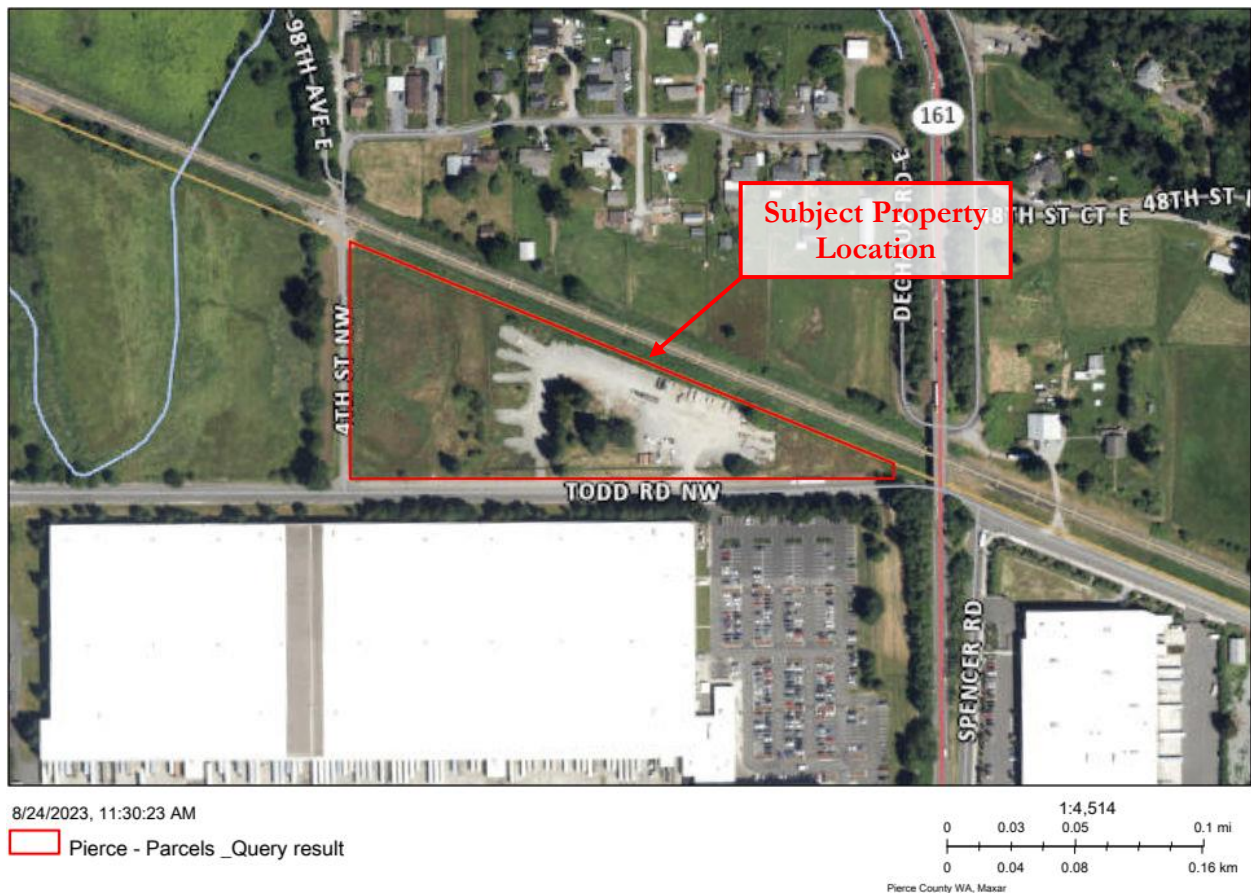
Figure 2. Aerial View of the Subject Property

The subject property is located in an urban-commercial and rural-residential setting within the City of Puyallup (Figure 2). The site is currently developed with a gravel lot throughout the eastern portion of the site that has been utilized for equipment storage and parking, and the western portion of the site consists of undeveloped field. A single-family residence and associated infrastructure was demolished between 2018 and 2019. Topography on the subject property is generally flat, sloping gently down from east to the west with elevations ranging from approximately 48 feet above mean sea level (amsl) to 40 feet amsl. A topographic map is provided in Appendix B1. The subject property is located within Water Resource Inventory Area (WRIA) 10 – Puyallup-White.

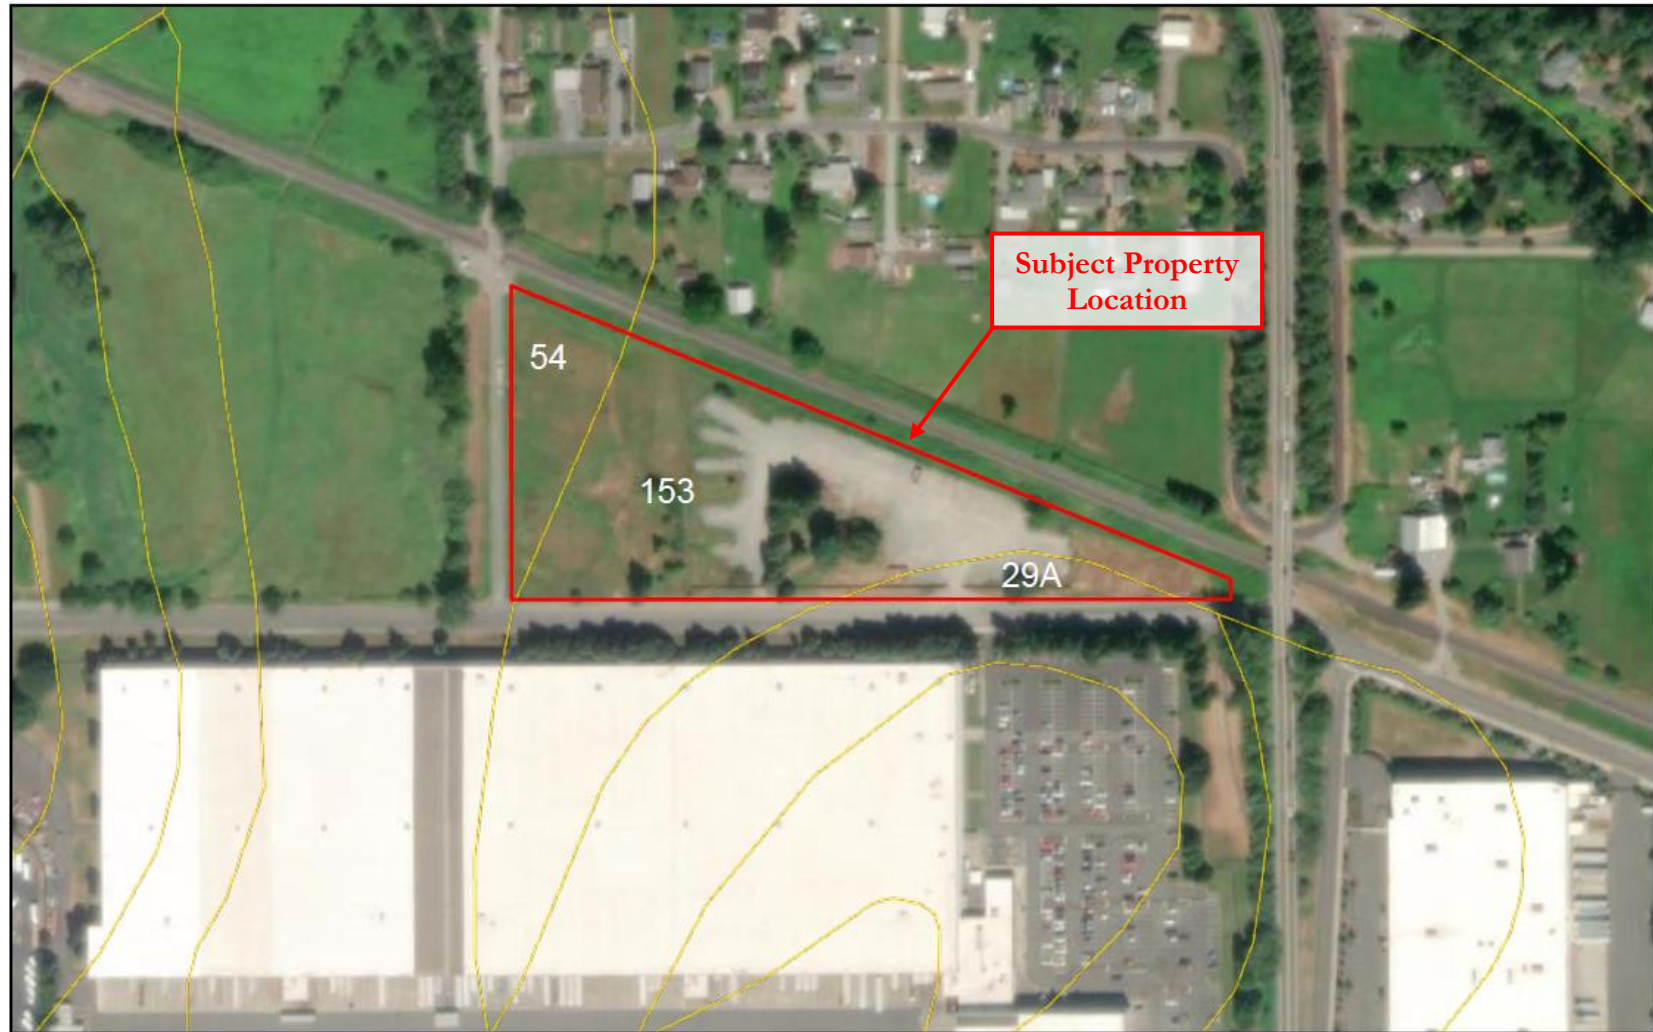
## Appendix B2. NRCS Soil Survey Map

The NRCS Soil Survey of Pierce County, Washington identifies three soil series on the site: Sultan silt loam (42A), Puyallup Fine Sandy Loam (31A), and Pilchuck Fine Sand (29A). A soil map is provided in Appendix B2 (Zulauf, 1979).

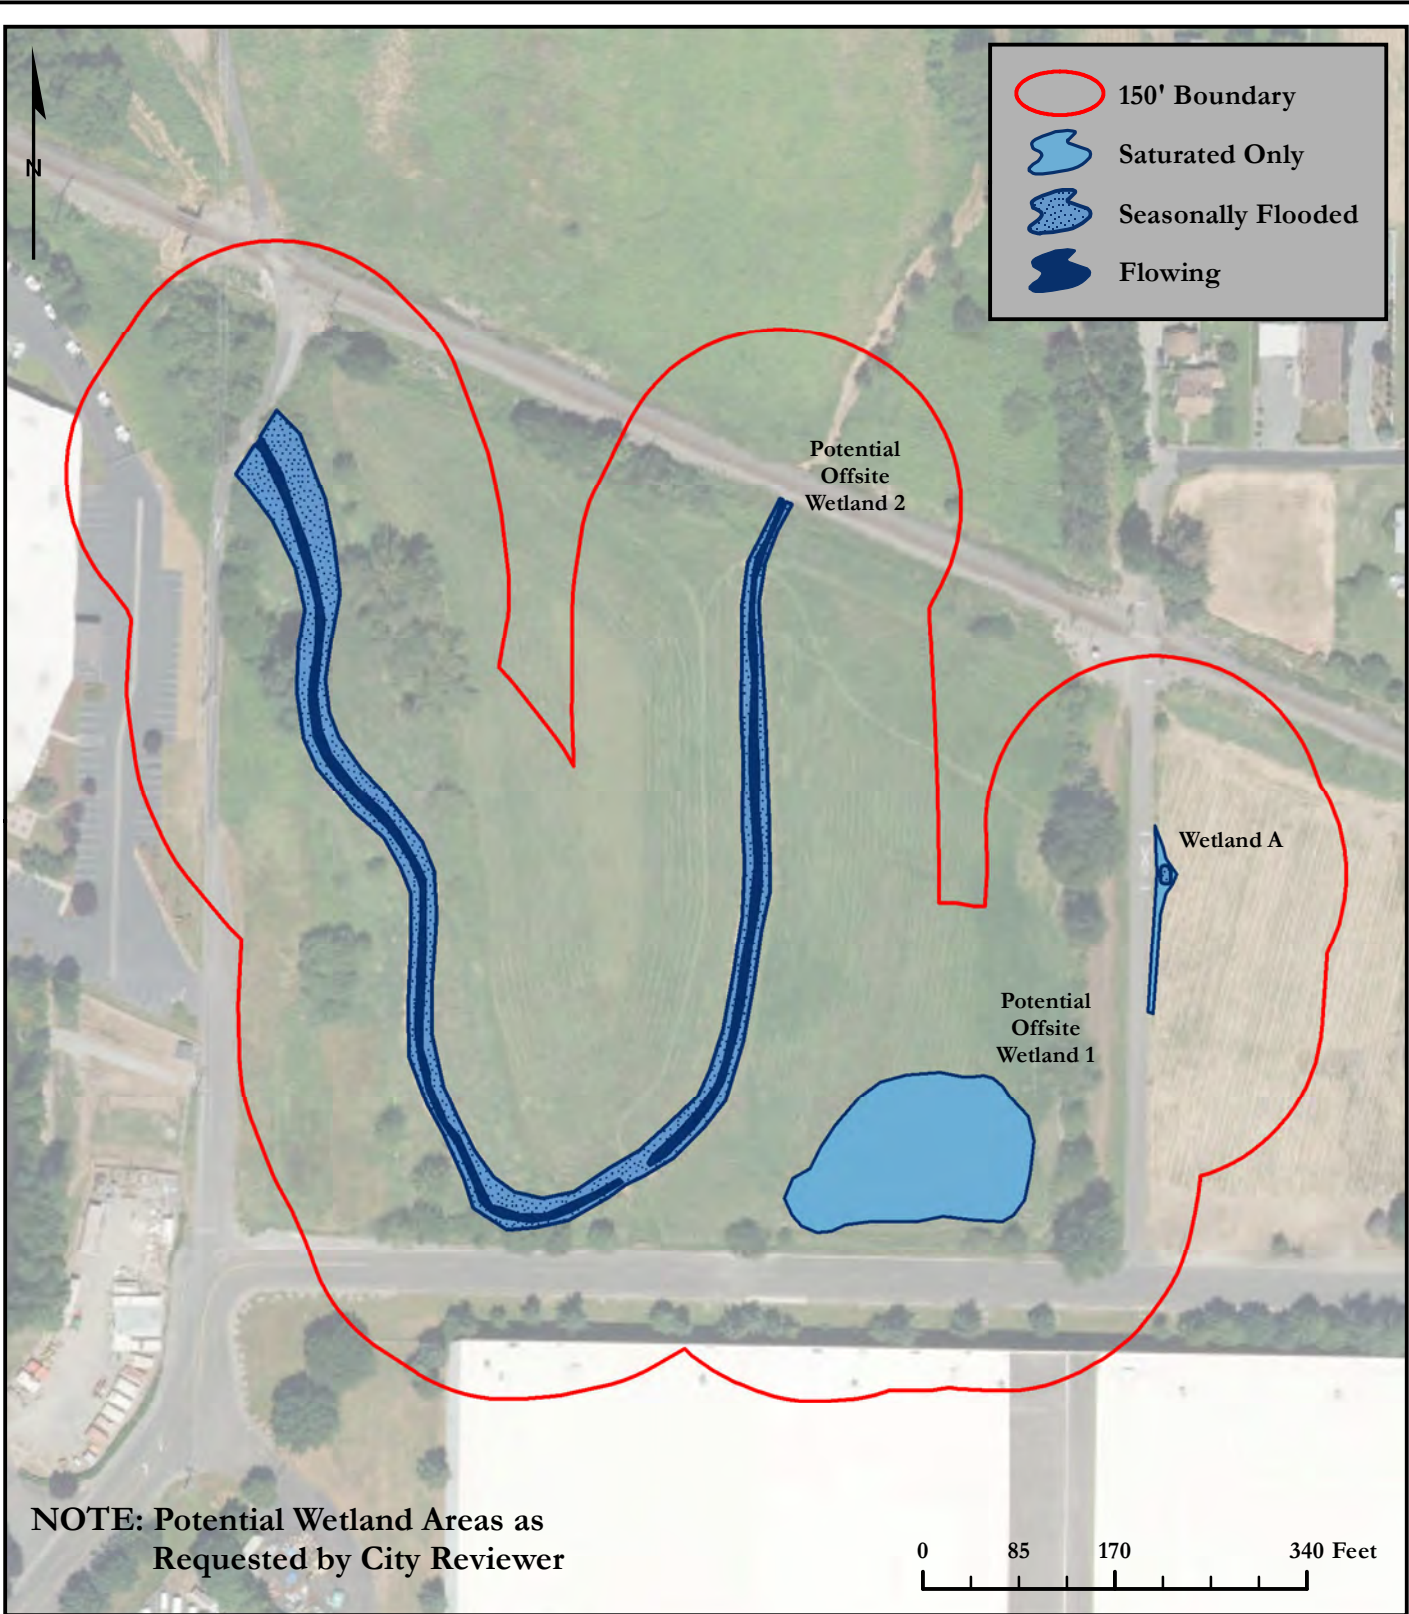
# HYDROPERIOD MAP

**NOTE: Potential Wetland Areas as Requested by City Reviewer**
