October 11, 2024  
ES-4556.03

Earth Solutions NW LLC

**Subject: Bearing Capacity Evaluation  
Cascade Christian School  
819 – 21<sup>st</sup> Street Southeast  
Puyallup, Washington**

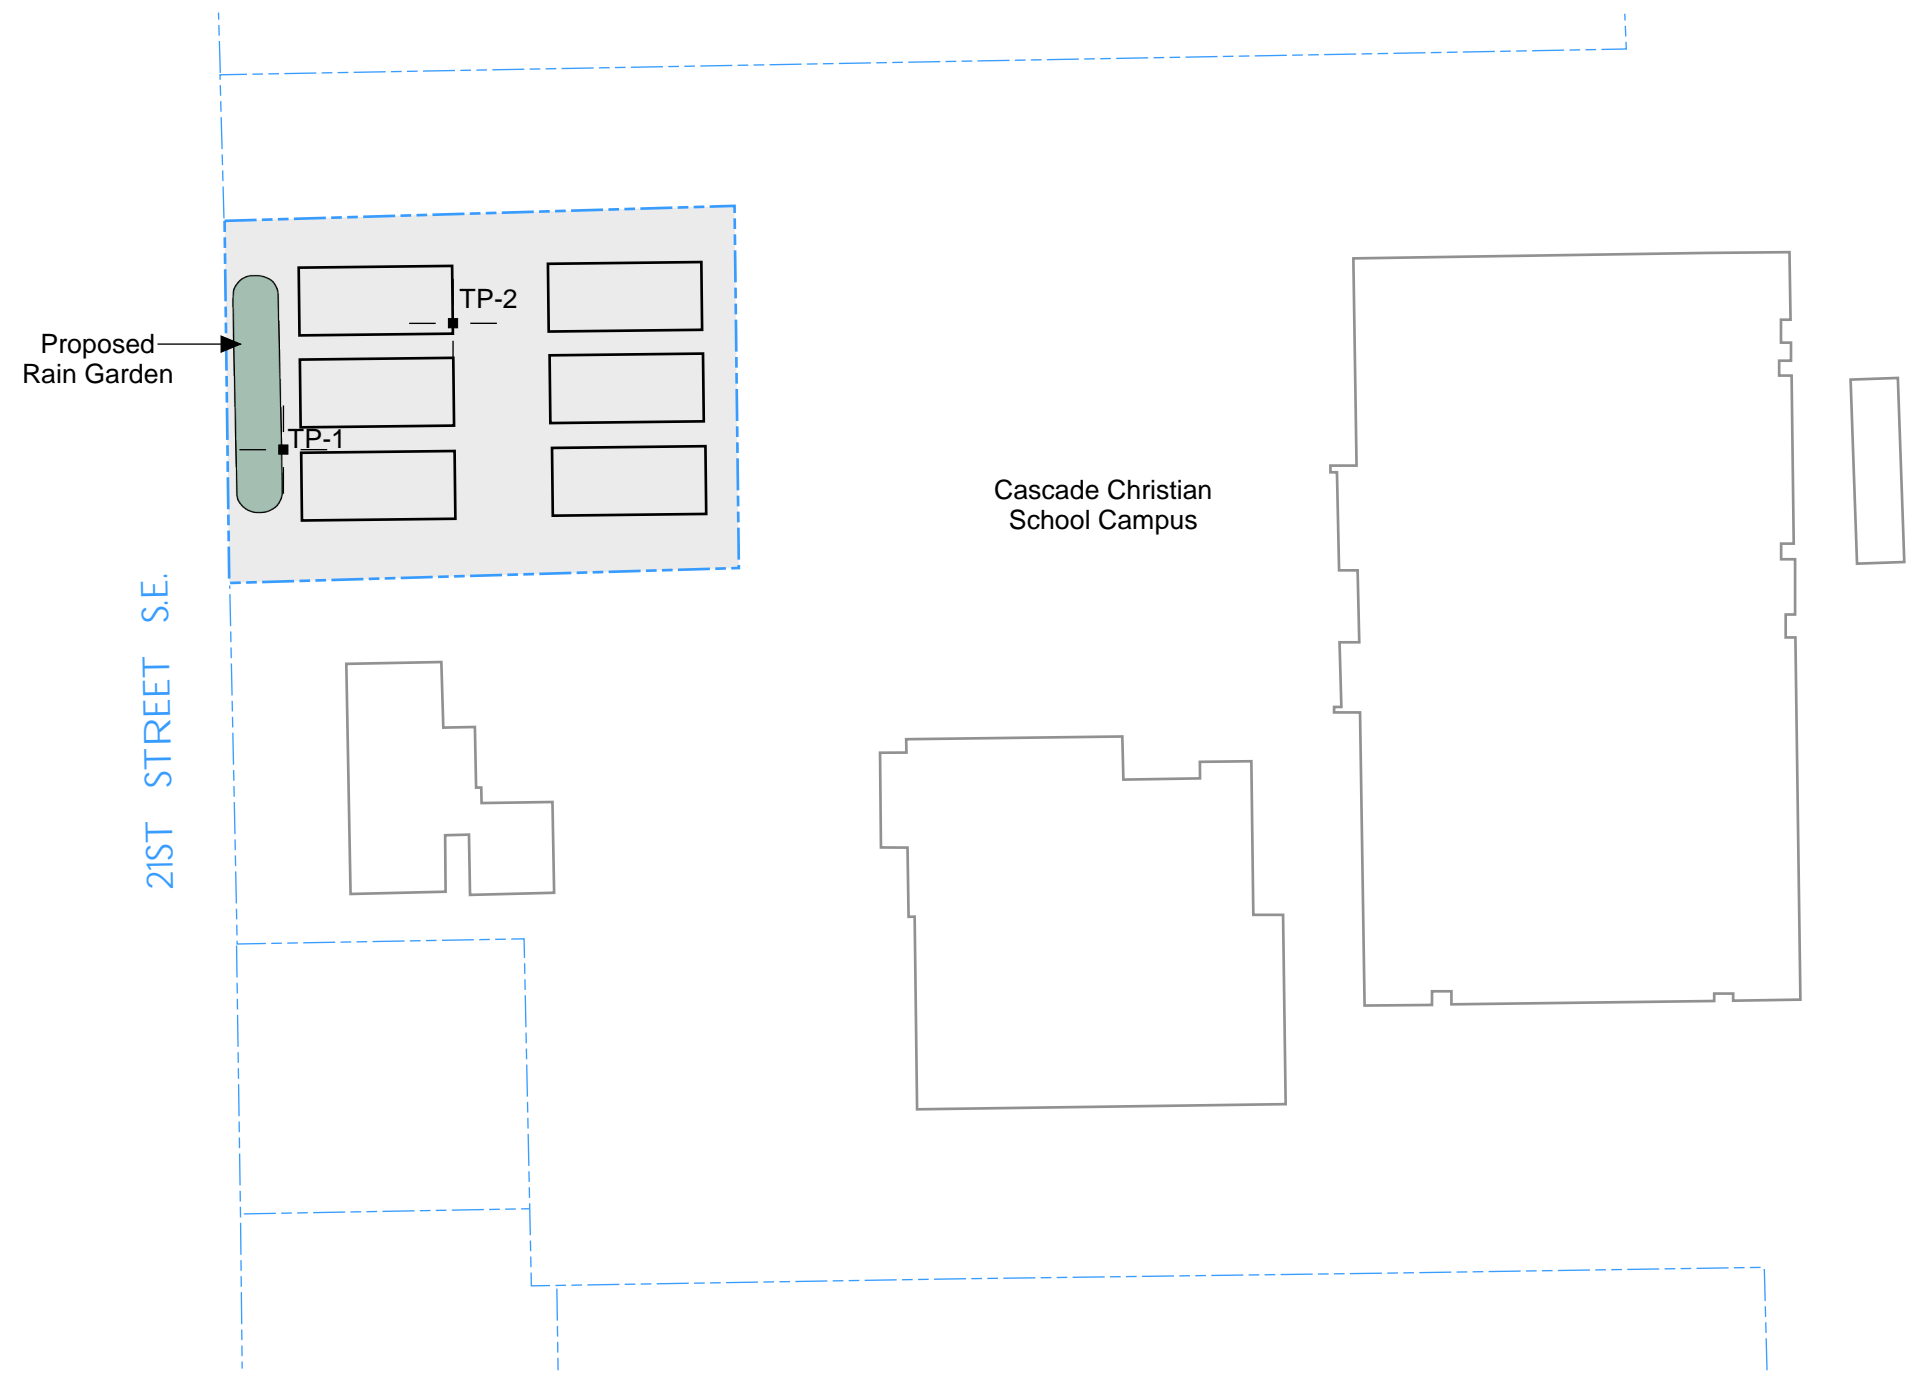
Drawn CAM
Checked SES
Date 10/11/2024
Proj. No. 4556.03
Plate 2

An ESNW representative observed, logged, and sampled two test pits on June 17, 2024. The test pits were excavated at accessible areas of the site. Based on our observations, native soils generally consisted of silty sand and localized exposures of sandy silt (USCS: SM and ML, respectively). In-situ soil density was generally characterized as loose to medium dense and in-situ soil moisture contents were characterized as moist to wet at the time of exploration. The maximum exploration depth was approximately nine and one-half feet below the ground surface (bgs). The local groundwater table was observed at test location TP-2 at a depth of approximately nine and one-half feet bgs during the June 2024 fieldwork. The locations of the test pits can be seen on the attached Test Pit Location Plan (Plate 2). The corresponding test pit logs are also attached to this letter.

Test Pit Location Plan  
Cascade Christian School  
Puyallup, Washington

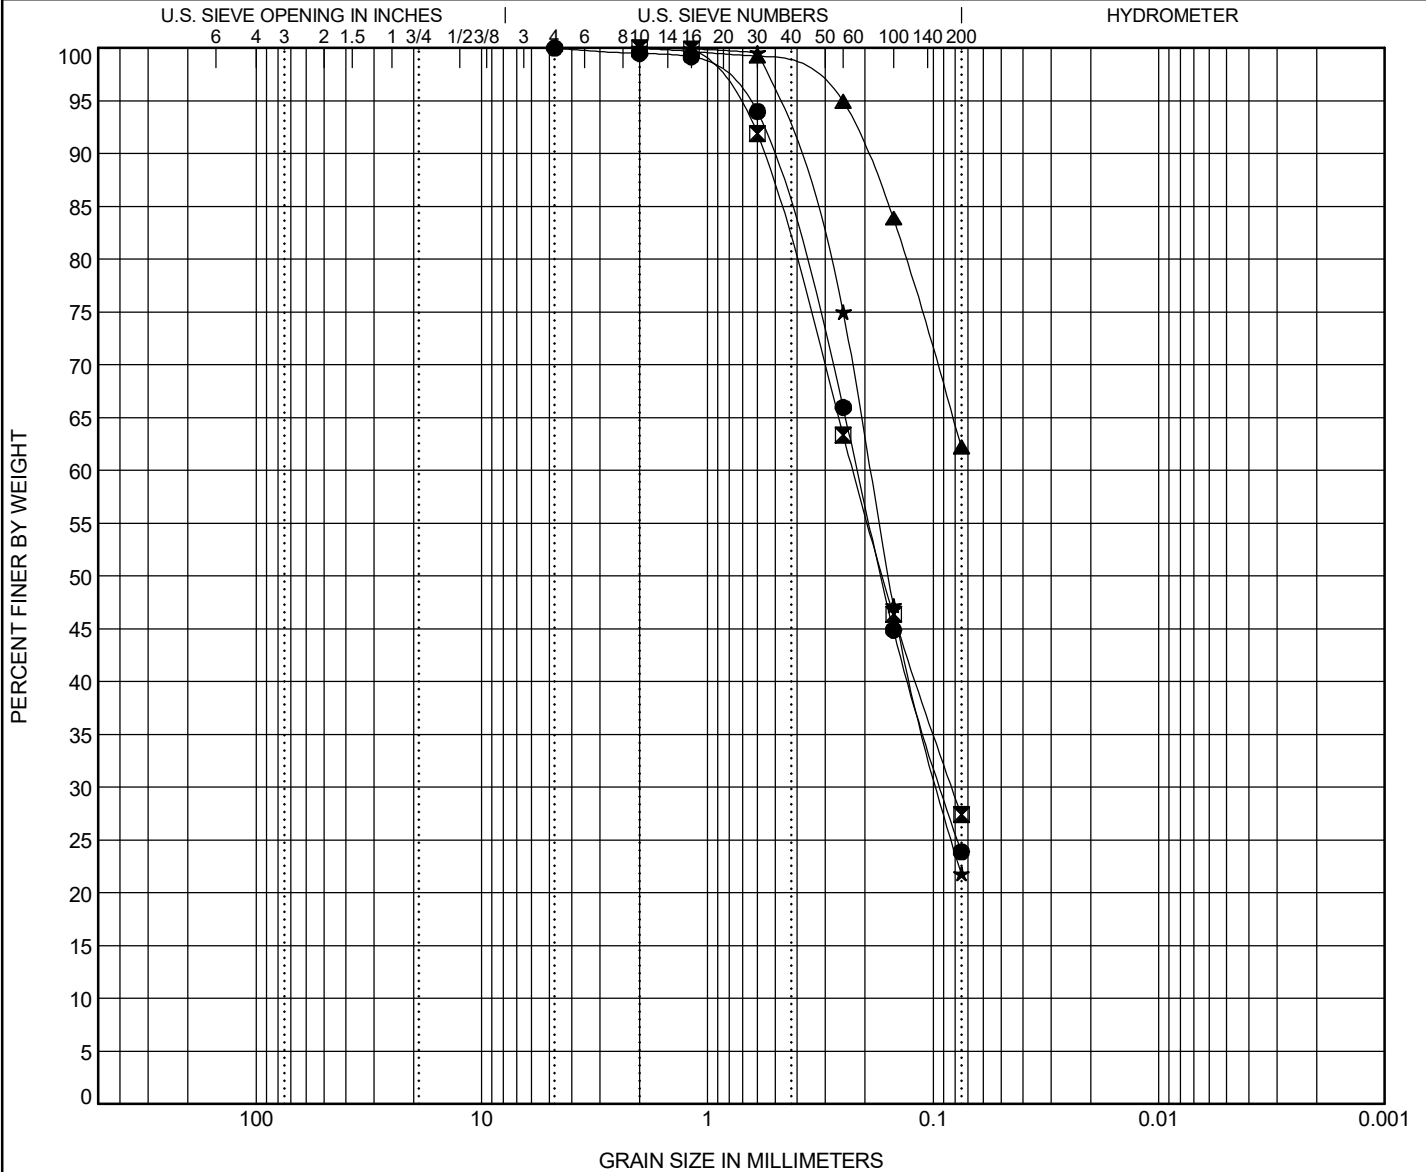
# GRAIN SIZE DISTRIBUTION

Specimen Identification	Classification						Cc	Cu
● TP-01 3.00ft.	<b>USDA: Dark Brown Slightly Gravelly Loamy Sand. USCS: SM.</b>							
☒ TP-01 5.00ft.	<b>USDA: Dark Brown Loamy Sand. USCS: SM.</b>							
▲ TP-01 8.50ft.	<b>USDA: Dark Brown Loam. USCS: Sandy ML.</b>							
★ TP-02 2.50ft.	<b>USDA: Dark Brown Loamy Sand. USCS: SM.</b>

Specimen Identification	D100	D60	D30	D10	LL	PL	PI	%Silt	%Clay
● TP-01 3.0ft.	4.75	0.216	0.092					23.9	
☒ TP-01 5.0ft.	2	0.226	0.082					27.4	
▲ TP-01 8.5ft.	2							62.2	
★ TP-02 2.5ft.	2	0.19	0.094					21.8

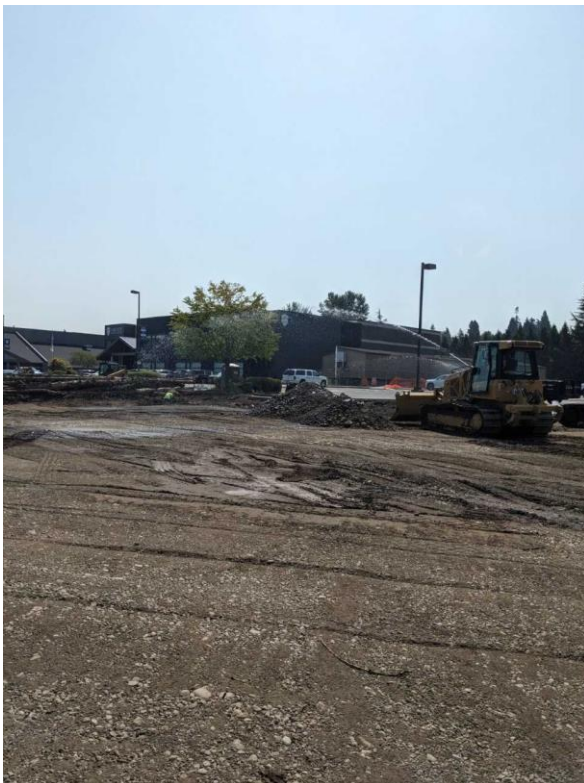
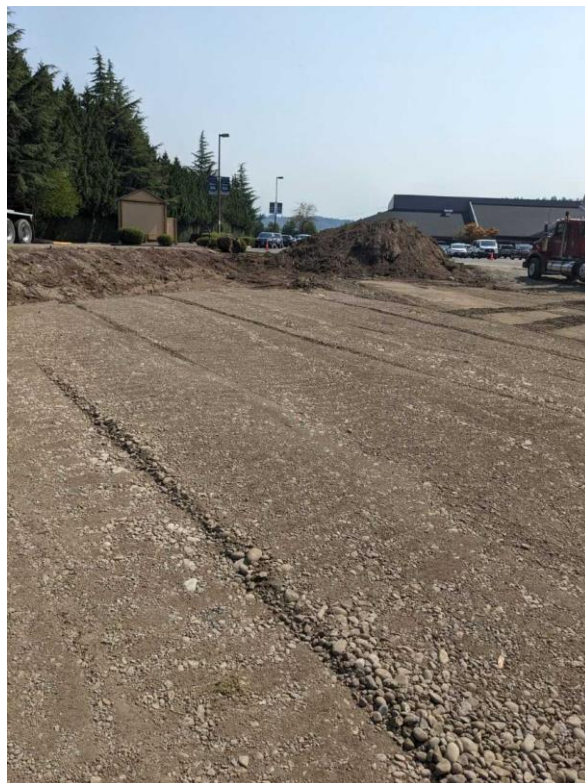
While onsite, ESNW observed the contractor grade and fill the area with imported material in approximately 6 inch lifts and compact with a large vibrating single-drum roller. Water was added to material during compaction. **Density test results indicate adequate compaction of at least 95% of the maximum dry density at the tested locations.** ESNW will return if requested.

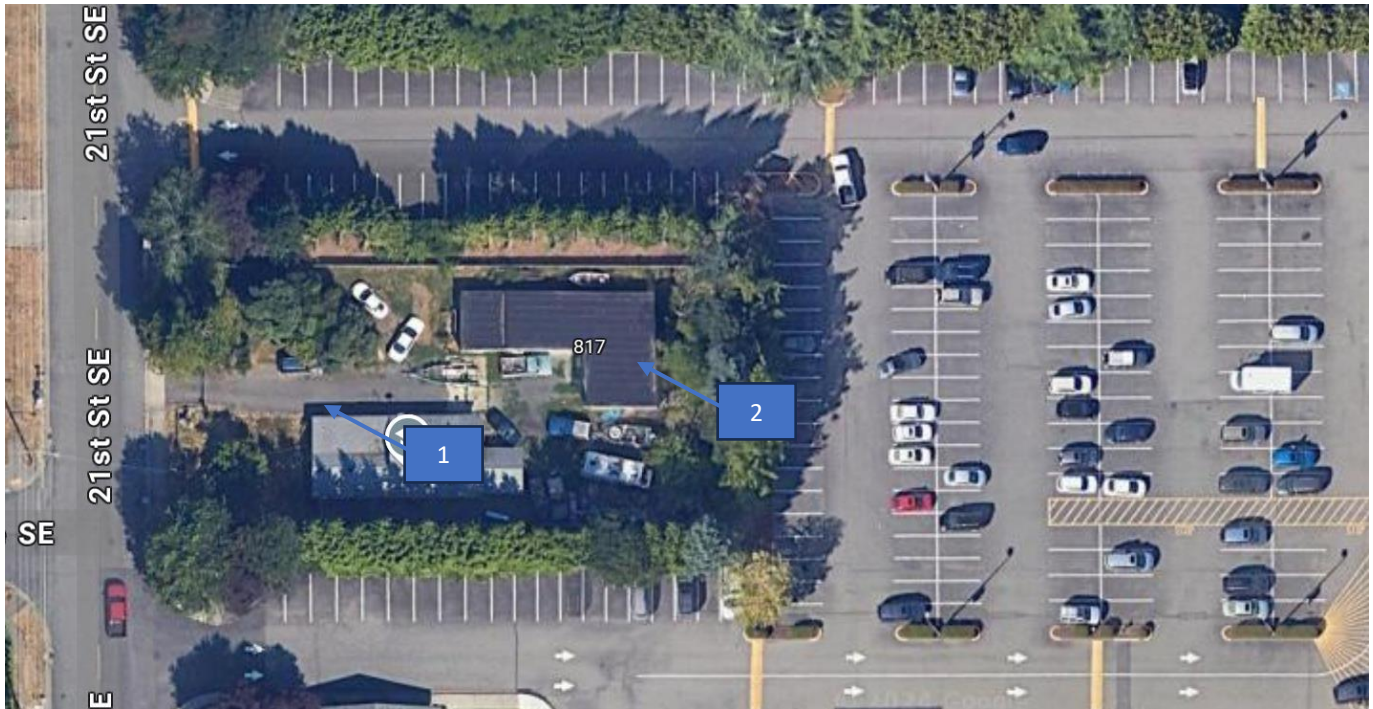
Test Number	Test Location	Elevation	Reference Proctor	Maximum Dry Density (pcf)	Test Moisture (%)	Test Dry Density (pcf)	% of MDD
1	General Fill	-1.5'	1	133.3	7.0	127.1	95
2	General Fill	-1.5'	1	133.3	6.4	127.8	96

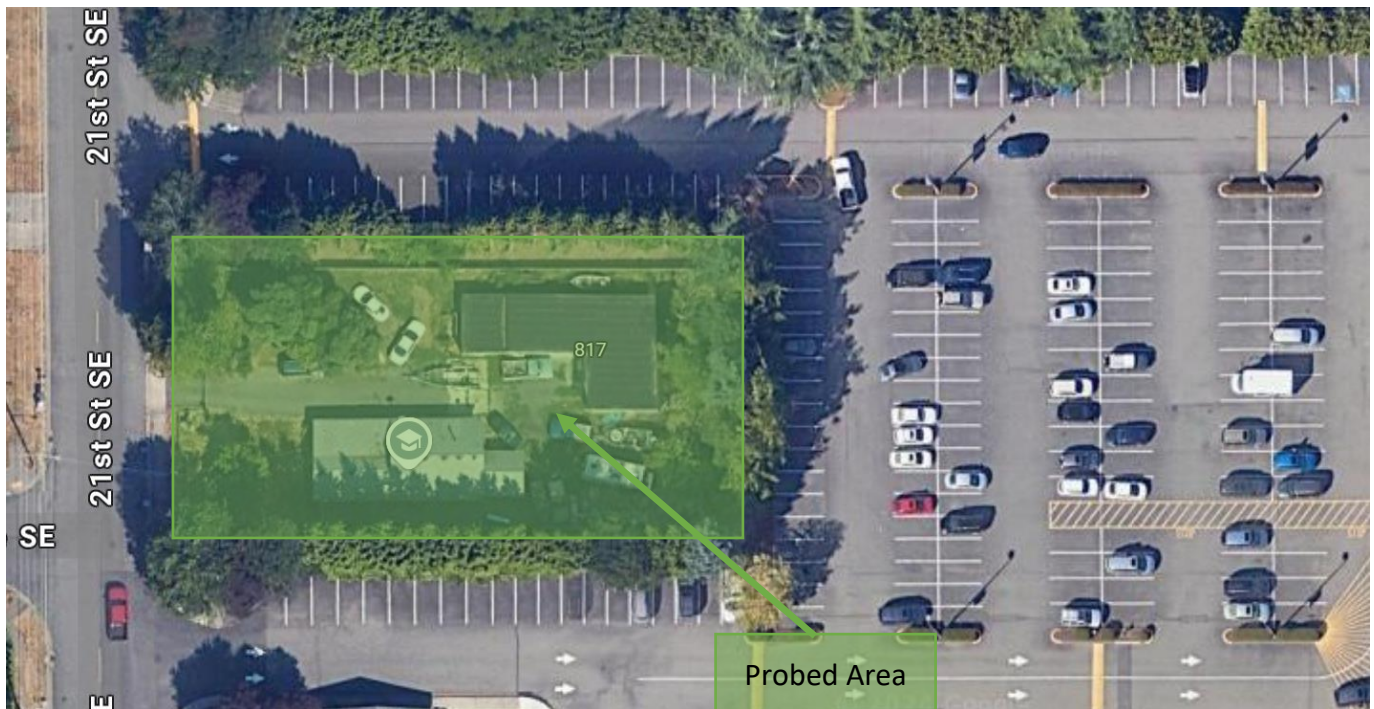
As requested, ESNW rep was onsite to observe fill and test compaction.

While onsite, ESNW observed the contractor grade and fill the area with imported material in approximately 6 inch lifts and compact with a large vibrating single-drum roller. Water was added to material during compaction. ESNW rep probed compacted fill with a ½-inch diameter steel T-probe. **ESNW rep observed the area to be dense.** ESNW will return if requested.

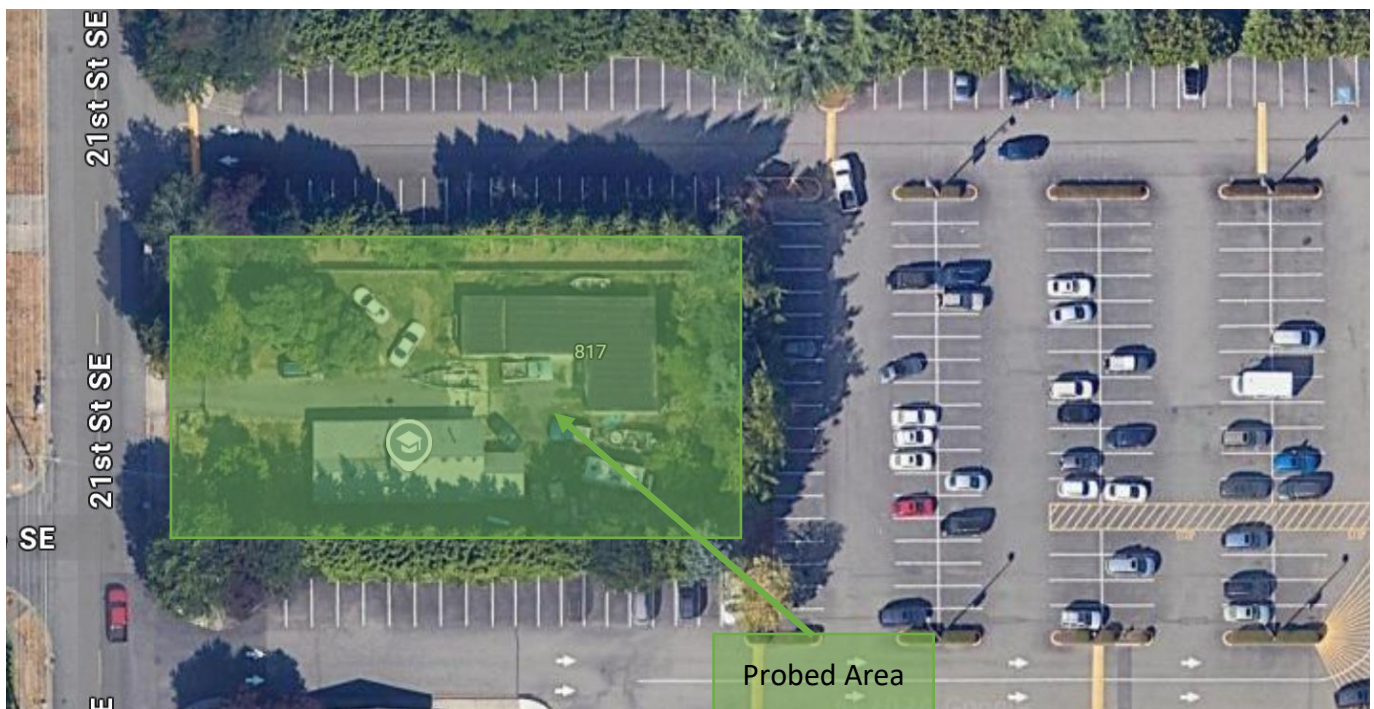
As requested, ESNW rep was onsite to observe fill and test compaction.

While onsite, ESNW observed the contractor grade and fill the area with imported material in approximately 6 inch lifts and compact with a large vibrating single-drum roller. Water was added to material during compaction. ESNW rep probed the compacted fill with a ½-inch diameter steel T-probe. **ESNW rep observed the area to be dense.** ESNW will return if requested.
