April 9, 2020  
Updated January 21, 2021  
ES-7182

Earth Solutions NW LLC

**Subject: Preliminary Geotechnical Evaluation  
Proposed Townhomes  
1200 – 7<sup>th</sup> Avenue Southeast  
Puyallup, Washington**

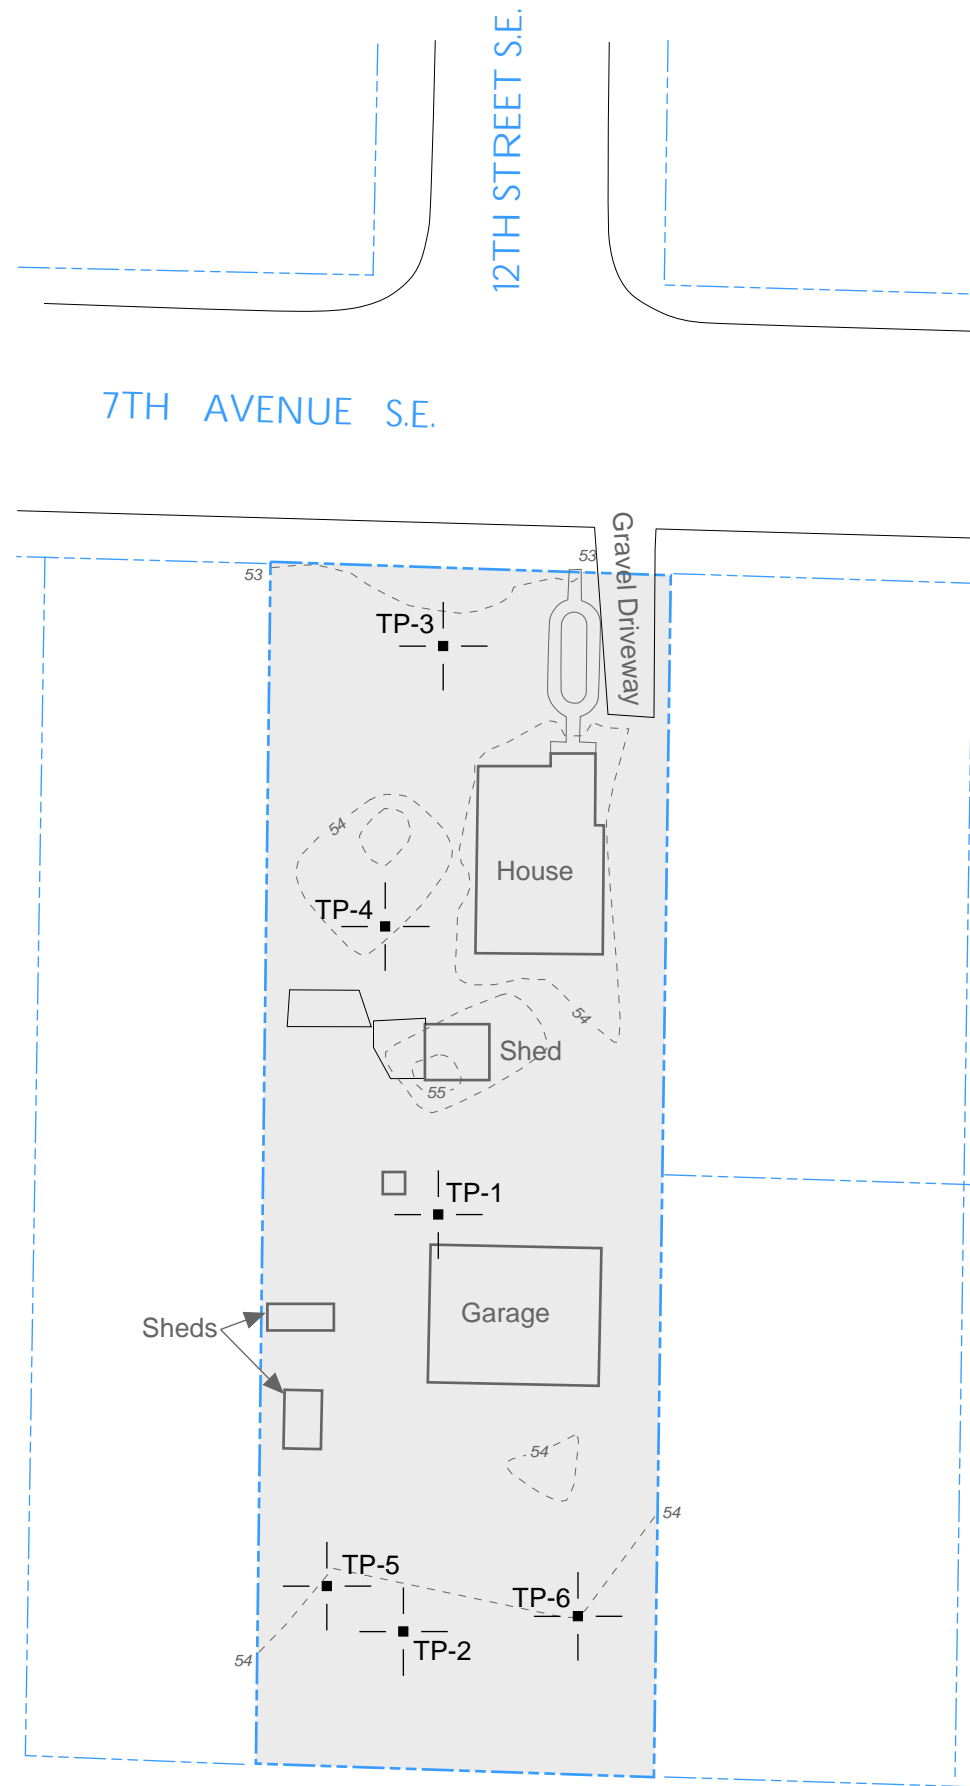
Test Pit Location Plan  
1200 – 7th Ave Townhomes  
Puyallup, Washington

- TP-1 | Approximate Location of ESNW Test Pit, Proj. No. ES-7182, Mar./Dec. 2020
- Subject Site
- Existing Building

The approximate locations of the test pits are depicted on Plate 2 (Test Pit Location Plan). Please refer to the attached test pit logs for a more detailed description of subsurface conditions. Representative soil samples collected at the test pit locations were analyzed in general accordance with both Unified Soil Classification System (USCS) and USDA methods and procedures.

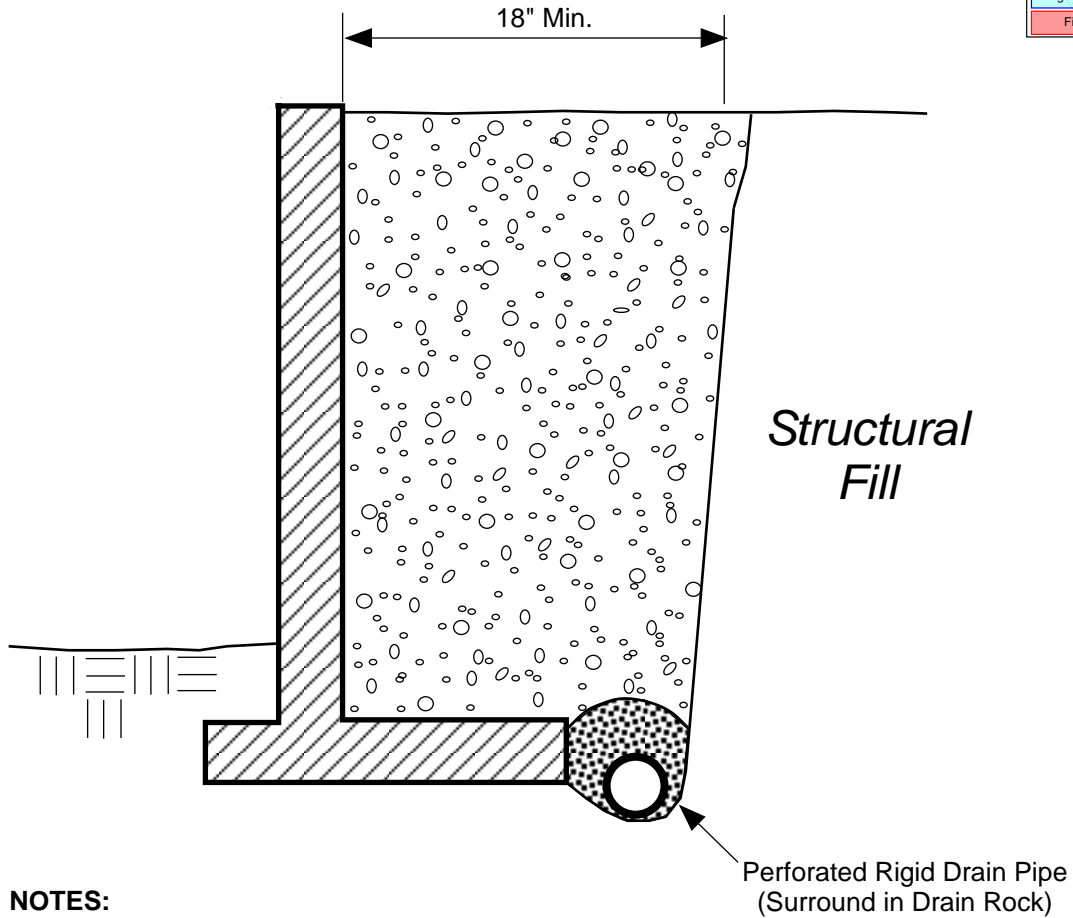
<b>Earth Solutions NW<sub>LLC</sub></b> Geotechnical Engineering Construction Observation/Testing and Environmental Services	
	<b>Retaining Wall Drainage Detail</b> 1200 – 7th Ave Townhomes Puyallup, Washington	
Drwn. MRS	Date 01/19/2021	Proj. No. 7182
Checked SES	Date Jan. 2021	Plate 3

- Free-draining Backfill should consist of soil having less than 5 percent fines. Percent passing No. 4 sieve should be 25 to 75 percent.
- Sheet Drain may be feasible in lieu of Free-draining Backfill, per ESNW recommendations.
- Drain Pipe should consist of perforated, rigid PVC Pipe surrounded with 1-inch Drain Rock.

Retaining walls should be backfilled with free-draining material that extends along the height of the wall and a distance of at least 18 inches behind the wall. The upper 12 inches of the wall backfill may consist of a less permeable soil if desired. A perforated drainpipe should be placed along the base of the wall and connected to an approved discharge location. A typical retaining wall drainage detail is provided on Plate 3. If drainage is not provided, hydrostatic pressures should be included in the wall design.

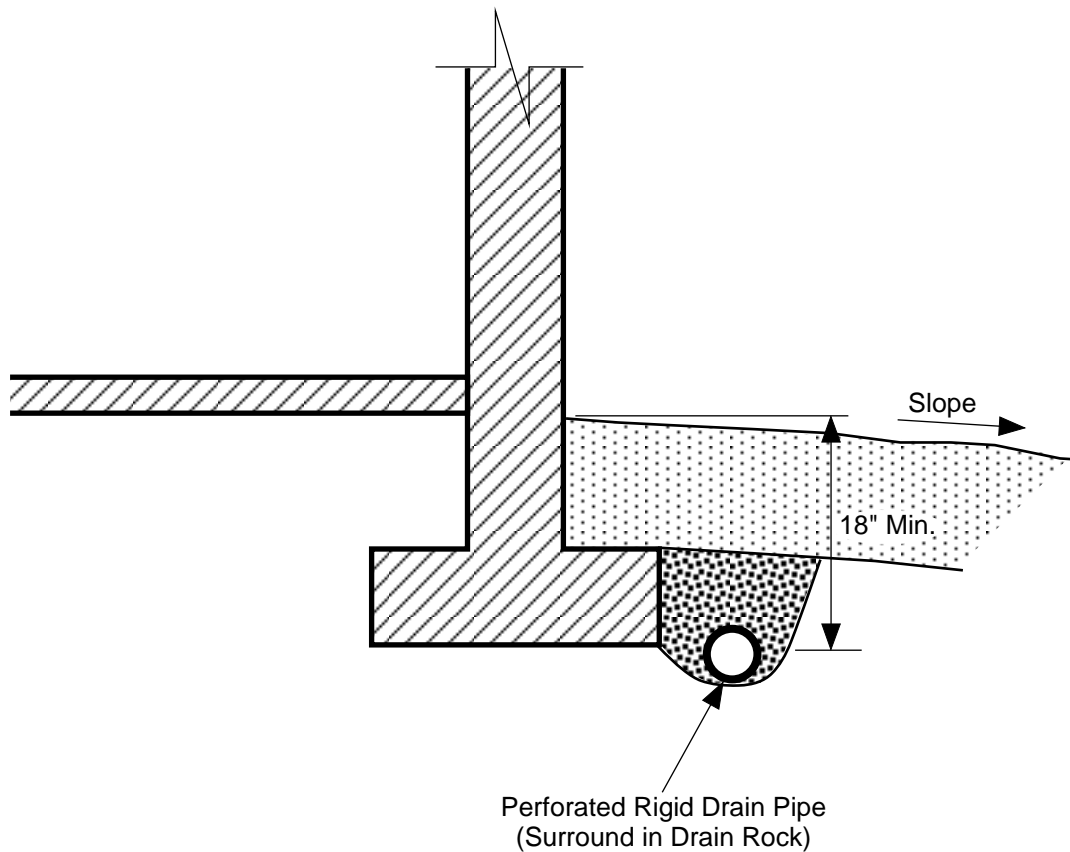
<b>Earth Solutions NW LLC</b> Geotechnical Engineering, Construction Observation/Testing and Environmental Services	
	<b>Footing Drain Detail</b> 1200 – 7th Ave Townhomes Puyallup, Washington	
Drwn. MRS	Date 01/19/2021	Proj. No. 7182
Checked SES	Date Jan. 2021	Plate 4

- Do NOT tie roof downspouts to Footing Drain.
- Surface Seal to consist of 12" of less permeable, suitable soil. Slope away from building.

Finish grades must be designed to direct surface drain water away from structures and slopes. Water must not be allowed to pond adjacent to structures. In our opinion, foundation drains should be installed along building perimeter footings. A typical foundation drain detail is provided on Plate 4.

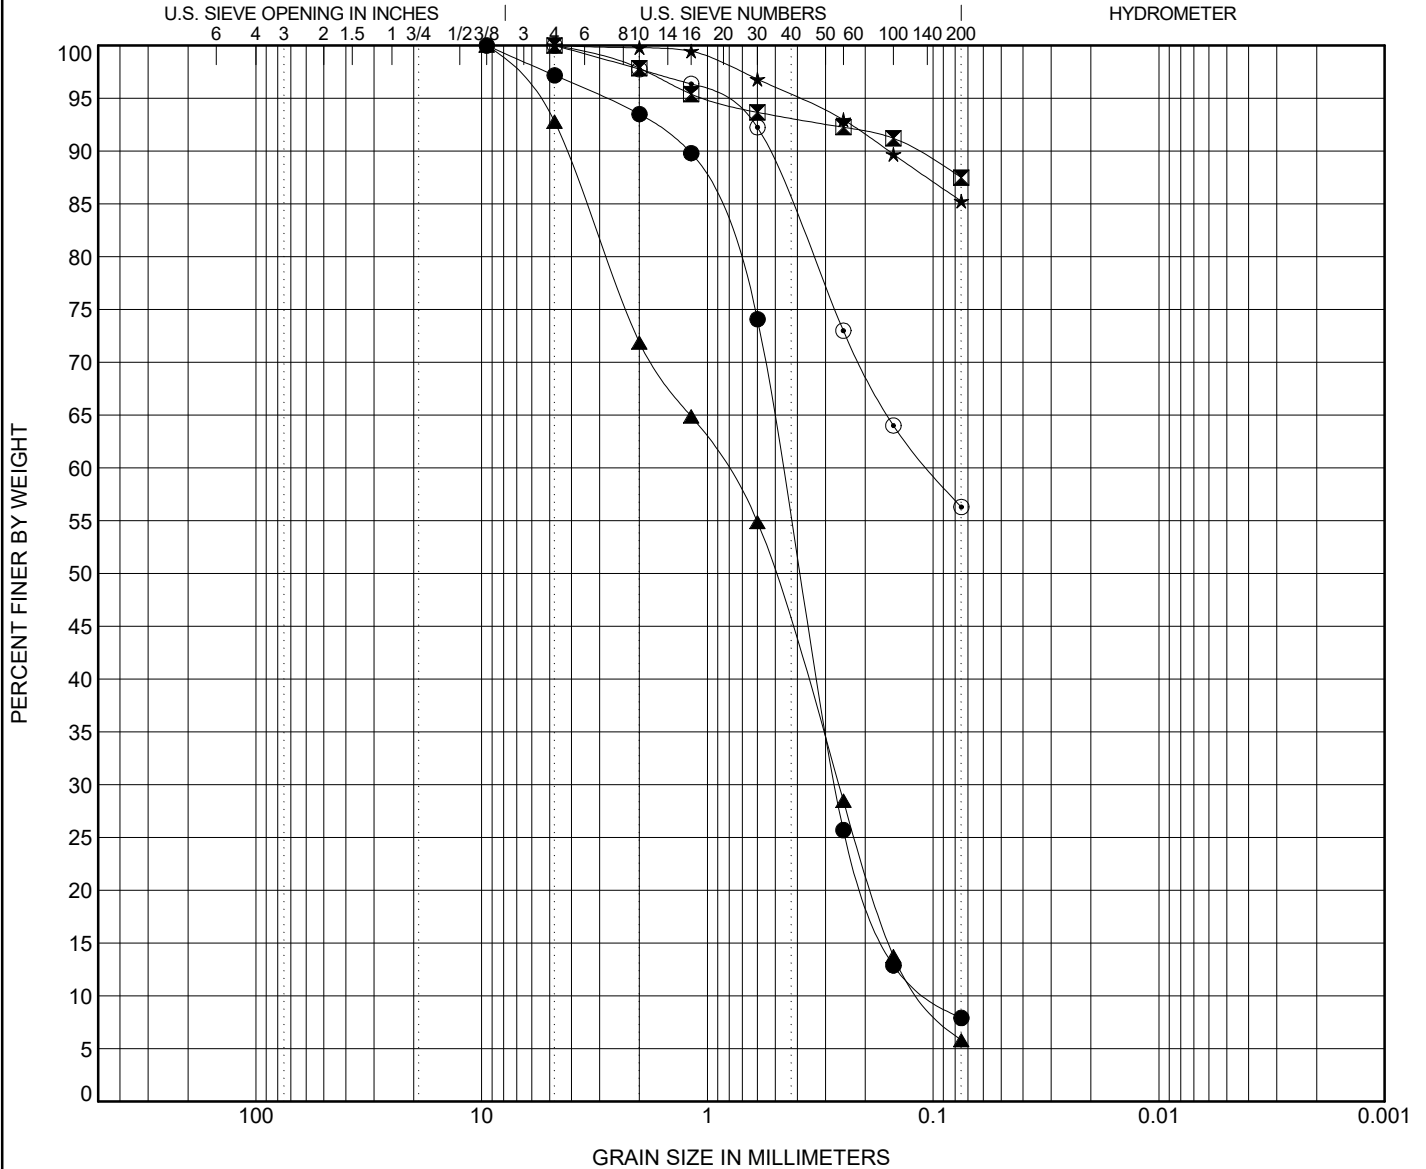
Specimen Identification	Classification						Cc	Cu
● TP-01 3.0ft.	USDA: Dark Gray Slightly Gravelly Sand. USCS: SP-SM.						1.56	4.63
☒ TP-02 1.5ft.	USDA: Gray Slightly Gravelly Loam. USCS: ML.							
▲ TP-02 5.0ft.	USDA: Dark Gray Gravelly Sand. USCS: SP-SM.						0.75	7.86
★ TP-02 7.0ft.	USDA: Gray Slightly Gravelly Loam. USCS: ML.							
⊙ TP-03 1.0ft.	USDA: Brown Slightly Gravelly Loam. USCS: Sandy ML.

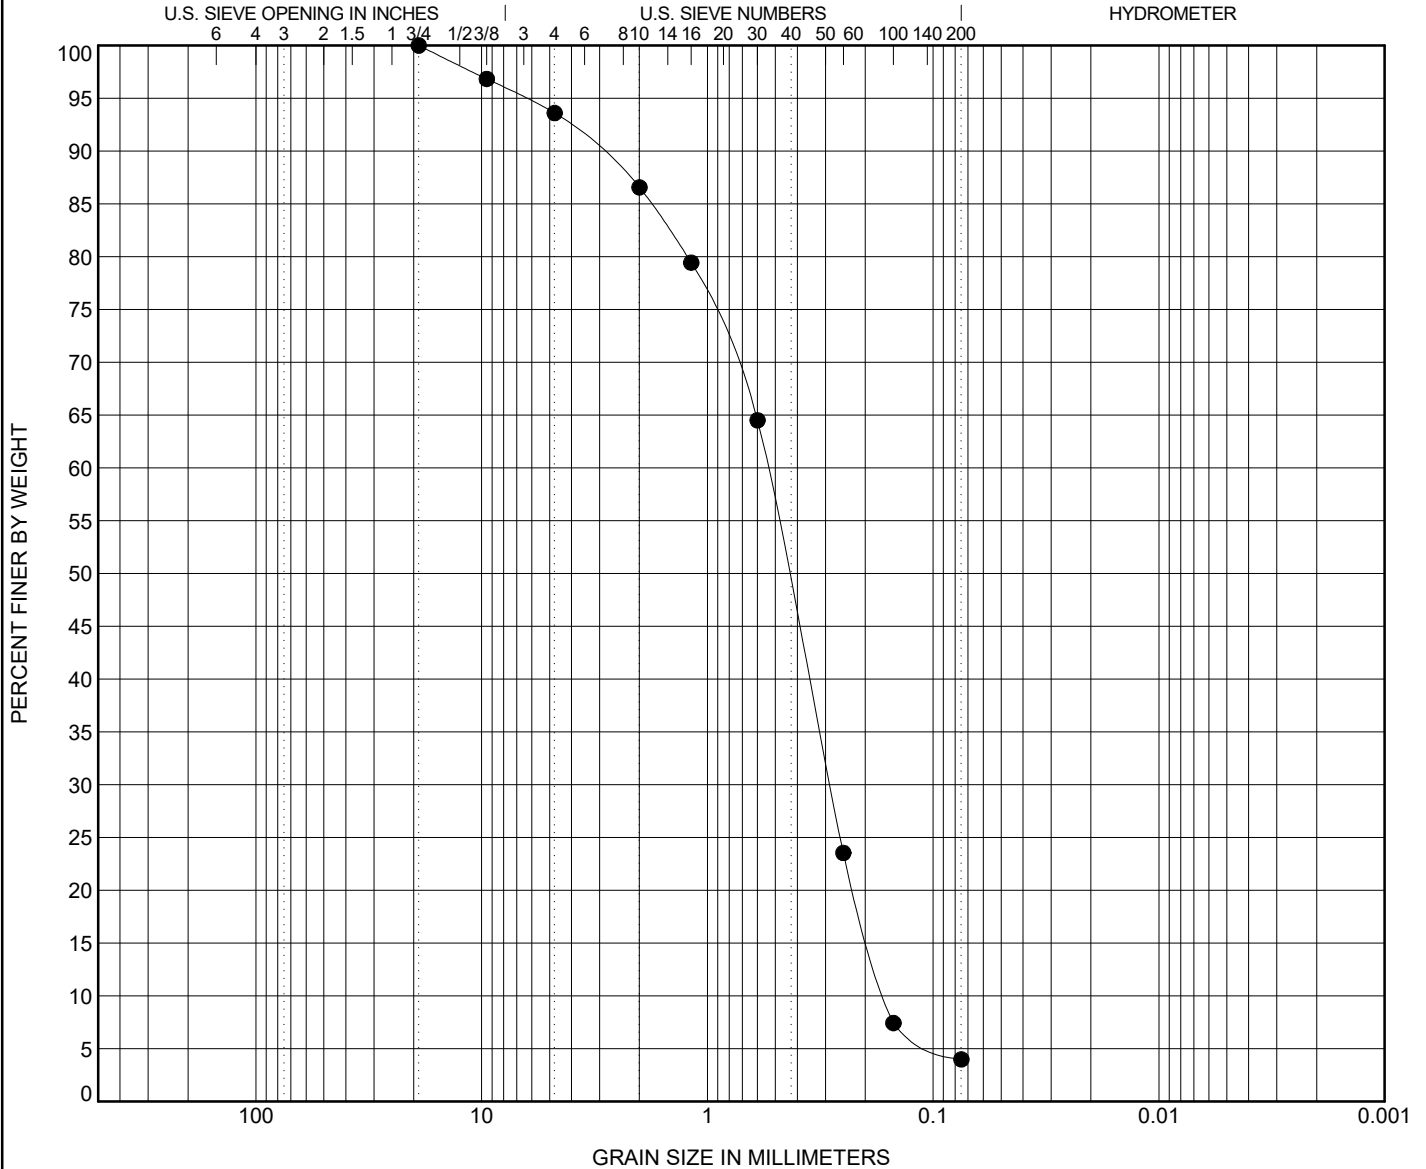
Specimen Identification		Classification								Cc	Cu	
●	TP-03	3.0ft.	<b>UDSA: Dark Gray Slightly Gravelly Coarse Sand. USCS: SP.</b>								<b>0.93</b>	<b>3.35</b>

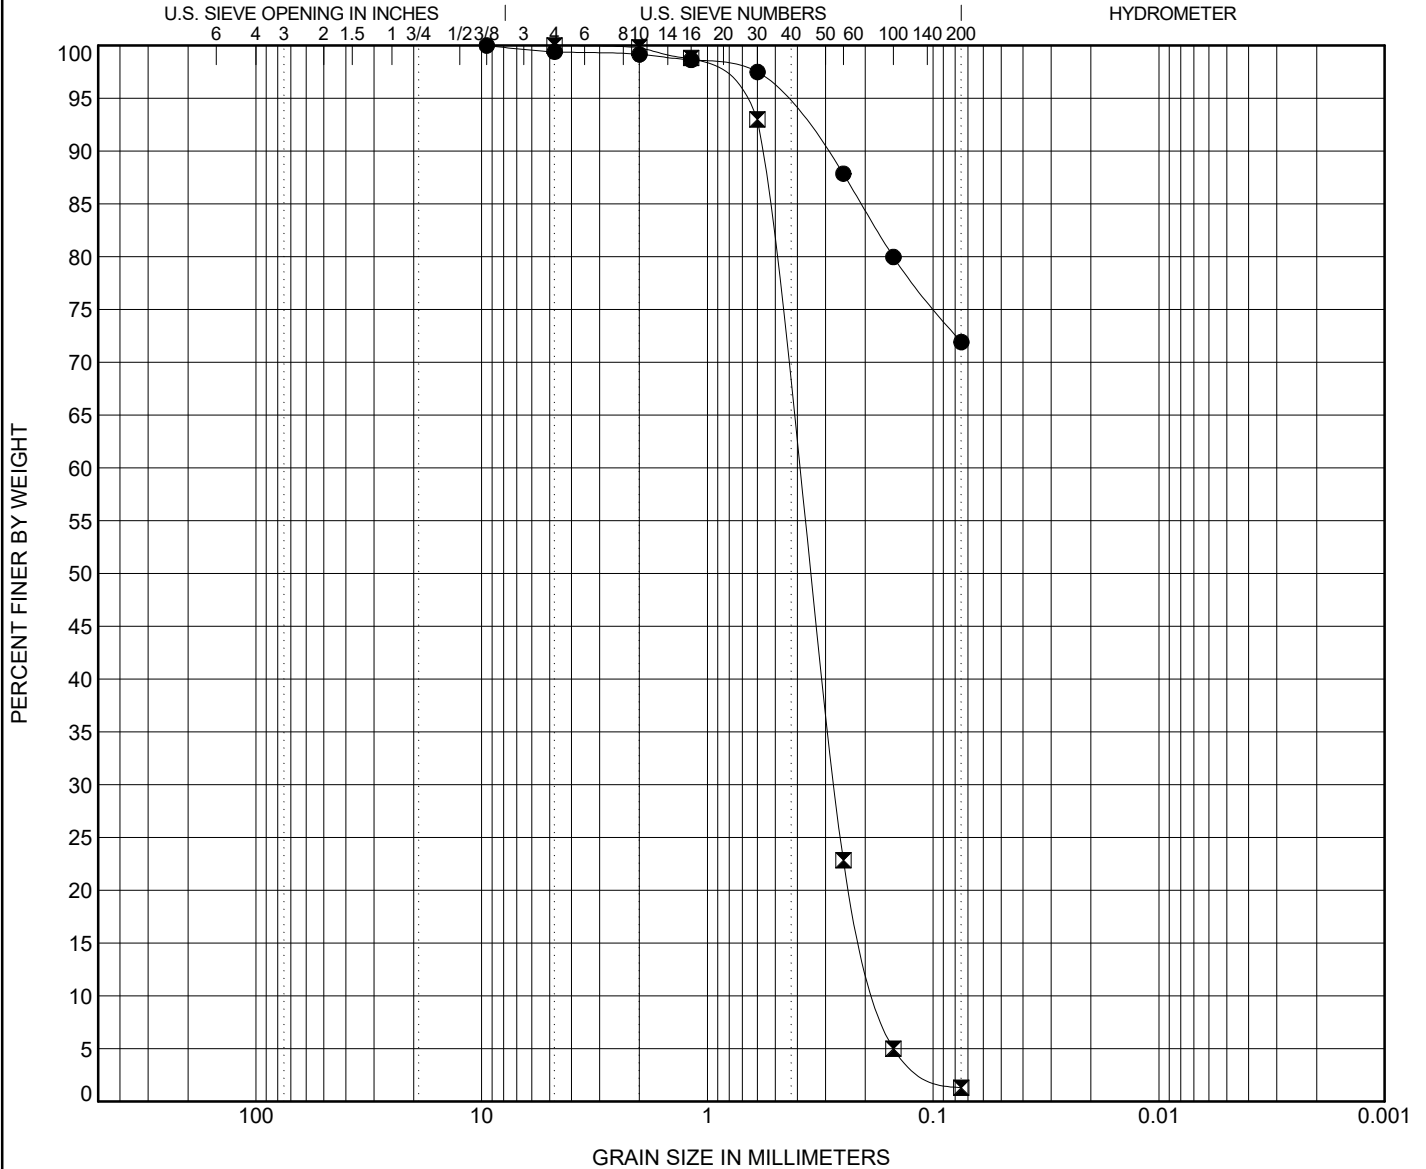
Specimen Identification	Classification							Cc	Cu
● TP-05 3.50ft.	<b>USDA: Gray Slightly Gravelly Loam. USCS: ML with Sand.</b>								
☒ TP-05 9.00ft.	<b>USDA: Gray Slightly Gravelly Sand. USCS: SP.</b>							<b>1.09</b>	<b>2.30</b>

The referenced preliminary site plan indicates the parking area will be comprised of pervious pavement. ESNW performed one small-scale Pilot Infiltration Test (PIT) at TP-5 at a depth of approximately three and one-half feet bgs. The PIT was performed outside of the building footprint. During the soaking and test periods, no measurable rate was obtained, i.e., the infiltration rate was 0 inches per hour. After the PIT was deemed complete, the test pit was advanced an additional five and one-half feet. Groundwater seepage was observed directly beneath the test depth and on intermittent silt layers, to the maximum exploration depth of about nine feet bgs.
