Re: Geotechnical Engineering Report Addendum Letter No. 1 - Infiltration  
Raising Cane's 1360  
43rd Ave SE & S Meridian  
Puyallup, WA  
Terracon Project No. 81255047

**Geotechnical Engineering Addendum – Infiltration**

Raising Cane's 1360 | Puyallup, WA

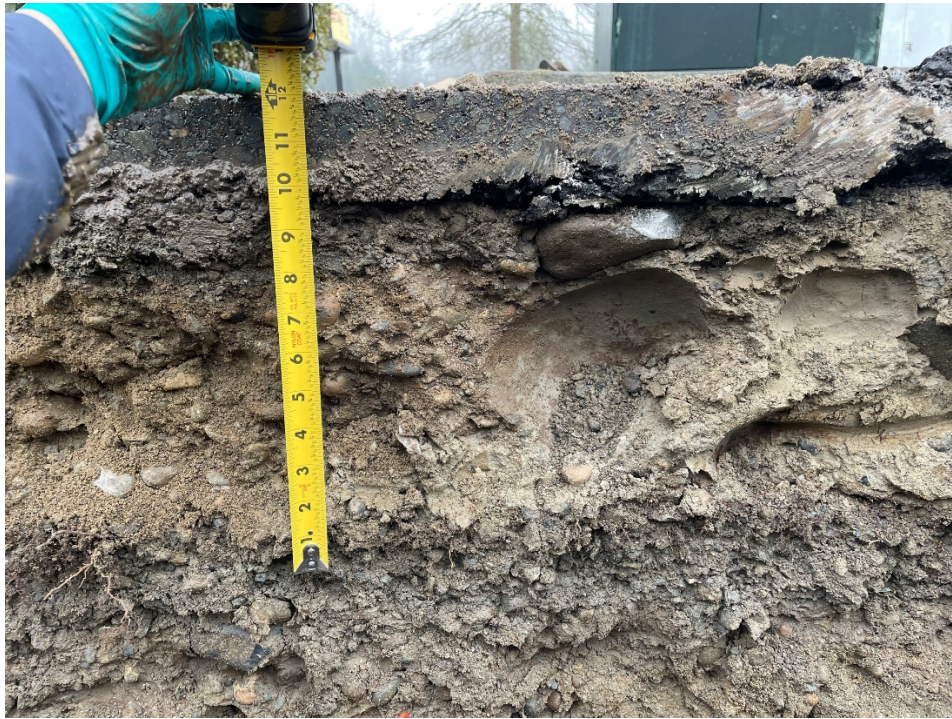
Photo 1: Fill and Root Layer at PIT-01

Approximately 1 foot of existing fill consisting of very dense silty sand with gravel and cobbles (SM) was encountered beneath the asphaltic pavement. The fill was identifiable by the presence of anthropogenic debris and likely consists of reused native soil. Below the fill was a thin relic topsoil layer with abundant roots overlaying very dense glacial till soils consisting of silty sand with gravel and cobbles (SM) extending through the termination depth. The topsoil layer below the fill signals the elevation of the site's original grade and validates that the soil below is glacial till.

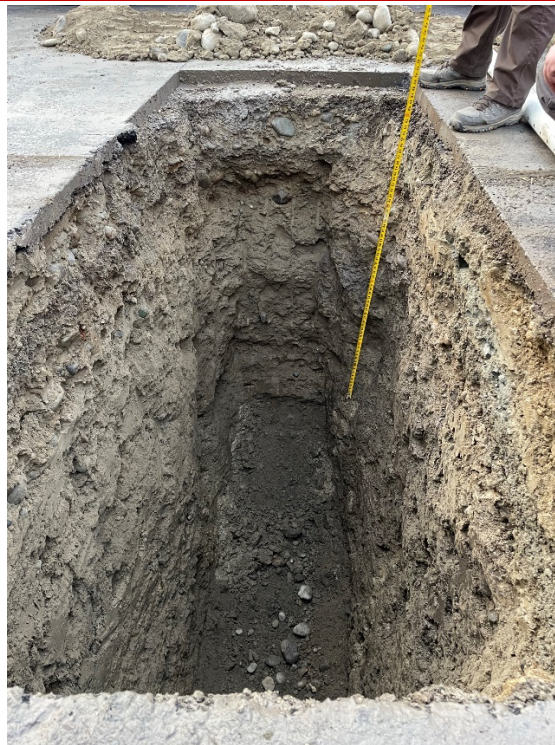
Photo 2: Temporary Water Seepage at PIT-01

Confining layers of lower permeability was not observed in the test pit, however, slight seepage was observed in the sidewalls of the pit at about 6 feet bgs. Because the seepage was observed only in the southern third of the pit, we suspect that this is a localized wet zone within the glacial till unit as compared to either a perched or regional ground water table. Additionally, the seepage did not persist after the initial opening of the pit indicating this wet zone lacks a recharge source. In our opinion, the wet zone did not influence our infiltration test.

Surface condition: paved nook adjacent to building  
 In the upper 4 feet: relative density was inferred from T-probe manually advanced until refusal  
 Below 4 feet: relative density was inferred from excavator effort and correlated with nearby boring data  
 At ~6 feet: Local wet zone in the glacial till unit created temporary seepage in the pit sidewalls. The wet zone drained and then stopped.

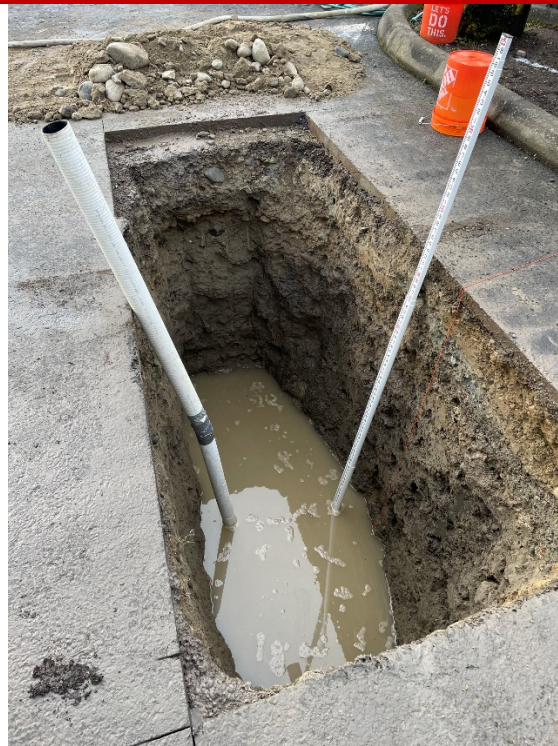
Photo 3: Infiltration Testing at PIT-01

Terracon advanced one test pit to 9 feet below ground surface (bgs) south of the planned storm facility. The test pit was excavated with a toothed bucket to ease advancement through dense gravels and cleaned up with a smooth bucket to reduce disturbance to the test pit base and sidewalls. The excavation sidewalls and excavated soil were observed by a Terracon field engineer and characterized accordingly in the test pit logs. The density/consistency of the soil was inferred through frequent probing of the base of the excavations for the upper 4 feet. Thereafter, soil densities presented on the logs are inferred from the level of excavator effort during test pit advancement and correlated with nearby boring data.

The testing was performed in general accordance with the SWMMWW. A description of the testing procedure is presented herein per the SWMMWW:

- A six-hour soaking period prior to field PIT testing
- One-hour constant head test

- One-hour falling head test
- Data recordings of flow rate and water head were performed every 5 minutes for the constant head and every minute for the falling head test.

Test Location	Test Depth (ft)	Approximate Dimensions (ft)	USCS Classification	Uncorrected Infiltration Rate <sup>1</sup> (in/hr)	Factored Infiltration Rate <sup>1</sup> (in/hr)
<b>PIT-01</b>	9	4 x 8	SM – silty sand with gravel and cobbles	3.6	1.3
<b>PIT-01 (grain size)</b>	8-9	---	SM – silty sand with gravel and cobbles	3.9	1.1

- Factored infiltration rate of 1.3 inches per hour for PIT-01.
- Infiltration facilities should be located deeper than the perimeter footing drains for the new building.
- Retain Terracon to observe the base of the infiltration facility, once excavated, to confirm that the exposed subsurface conditions are consistent with the PIT testing conditions
- Compaction is avoided in the base of the infiltration facility. Compacting soils within the infiltration area may reduce the infiltration rate.

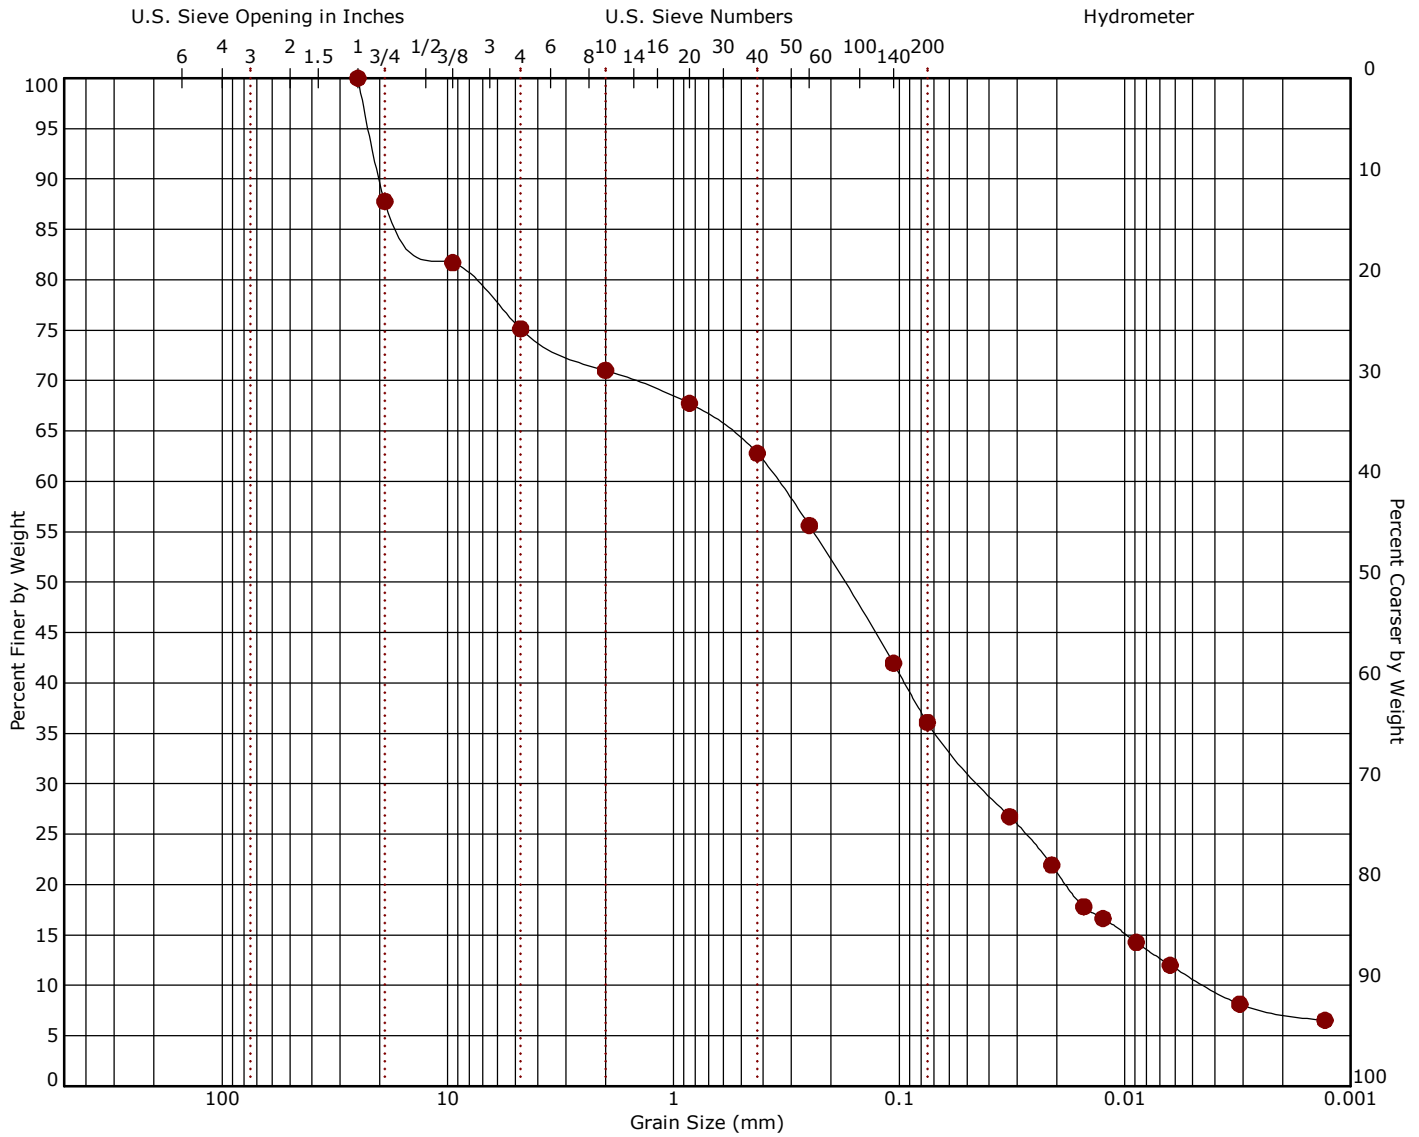
## Grain Size Distribution

According to the SWMMWW, a saturated infiltration rate may also be determined using a grain-size correlation. The methodology recommended by the manual is the Massmann equation (2003). However, grain-size correlation neglects considerations for soil density and is less representative of in situ conditions when compared to PIT testing.

The grain-size analysis methodology is primarily used to efficiently compare the relative permeability of the glacial till soils tested within PIT-01. The PIT results and grain size analysis results are presented in the **Stormwater Infiltration Results** section.

Boring ID	Depth (Ft)	Description	USCS	LL	PL	PI	Cc	Cu
● PIT-01	8 - 9	Silty Sand	SM				1.25	79.34

Boring ID	Depth (Ft)	D <sub>100</sub>	D <sub>60</sub>	D <sub>30</sub>	D <sub>10</sub>	%Cobbles	%Gravel	%Sand	%Fines	%Silt	%Clay
● PIT-01	8 - 9	25	0.346	0.043	0.004	0.0	24.9	39.0		25.3	10.7
