STORMWATER SITE PLAN

Normandy Heights – Puyallup, WA

Brent Kunz, P.E.

02/03/2026

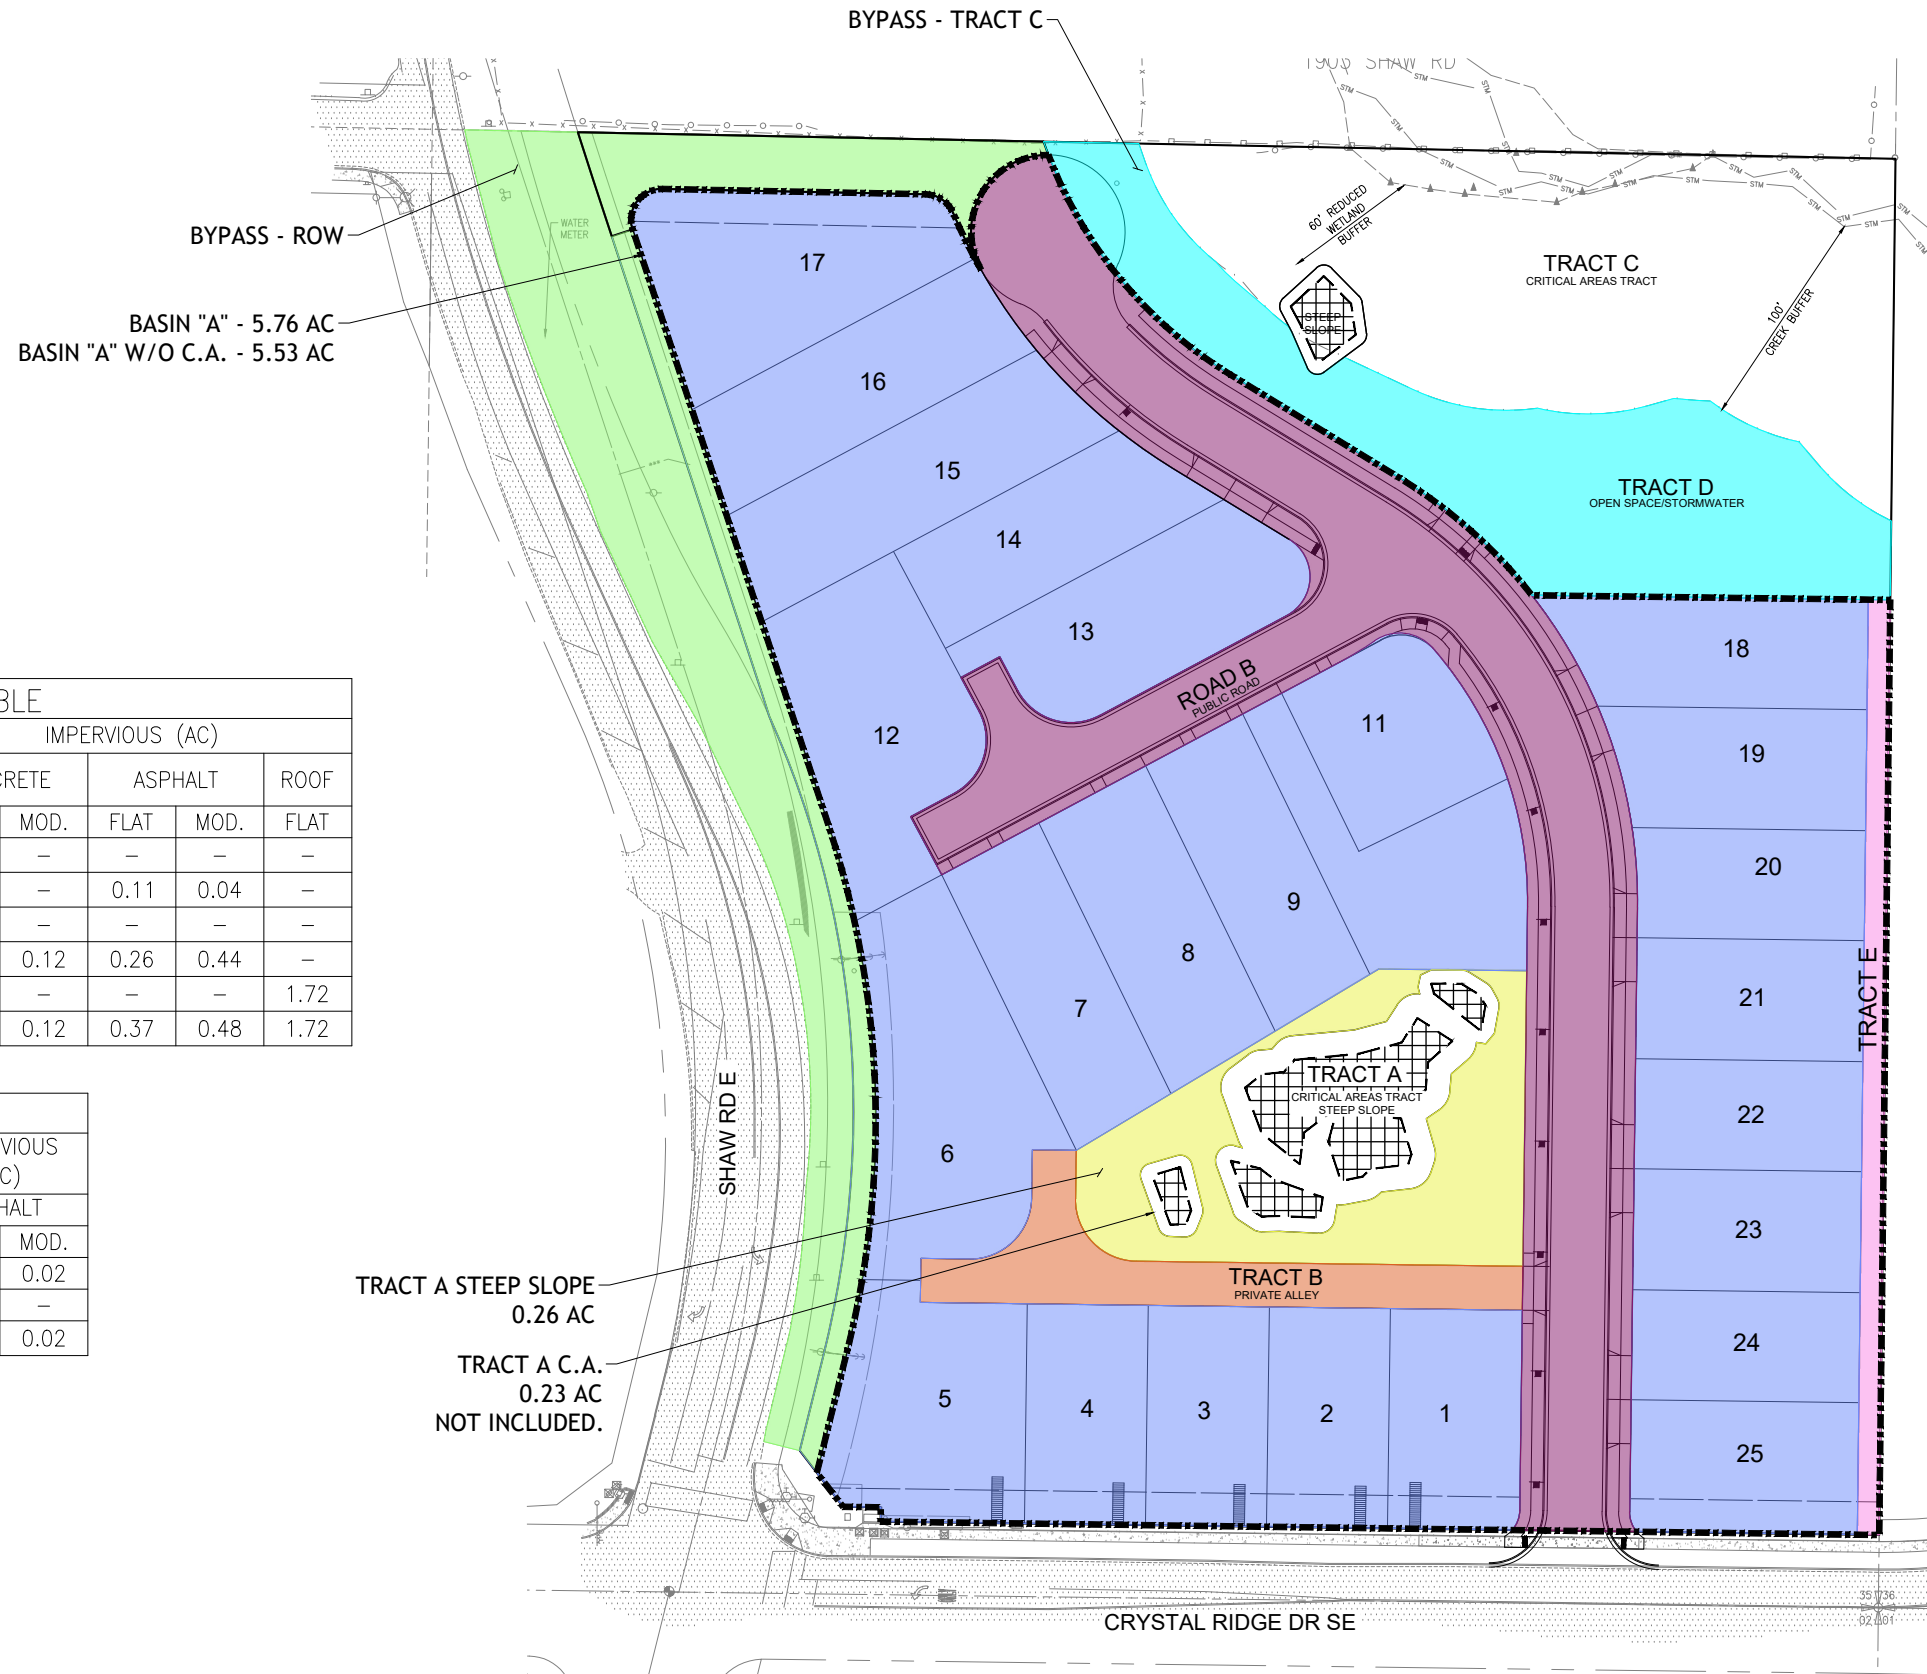
BASIN "A" - 5.76 AC
 BASIN "A" W/O C.A. - 5.53 AC

TRACT A STEEP SLOPE
 0.26 AC
 TRACT A C.A.
 0.23 AC
 NOT INCLUDED.

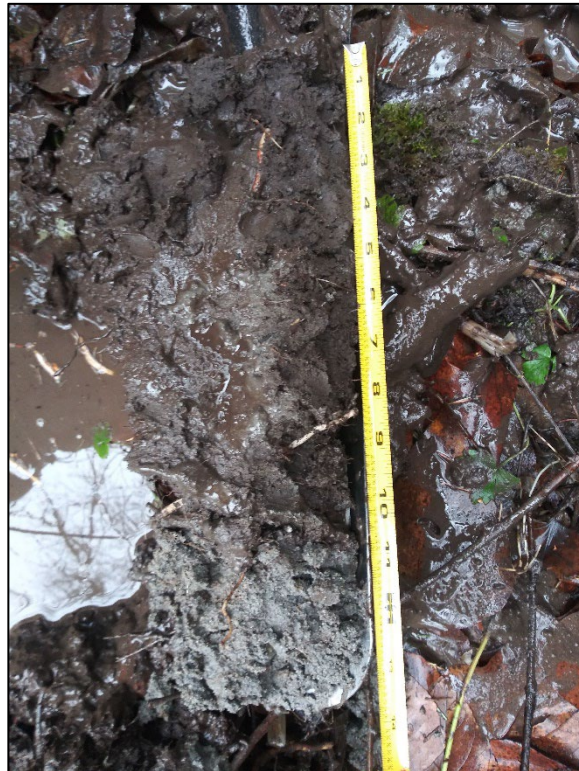
Photo 6: Soil profile at DP-2.

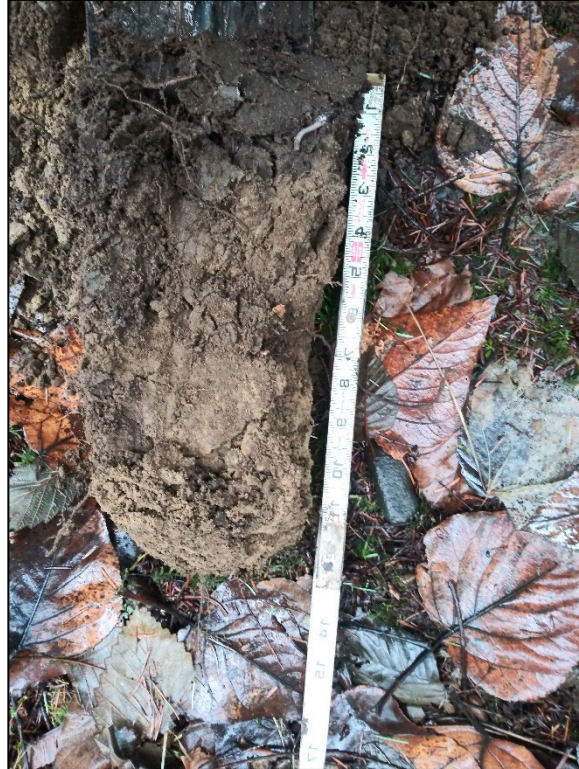
Photo 7: Soil profile at DP-3

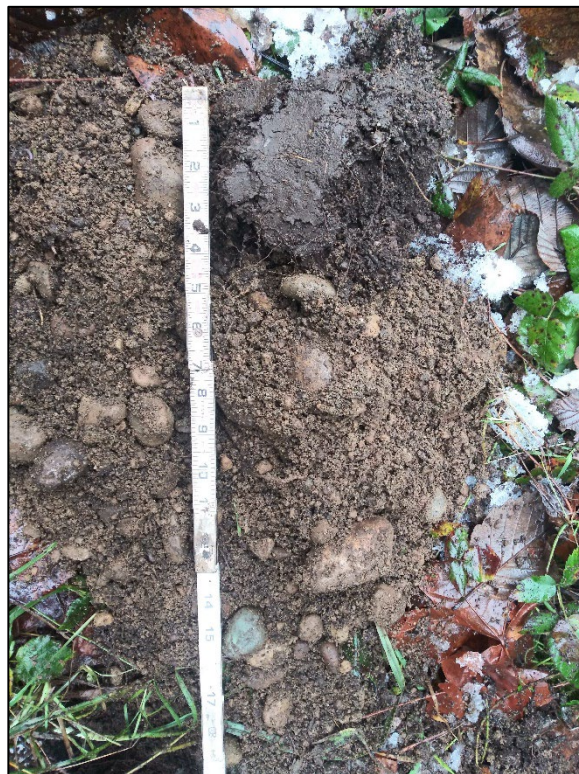
Photo 8: Soil profile at DP-4.
