## STORMWATER SITE PLAN

Normandy Heights – Puyallup, WA

### PROJECT NO.

12663

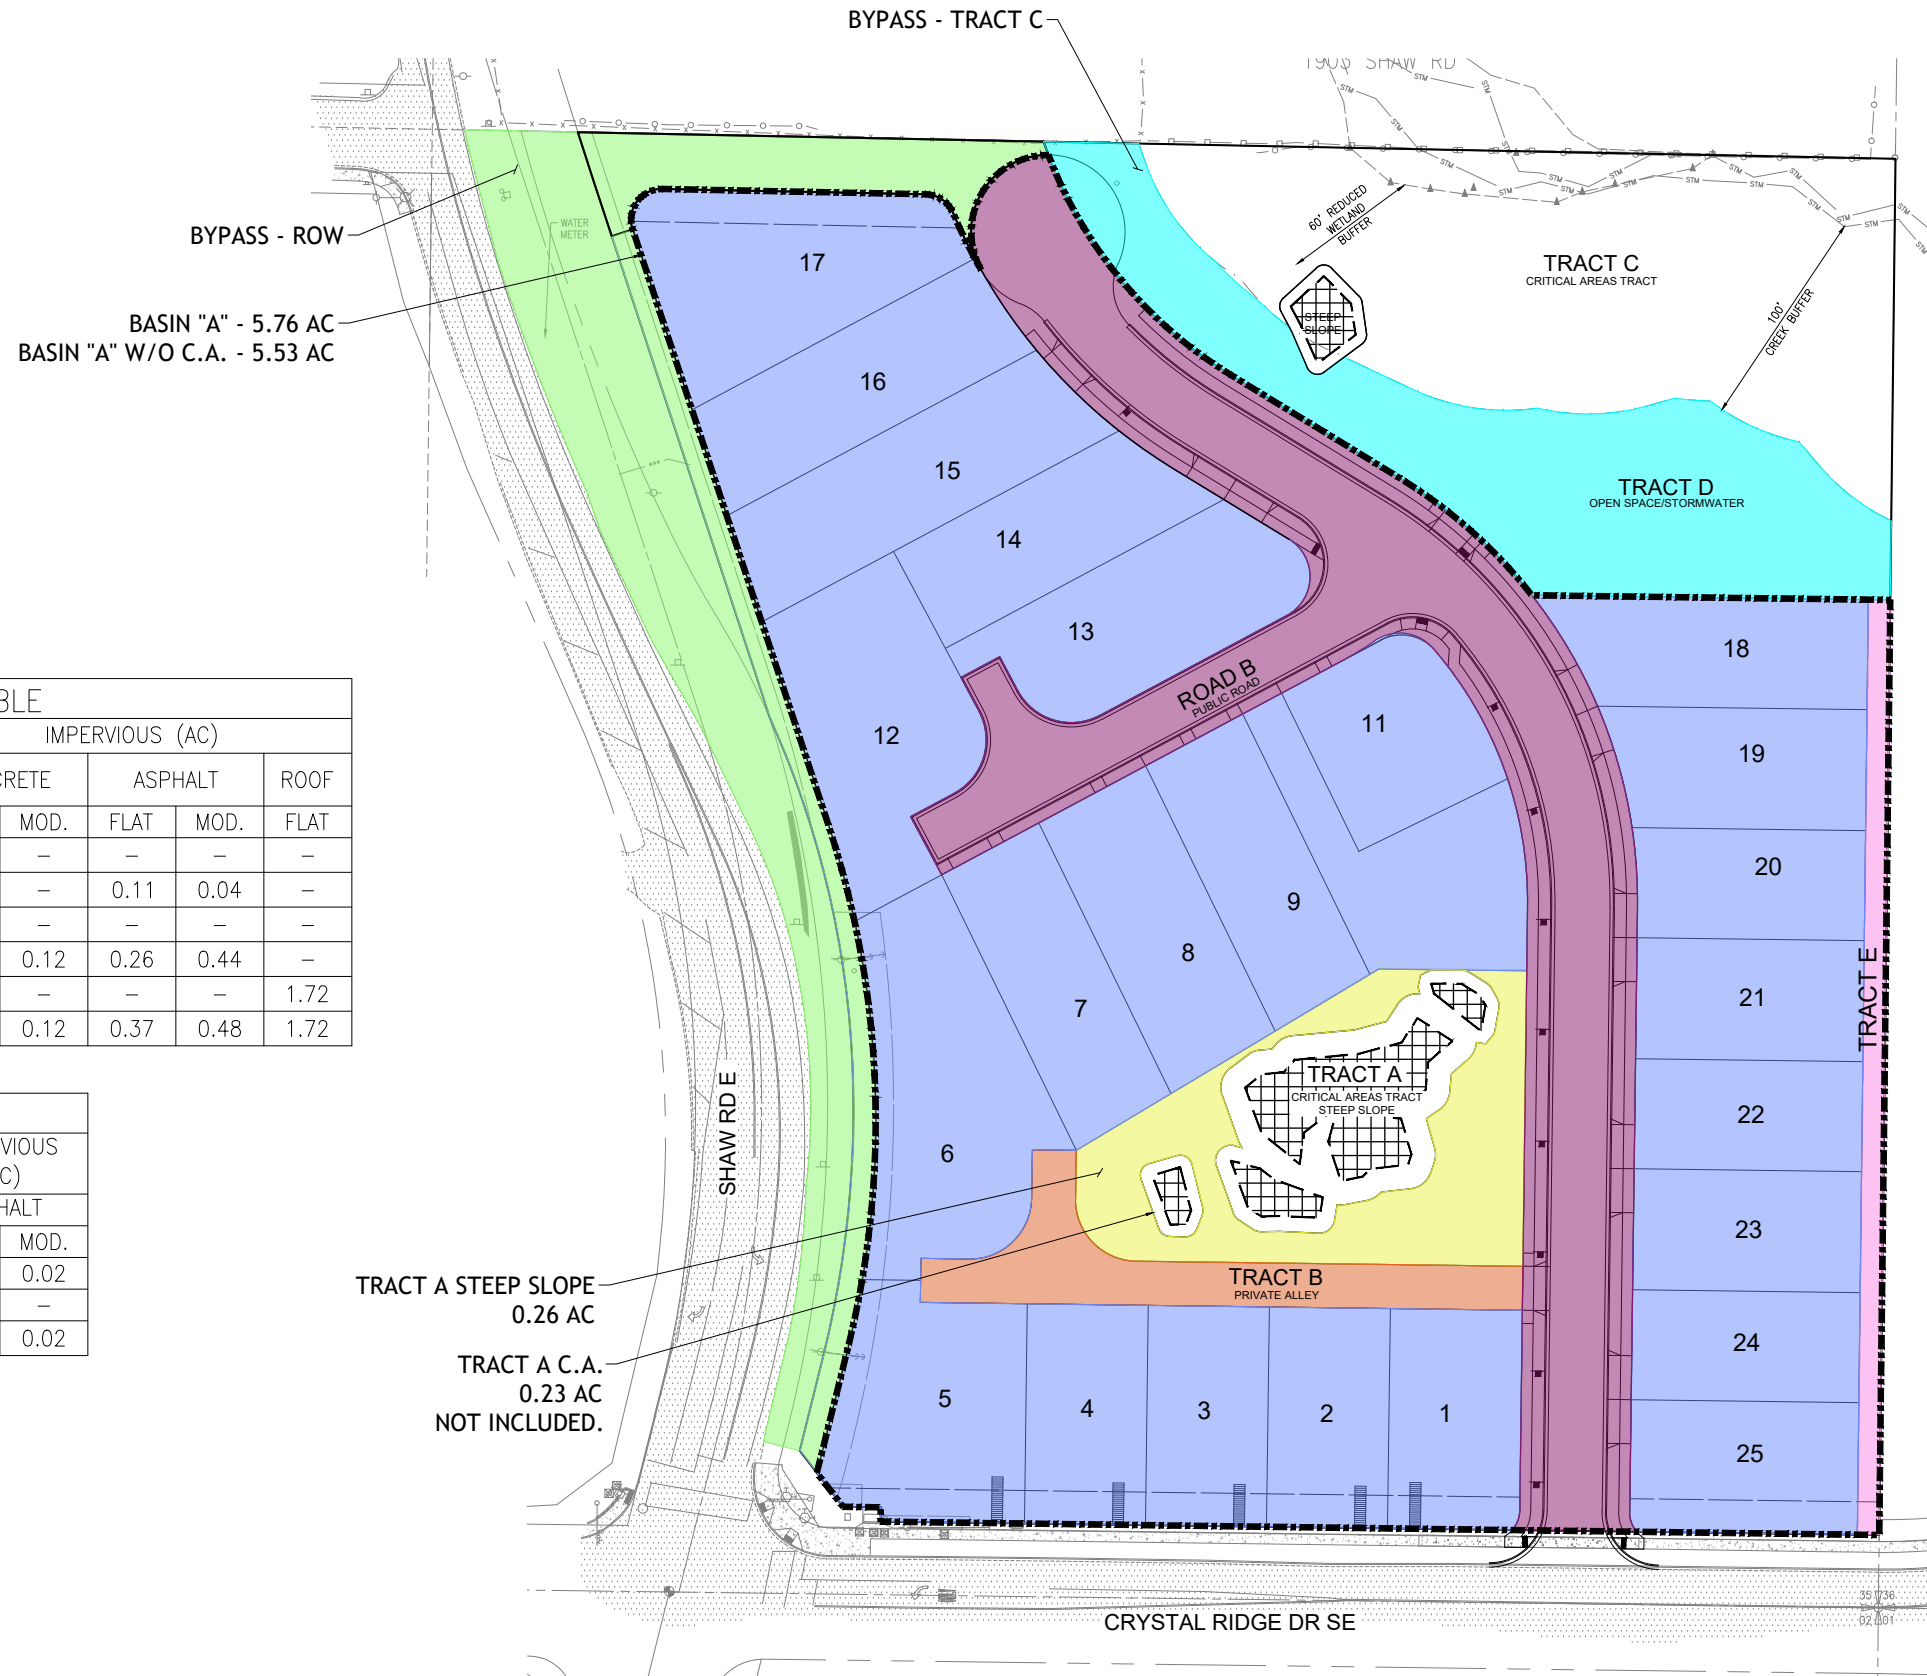
# POSTDEVELOPED BASIN MAP EXHIBIT

AREA NAME	COLOR	AREA (AC)	PERVIOUS (AC)			IMPERVIOUS (AC)				
			PASTURE			CONCRETE		ASPHALT		ROOF
			FLAT	MOD.	STEEP	FLAT	MOD.	FLAT	MOD.	FLAT
TRACT A		0.26	0.02	0.09	0.15	-	-	-	-	-
TRACT B		0.15	-	-	-	-	0.11	0.04	-	-
TRACT E		0.10	0.01	0.00	0.09	-	-	-	-	-
ROADS		1.03	0.04	0.09	0.02	0.06	0.12	0.26	0.44	-
LOTS		3.99	1.32	0.23	0.72	-	-	-	-	1.72
TOTAL		5.53	1.39	0.41	0.98	0.06	0.12	0.37	0.48	1.72

AREA NAME	COLOR	AREA (AC)	PERVIOUS (AC)			IMPERVIOUS (AC)	
			PASTURE			ASPHALT	
			FLAT	MOD.	STEEP	FLAT	MOD.
TRACT D		0.51	0.21	0.04	0.22	0.02	0.02
ROW		0.71	0.12	0.33	0.14	0.12	-
TOTAL		1.22	0.33	0.37	0.36	0.14	0.02
