# Shao Short Plat Drainage Report

April 21, 2026

This report has been prepared for review by the City of Puyallup (City) in accordance with the Department of Ecology's 2019 Stormwater Management Manual for Western Washington as adopted by PMC 21.10.040 (Manual).

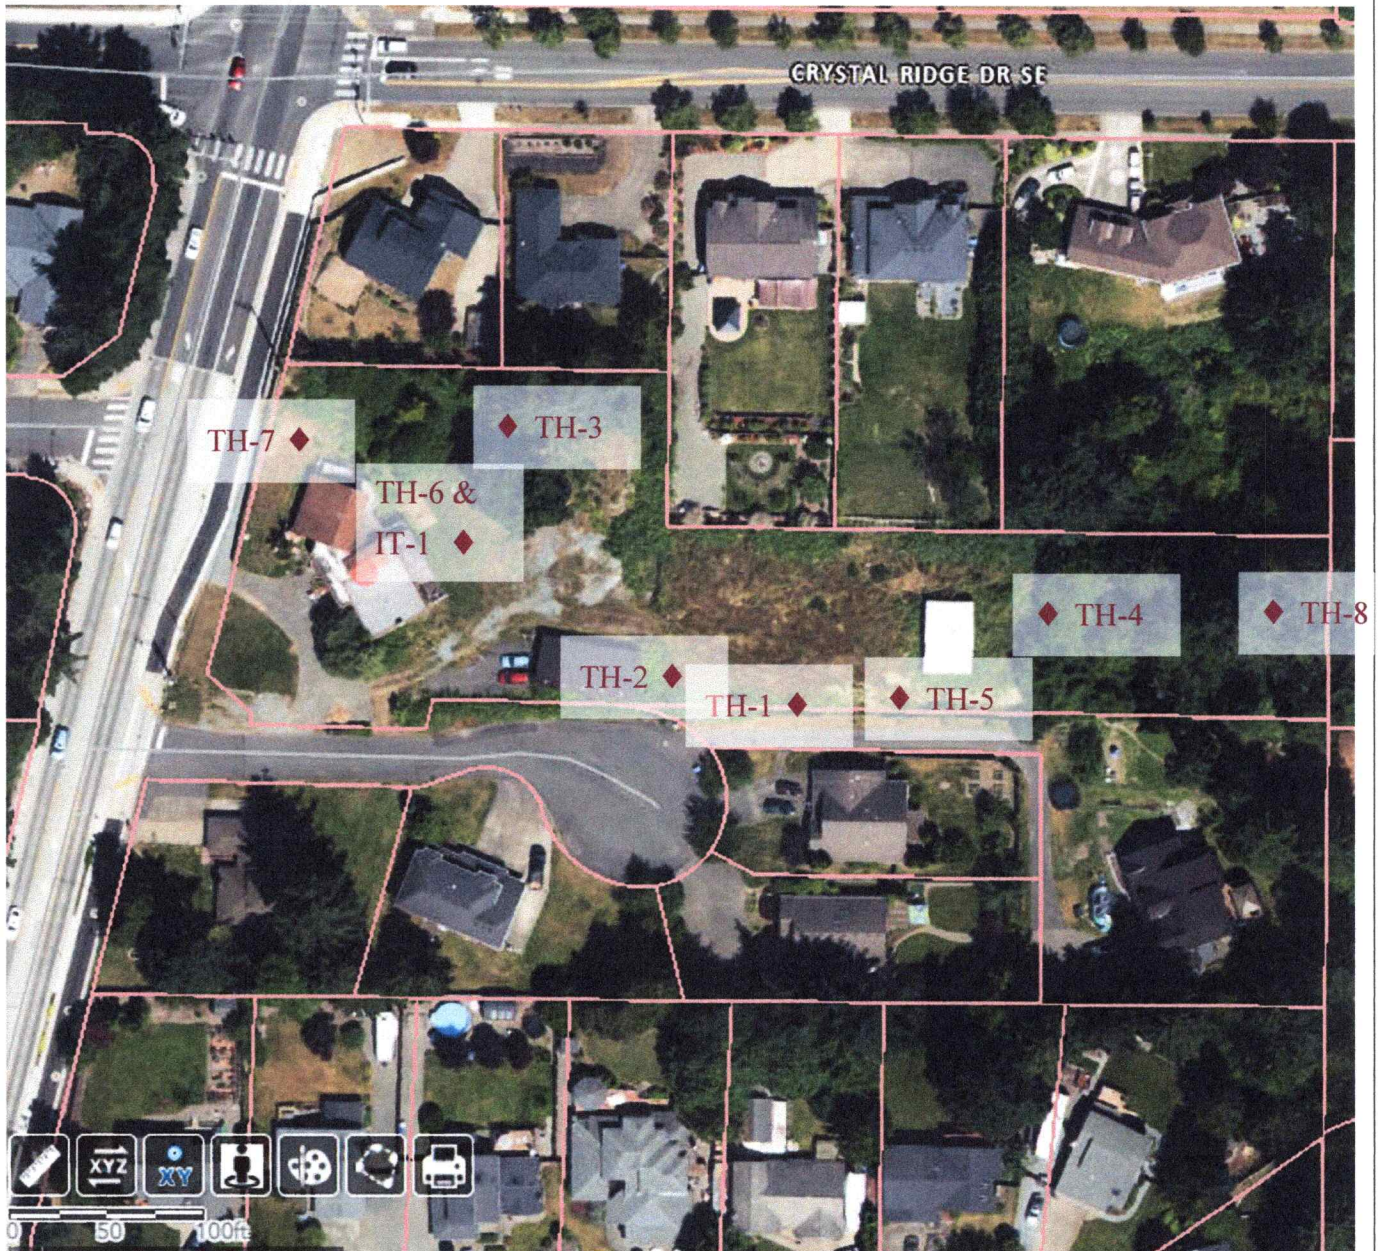
**Figure 2**

Figures A-1 and A-2 present more detailed descriptions of the subsurface conditions encountered in the test holes. The approximate test hole and test boring locations are shown on the Exploration Location Plan provided in Figure 2.
