**TECHNICAL INFORMATION REPORT
CASCADE CHRISTIAN SCHOOL**

815 21st Street East
Puyallup, Washington

Job #03-143

March, 2016
Revised May 2016

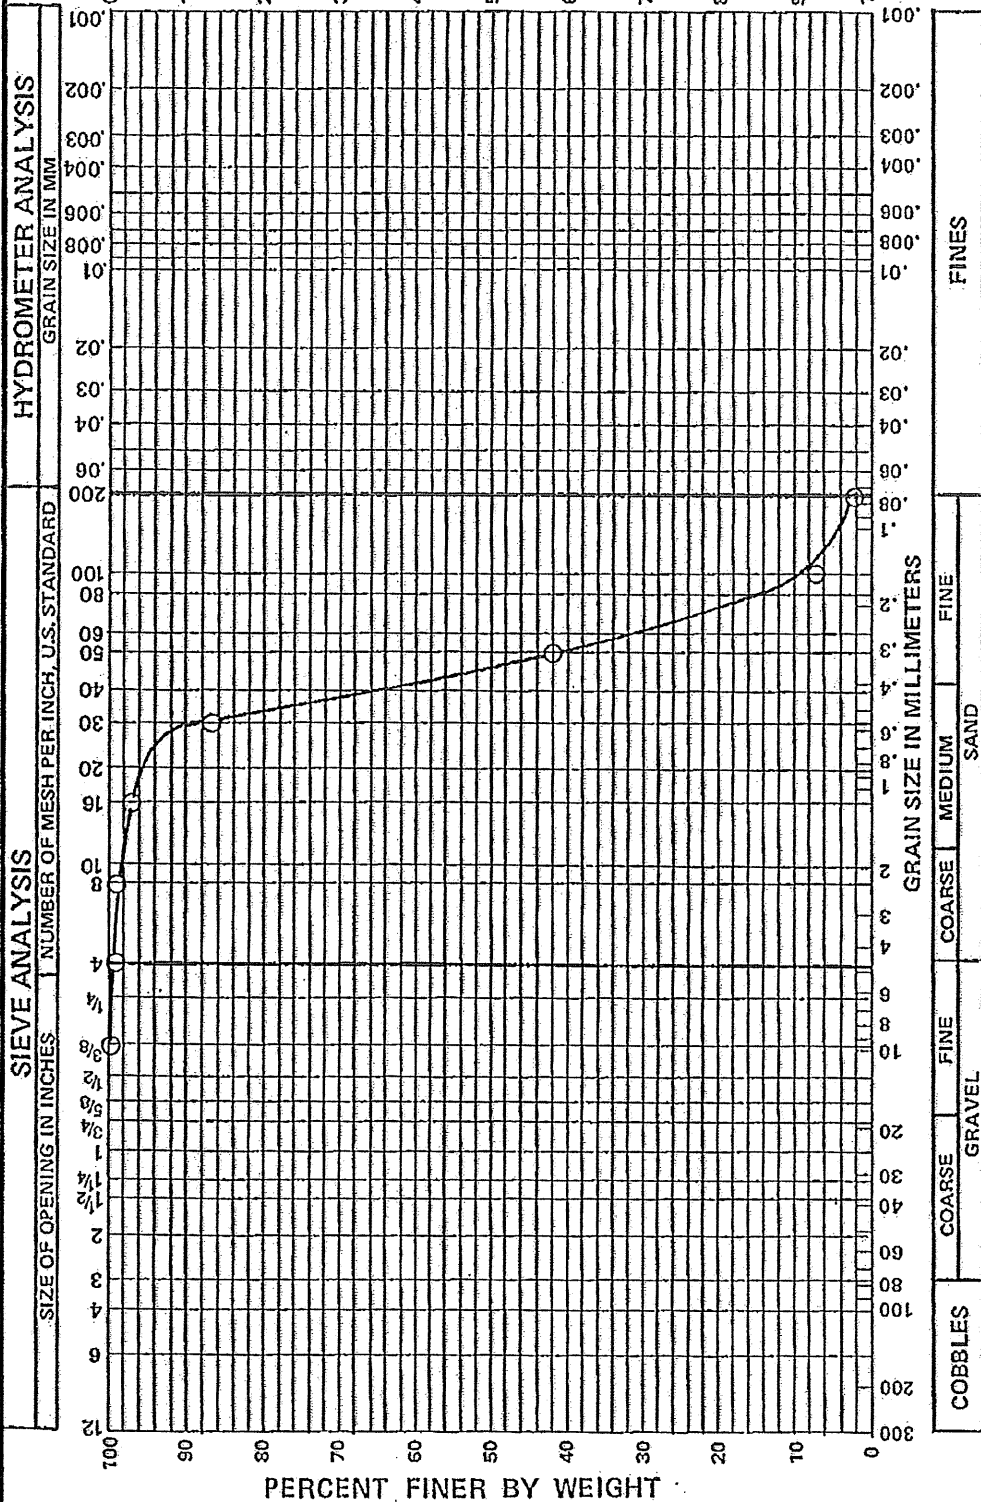
LABORATORY TEST RESULTS

KEY	Boring or Test Pit No.	DEPTH (ft.)	USCS	DESCRIPTION	Moisture Content (%)	LL	PL
○	TP-12	6	SP	Black poorly graded SAND	26.6	--	--

Laboratory tests indicate the majority of near surface soils expected to be exposed in the excavations have in excess of 23 percent fines and a natural moisture content ranging from 9 to 37 percent. As mentioned above, due to the relatively high fines and natural moisture contents, it is our opinion this soil would not be suitable for use as a structural fill in its present condition. Unless the moisture content can be lowered to near optimum conditions, any native soil excavated from foundation or utility areas should either be removed from the site or used in non-structural areas.
