Presidential Homes  
1212 – 39<sup>th</sup> Avenue Southwest  
Puyallup, WA 98373

Stormwater Feasibility Soils Report  
Proposed Office Building  
1212 – 39<sup>th</sup> Avenue Southwest  
Puyallup, Washington  
PN: 0419092021  
Doc ID: PresidentialHomes.39thAveSW.SR

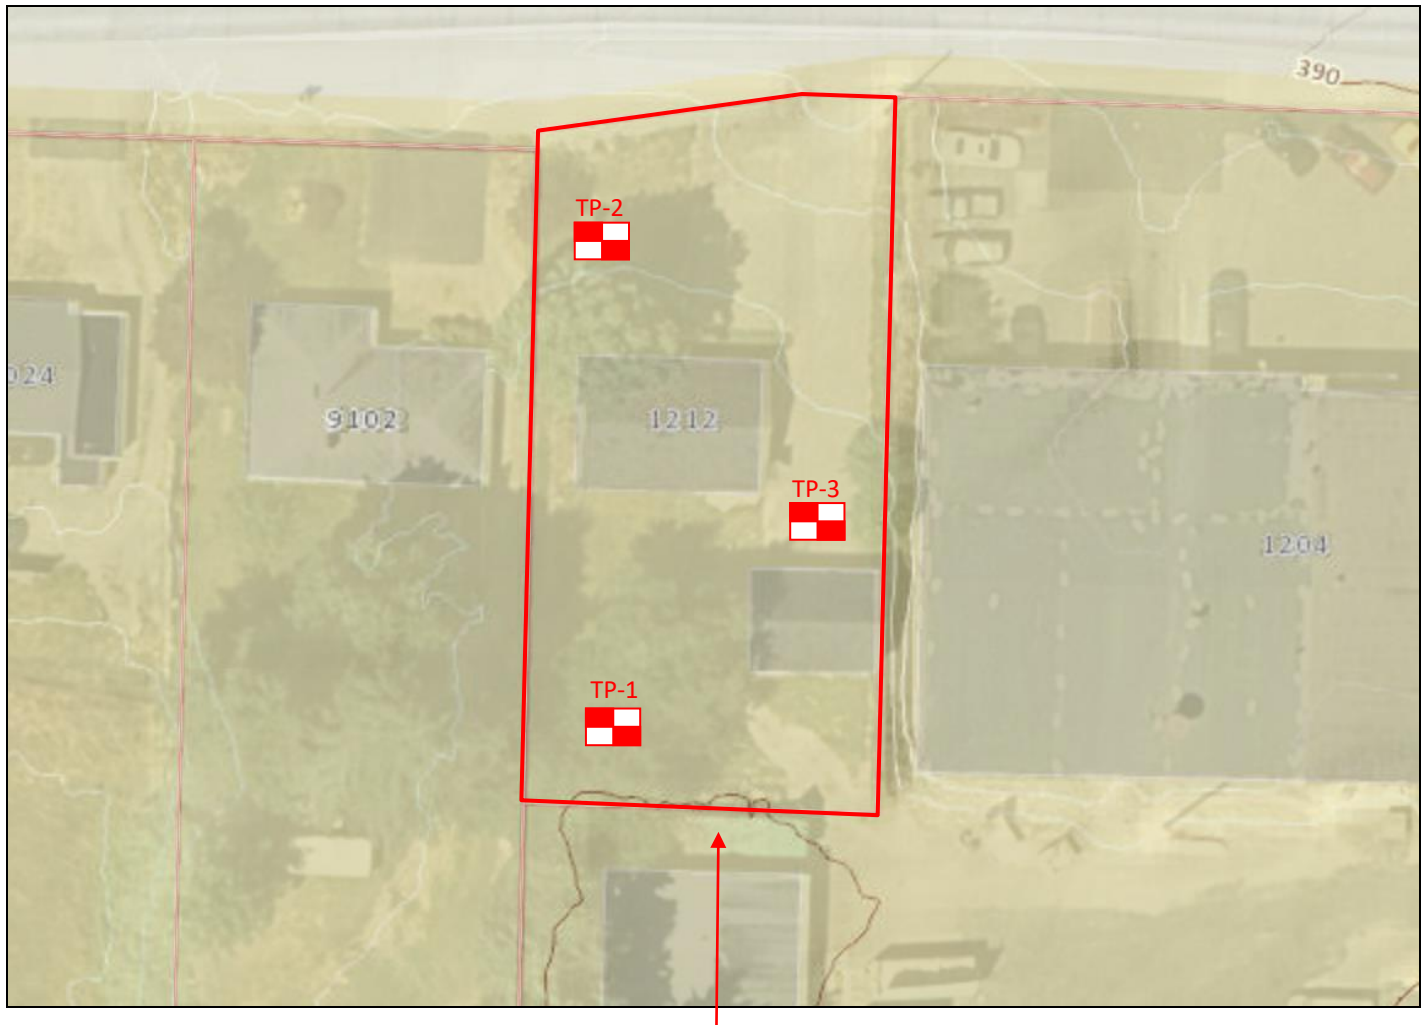
### Site & Exploration Plan

According to the information obtained from the Pierce County Public GIS, the site generally slopes up from north to south. The site's northern boundary is generally at grade with 39<sup>th</sup> Avenue Southwest and slopes up to the south at about 5 percent along the driveway. A short landscaping wall provides grade separation along the northern property line adjacent west of the driveway. Steeper slopes are located on the southeastern portion of the site. These slopes slope down from west to east at about 80 to 100 percent to the adjacent development's parking area and are about 2 to 4 feet in height. The total topographic relief across the site is on the order of about 6 feet. The existing site configuration and topography is shown on the attached Site and Exploration Plan, Figure 2.

The approximate locations of our test pits are indicated on the attached Site and Exploration Plan, Figure 2. The soils encountered were visually classified in accordance with the Unified Soil Classification System (USCS) and ASTM D: 2488. The USCS is included in Appendix A as Figure A-1, while the descriptive logs of our test pits are included as Figures A-2.

Approximate location and number of test pit

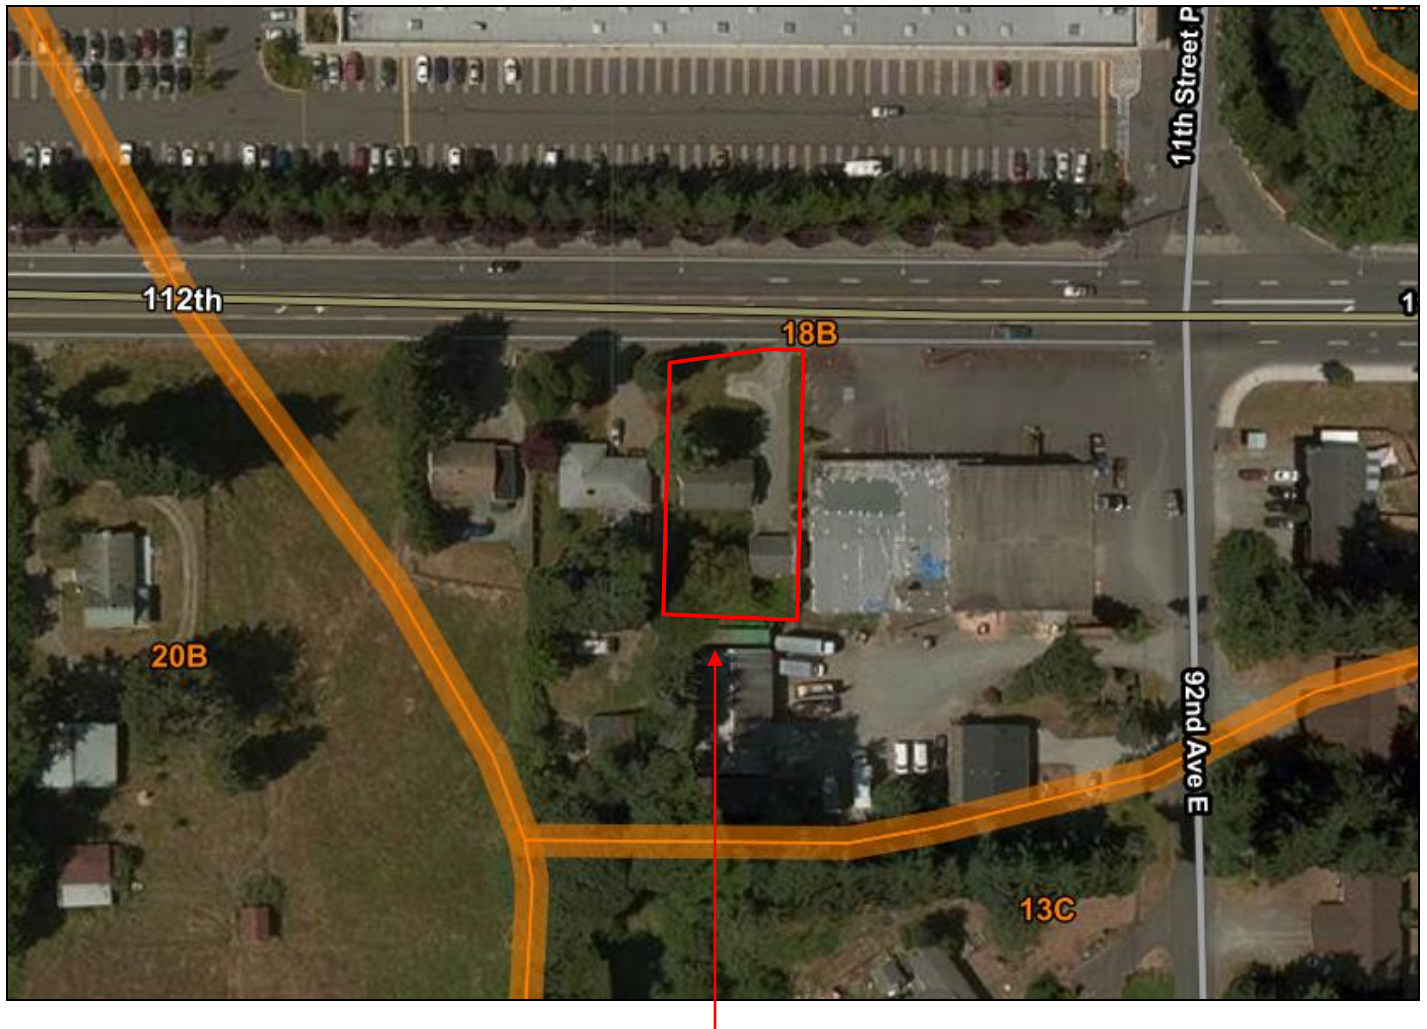
### NRCS Soils Map

The Natural Resources Conservation Survey (NRCS) Web Soil Survey maps the site as being underlain by Indianola loamy sand (18B). The Indianola soils are typically derived from sandy glacial outwash, form on slopes of 0 to 5 percent, have a "slight" erosion hazard when exposed, and are included in hydrologic soils group A. An NRCS soils map for the site area is included as Figure 3.

| Soil Type | Soil Name | Parent Material | Slopes | Erosion Hazard | Hydrologic Soils Group |
|---|---|---|---|---|---|
| 18B | Indianola loamy sand | Sandy glacial outwash | 0 to 5 | Slight | A |
