# **GEOTECHNICAL REPORT**

**Freeman Logistics  
Freeman Road East and 19th Avenue Northwest  
Pierce County, Washington**

**Project No. T-8565**

**Terra Associates, Inc.**

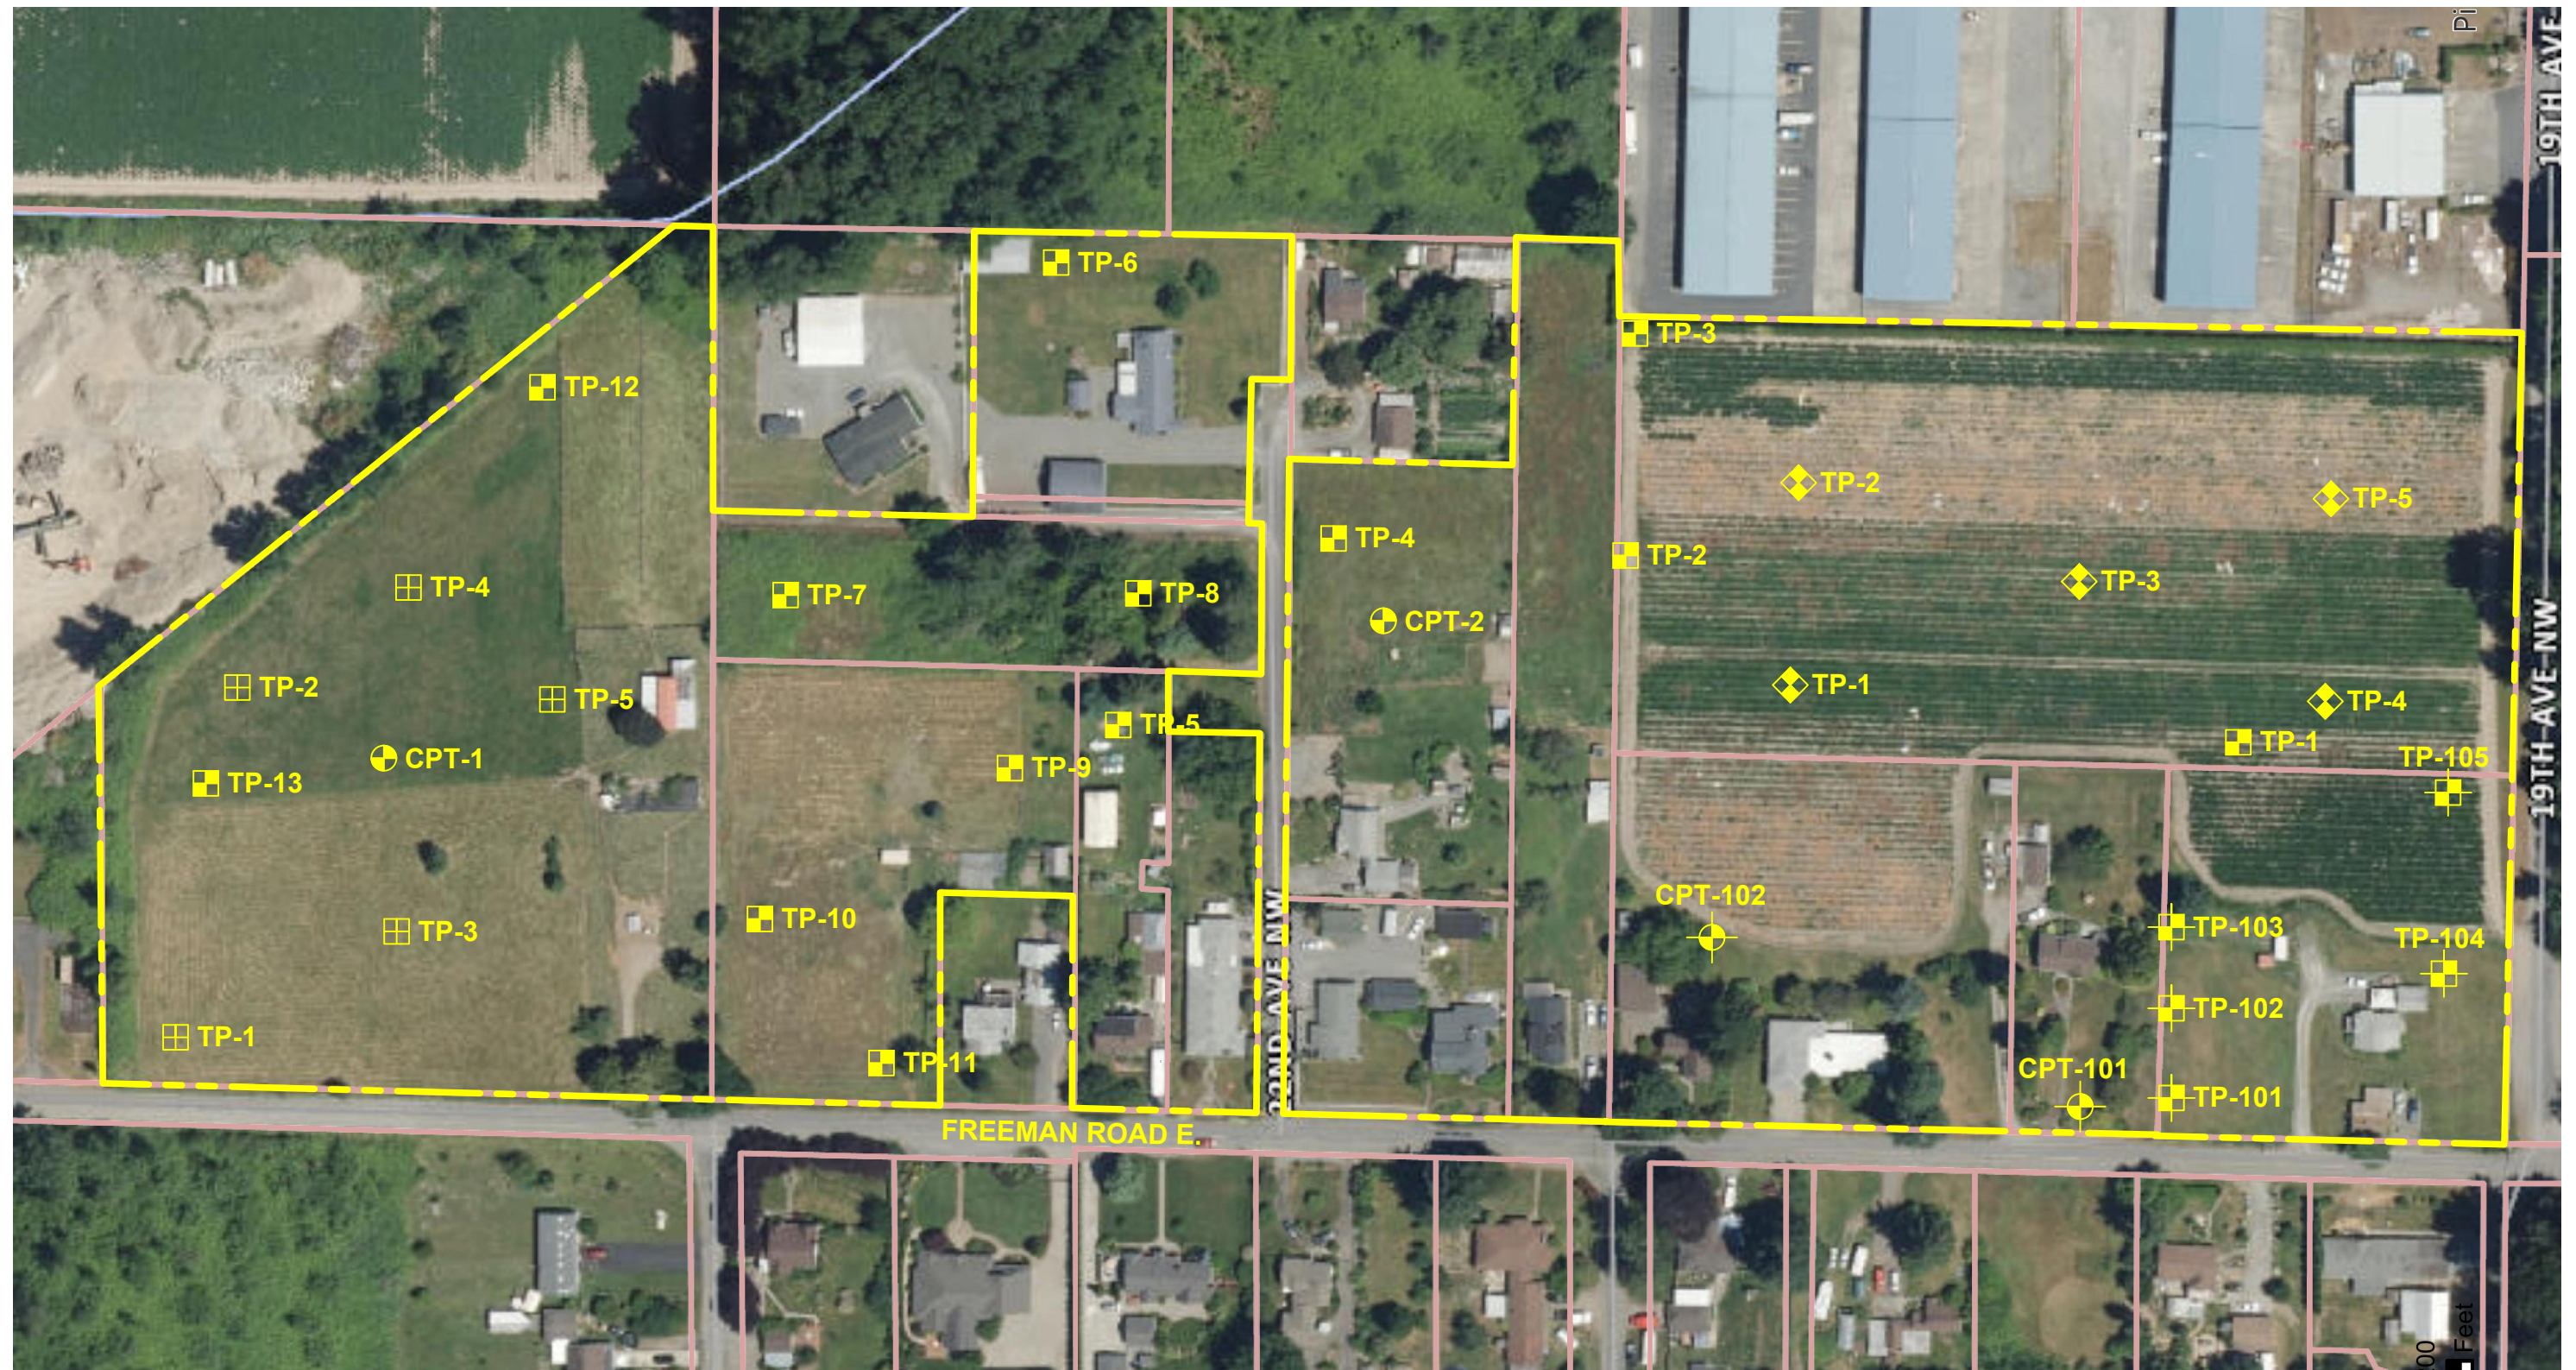
Figure 2

EXPLORATION LOCATION PLAN  
FREEMAN LOGISTICS  
PIERCE COUNTY, WASHINGTON

Detailed descriptions of the subsurface conditions observed in our subsurface explorations are given on the Test Pit Logs. The Test Pit Logs and CPT Data are attached in Appendix A. The approximate test pit and CPT locations are shown on Figure 2.

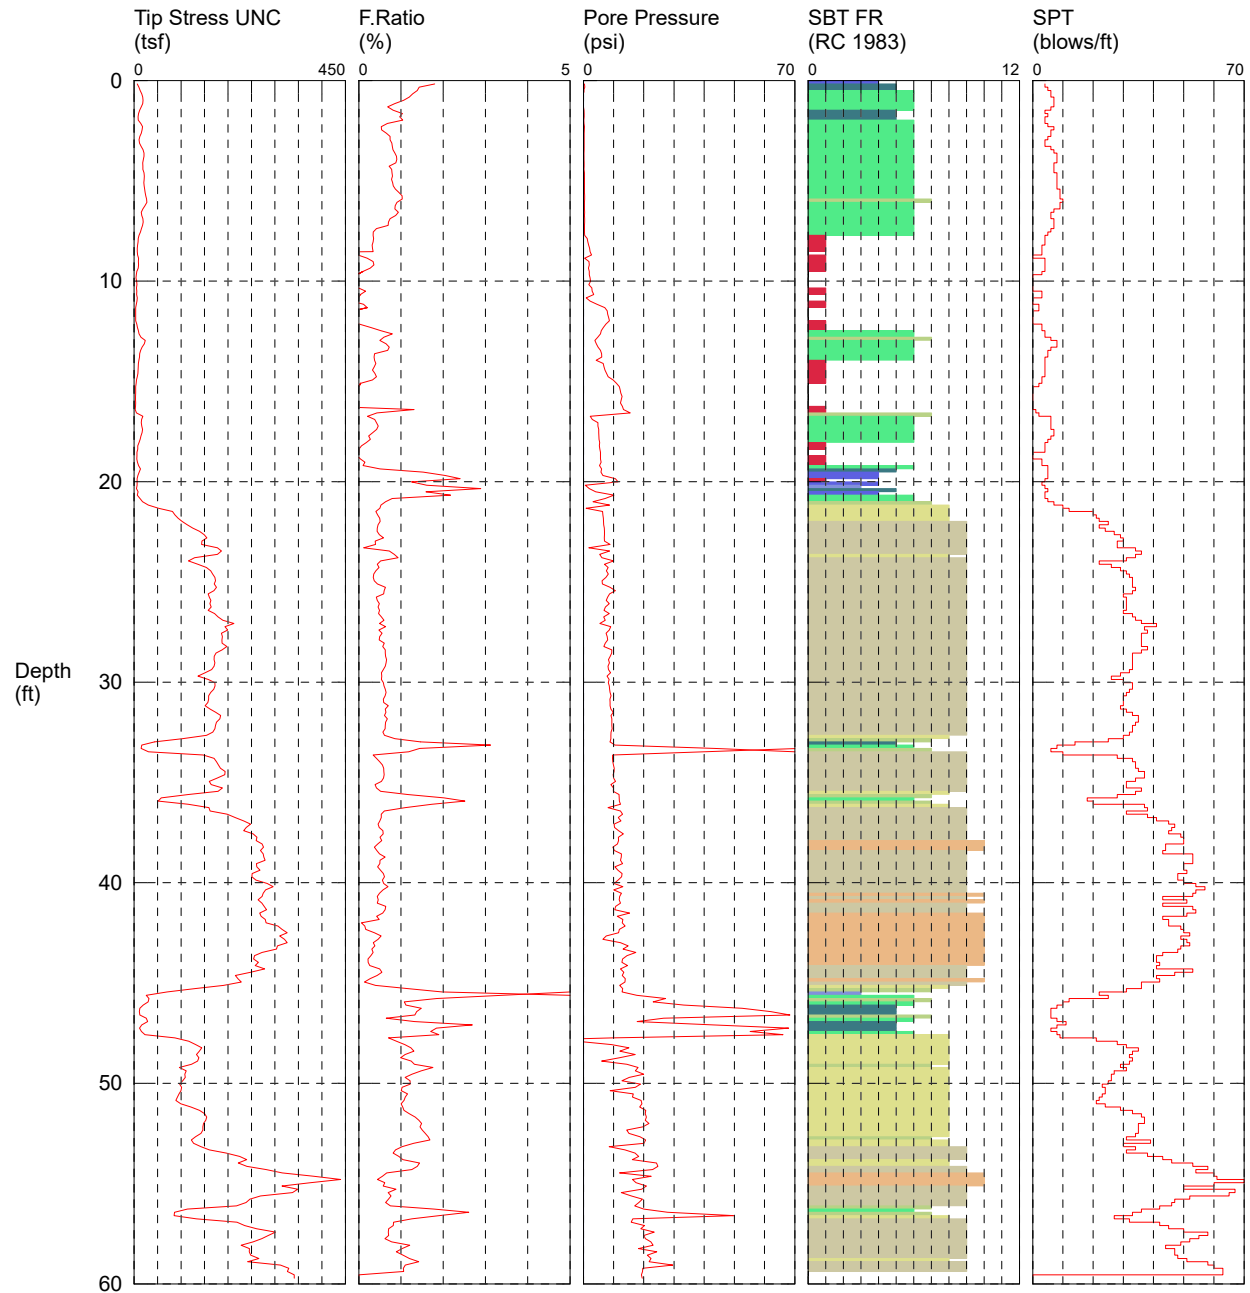
## CPT-101

CPT CONTRACTOR: In Situ Engineering  
CUSTOMER: Terra Associates  
LOCATION: Puyallup  
JOB NUMBER: T-8565

OPERATOR: Okbay/Forinash  
CONE ID: DDG1263  
TEST DATE: 6/9/2022 11:11:29 AM  
PREDRILL:  
BACKFILL:  
SURFACE PATCH:

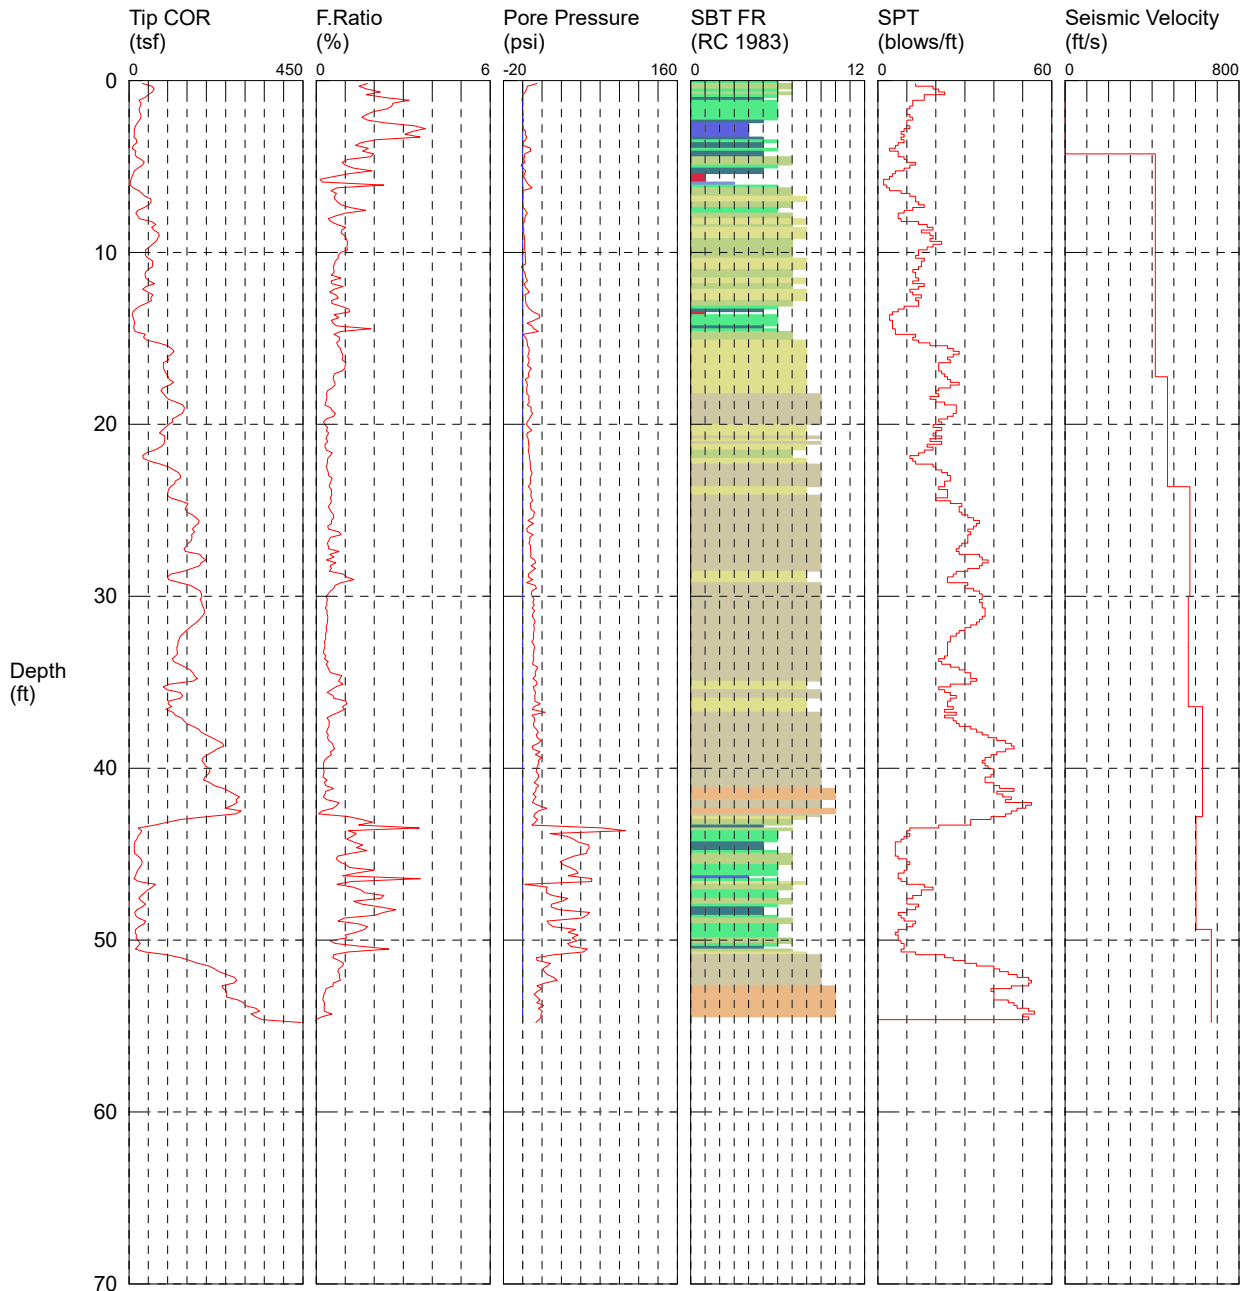
## CPT-02

CPT CONTRACTOR: In Situ Engineering  
CUSTOMER: Terra Associates  
LOCATION: Puyallup  
JOB NUMBER: T-8565

OPERATOR: Mayfield/Okbay  
CONE ID: DDG1394  
TEST DATE: 7/8/2021 1:09:48 PM  
PREDRILL:  
BACKFILL: 20% Bentonite Grout + Bentonite Chip  
SURFACE PATCH:

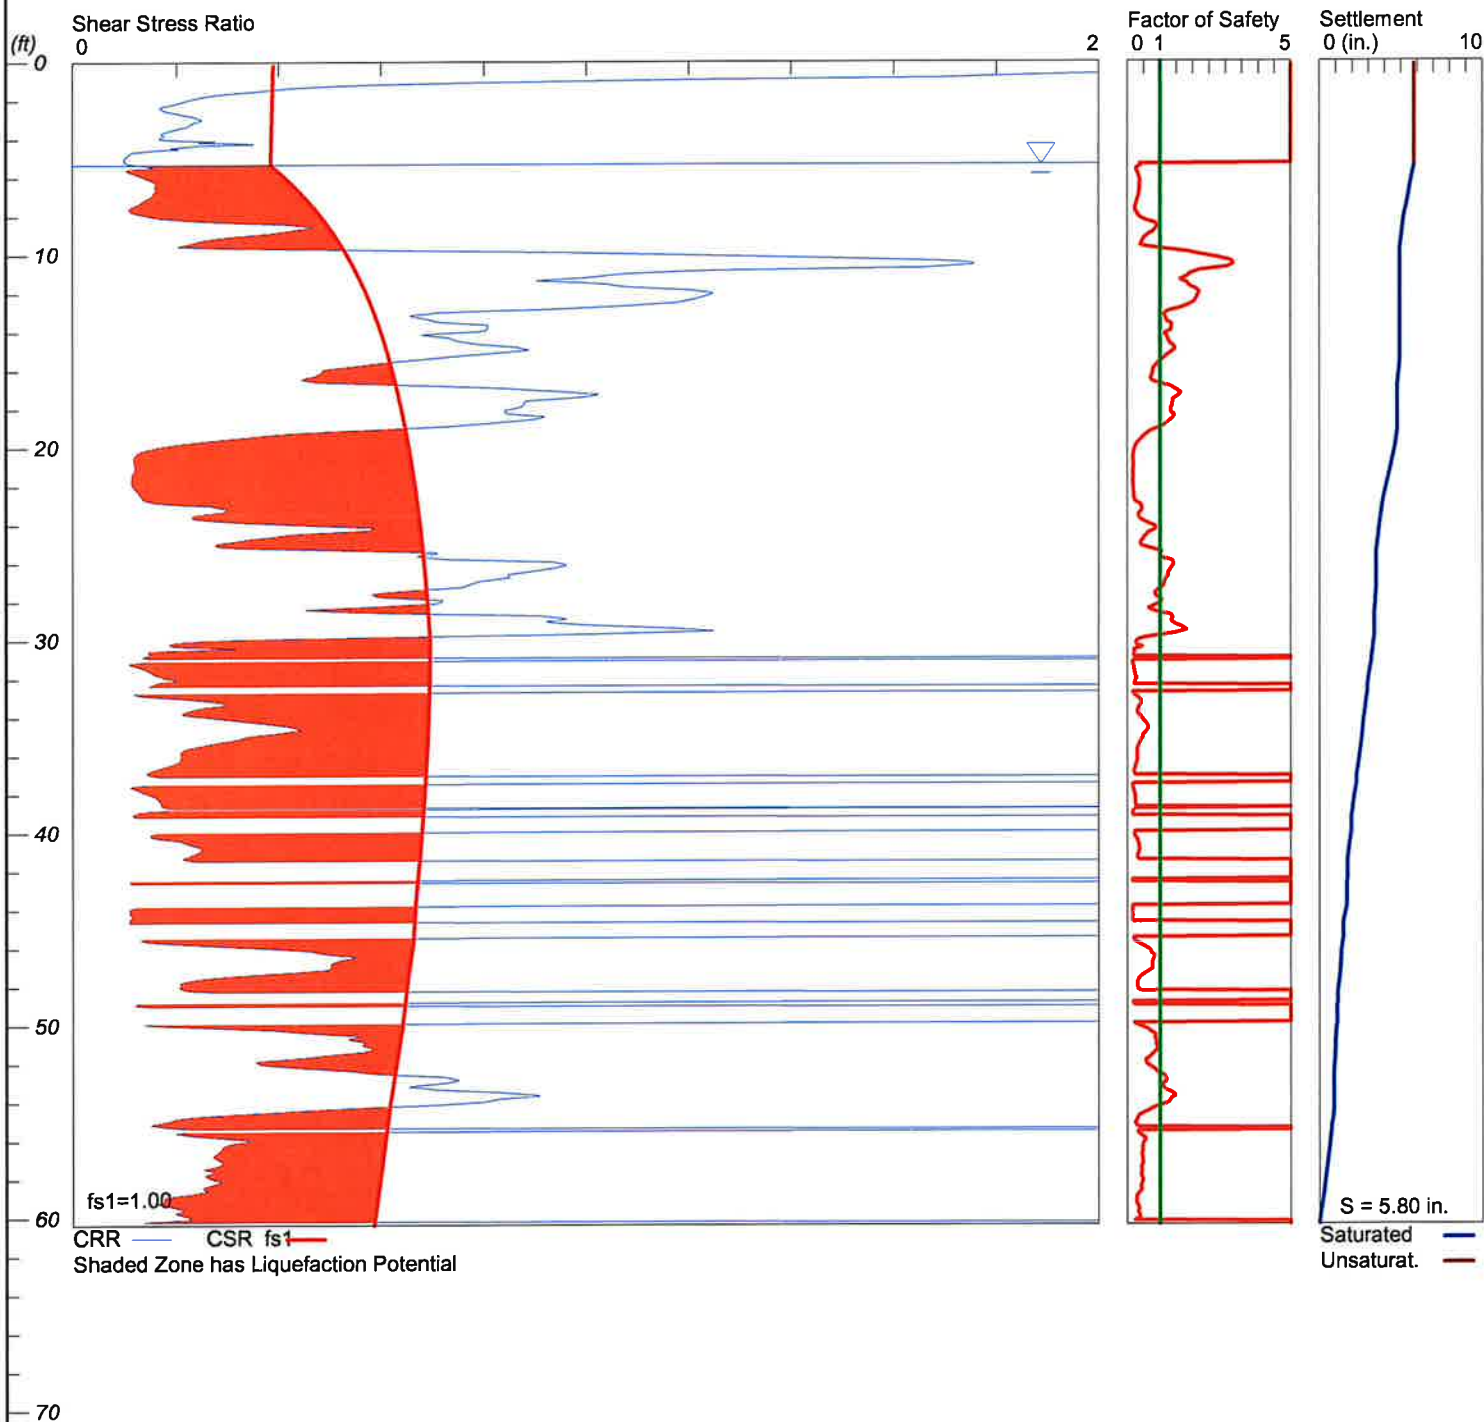
Hole No.=CPT-1 Water Depth=5.3 ft

Magnitude=7  
Acceleration=0.6g

The results of our analysis indicate that soil liquefaction could occur during the design earthquake event resulting in total settlements ranging between about 2.8 and 5.8 inches with about one-half of this settlement likely being differential in nature. In our opinion, this amount of settlement would not structurally impair the building. However, cosmetic damage to the structure in the form of misaligned doors and windows, cracking, and floor settlement could occur. Some utility connections may also be impacted. If the owner is not willing to accept the risk of building damage requiring repair should liquefaction-induced settlements occur, foundations should be supported on ground improved using stone columns designed to mitigate soil liquefaction settlements below the building foundations. The results of the liquefaction analysis are attached in Appendix B.

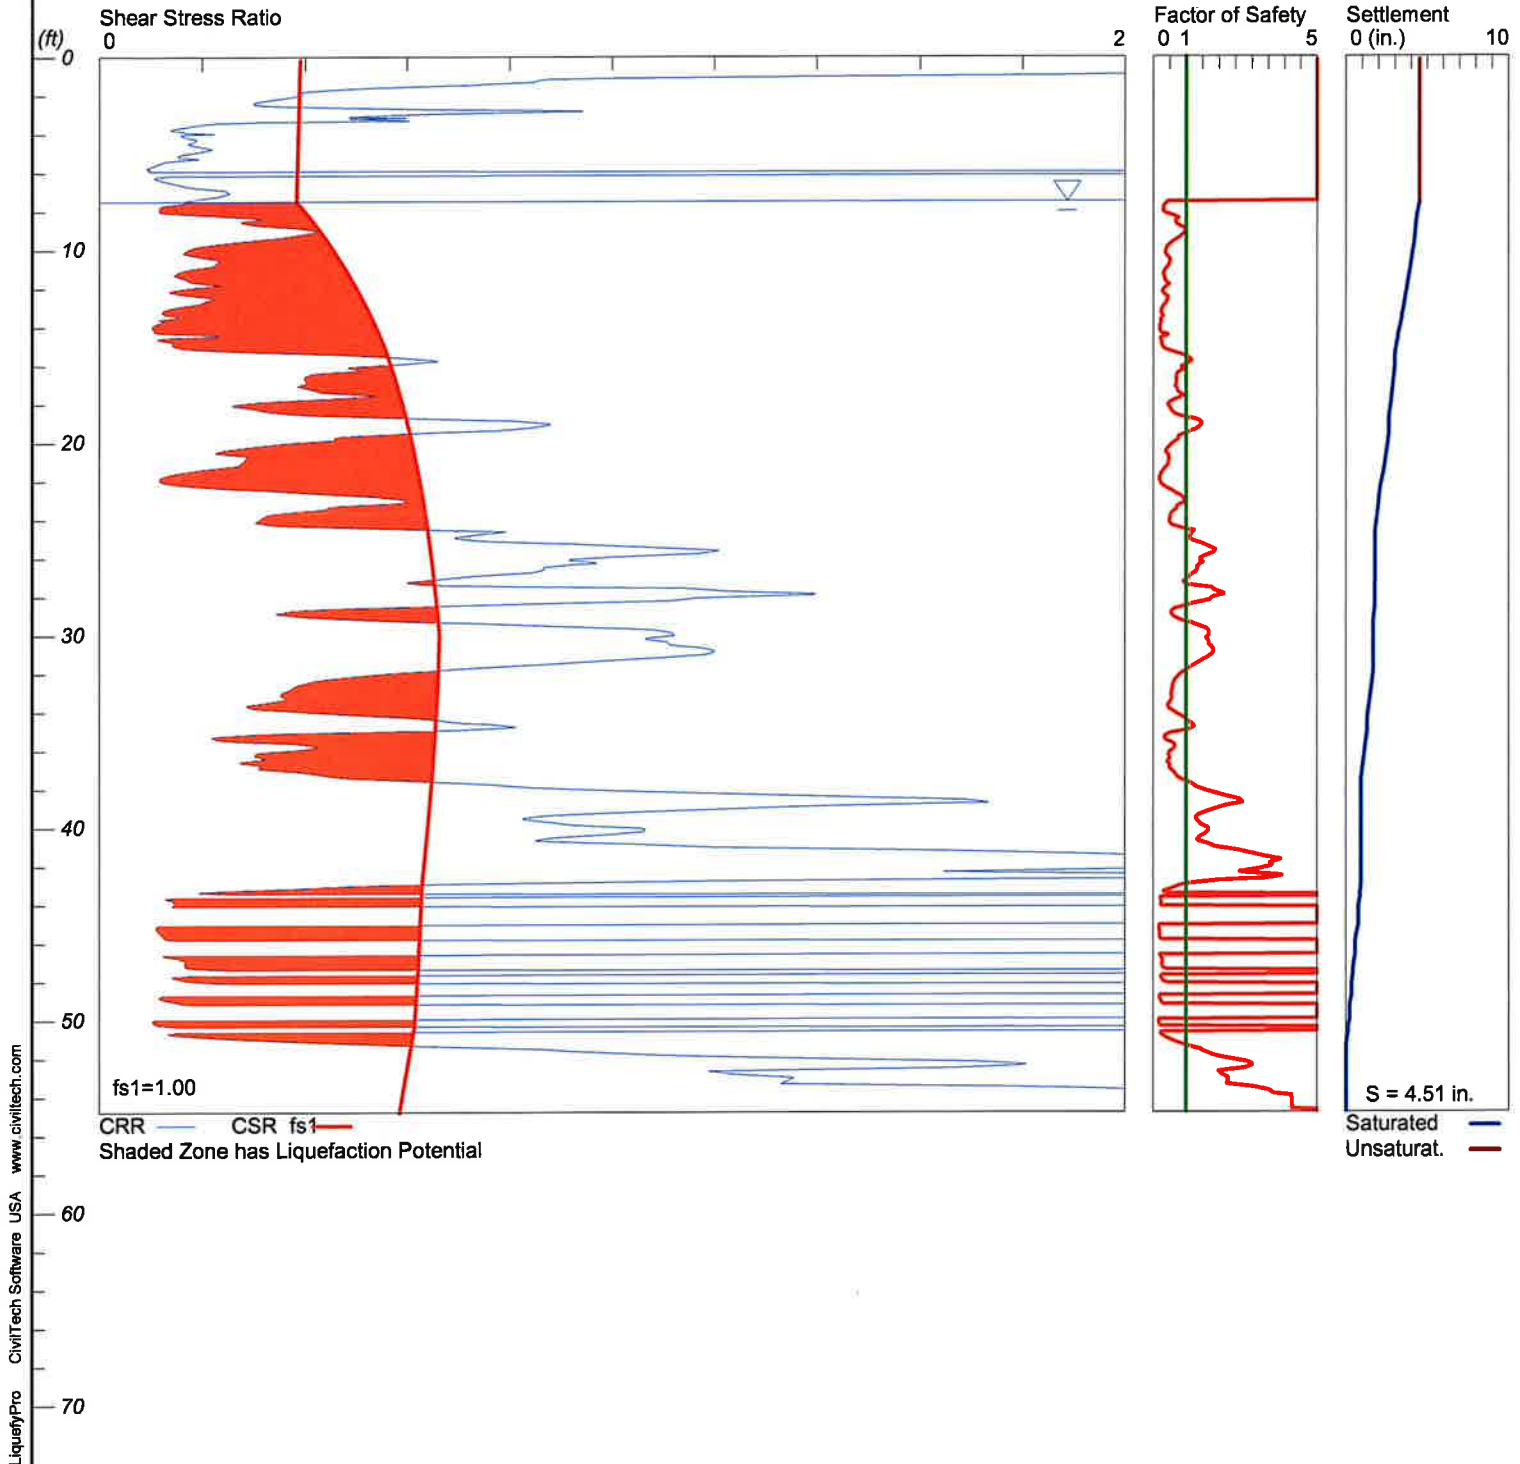
Hole No.=CPT-2 Water Depth=7.5 ft

Magnitude=7  
Acceleration=0.6g

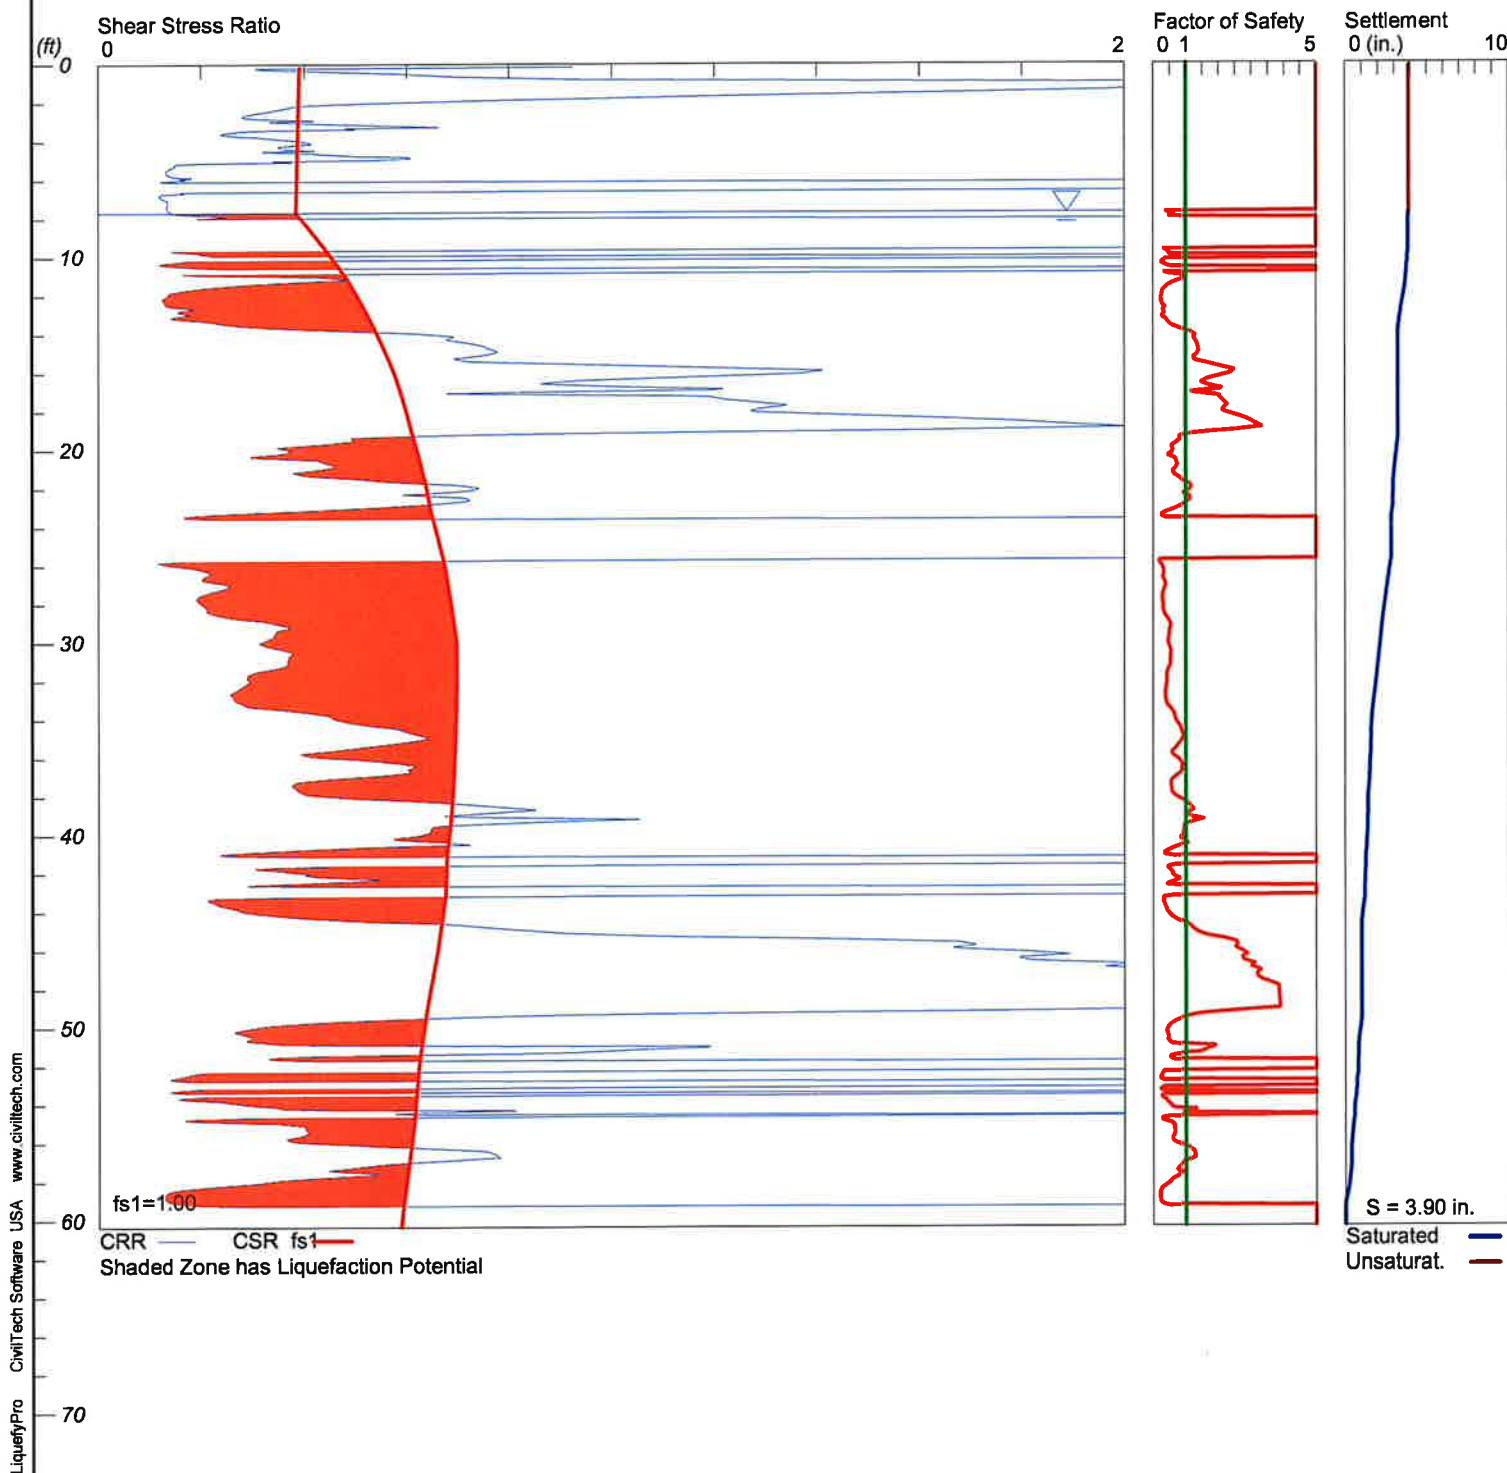
Hole No.=CPT-3 Water Depth=7.7 ft

Magnitude=7  
Acceleration=0.6g
