Soils Report
Proposed Redevelopment
204 4th Street SW
Puyallup, Washington
PN: 57450016-31, -32, -41
Doc ID: AGC.4thStSW.SR

This *Soils Report* summarizes our site observations and geotechnical data review and addresses the feasibility of stormwater infiltration for the proposed residential redevelopment to be constructed at 204 – 4th Street SW in Puyallup, Washington. The approximate site location is shown on Figure 1.

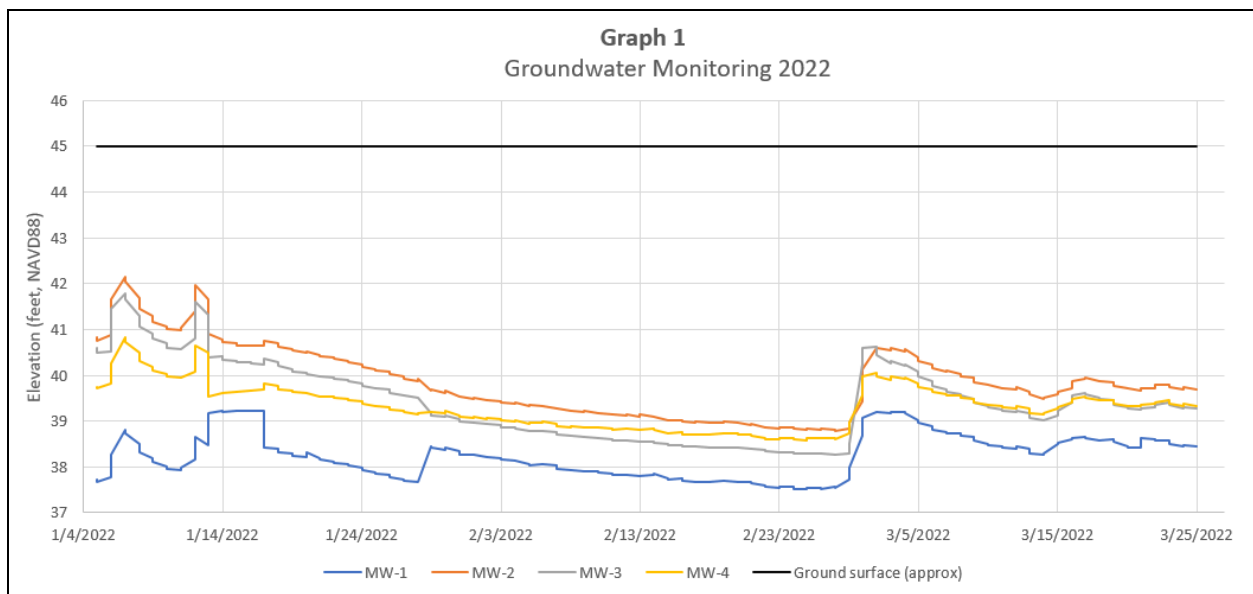
Based on our groundwater monitoring over the wet season, it appears that seasonal high groundwater levels occurred between elevation 39 to 42 feet (NAVD 88) in early to mid-January. Graph 1, below, summarizes the groundwater levels recorded as part of our groundwater monitoring program during our monitoring period.

We installed downhole pressure transducers in each groundwater monitoring well on January 5, 2022. Water temperature and pressure were collected on 12-hour intervals on each instrument. An additional pressure transducer was installed in one monitoring well above the water line to record barometric pressure. All instruments were removed on March 25, 2022.

Data sets were uploaded into Solinst Levelogger Software (v 4.40), where water level measurements captured by the deployed instruments were adjusted to compensate for barometric pressure variations. The resulting compensated water level dataset provides a barometrically corrected record of groundwater levels within each groundwater monitoring well.

Based on our groundwater monitoring measurements, the bottom of the proposed infiltration facilities should be no greater than 1.5 feet below existing grades, in order to meet the minimum 1 foot of vertical separation. We do not recommend infiltration in the area of MW-3. The surficial silty alluvium soils encountered at the surficial elevation of each exploration contain a significant amount of fines that will not support infiltration. The silty sands located at the surficial elevation in MW-1, MW-2, and MW-4 should be suitable for infiltration

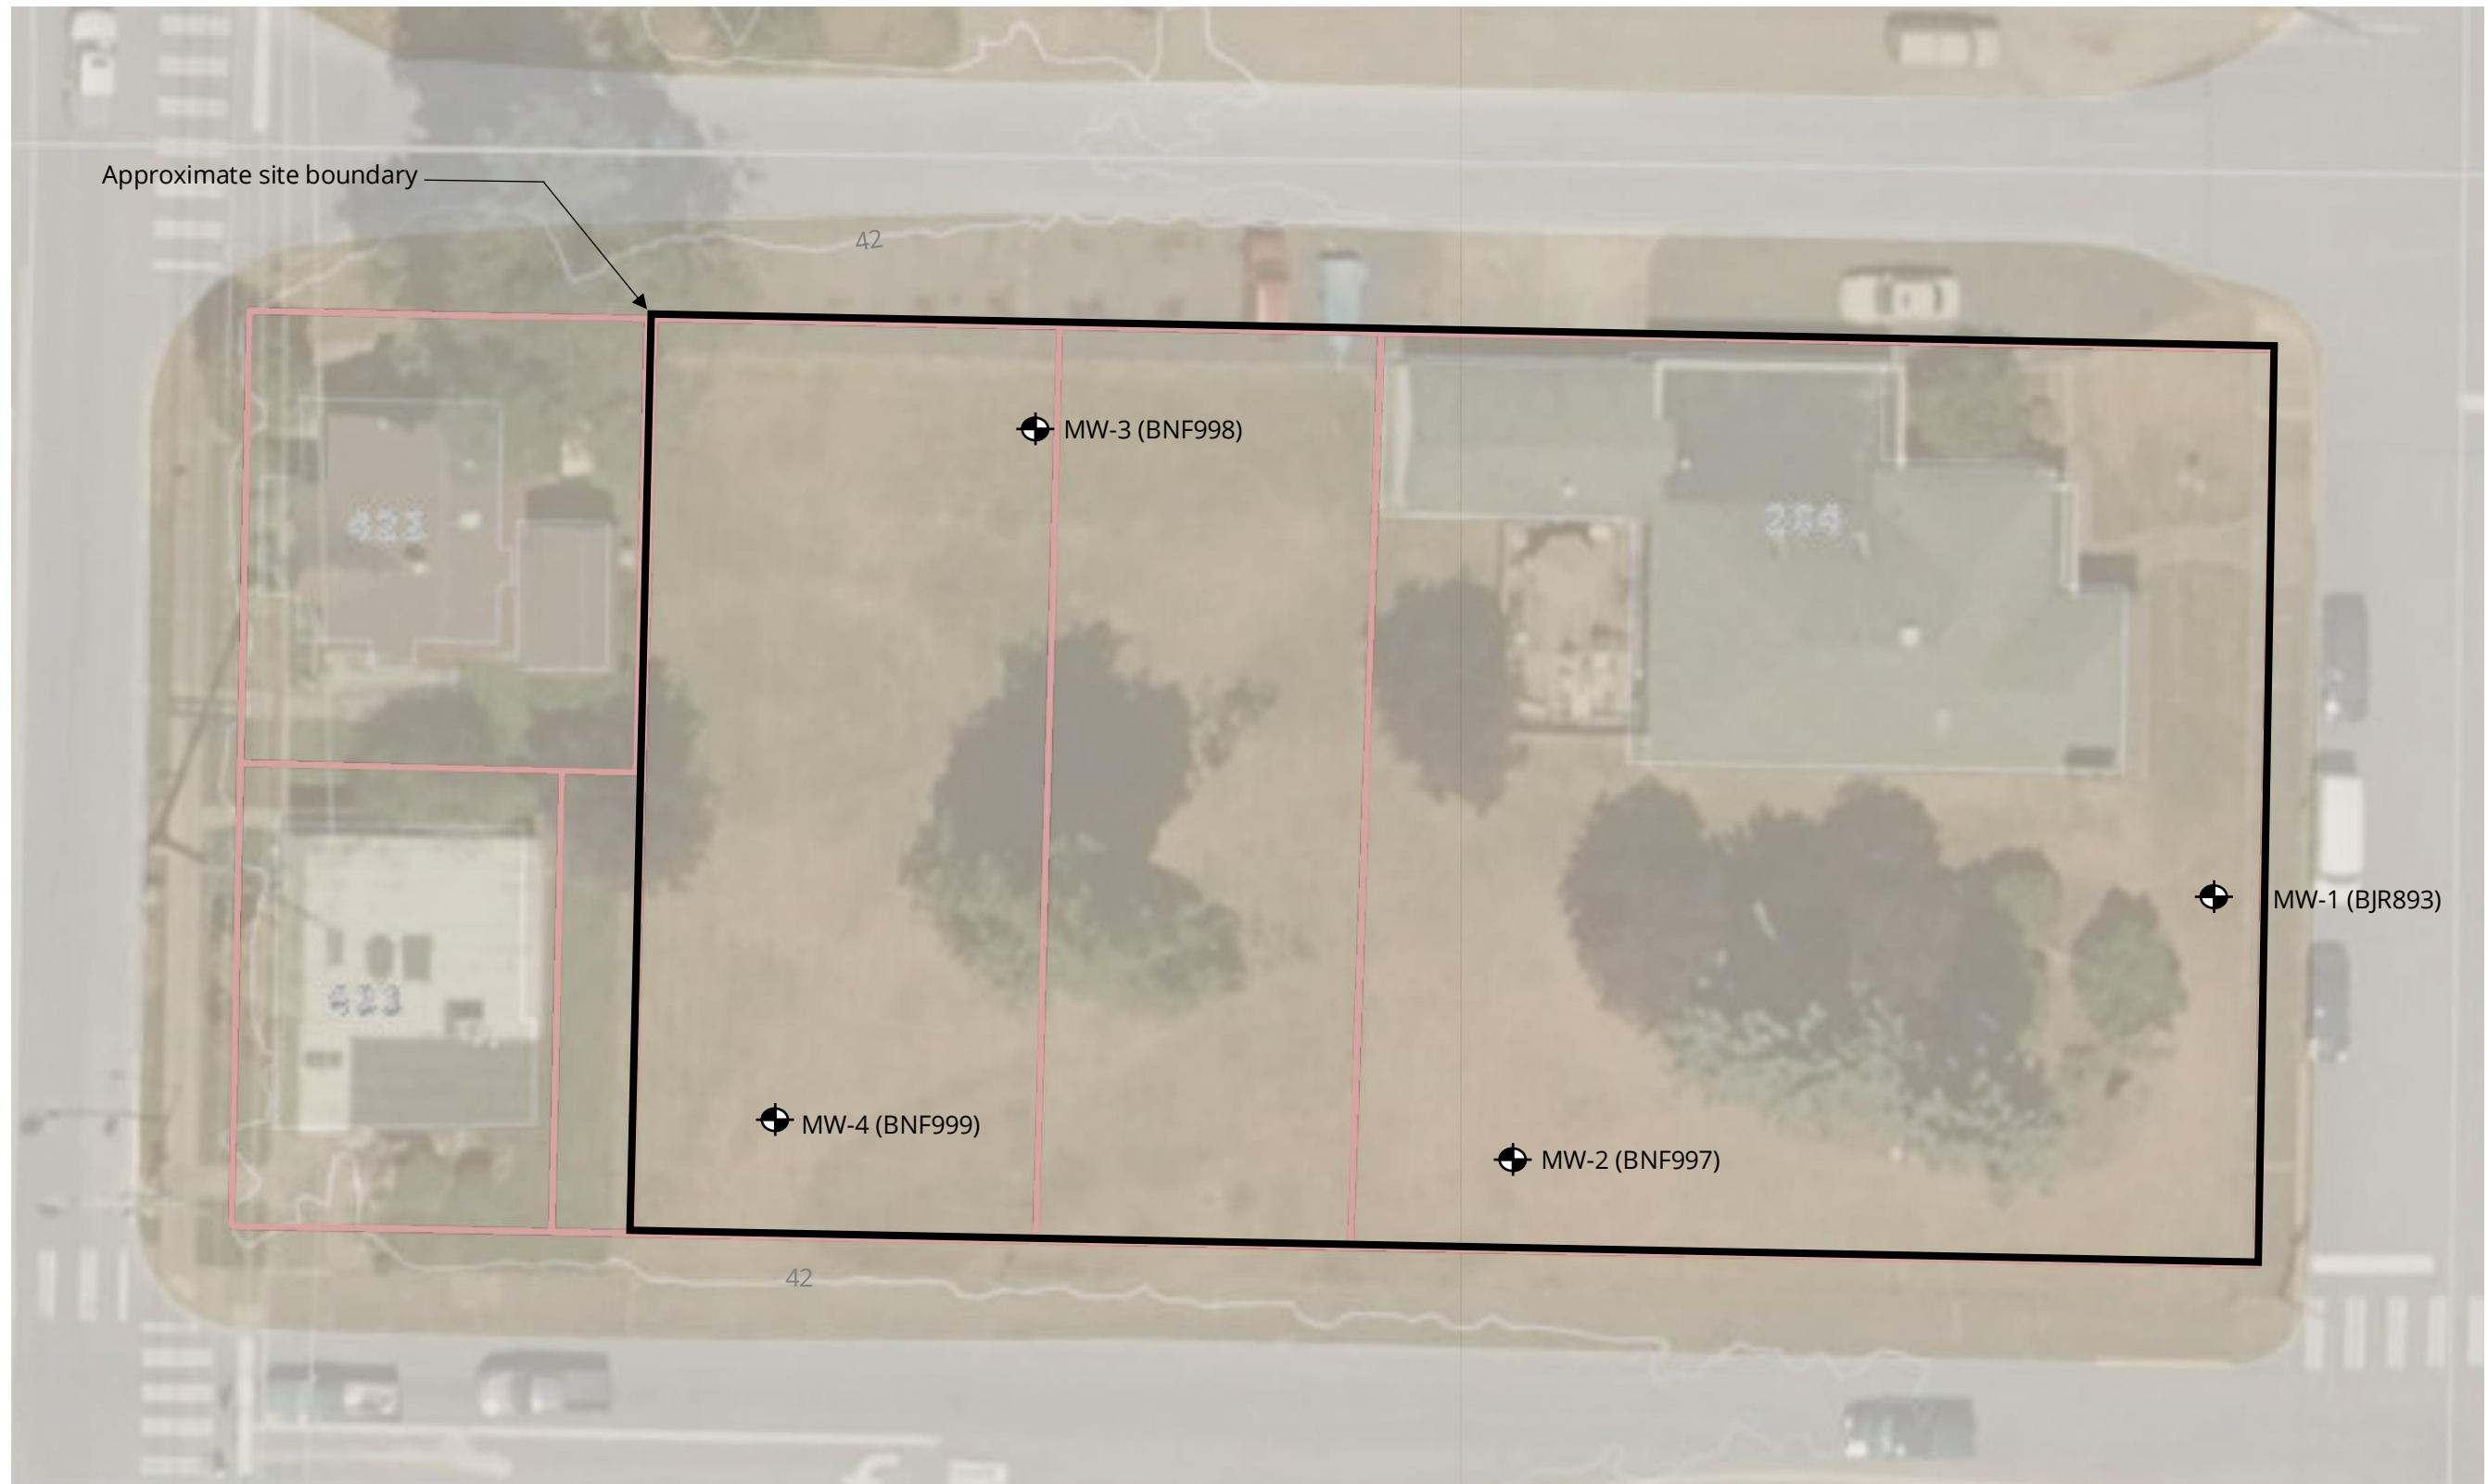
Figure 2

☛ Exploration number and approximate locations (GeoResources 2021)

Additional Notes:
 Imagery and topography accessed from Pierce County Public GIS, not to scale, NAVD88
 Downhole pressure transducers installed in all wells, suspended via mason line secured under well cap
 Barometric pressure transducer installed in MW-1, suspended 18-inches below well cap
 Must secure mason line before removing well cap
 All instruments set to record at 1200 and 2400 hours daily

Site & Exploration Plan
 Proposed Mixed-use Development
 204 - 4th St SW
 Puyallup, Washington
 PN: 5745001631, -32, -41

subsurface conditions, and obtained representative soils samples. The probes were completed by a licensed drilling company working for GeoResources. The approximate locations of the probes are indicated in the attached Site & Exploration Plan, Figure 2.

The soils encountered were visually classified in accordance with the Unified Soil Classification System (USCS) and ASTM D: 2488. The approximate locations of our explorations are indicated on the attached Site & Exploration Map, Figure 2. The USCS is included in Appendix A as Figure A-1, while the descriptive logs of our explorations are included as Figures A-2 through A-5.

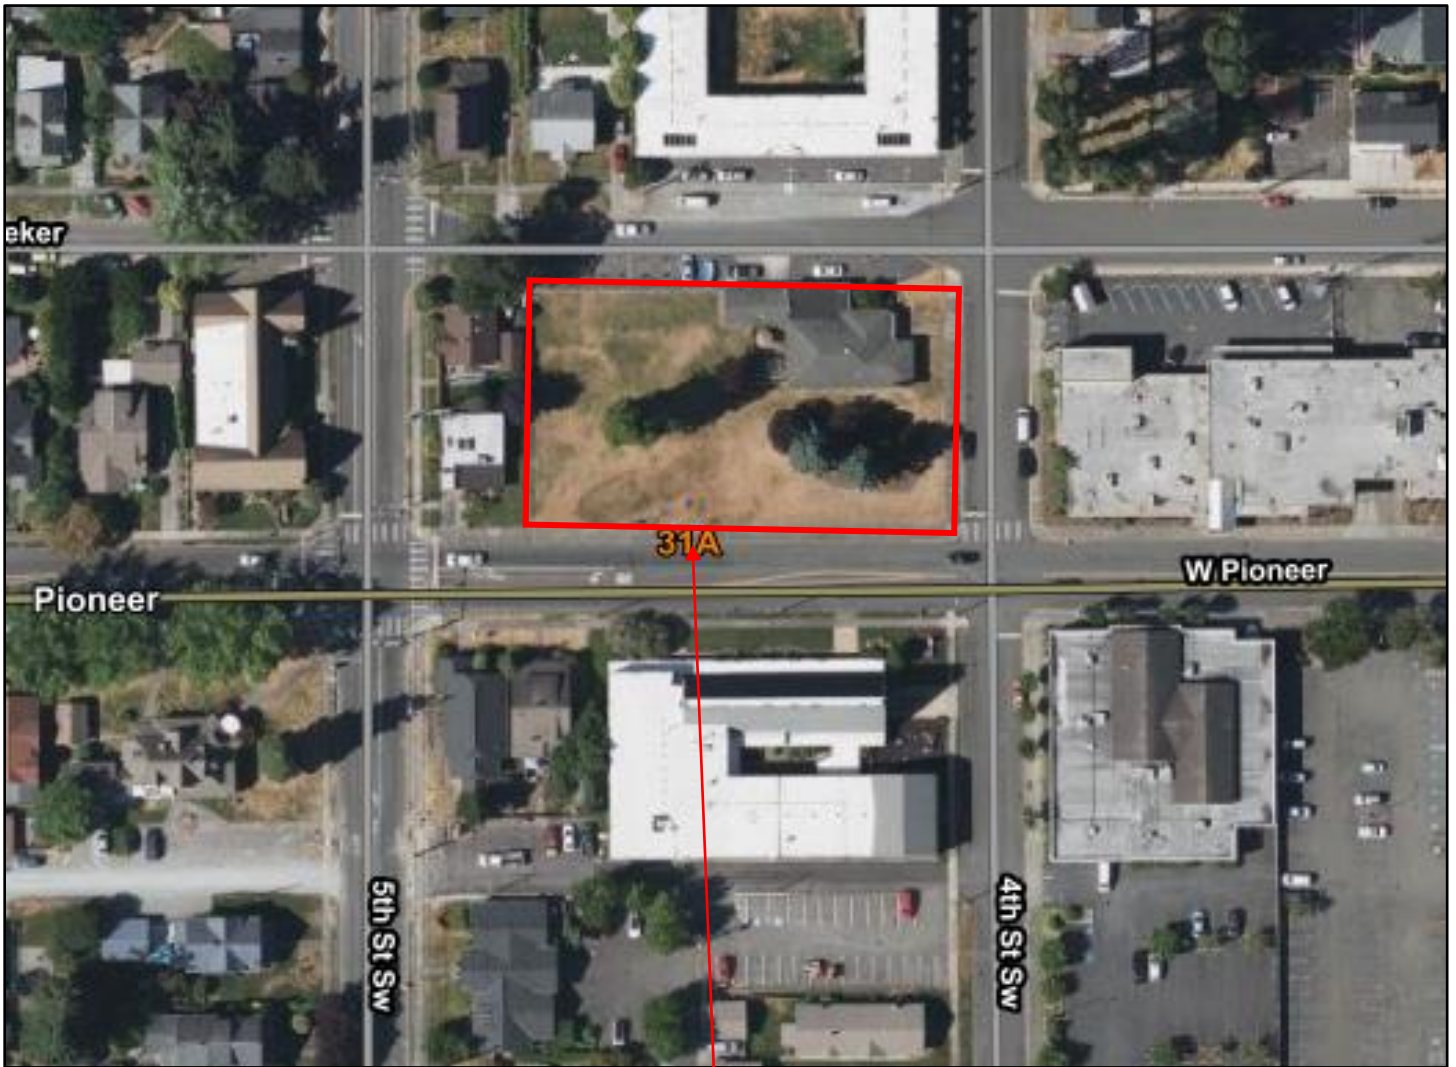
Figure 3

Soil Type	Soil Name	Parent Material	Slopes	Erosion Hazard	Hydrologic Soils Group
31A	Puyallup fine sandy loam	Alluvium	0 to 3	Slight	A

NRCS Soils Map
 Proposed Redevelopment
 204 4th Street SW
 Puyallup, Washington
 PN: 57450016-31,-32,-41

The Natural Resource Conservation Service (NRCS) Web Soil Survey maps the site as being underlain by Puyallup fine sandy loam (31A) soils. These soils are derived from alluvium, form on slopes of 0 to 3 percent, are considered to have a “slight” erosion hazard when exposed, and are included in hydrologic soils group A. A copy of the NRCS soils map is included as Figure 3.

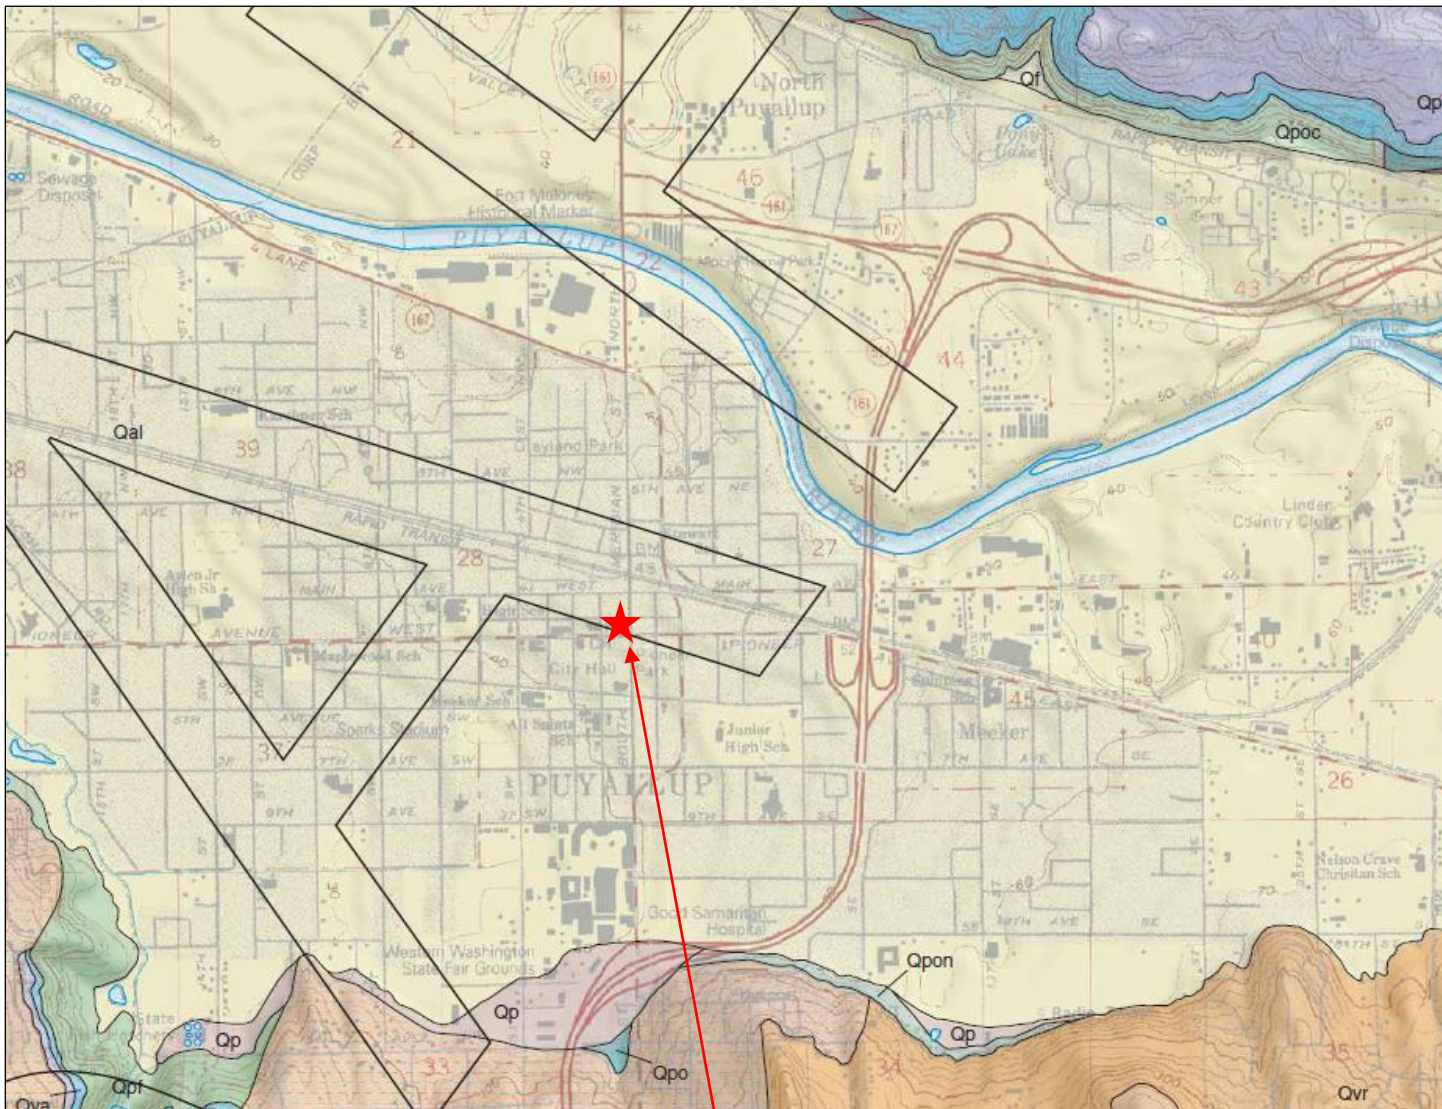
Qal	Alluvium
-----	----------

Geologic Map
 Proposed Redevelopment
 204 4th Street SW
 Puyallup, Washington
 PN: 57450016-31,-32,-41

According to the *draft Geologic map of the Puyallup 7.5-minute Quadrangle, Washington* by Troost, (in review) the site is mapped as being underlain by Quaternary Alluvium (Qal). Alluvial soils generally consist of normally consolidated, stratified deposits of sand, silt, clay, and occasional peat that were deposited along the Puyallup River channel. The existing topography, as well as the surficial and shallow soils in the area, are the result of fluvial action, including down-cutting by the river, channel meandering and migration, and flood deposits. An excerpt from the geologic map is included as Figure 4.

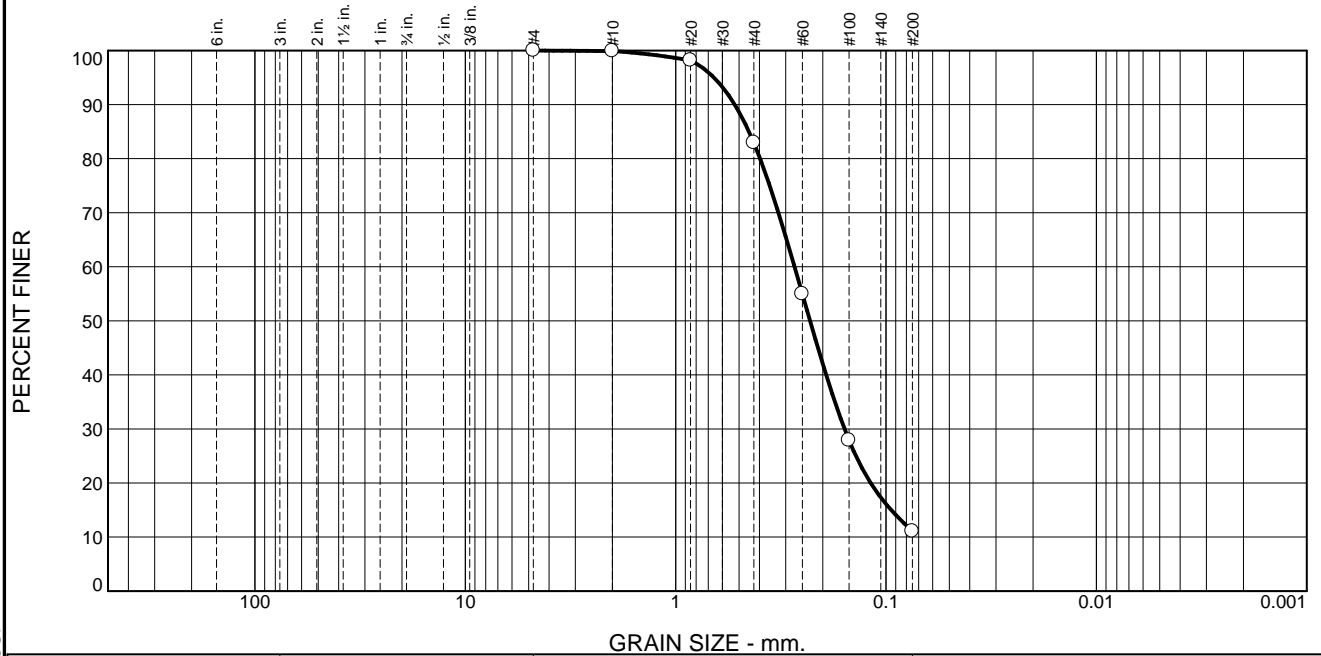
GeoResources, LLC Fife, WA	Client: Azure Green Consultants Project: AGC.4thStSW Project No: _____ Figure B-1
---	--

Particle Size Distribution Report

% +3"	% Gravel		% Sand			% Fines	
	Coarse	Fine	Coarse	Medium	Fine	Silt	Clay
0.0	0.0	0.0	0.1	17.0	71.8	11.1

Test Results (ASTM D 6913 & ASTM D 1140)			
Opening Size	Percent Finer	Spec.* (Percent)	Pass? (X=Fail)
#4	100.0		
#10	99.9		
#20	98.2		
#40	82.9		
#60	55.0		
#100	27.9		
#200	11.1

Poorly graded SAND with some silt (SP-SM)

USCS (D 2487)= SP-SM AASHTO (M 145)= A-2-4(0)

We completed a soil gradation analyses on three representative soil sample from the site per the 2014 SWMMWW, Volume III, Section 3.3.6, Method 3 and in accordance with ASTM D6913. Based on our gradation analyses, we recommend a design infiltration rate of 0.5 inches per hour for permeable pavements or bio swales founded no greater than 1.5 feet below existing grades in the shallow silty sand alluvium soils encountered in the areas of MW-1, MW-2, and MW-4. Appropriate correction factors have been applied to these values in accordance with the 2014 SWMMWW, Volume III, Section 3.3.6, Table 3.3.1, including correction factors 0.33 for site variability ($F_{variability}$), 0.4 for testing method ($F_{testing}$) and 0.9 for maintenance for situation biofouling ($F_{maintenance}$).

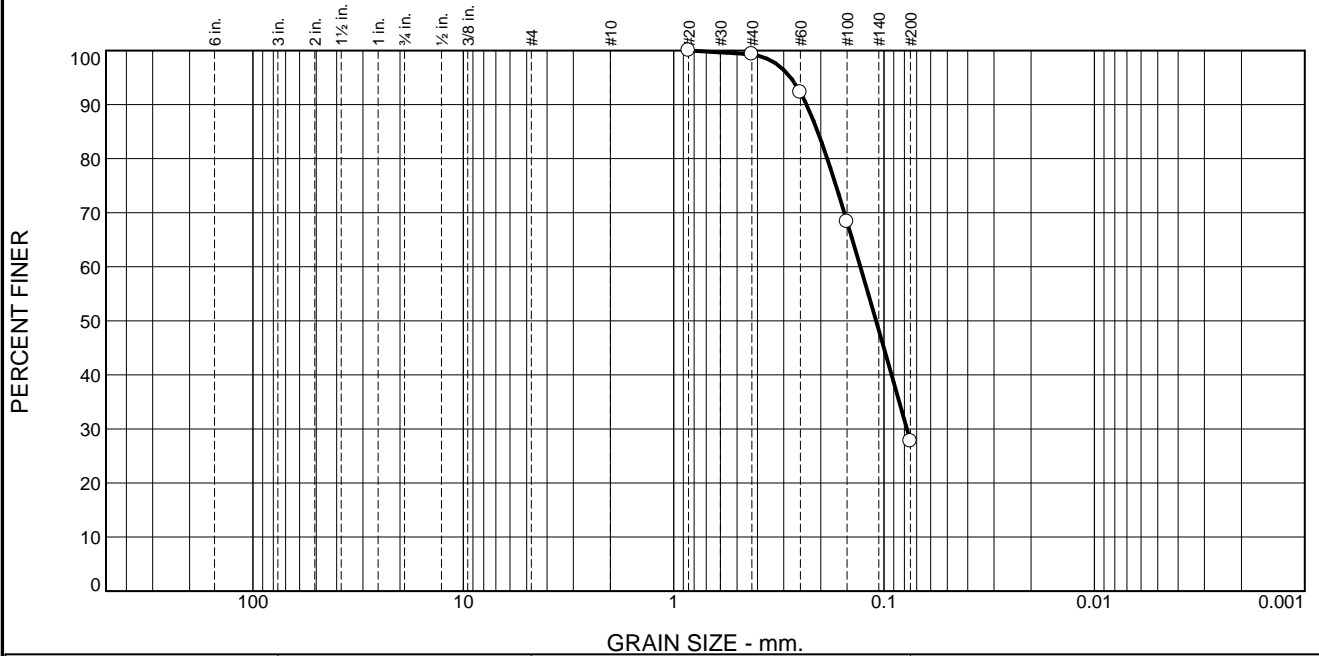
GeoResources, LLC Fife, WA	Client: Azure Green Consultants Project: AGC.4thStSW Project No: _____ Figure B-2
---	--

Particle Size Distribution Report

% +3"	% Gravel		% Sand			% Fines	
	Coarse	Fine	Coarse	Medium	Fine	Silt	Clay
0.0	0.0	0.0	0.0	0.7	71.6	27.7

Test Results (ASTM D 6913 & ASTM D 1140)			
Opening Size	Percent Finer	Spec.* (Percent)	Pass? (X=Fail)
#20	100.0		
#40	99.3		
#60	92.2		
#100	68.3		
#200	27.7

Silty SAND (SM)

USCS (D 2487)= SM AASHTO (M 145)= A-2-4(0)
