CONCEPTUAL MITIGATION PLAN

EAST TOWN CROSSING

APRIL 7, 2023

ASH DEVELOPMENT

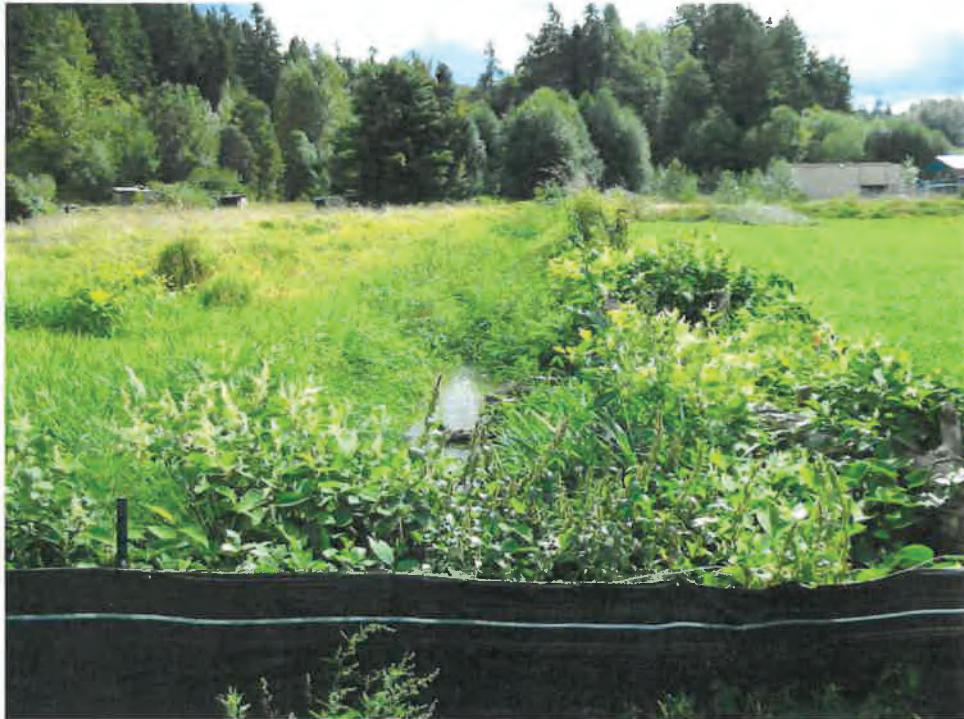
Photo #1: Looking south from the northeast portion of the property at the location where the silt fence jogs east about 25 ft. The water standing in the ditch at this time appears to flow north from the southeastern corner of the site along the east property line. (Taken 9/28/07)

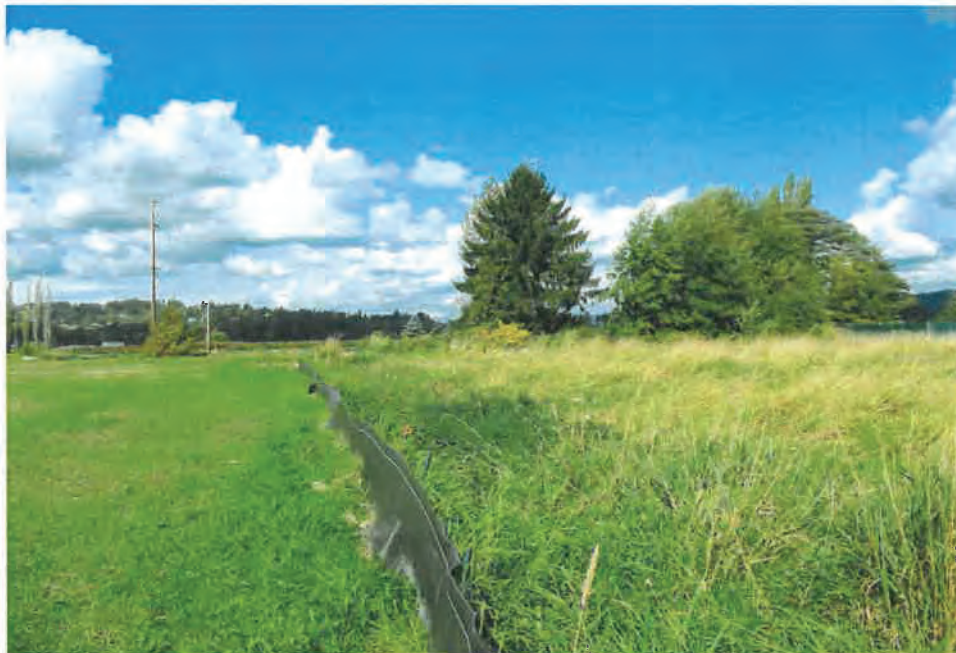
Photo #2: Looking north along the ditch-line pictured in photo #1. The ditch flows along (just outside) the east property line. The silt fence runs along the property line to protect the ditch from onsite surface runoff in accordance with the City of Puyallup requirements for the approved site development permit.

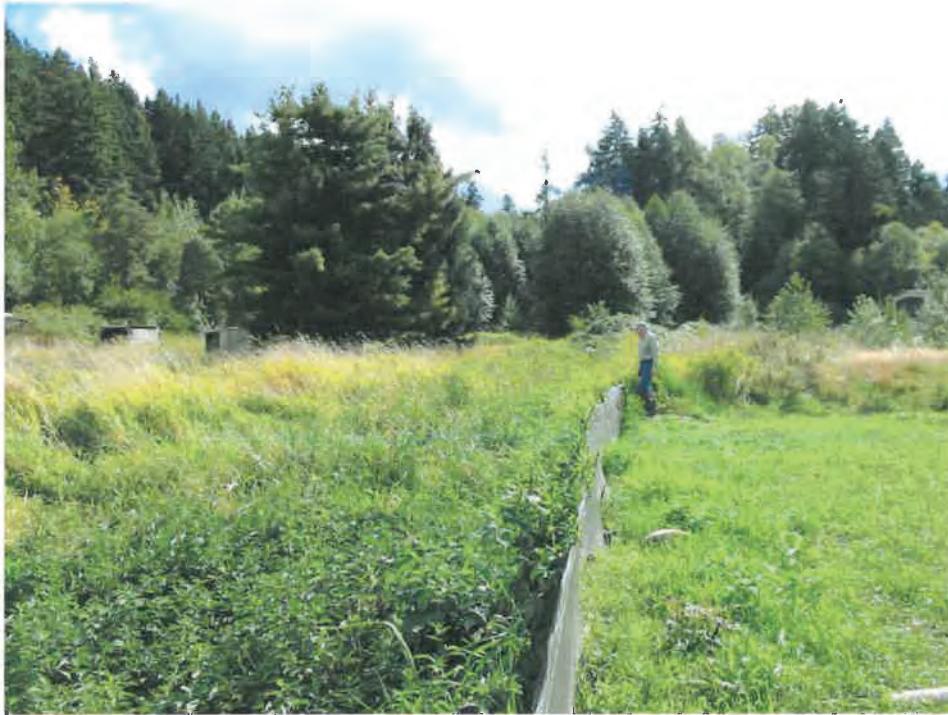
Photo #3: Looking south from the central portion of the site along the silt fence at the east property line. Notice the dominant reed canary grass and Himalayan blackberry along the adjacent offsite area. The ditch is piped thru this adjacent offsite area. (Taken 9/28/07)

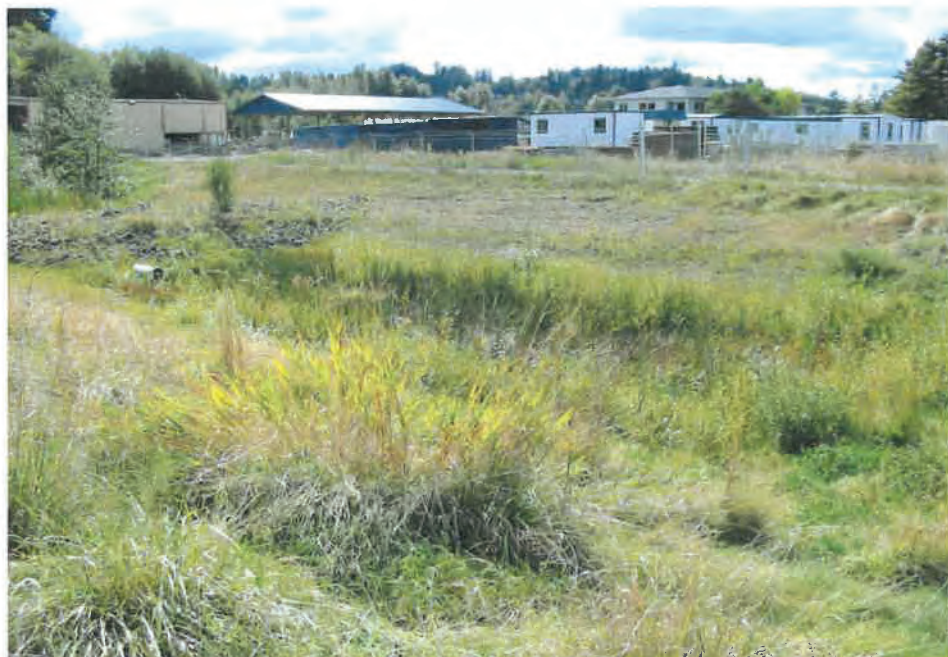
Photo #4: Looking southwest toward the northern cell of the storm detention pond located in this part of the site. The southern cell is just left of the berm and culvert pipe shown in this photo. (Taken 9/28/07)

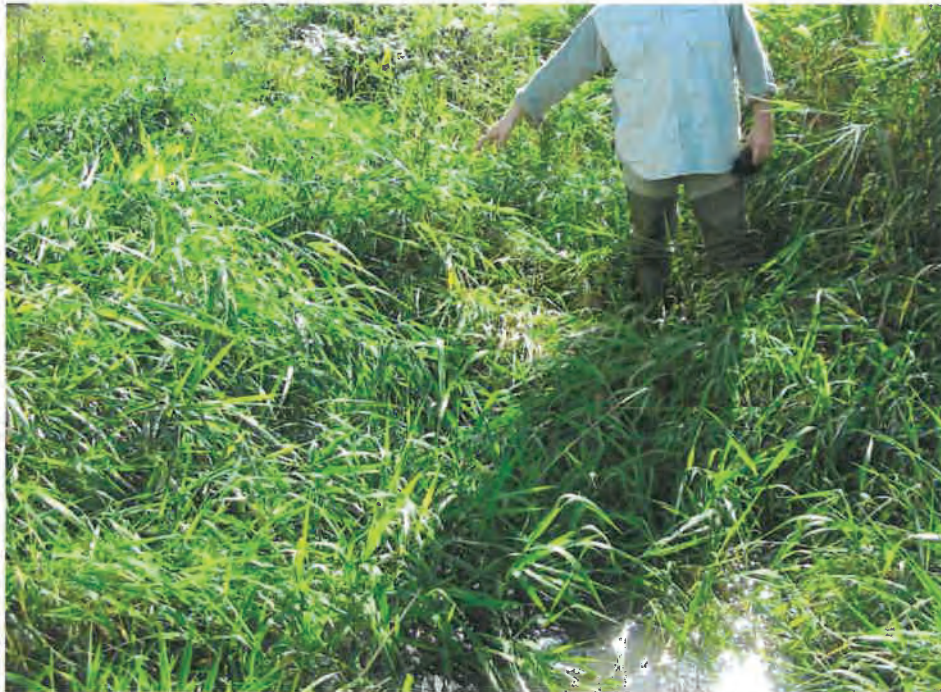
Photo #5: Looking directly down into the small, overgrown drainage ditch just east of the property line. The location of this portion of the ditch is near the central part of this property. Note the slow flow out of this area is due to clogging by dense vegetation (Reed Canary Grass). (Taken 9/28/07)

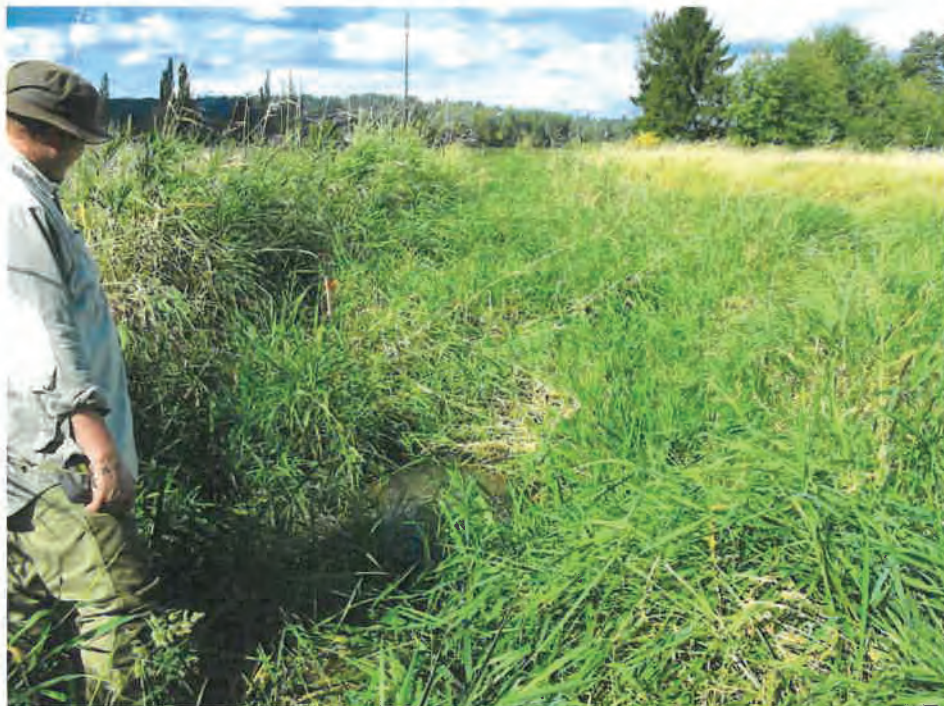
Photo #6: Looking north at slowly flowing water in the small drainage ditch as shown in Photo #8 is due to clogging by dense vegetation (Reed Canary Grass). (Taken 9/28/07)

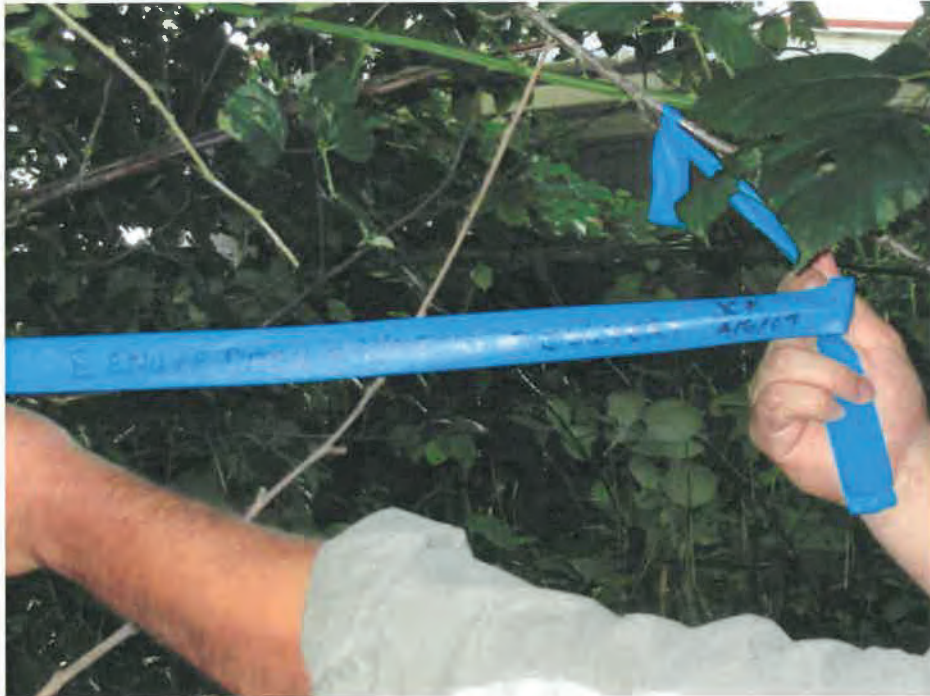
Photo #7: Looking at a blue flag marking the “center-line at end of ditch = upstream end of culvert.” This is located offsite and just north of the southeast property corner. (Taken 9/28/07)

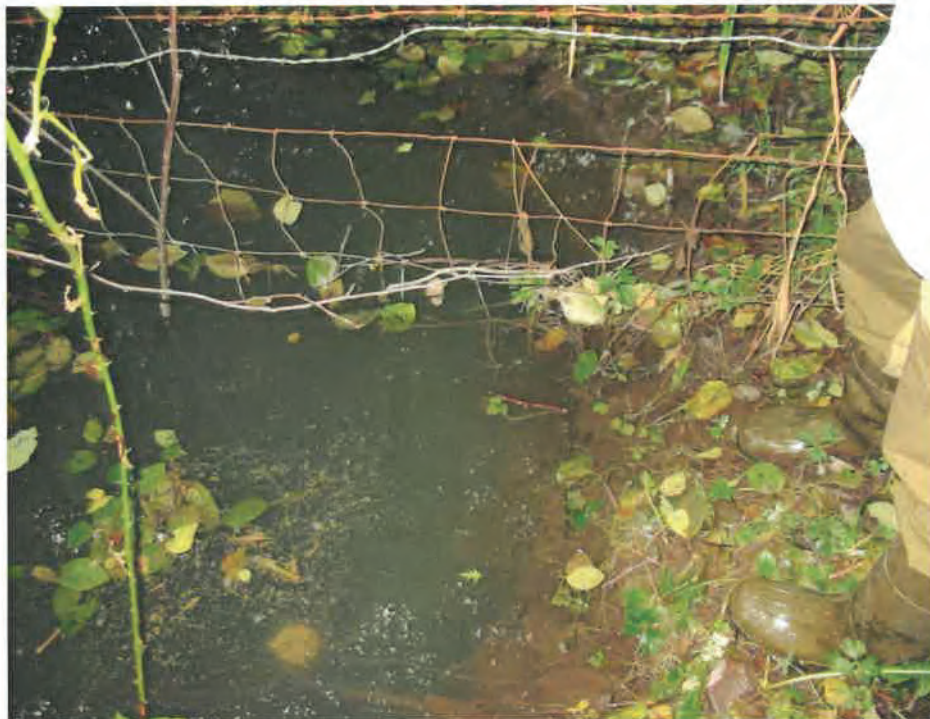
Photo #8: Looking directly down at the submerged end of the culvert that is located directly beneath the flag shown in Photo #7. At this time the water is flowing slowly north in the ditch and into the upstream end of the culvert. This area requires maintenance and possibly a larger culvert. (Taken 9/28/07)

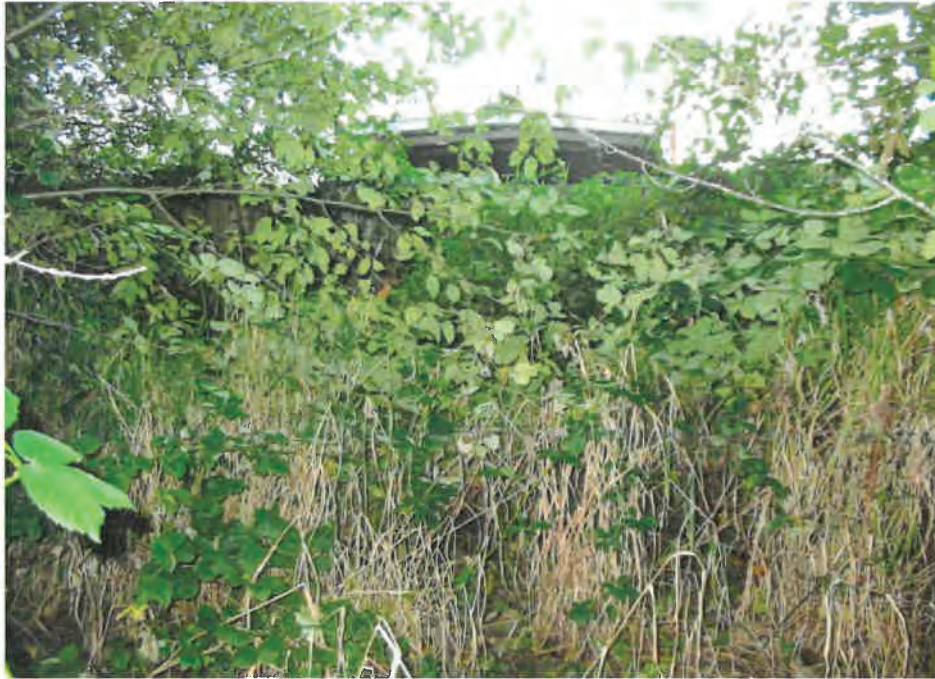
Photo #9: Looking west from the same location as at Photo #8 about 30 ft. south of the southeast property corner. Notice the dense vegetation (reed canary grass, Himalayan blackberries and red alder trees overgrowing the ditch and culvert pipe in this area. (Taken 9/28/07)

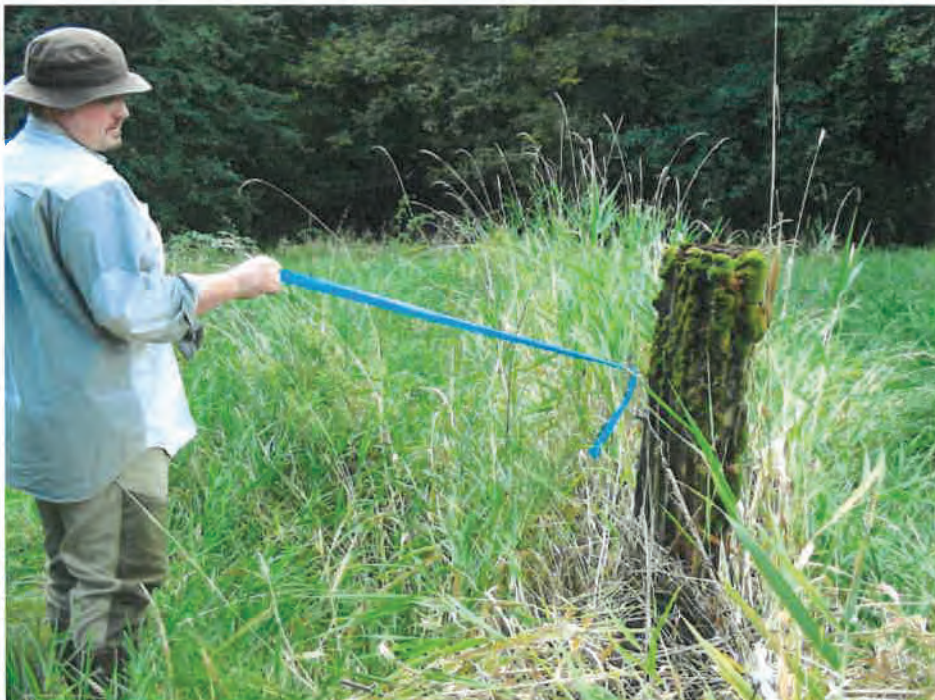
Photo #10: Looking south along the old fence line that extends thru offsite Wetland "A" located about 150 feet south of the subject property (see next photos for more about offsite Wetland "A"). (Taken 9/28/07)

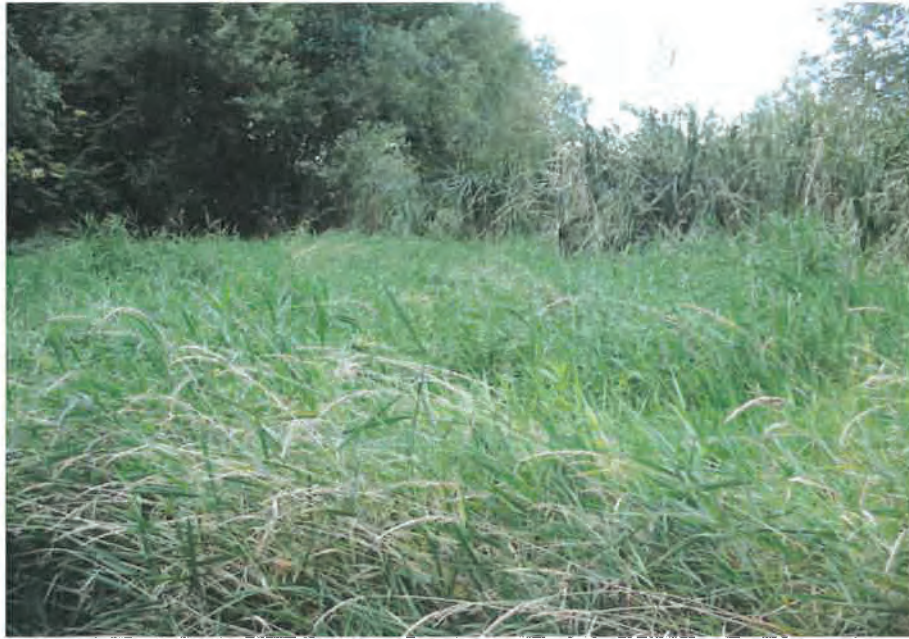
Photo #11: Looking west across offsite Wetland "A" located approximately 150 ft. south of the southeast property corner. Notice the dominant overgrown Reed Canary Grass (FACW indicator species) and cattail (OBL indicator species) in this part of Wetland "A". (Taken 9/28/07)

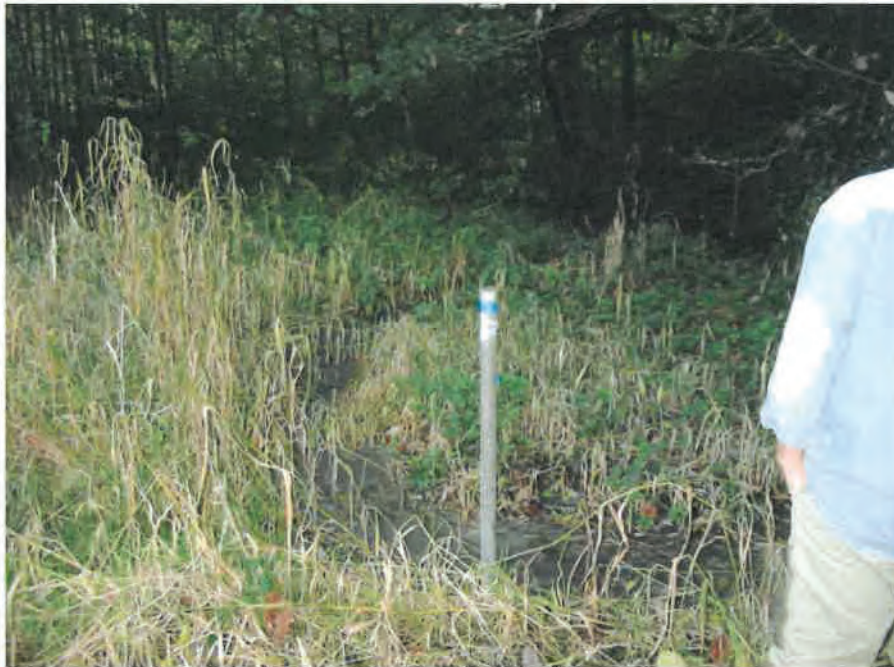
Photo #12: Looking south from a location approximately 230' south of the southeast property corner in offsite Wetland "A". Note the metal pole in the photo was found but not placed by JCA. A stream was flowing thru this part of Wetland "A" out of a ravine from the southeast (see Fig. 6). (Taken 9/28/07)

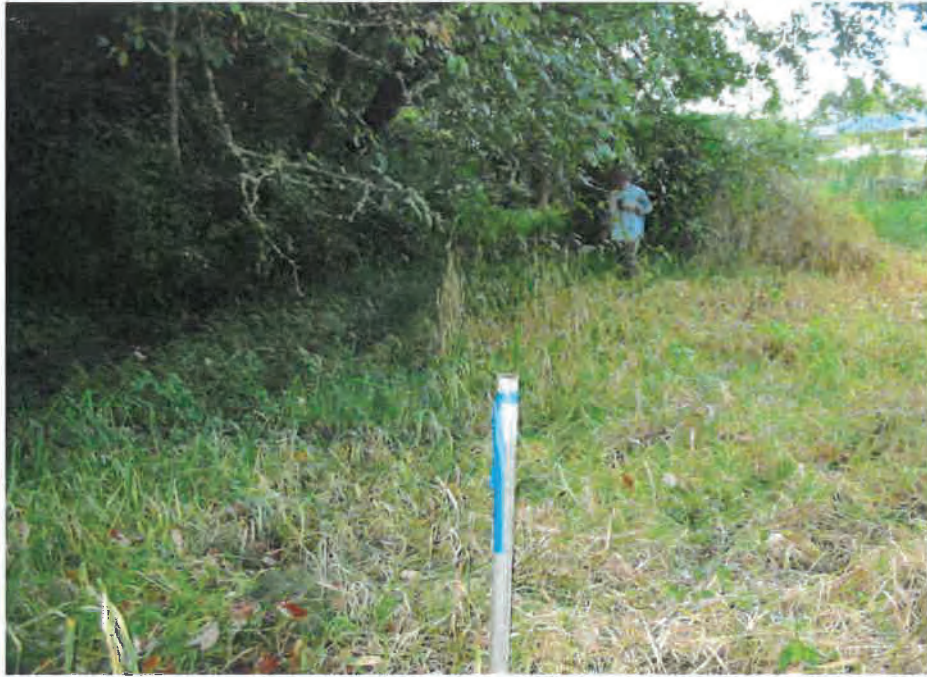
Photo #13: Looking west from the metal pole in Photo #12 toward the forested and shrub part of Wetland "A". The stream flows around to the west and then north into the ditch section from this location. Some skunk cabbage (OBL) was found growing along the stream. (Taken 9/28/07)

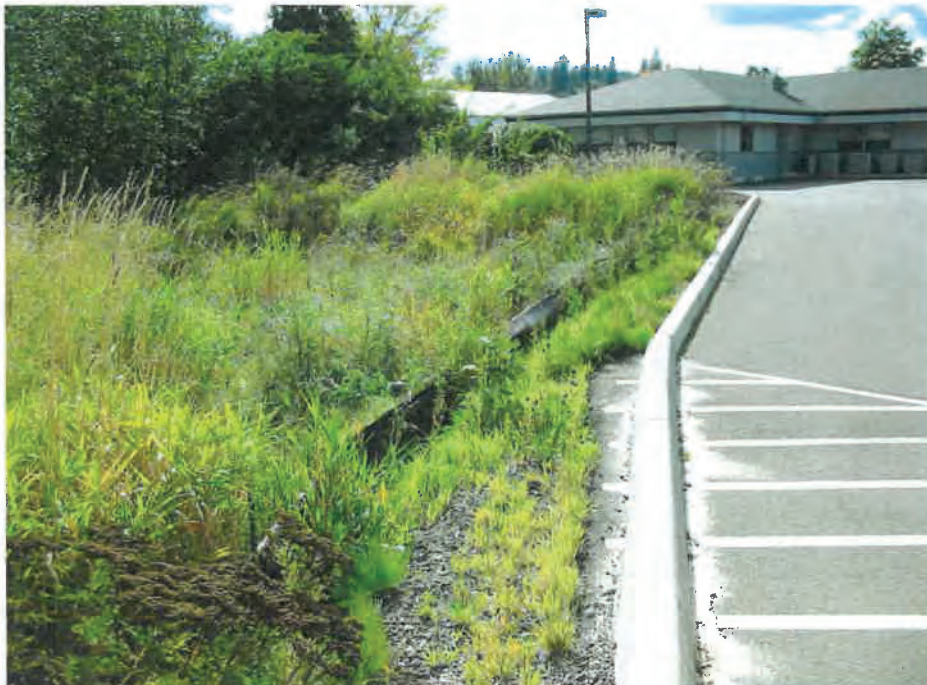
Photo #14: Looking southwest toward the forested portions of offsite Wetland "A" from the parking lot about 150 feet south of the subject site. There is a 25' buffer between the edge of the parking lot and the edge of the original wetland. The wetland extends to the east along the parking lot. (Taken 9/28/07)

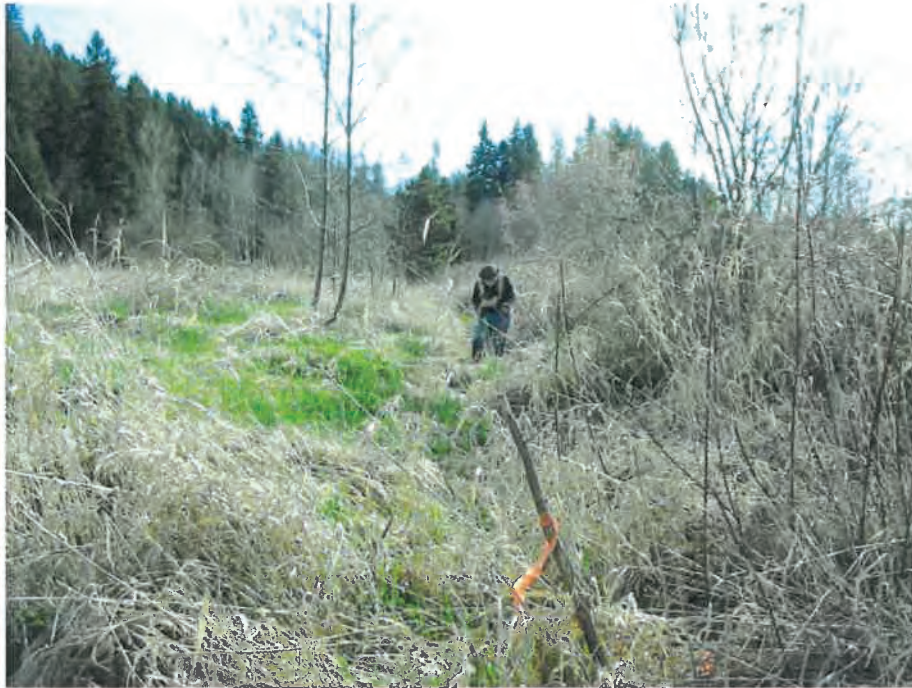
Photo #1: Looking south from the downstream end of the drainage ditch along the eastern side of the project site. Note the higher ground on the right in this photo is the NE corner of the project site. The lower ground on the left is offsite, overgrown meadow with Reed Canary Grass and found to be upland throughout the entire area. (IMG-002, 3/4/20)

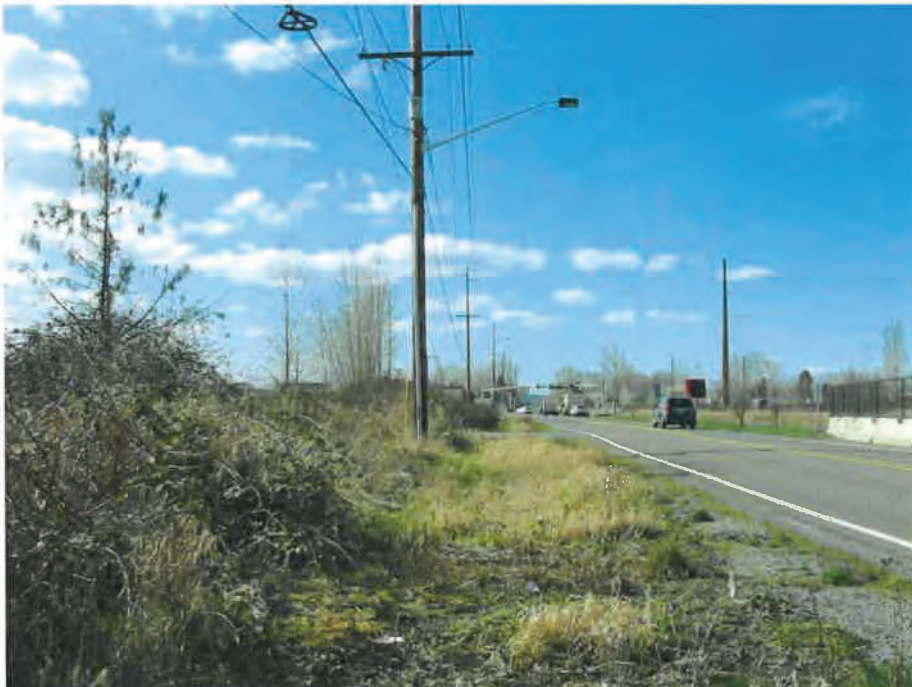
Photo #2: Looking west from the downstream end of the drainage ditch along the eastern side of the project site. Note the NE corner of the project site is on the left in this photo, and the drainage ditch along the south side Pioneer Way has very little surface water flowing at this time downstream from this point to the driveway crossing in the background. (IMG-004, 3/4/20)

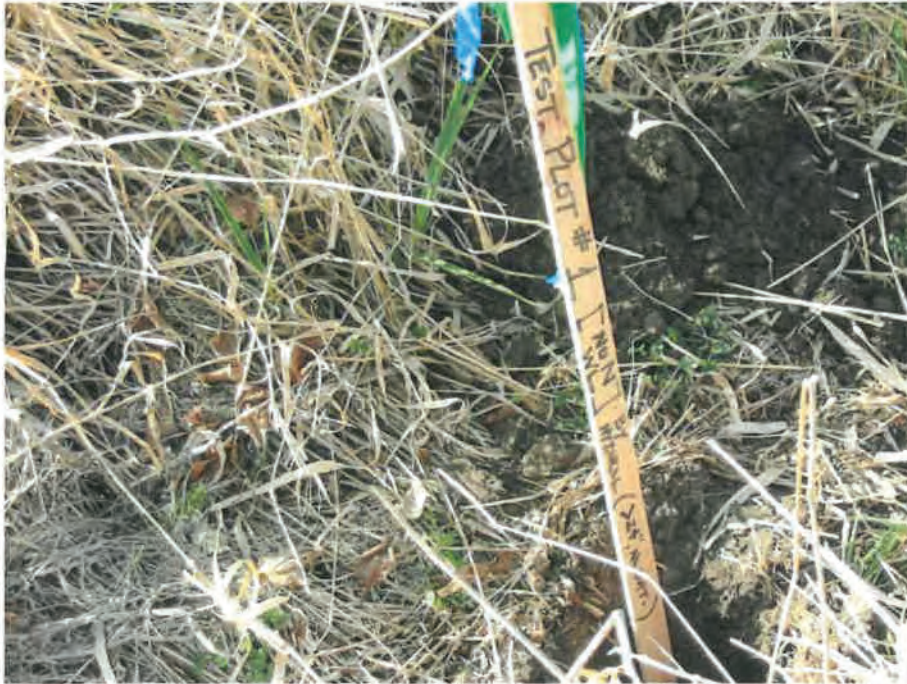
Photo #3: Looking down at the first sample test plot (TP1) that was dug by shovel in the bottom of the drainage ditch and found to be non-wetland by a lack of hydrology at a depth of 24". Note the soil material in the background was removed from the test hole and found to be non-hydric based on field color indicators. (IMG-012, 3/4/20)

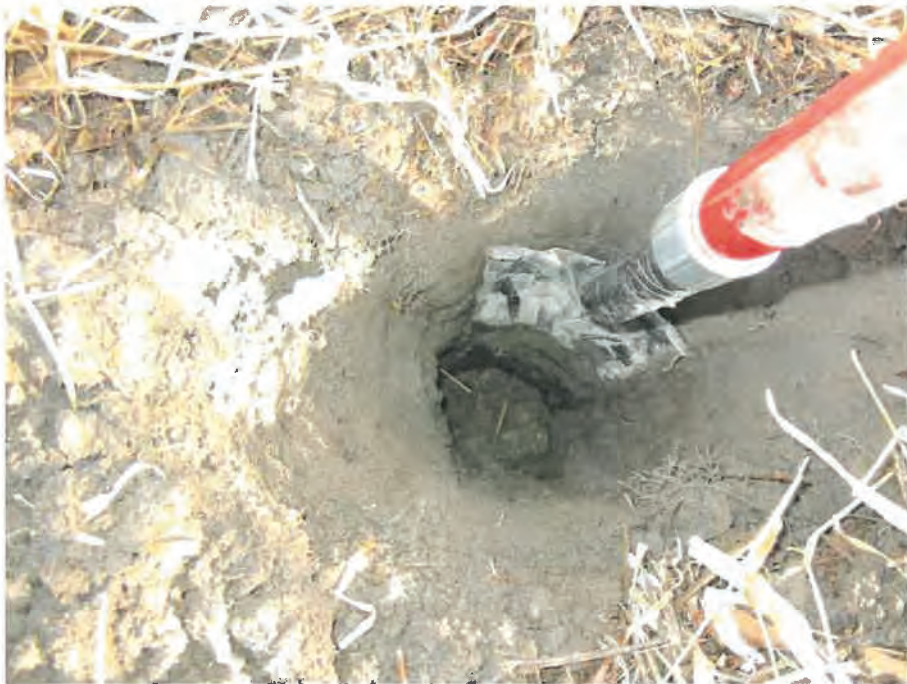
Photo #4: Looking down into the bottom of test hole at TP1 that has no seepage or groundwater evident at 24" deep. Note the soil color was also indicating non-wetland by field color indicators. (IMG-008, 3/4/20)

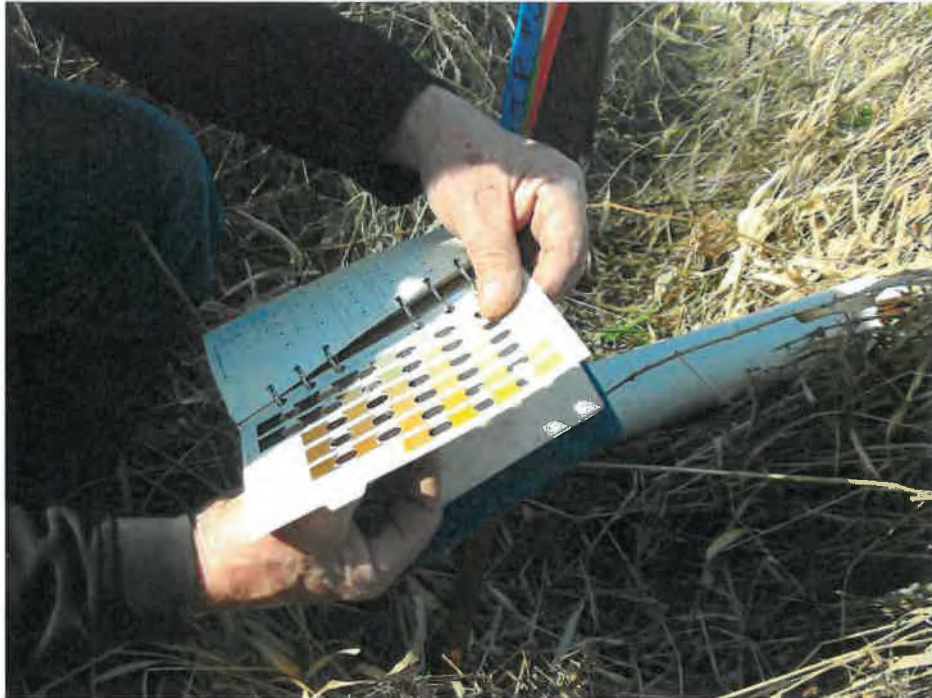
Photo #5: Looking at TP3 while checking the field color indicators for the soil that was dug from this sample test plot. (IMG-021, 3/4/20)

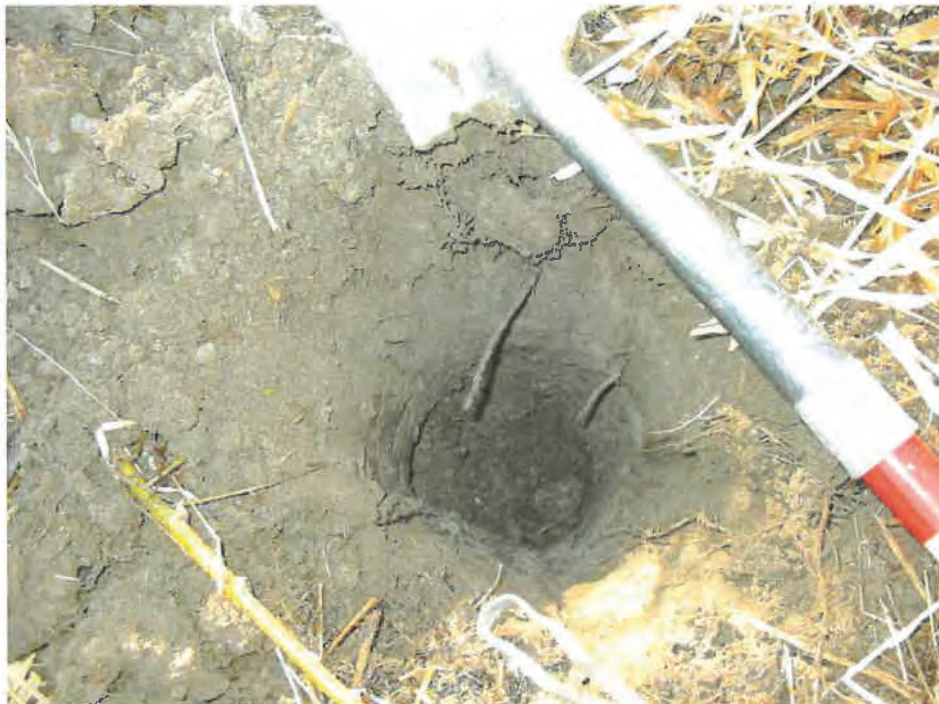
Photo #6: Looking down into the bottom of TP3 with no saturation or groundwater evident at this time in the lowest part of the old drainage ditch that had flowed along the eastern side of the project site. (IMG-020, 3/4/20)

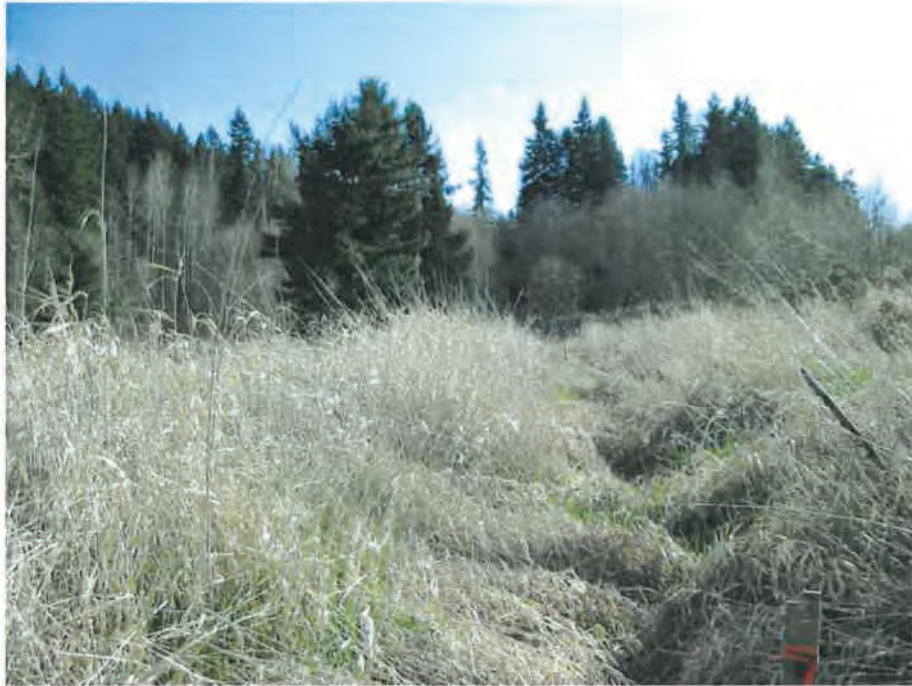
Photo #7: Looking south at the overgrown drainage ditch that is supposed to be flowing water to the north along the eastern side of the project site. Note the lower ground on the left is offsite, overgrown meadow with Reed Canary Grass that is found to be upland throughout the entire area. (IMG-032, 3/4/20)

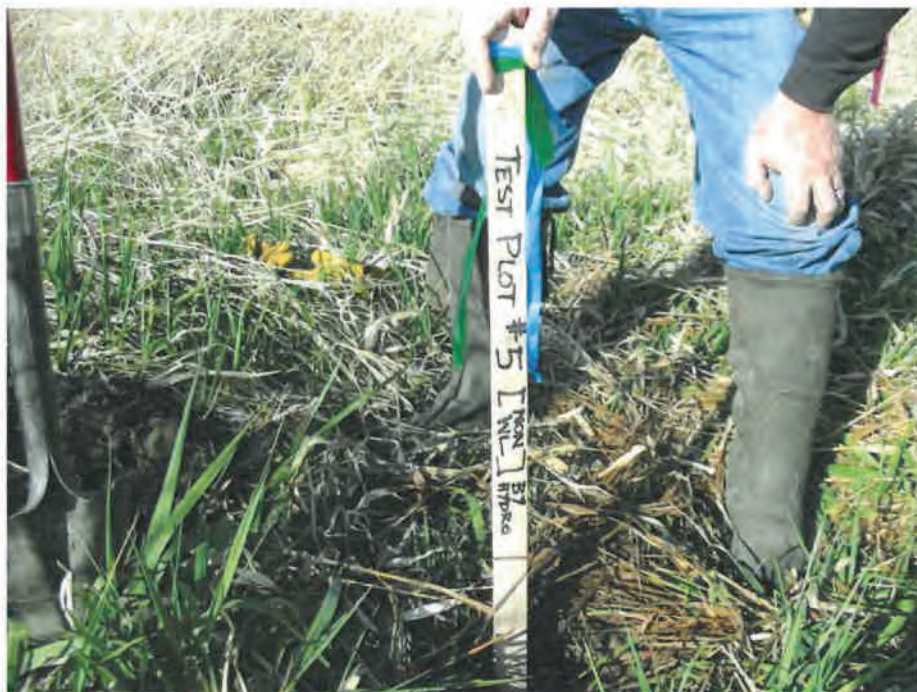
Photo #8: Looking down at TP5 that was dug in the lower part of the adjacent overgrown Reed Canary Grass meadow on the offsite property to the east of the drainage ditch and TP4. Note the non-wetland determination was primarily due to the lack of hydrology at the bottom of the hole dug 30" deep. (IMG-028, 3/4/20)

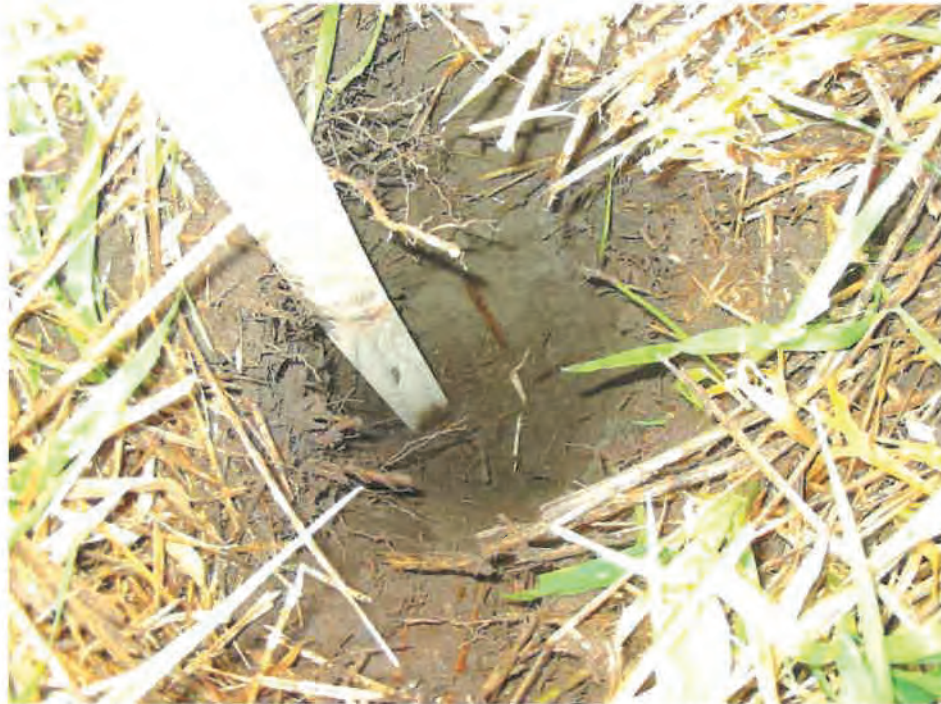
Photo #9: Looking down into the bottom of test hole at TP5. Note the lack of any saturation or groundwater seepage in the bottom at 30". (IMG-029, 3/4/20)

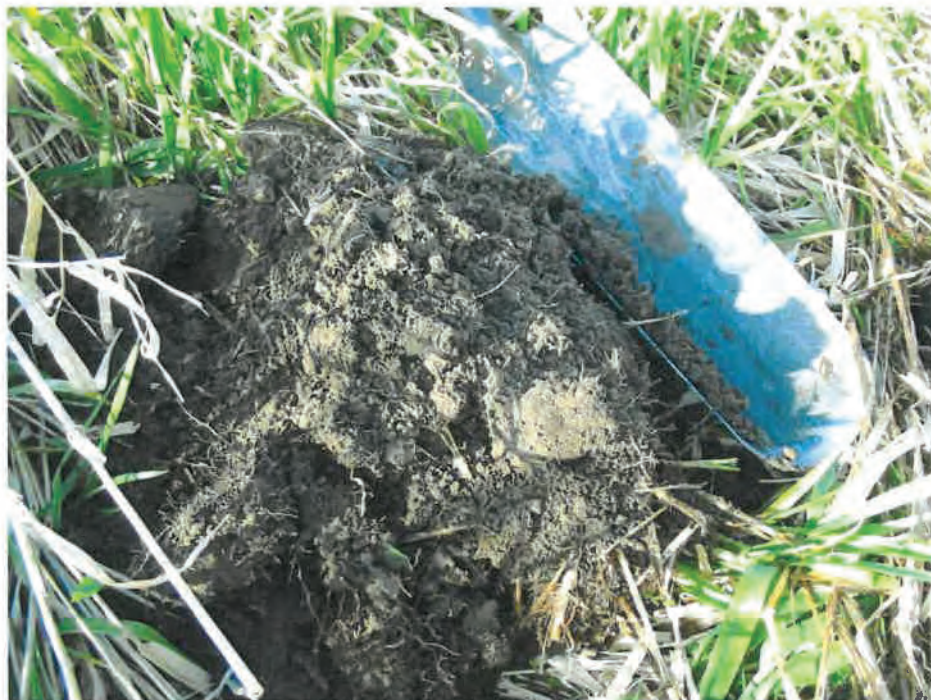
Photo #10: Looking at the soil dug from TP5 that indicates non-hydric conditions based on matrix color = 10yr 3/3 to 15" deep, and none to faint redox features above 15" deep, many fine roots, etc. (IMG-030, 3/4/20)

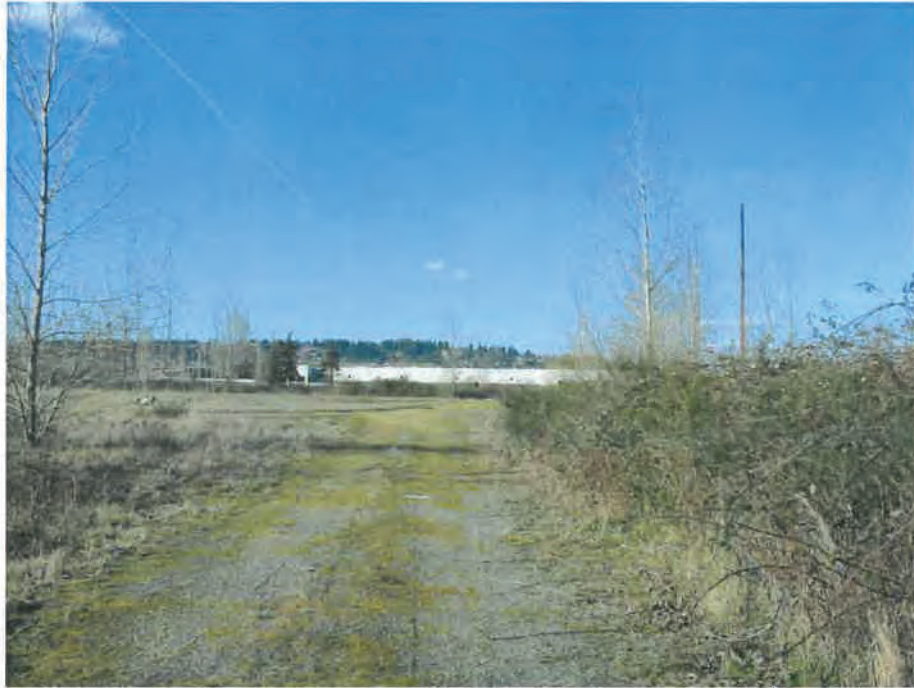
Photo #11: Looking north from within the eastern part of the project site along the gravel road that is constructed in the surveyed location shown on Figure 7. Note the 12" CMP storm drain from the storm pond (see Photo #13) is buried under the existing roadway through to Pioneer Way. (IMG-031, 3/4/20)

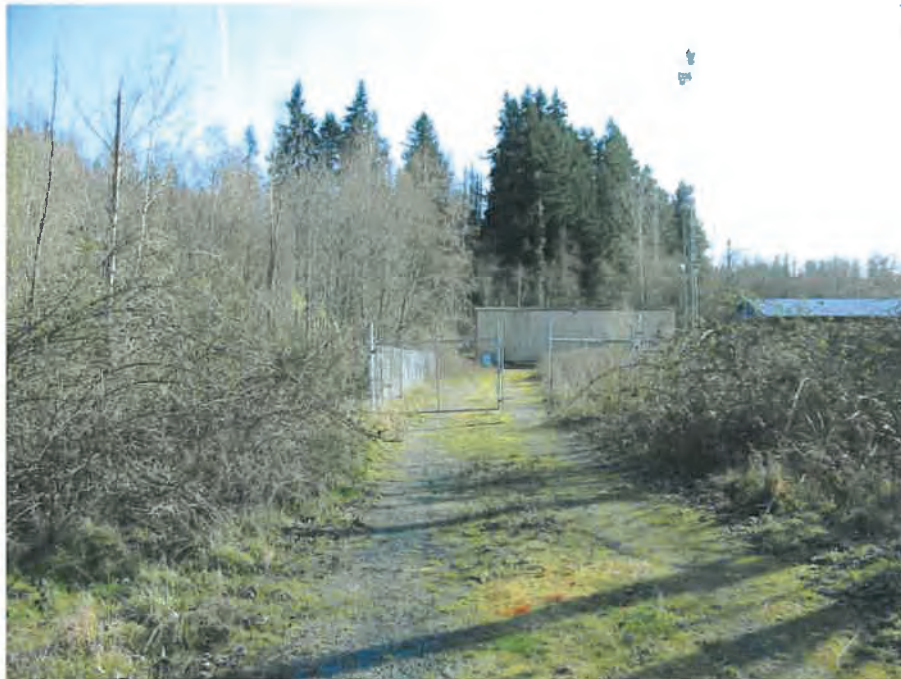
Photo #12: Looking south from within the eastern part of the project site along the gravel road that is constructed in the surveyed location shown on Figure 7. Note the storm water detention pond is on the left in the photo, and the fenced area in the background is within the project site. (IMG-032, 3/4/20)

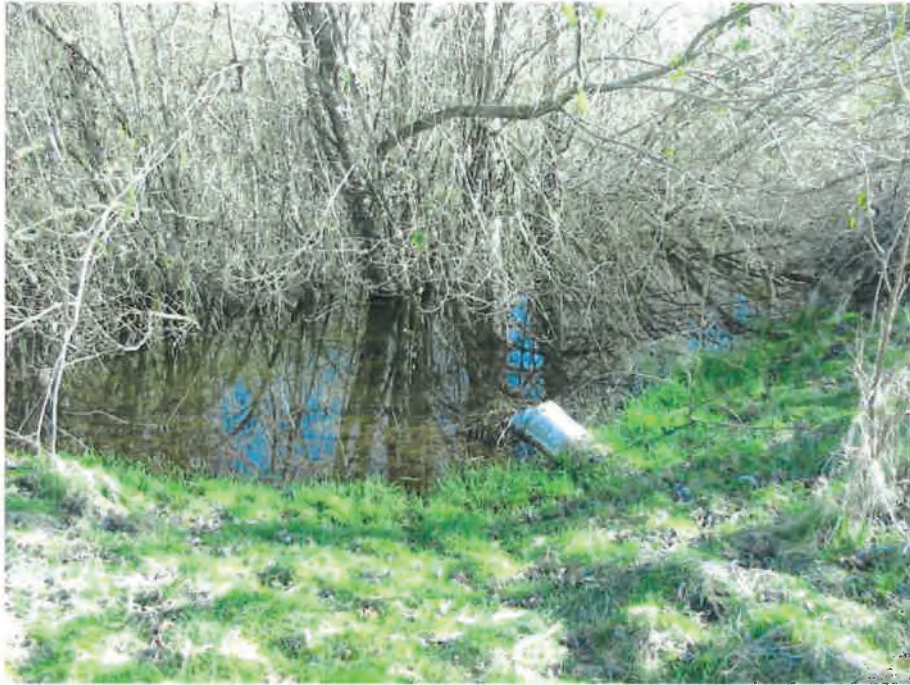
Photo #13: Looking down at the 12" CMP outlet from the storm water detention pond that is constructed in the surveyed location shown on Figure 7. Note the standing water is actually flowing out at this time due to the diverted stream flow into the pond. (IMG-033, 3/4/20)

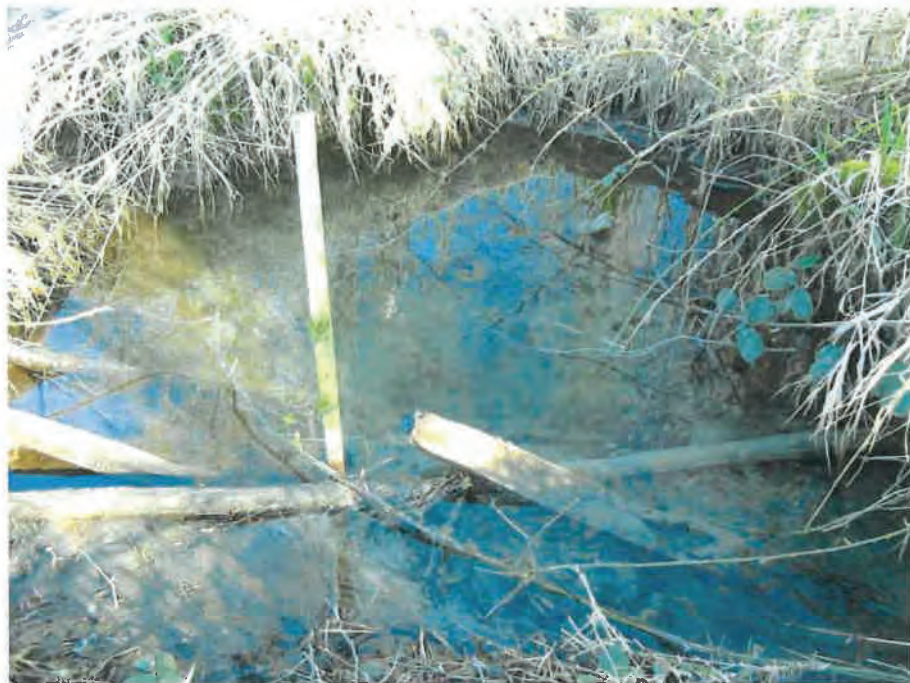
Photo #14: Looking down at what appears to be the inlet end of an old buried drain pipe (see Figure 7) that is flowing under head pressure due to water level in pool (noted small whorl pool in water >2' deep). (IMG-037, 3/4/20)

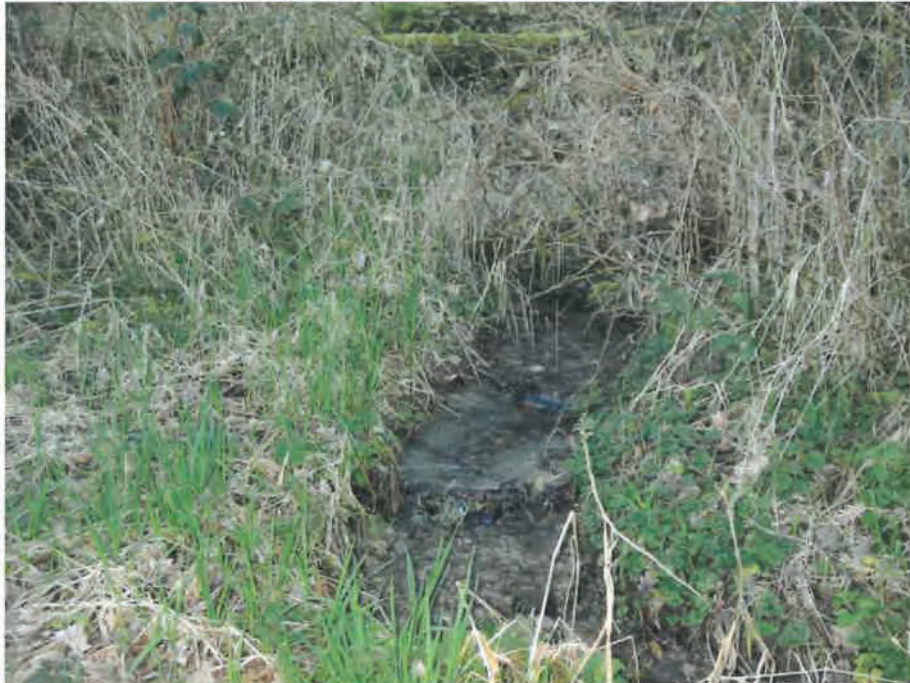
Photo #15: Looking upstream (south) at the stream flowing toward the inlet end of the old buried drain pipe (see Figure 7). Note the stream flows from the outlet of the wet meadow at the northeastern end of offsite Wetland "A". (IMG-039, 3/4/20)

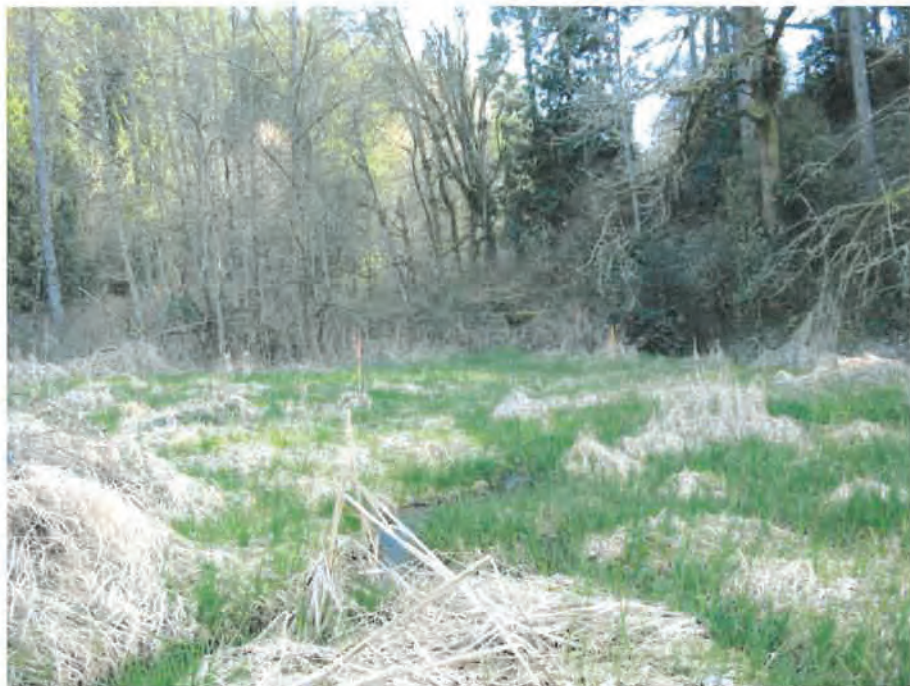
Photo #16: Looking upstream (south) at the stream flowing through the northeastern end of offsite Wetland "A". Note the stream flows out of the canyon on the left and through the wet meadow at old JCA Test Plot #4 (see Figure 7 for stream and TP4 location). (IMG-048, 3/4/20)

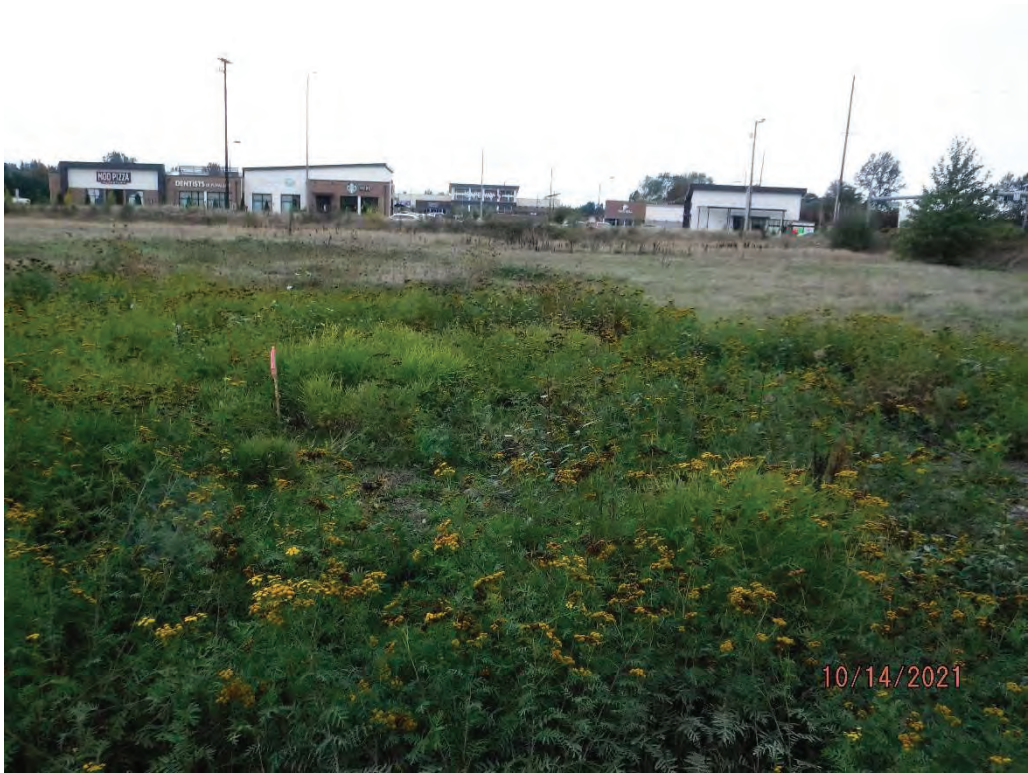
General view of Sample Plot #2 in the northwestern portion of the project site.

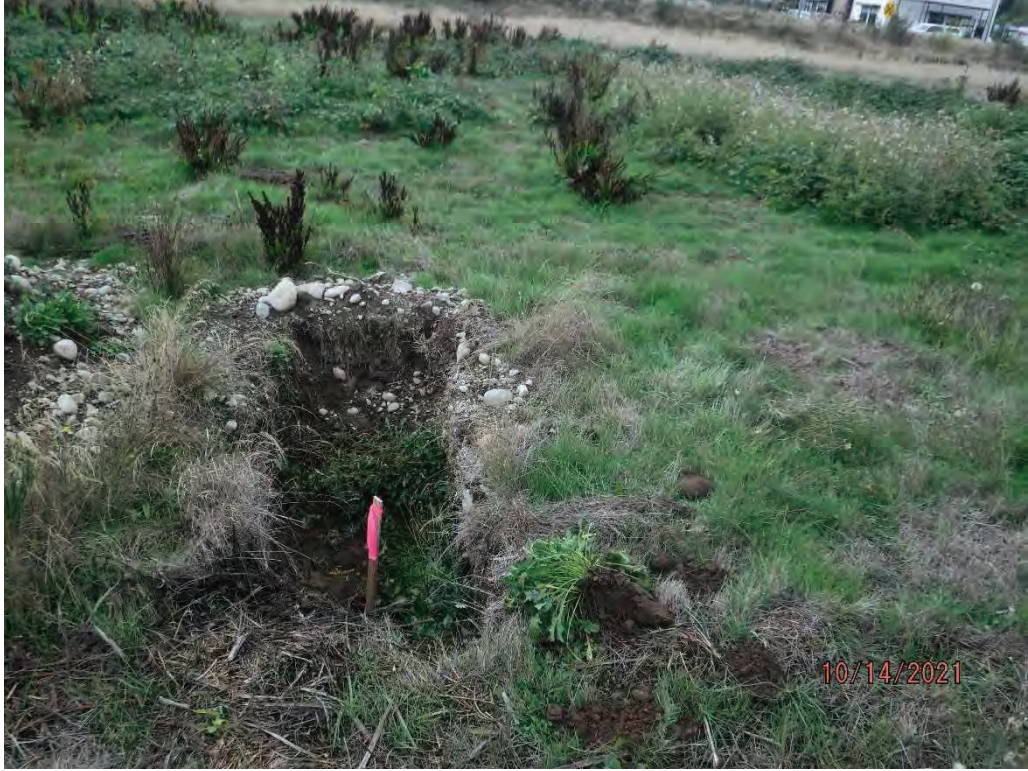
View of the depth of fill in the central portion of the project site – SP#3.
