CONCEPTUAL MITIGATION PLAN

EAST TOWN CROSSING

APRIL 7, 2023

ASH DEVELOPMENT

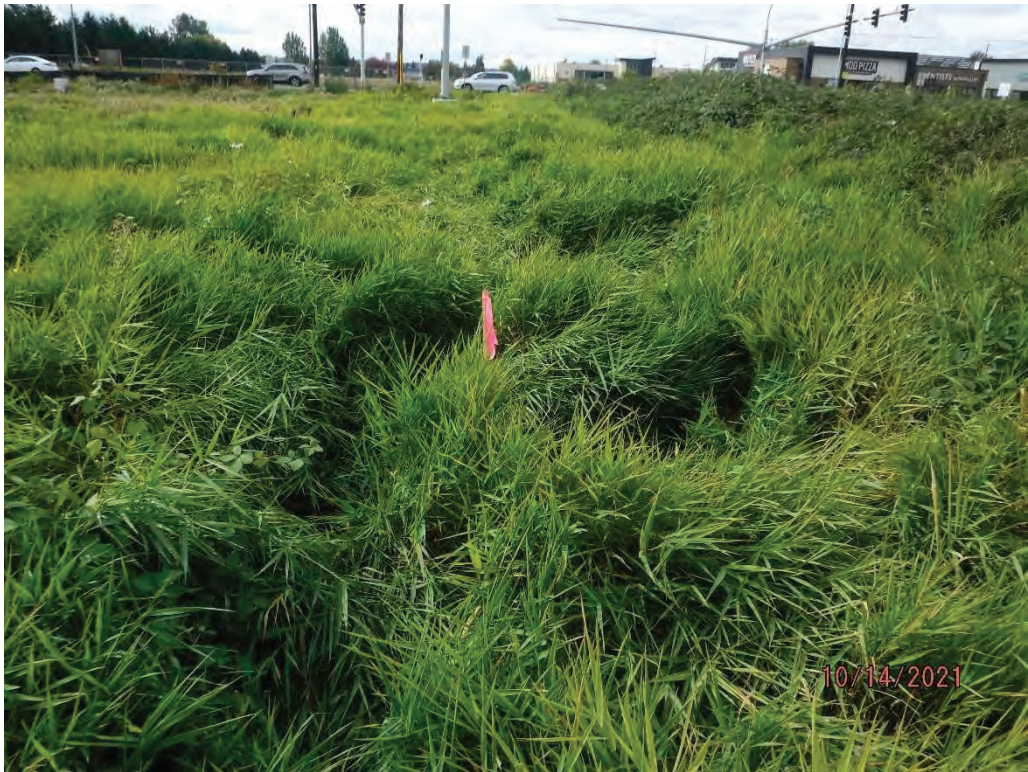
General view westerly at SP#4. Edge of fill to right and prior homesite area to left.

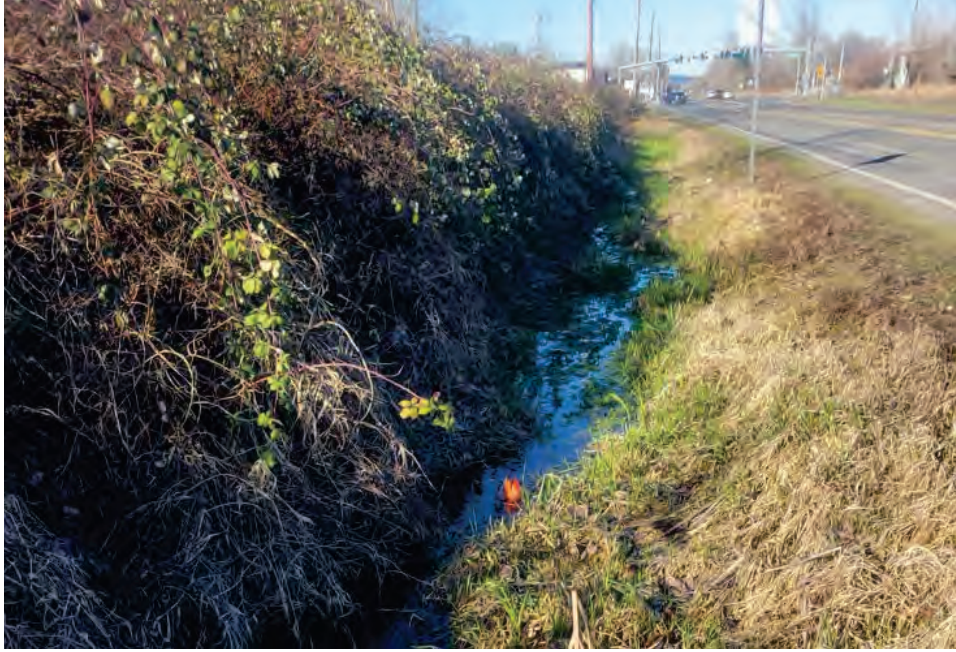
Typical degraded conditions of Stream Z within ROW of East Pioneer Avenue

In the existing linear, ditched alignment, Stream Z is extremely degraded as the system is situated in a roadside ditch with several piped segments and lacks riparian cover, habitat complexity, and floodplain function. The stream consists of one long run that lacks pool and riffle sequences. The stream along the majority of its length is choked with non-native invasive reed canarygrass, which reduces water velocity and creates low levels of dissolved oxygen due to the stagnant conditions and die-off of vegetative material. The majority of the onsite stream channel will be permanently filled, and portions of the stream piped will be modified pre- and post-development based on frontage improvement requirements and existing conditions. The proposed stream relocation will result in a permanent loss of existing degraded habitat. Refer to Appendix C for photographs of Stream Z in its existing degraded condition.

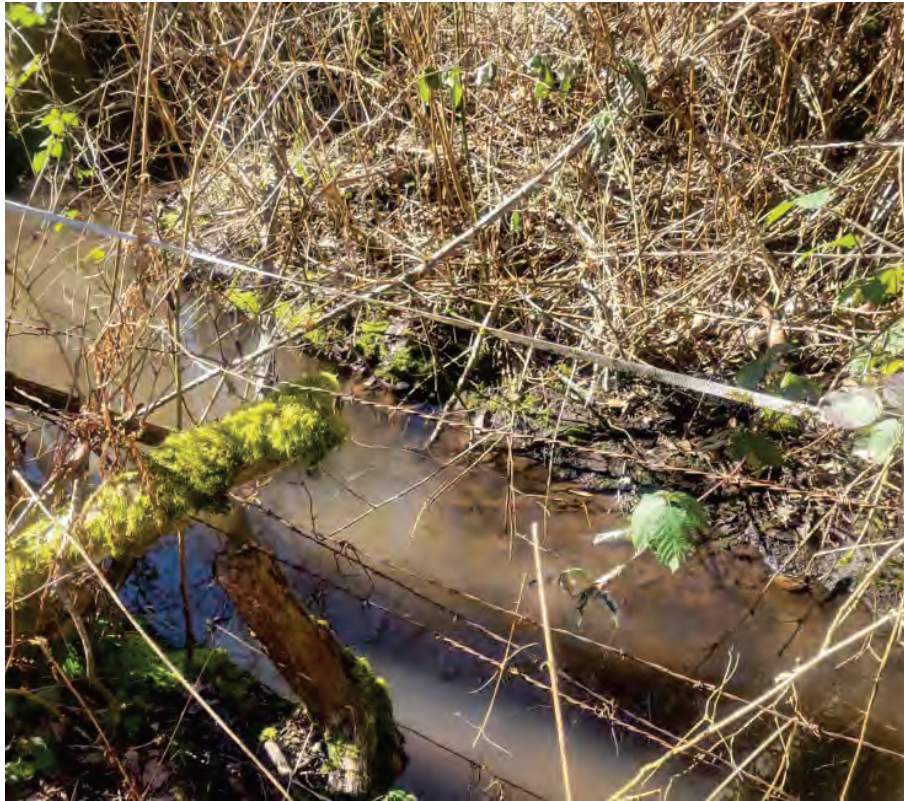
Existing Stream Z crossing providing access from East Pioneer Avenue to site (source: Google Earth)
