Technical Memorandum

Re: Offsite Wetland Assessment

2902, 13102, and 3104 East Pioneer Avenue and 813, 901, and 911 Shaw Road East,
Puyallup, Washington 98374

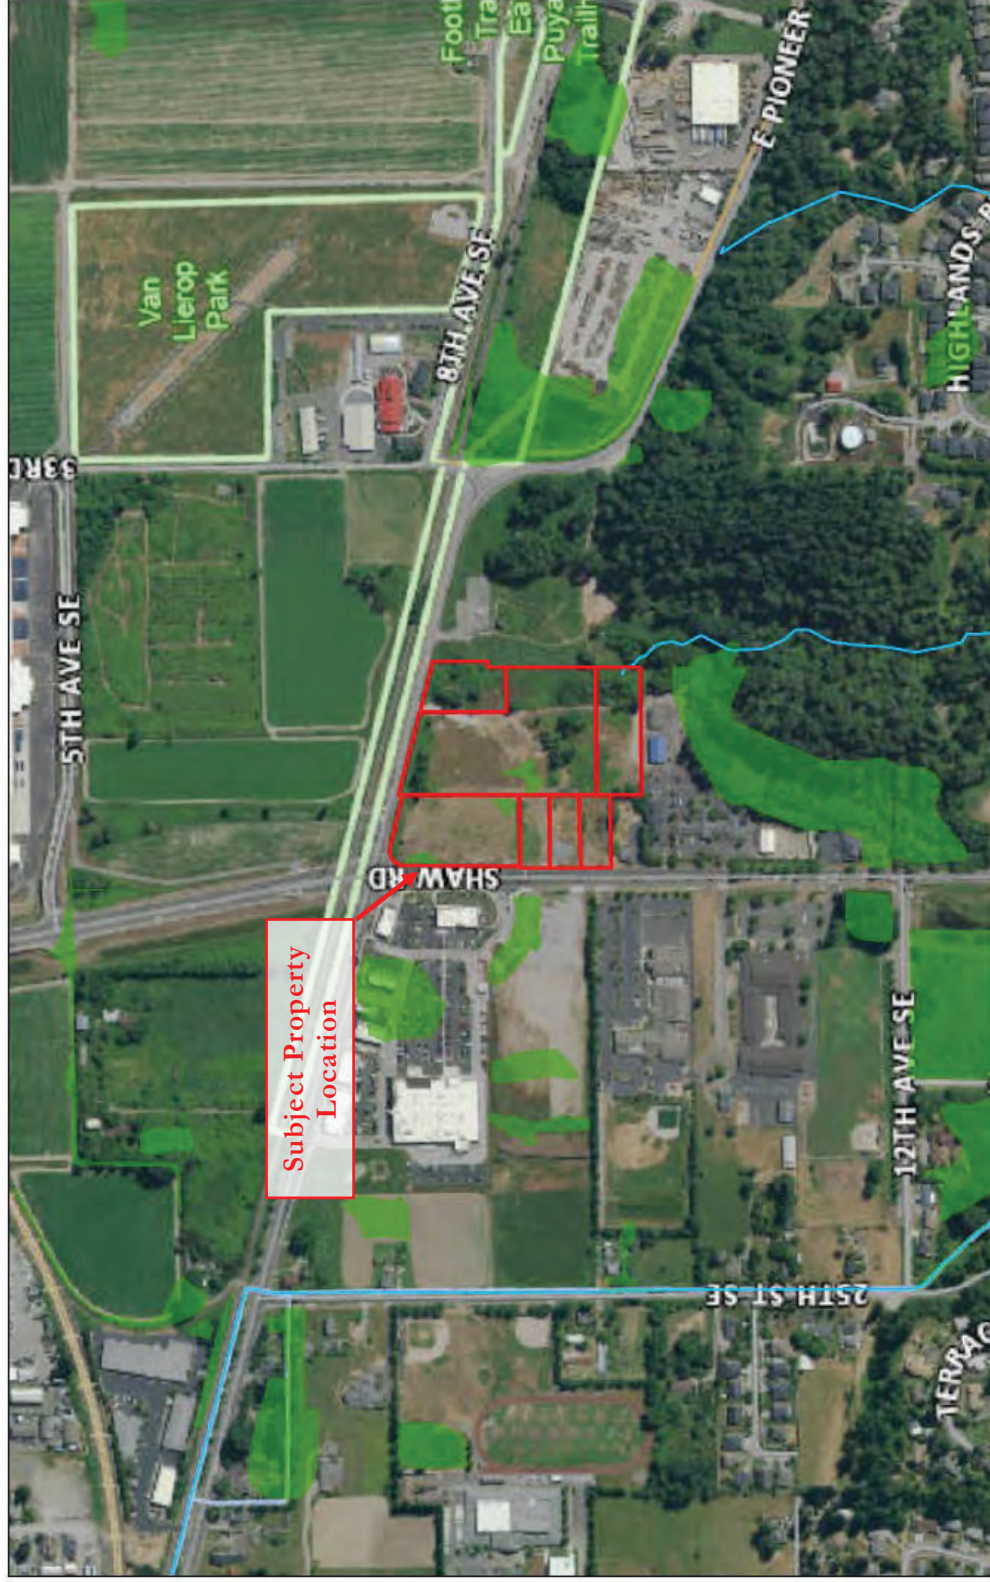
Attachment A1 – City of Puyallup Stream and Wetland Inventory Map

The City of Puyallup Stream and Wetland Inventory Map (Attachment A1) identifies two potential wetlands in the northwest corner and in the central portion of the subject property. One stream is also identified by the City of Puyallup map as originating in the southeast corner of the subject property and extending offsite to the south. The USFWS NWI Map (Attachment A2) and the WDFW PHS Map (Attachment A3) also identify one potential wetland in the southeast corner of the subject property that extends offsite to the south. No other potential wetlands are identified by the Pierce County Stream & Wetland Inventory Map (Attachment A4) or the DNR Rare Plant and Wetland Inventory Map (Attachment A5). In addition, no fish and wildlife habitat conservation areas are documented in the subject property. The WDFW & NWIFC SWIFD Map (Attachment A6) and DNR Stream Typing Map (Attachment A7) do not identify any streams, salmonid presence, or other priority habitat or species on the site. No other wetlands, streams, or fish and wildlife habitat conservation areas are documented within 300 feet of the subject property.

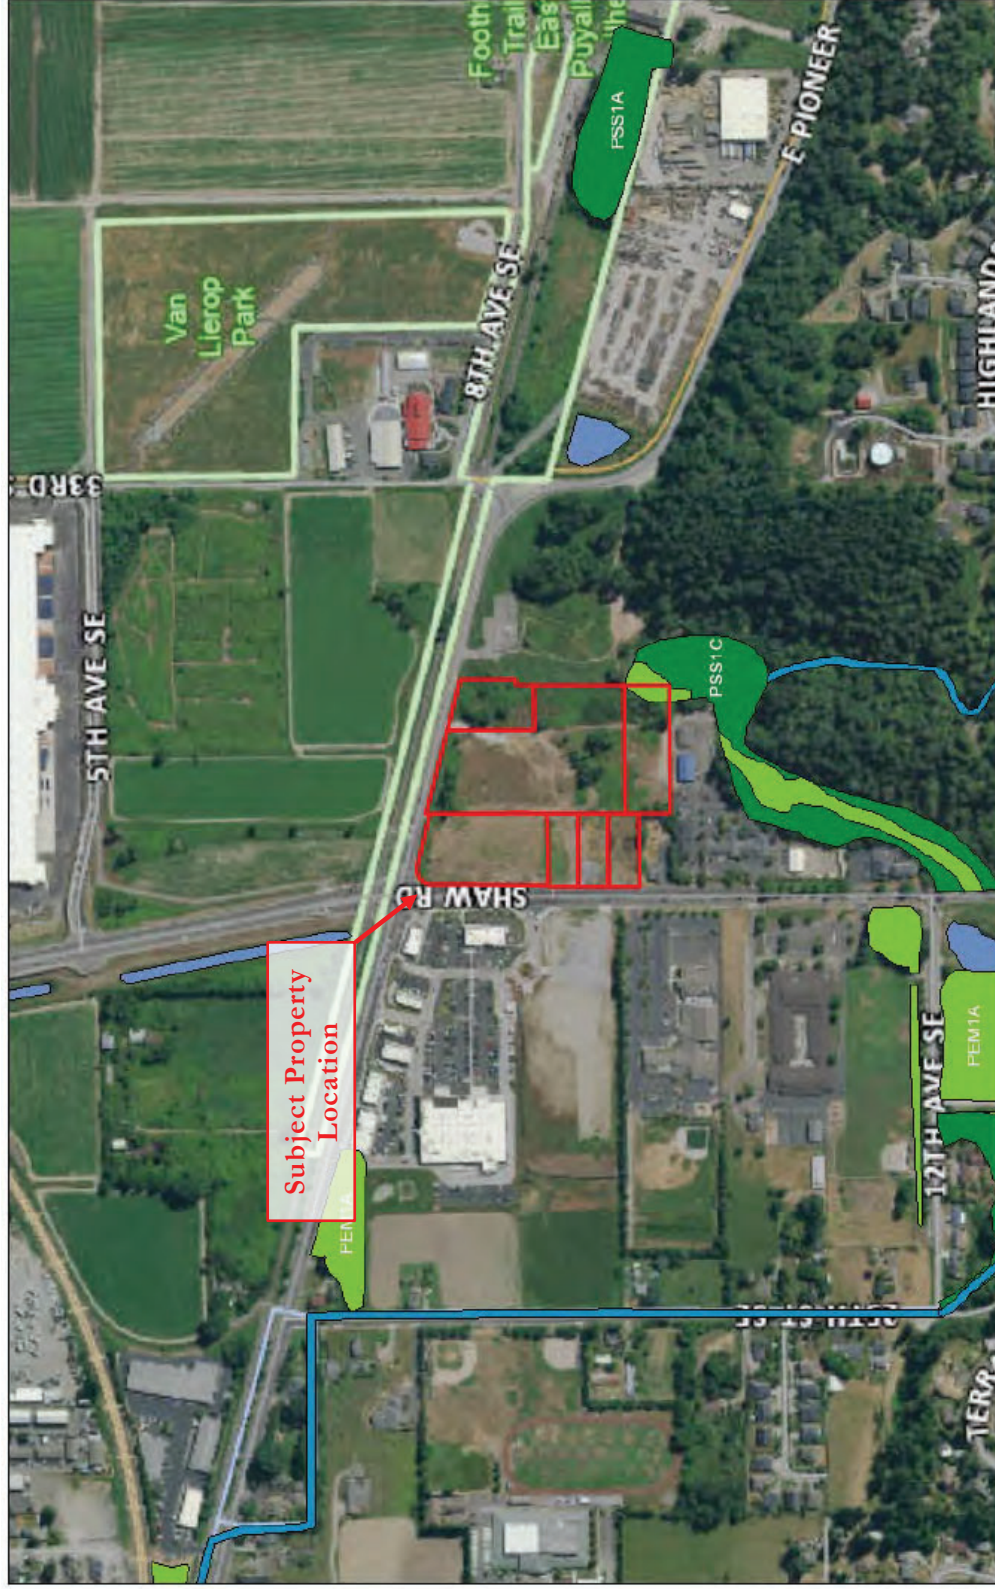
Attachment A2 – USFWS NWI Map

Pierce - Parcels_Query result
 Wetlands

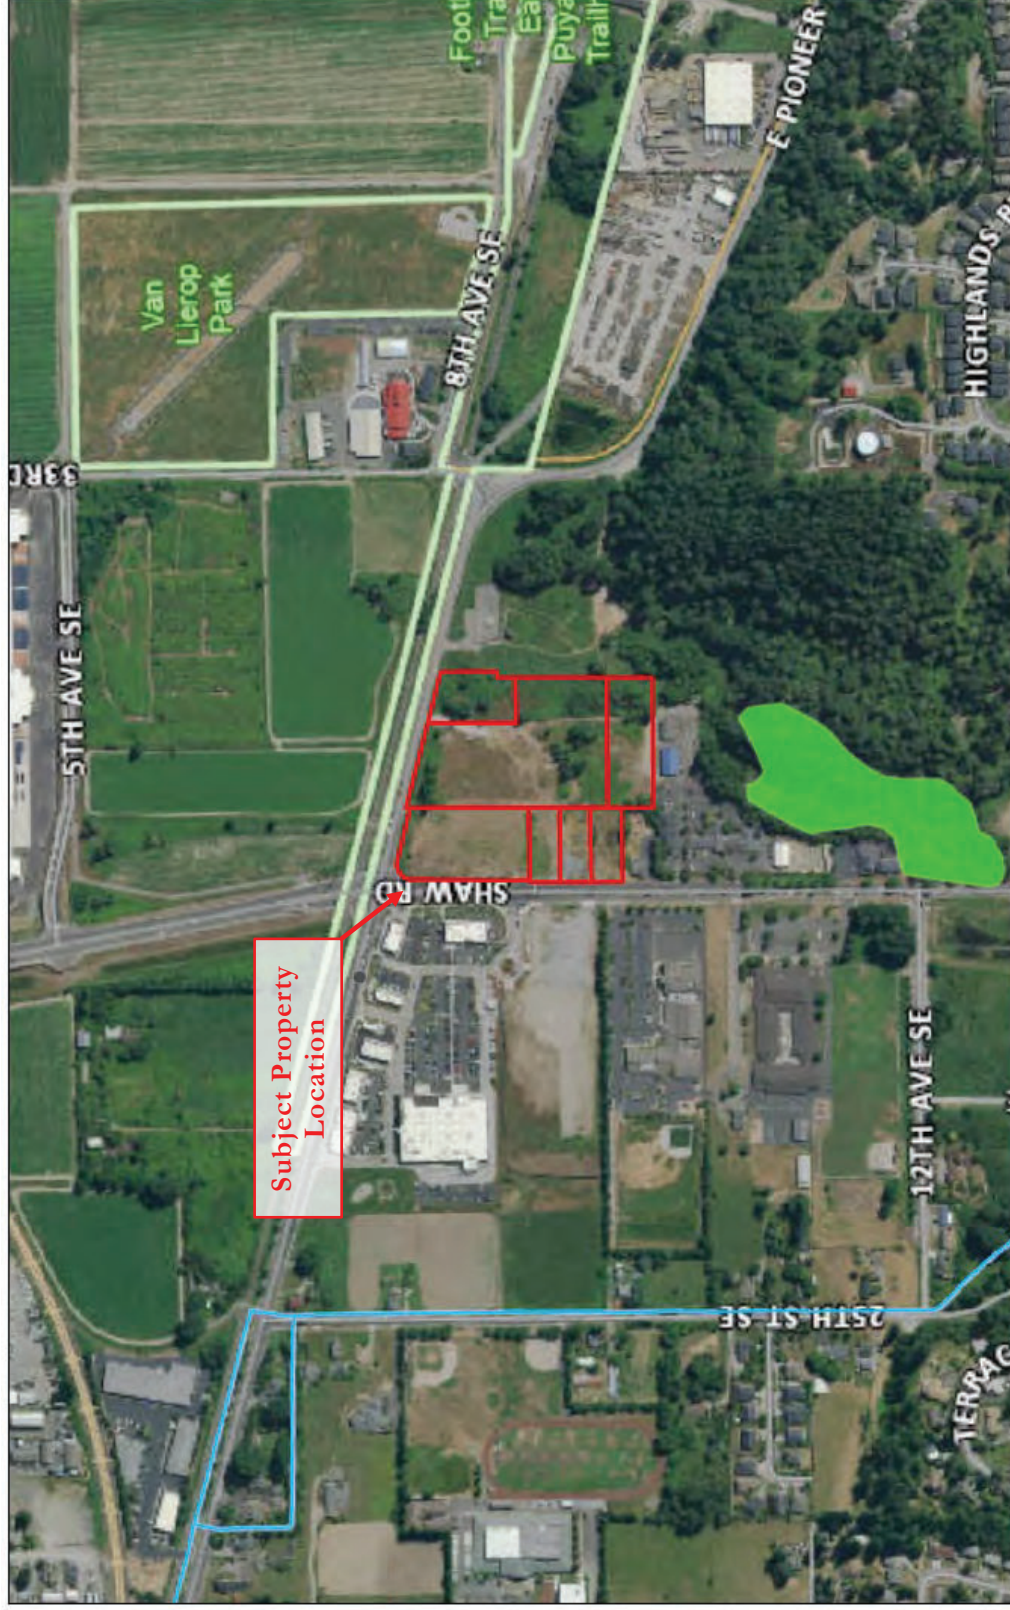
Attachment A4 –Pierce County Stream and Wetland Inventory Map

- Pierce - CWI Wetlands
- Pierce - Streams
- Pierce - Parcels _Query result

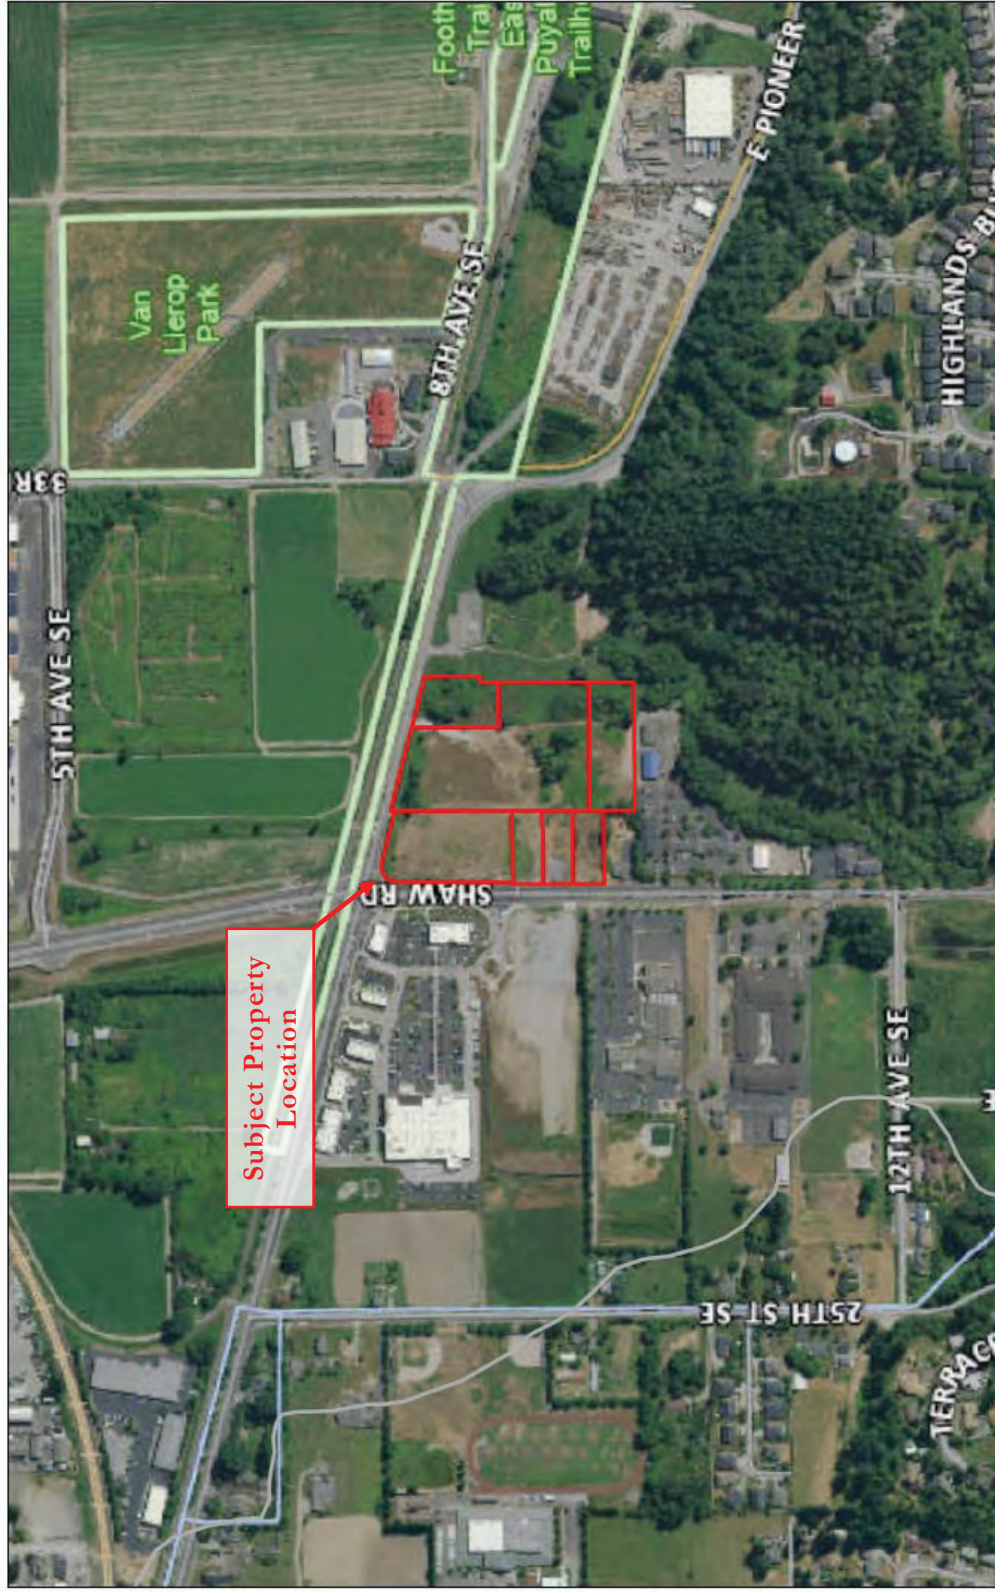
Attachment A7 – DNR Stream Typing Map

Pierce - Parcels_Query result DNR - Stream Typing - Watercourses (DNR)

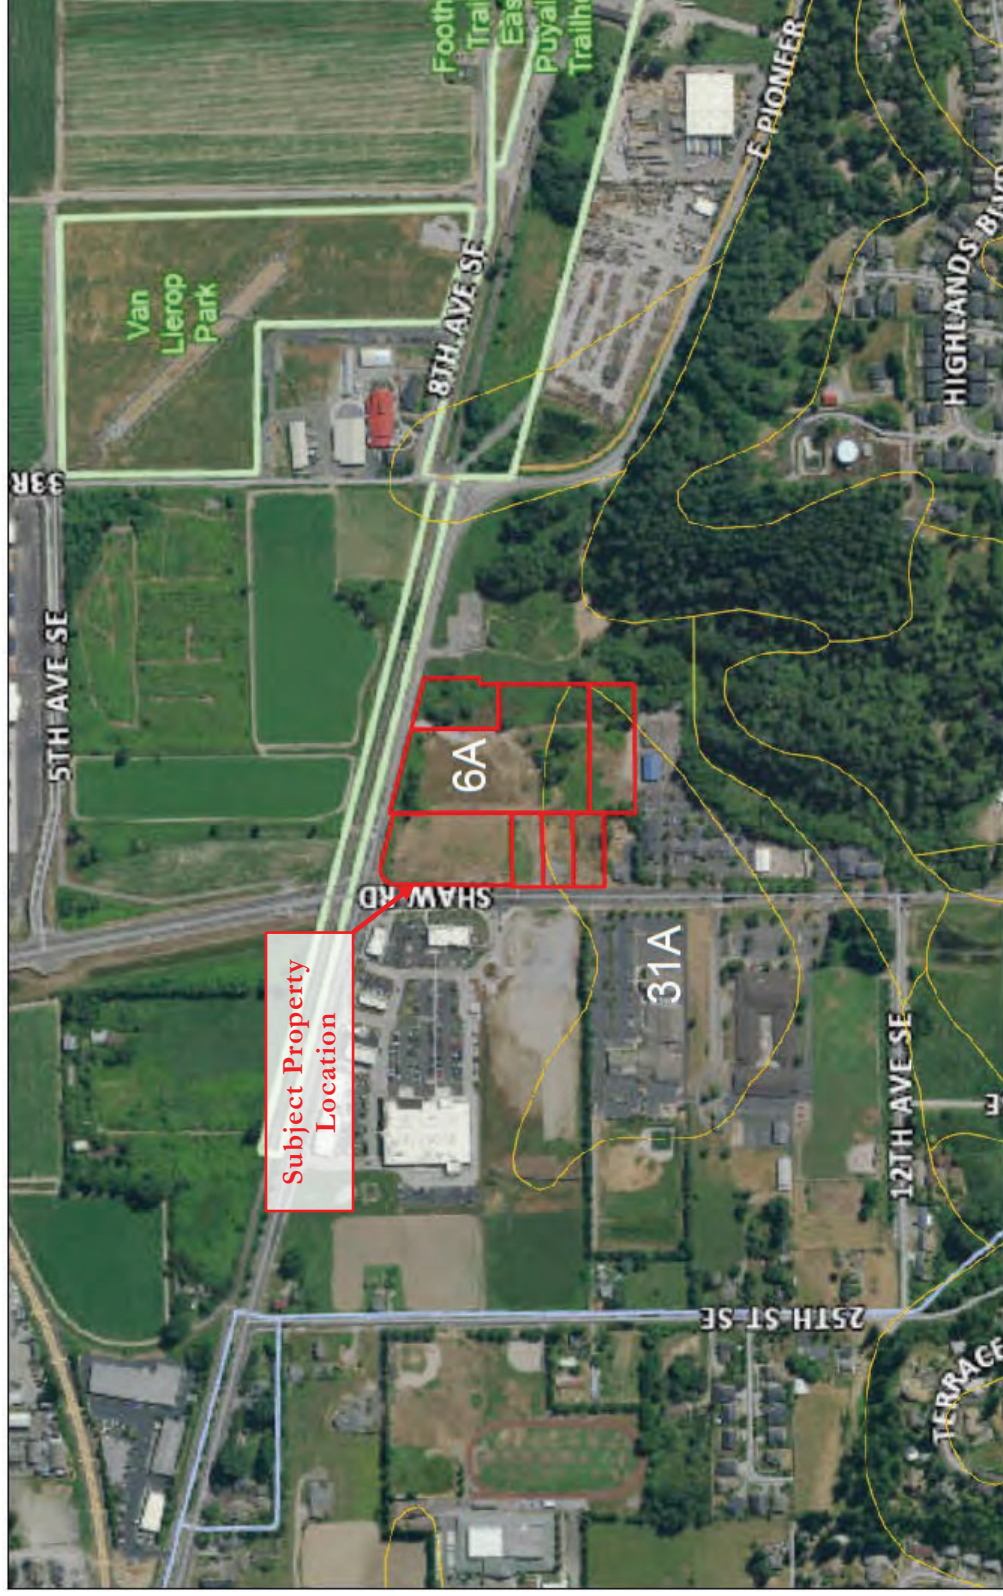
Attachment A8 – NRCs Soil Survey Map

The NRCS Soil Survey Map (Attachment A8) identifies two soil series on the subject property: Puyallup fine sandy loam (31A) and Briscot loam (6A). Puyallup fine sandy loam is a non-hydric soil; however, up to 2 percent of the soil map unit contains inclusions of the hydric Briscot undrained soil. Briscot loam, 6A, is considered a hydric soil in Pierce County (NRCS, N.d.). However, hydric soils are common in valley floors associated with historical floodplains, such as in the Puyallup area. Briscot loam is noted as occurring on floodplains, per the NRCS list of hydric soils for the Pierce County Area. Small 100-year floodplain areas are present along the mapped streams on the eastern and northern property boundaries (Attachment A9).

- Pierce - Parcels_ Query result
- USA Soils Map Units
- 31A- Puyallup fine sandy loam
- 6A- Briscot loam

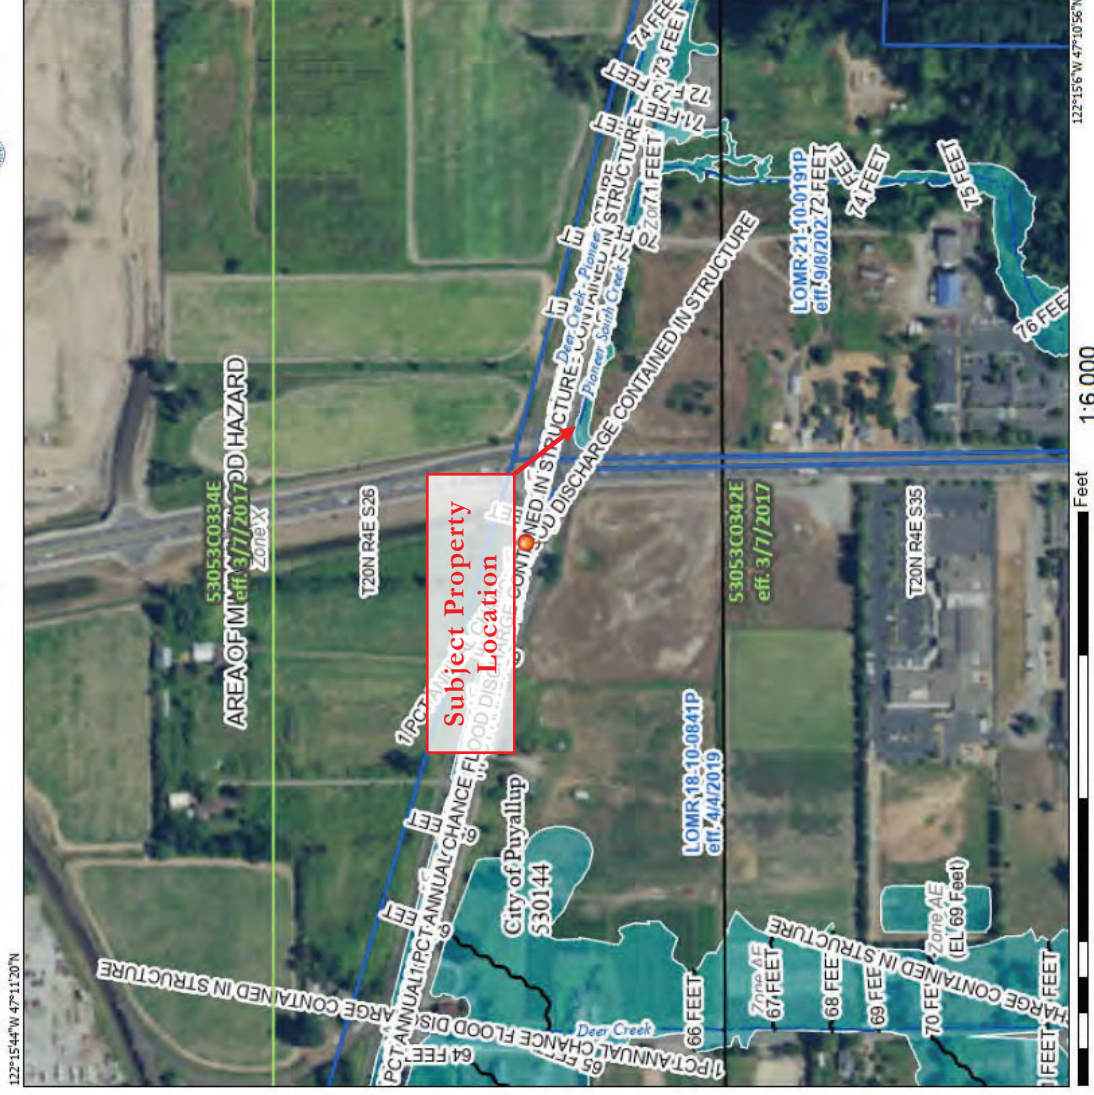
Attachment A9 – FEMA Floodplain Map

National Flood Hazard Layer FIRMette

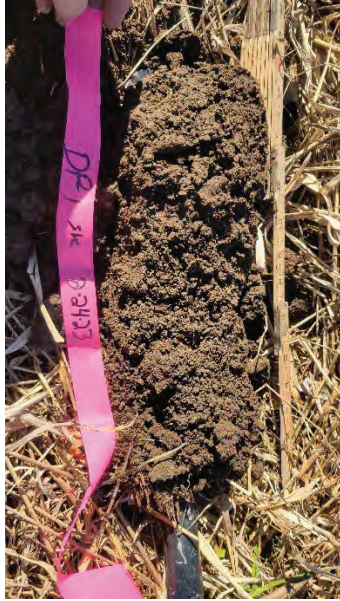
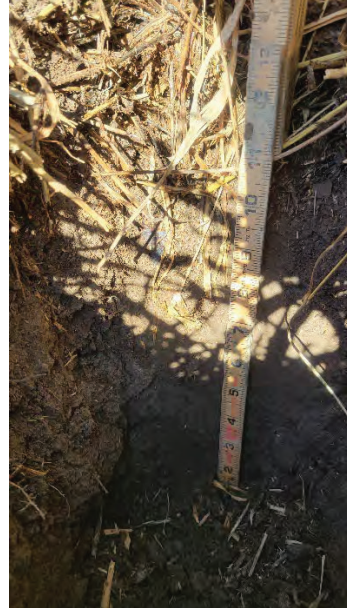
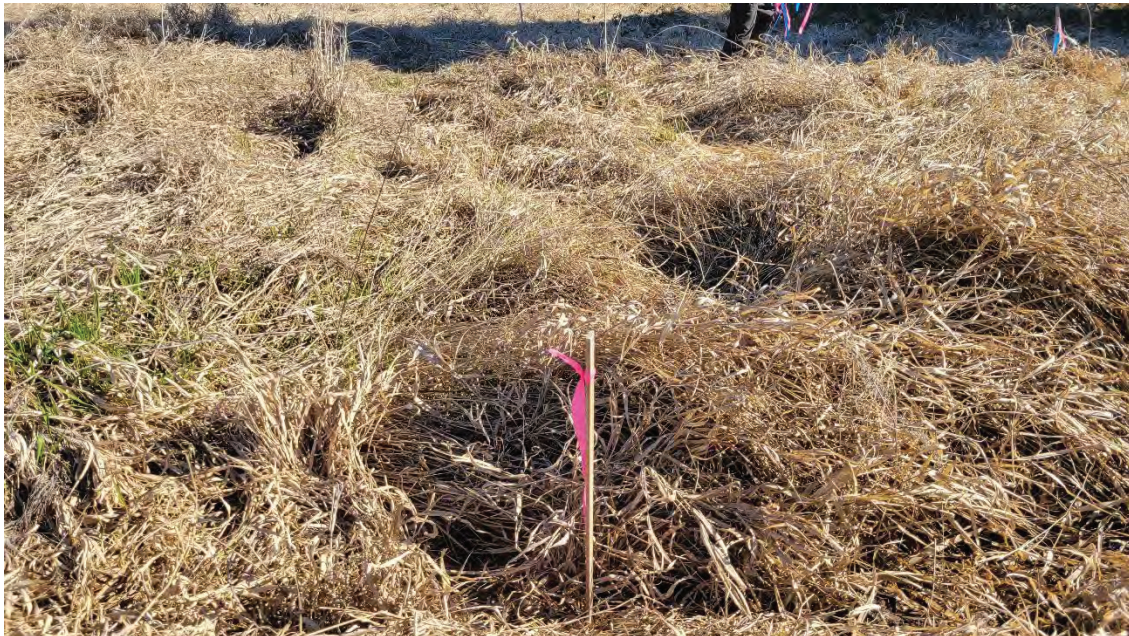
DP-1 Soil

DP-1 Soil Pit

General View of DP-1

| Remarks: <p style="text-align: center;">Not all three wetland criteria met. Only hydrophytic vegetation observed. Data plot located in historic ditched stream.</p> | |

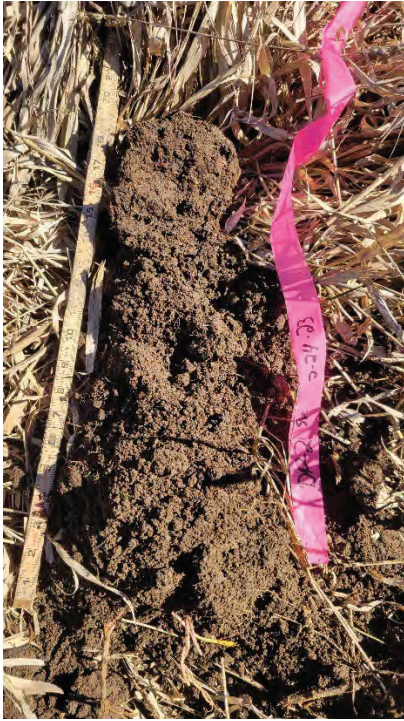
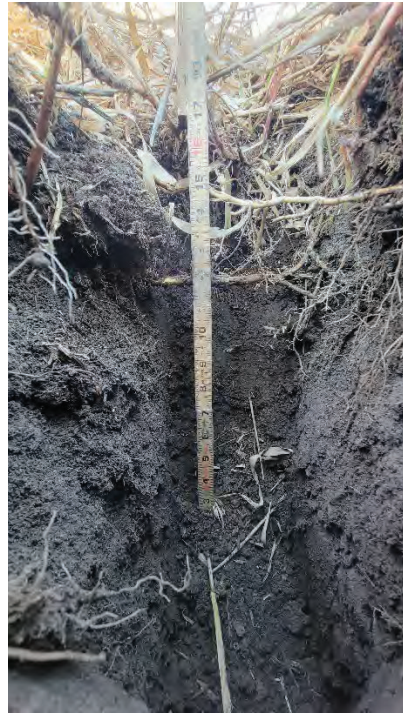
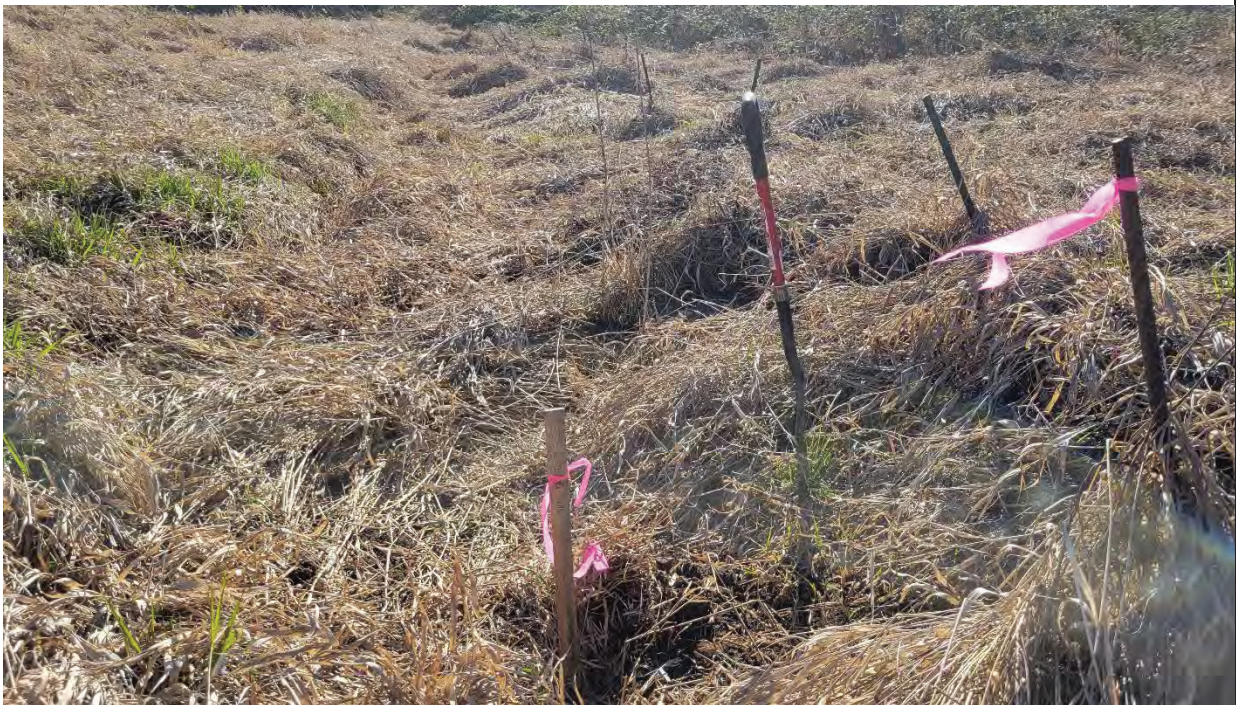
DP-2 Soil

DP-2 Soil Pit

General View of DP-2

Remarks:
 Wetland hydrology criteria not met. No hydrology observed to 20 inches. Test pit open 2+ hours.

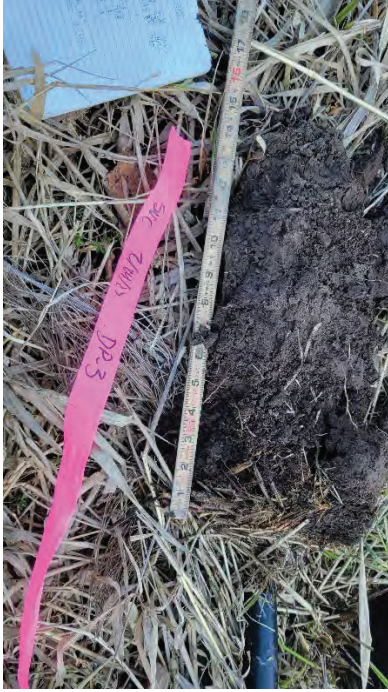
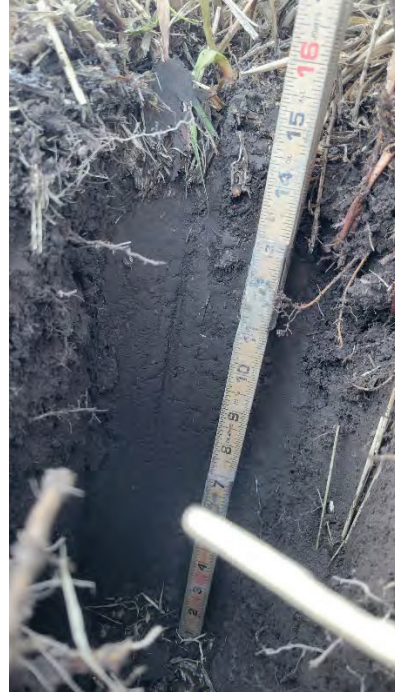
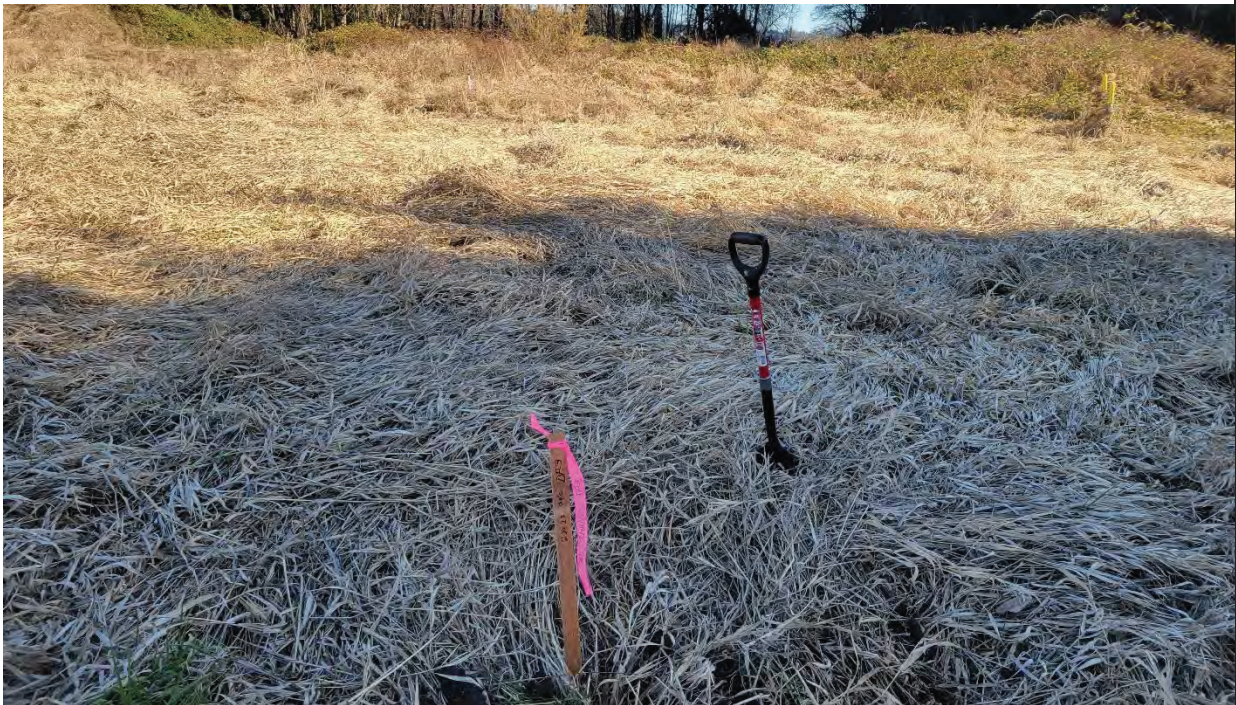
The soils in the large swale (DP-3 and DP-4) did not meet any hydric soil indicators due to the lack of depleted layers, redox concentrations, and/or dark surface layers at depths required for hydric soil indicators. One of the two data plots (DP-1) collected in the historic Stream Y channel also did not meet hydric soil indicators, lacking a depleted matrix.

DP-3 Soil

DP-2 Soil Pit

General View of DP-3

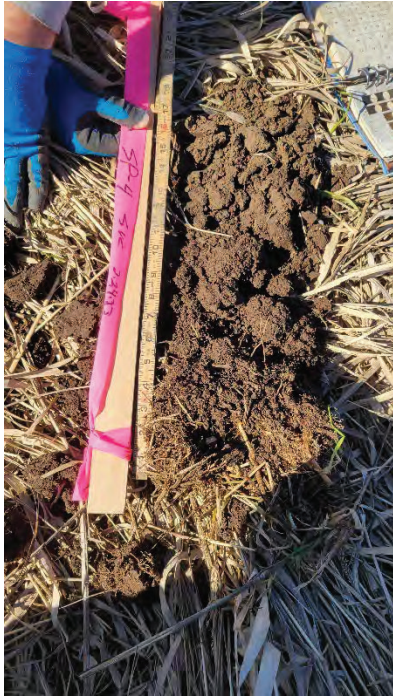
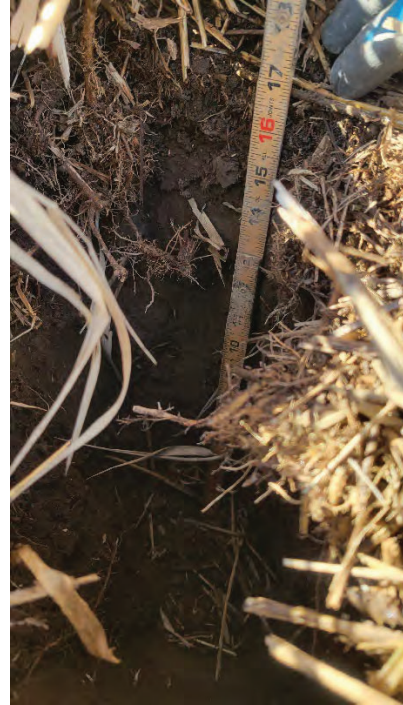
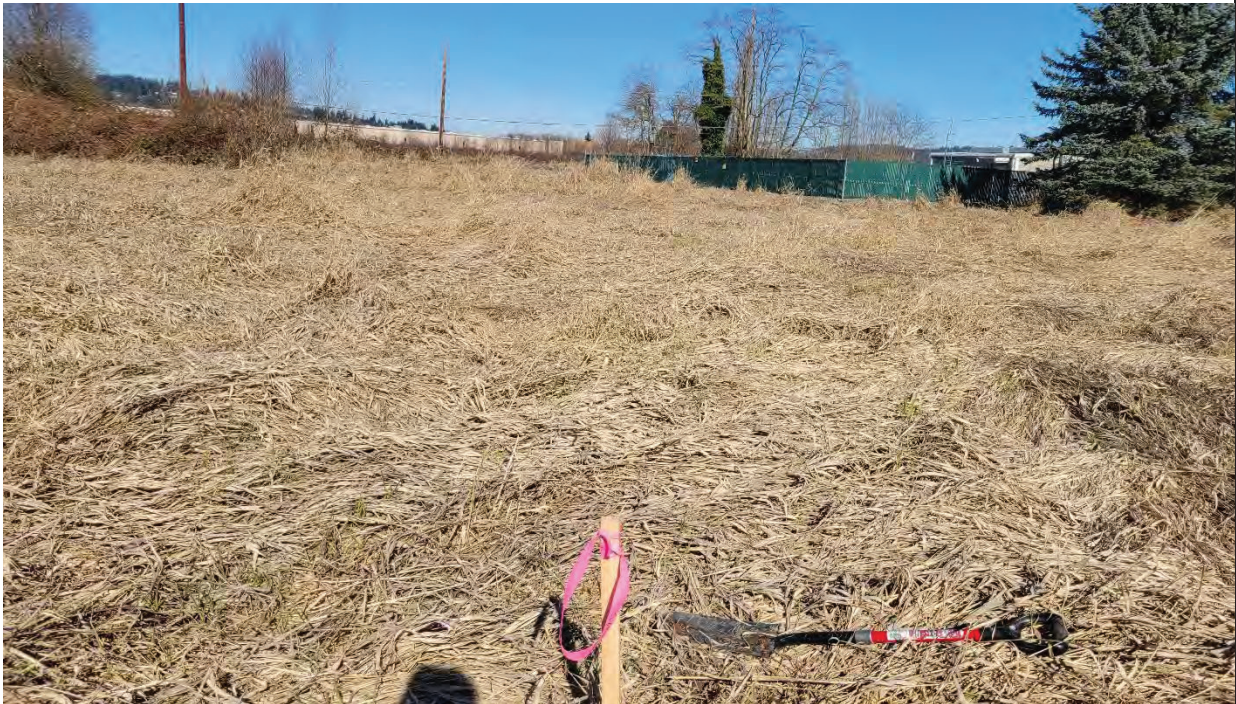
DP-4 Soil

DP-4 Soil Pit

General View of DP-4

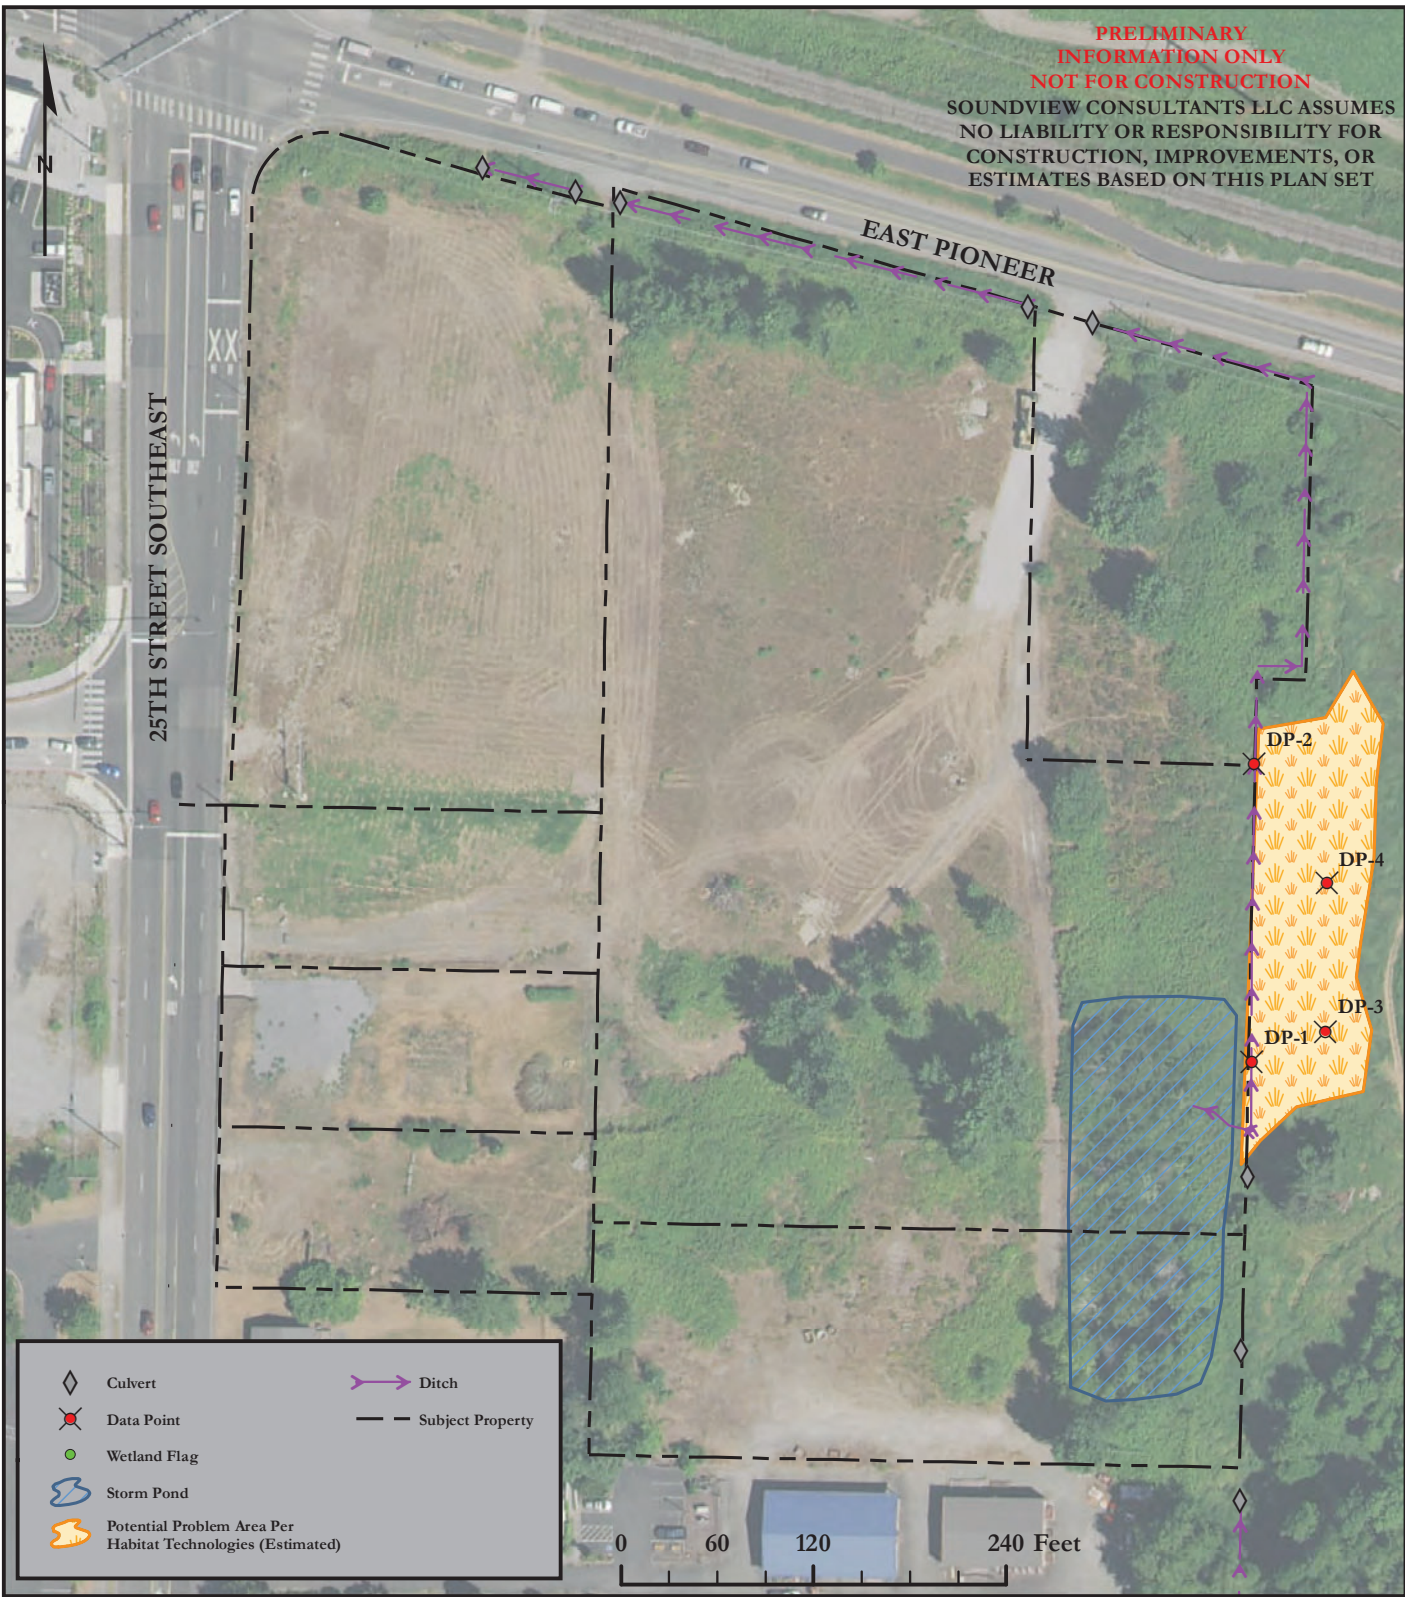
| FIGURE NO. 1 |

No potentially regulated wetlands were identified during the offsite investigation. Formal data plots were collected at four locations in the historic Stream Y channel and the large depressional swale to document the absence of wetlands. Photographs of each data plot and site conditions are included in Attachment B. None of the data plots met for all three required wetland criteria (i.e., vegetation, soils, and hydrology) according to current wetland delineation methodology. All data plots exhibited hydrophytic vegetation; however, only one data plot (DP-2) within the historic Stream Y channel exhibited hydric soils. All data plots were excavated to a depth of at least 18 inches and left open for a minimum of 2 hours to allow adequate time for the groundwater table to equilibrate. However, no water tables were observed in any data plots. No other indicators of primary wetland hydrology were observed. Due to the lack of wetland hydrology indicators, and the lack of hydric soil indicators in three out of the four formal data plots, no wetlands were observed.

EXISTING CONDITIONS
