Update of the Wetland Delineation and Analysis Report  
for Offsite Wetlands and Streams  
for the **Kilcha Sekyra Senior Housing Complex** in Puyallup,  
Washington

Original Report: October 10, 2016  
Update: January 4, 2022

## CITY OF PUYALLUP – WETLAND UPDATE REQUEST

Project Name: **Kilcha Sekyra Senior Housing Complex**

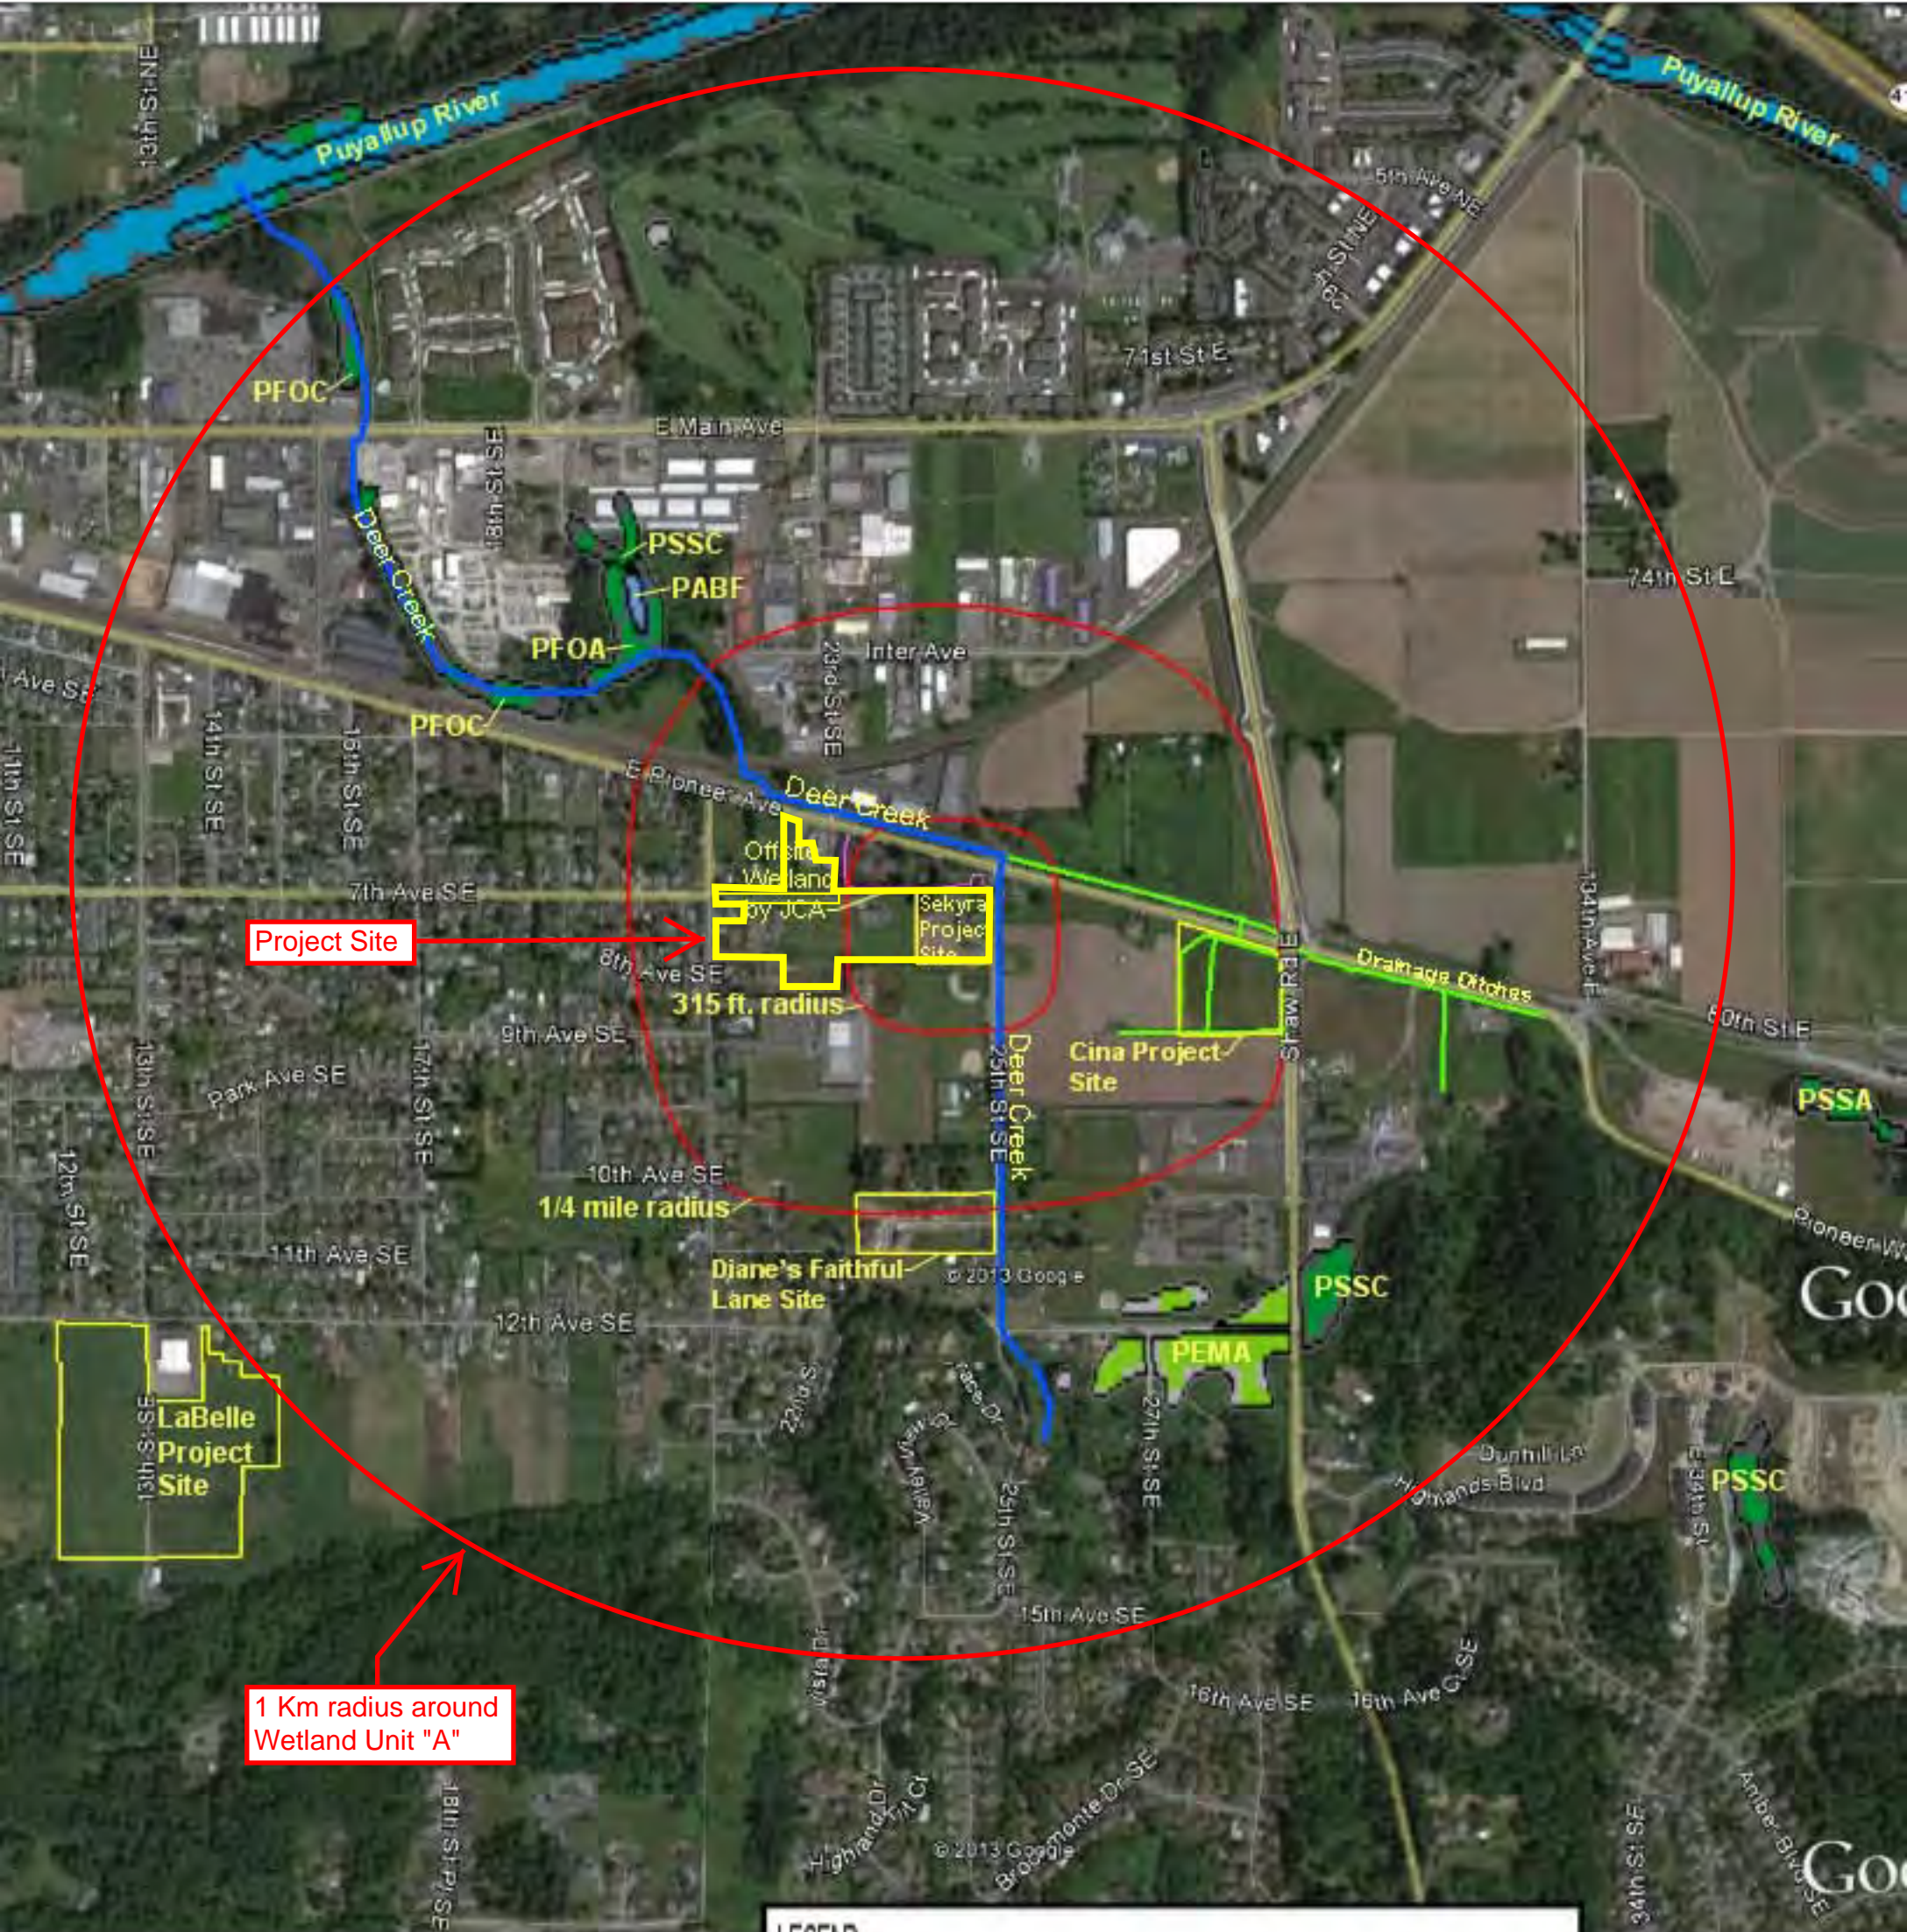
1"=1000'  
**Fig:**  
**1**

Project Site

315 ft. radius

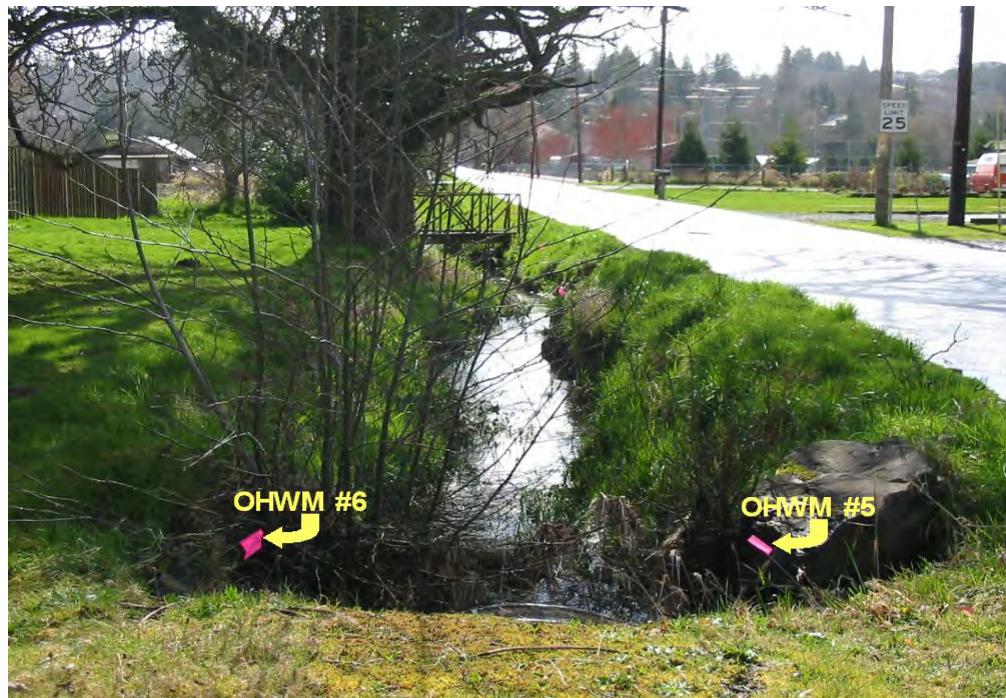
Photo #2: Looking upstream (south) along the main channel of *Deer Creek* from the top of the culvert that flows under Pioneer Way East. The roadway on the right was 25<sup>th</sup> Street SE, which separates the regulated stream and its buffer from the Sekyra property. (Taken 4/11/08)

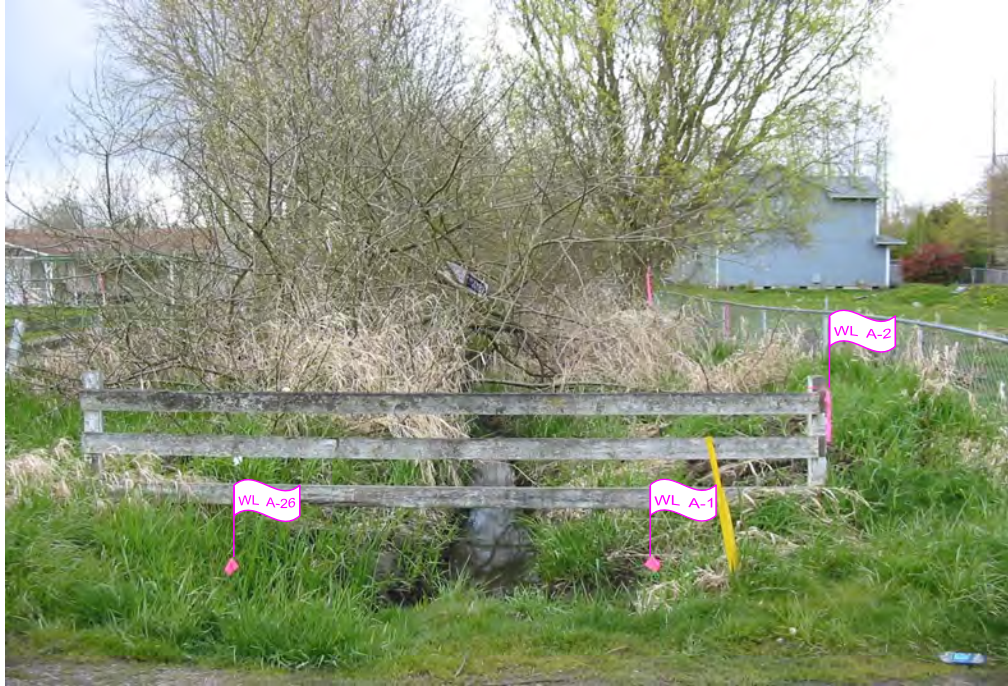
Photo #3: Looking west from 25<sup>th</sup> Street along the “linear depressional wetland” called Wetland ‘A’ for this study. The depression appeared to have been formed by an old abandoned swale for *Deer Creek*. The water seen in the ditch was not hydrologically connected with the water flowing in *Deer Creek*. The wetland delineation flags were set by JCA for the Schuh Property (on right) in 2008. (Taken 4/11/08)

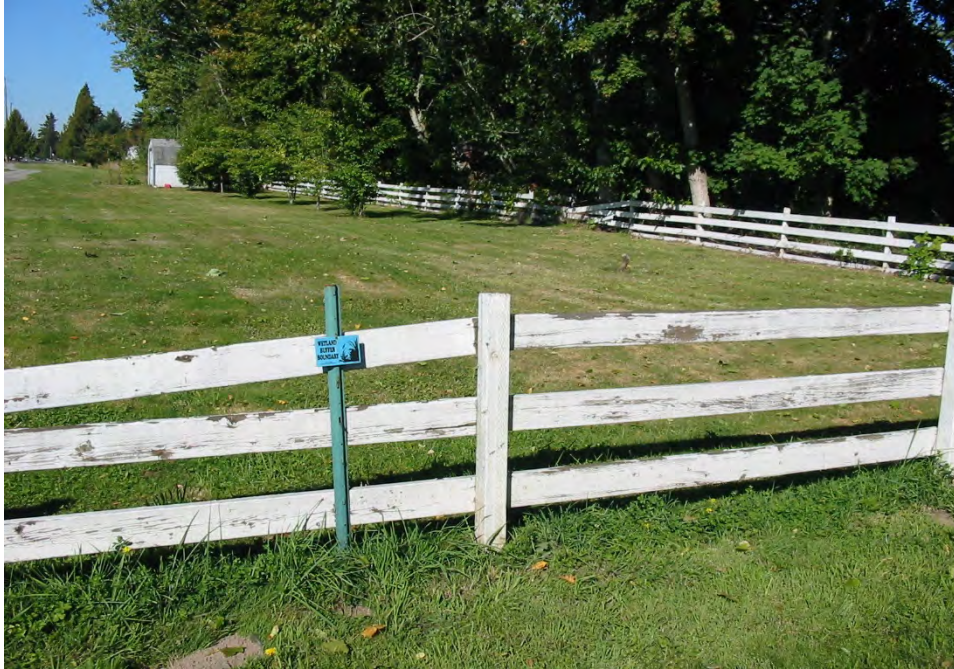
Photo #5: Looking northwest from the fence line that separates the western Sekyra Property (Parcel #0420267003) from the eastern property (#0420267027 & 0420267028). Note the blue buffer boundary signs set for the 2013 wetland study of the eastern property were located 50 feet from the delineated edge of OFFSITE Wetland “A” [pink flags marked by JCA in 2008, 2011 and 2013]. (IMG 019, Taken 9/13/16)

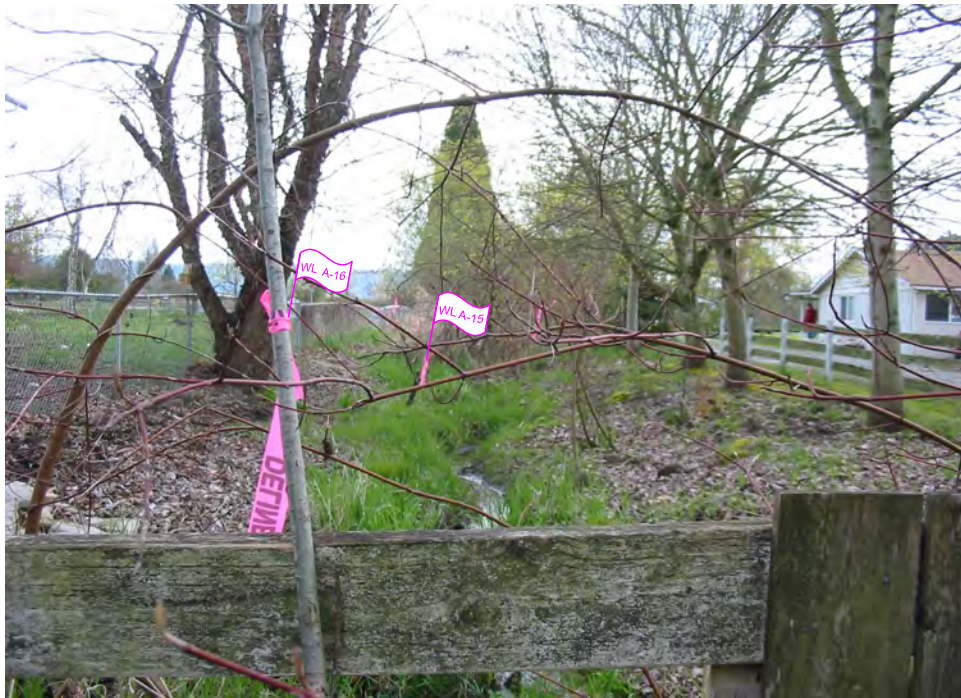
Photo #6: Looking east along the centerline of linear Wetland ‘A’ from about the center of the (extended) property line between the two Sekyra Properties. The property on the right along the wood fence was the eastern part of the Sekyra Property, and it was entirely outside and beyond the edge of the delineated wetland. The pink ribbons on the left mark the delineation points along the northern bank. (Taken 4/11/08)

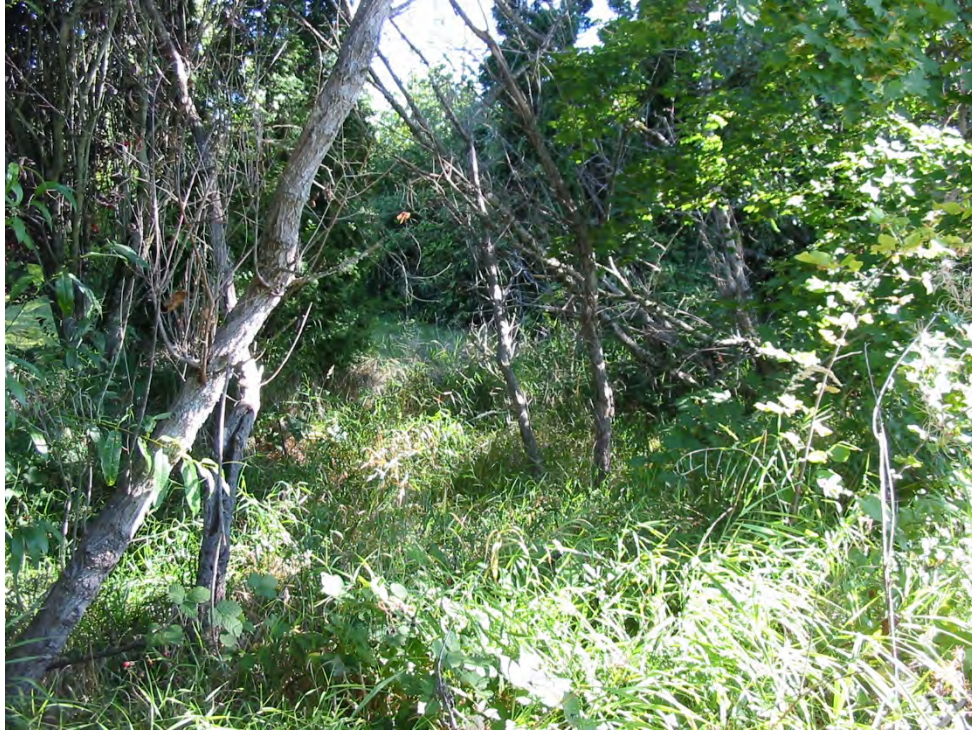
Photo #7: Looking east along the centerline of linear Wetland "A". Note the densely overgrown woody and shrub vegetation along both sides of the wetland, and the dense grasses and forbs growing up out of the wetland bottom. Compare this photo with photos #9 & #10 taken in 2011. (IMG-024, Taken 9/13/16)

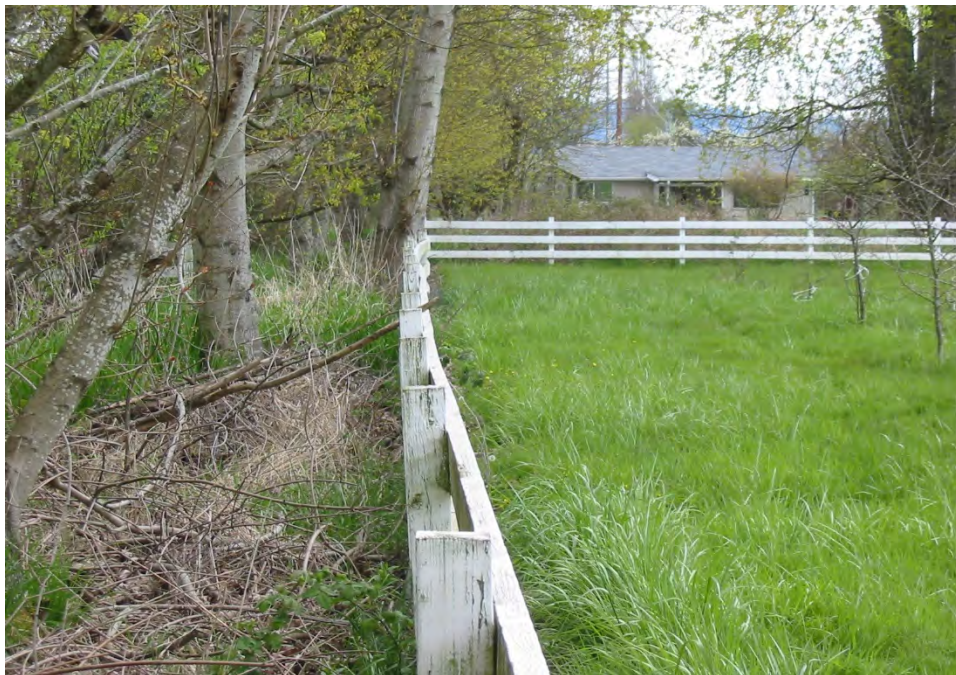
Photo #8: Looking east (upstream) along the southern buffer of Wetland 'A' at the western part of the Sekyra Property (Parcel #0420267003) in the foreground on the right side of the wood rail fence. The eastern part of the Sekyra Property in the background beyond the white rail fence was short platted in 2013 (Parcel #0420267027 & #0420267028). (Taken 4/22/2011)

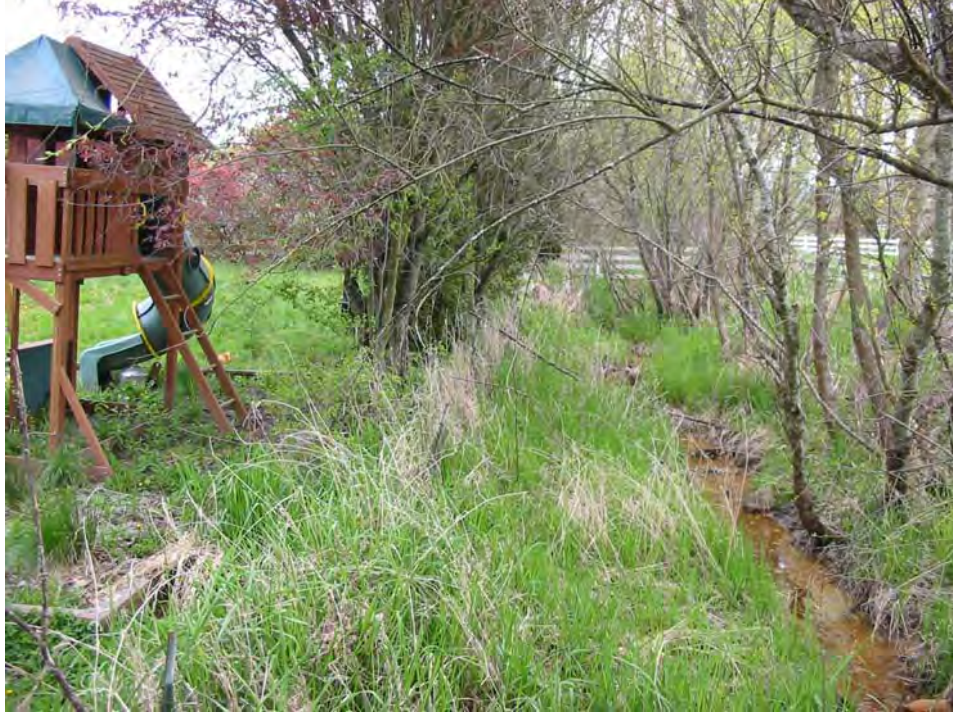
Photo #9: Looking east along the northern side of offsite Wetland “A”. The property on the left has residential uses with mowed yards and a playhouse that extend along the delineated upland side of the wetland. Note the bottom in the depression was not flowing and had some stagnant water with accumulated oils and iron bacteria. (Taken 4/22/11)

Please note that we found an old yard drain in the center of this emergent part of Wetland ‘A’ that appeared to be partly (or entirely) plugged. If this drain were functioning, it may reduce the levels of saturation that previously existed in this area. However, if the drain was not functioning as indicated by the current study, then this area does appear to have sufficient hydrology for a positive wetland determination for the mowed yard area of Wetland ‘A’.

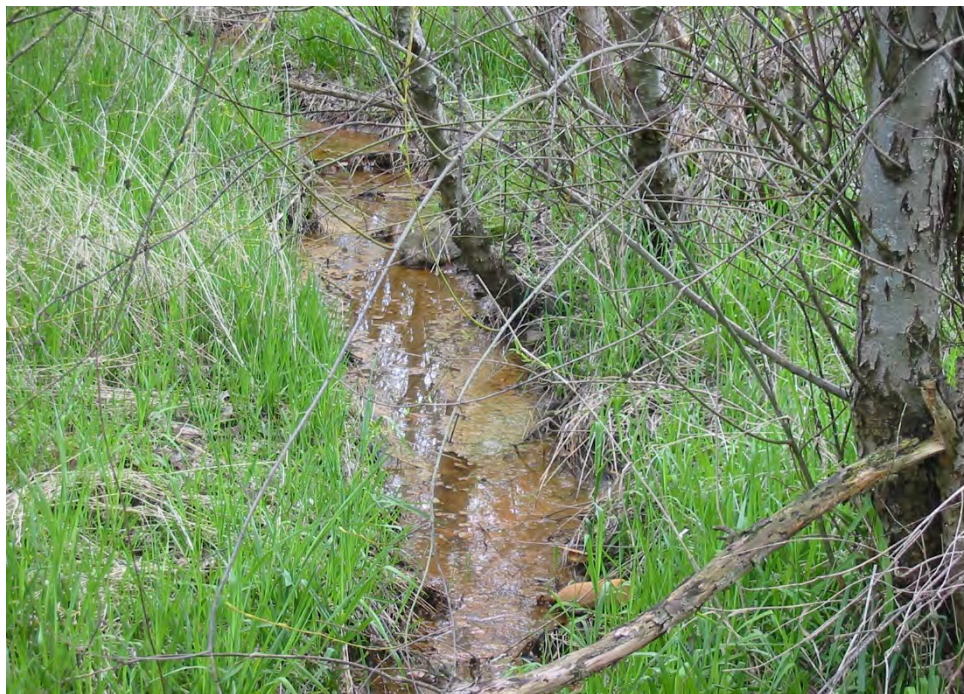
Photo # 10: Looking east along the offsite Wetland “A”. The average width of Wetland ‘A’ in this part of the site was 15 feet, measured from the north side to the south side of the wetland [flagged by JCA in 2011 with pink ribbons]. Note the bottom in this linear depression was not flowing and had accumulated surface water runoff that generally stagnates with oils and iron bacteria that have formed in the bottom of the swale. (Taken 4/22/11)

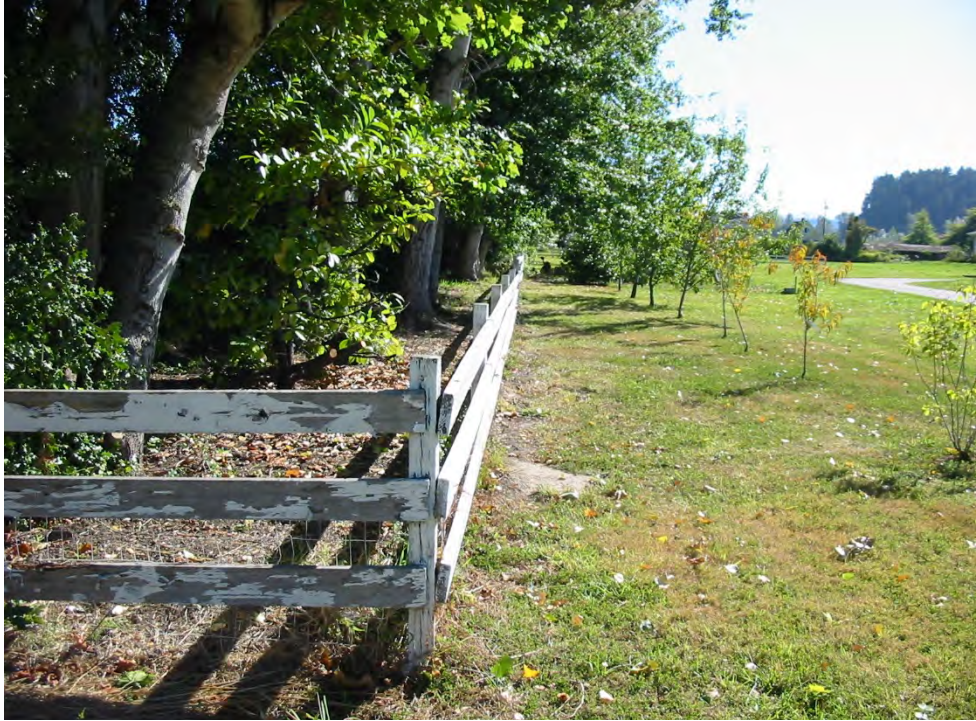
Photo #11: Looking east along the north side of the Sekyra Property from the fence corner. Note the wood rail fence marks the north property line, and the tall trees in the offsite buffer provide adequate shade for Wetland “A” in this area [see IMG-032 thru IMG-039 for more details]. (IMG-040, Taken 9/13/16)

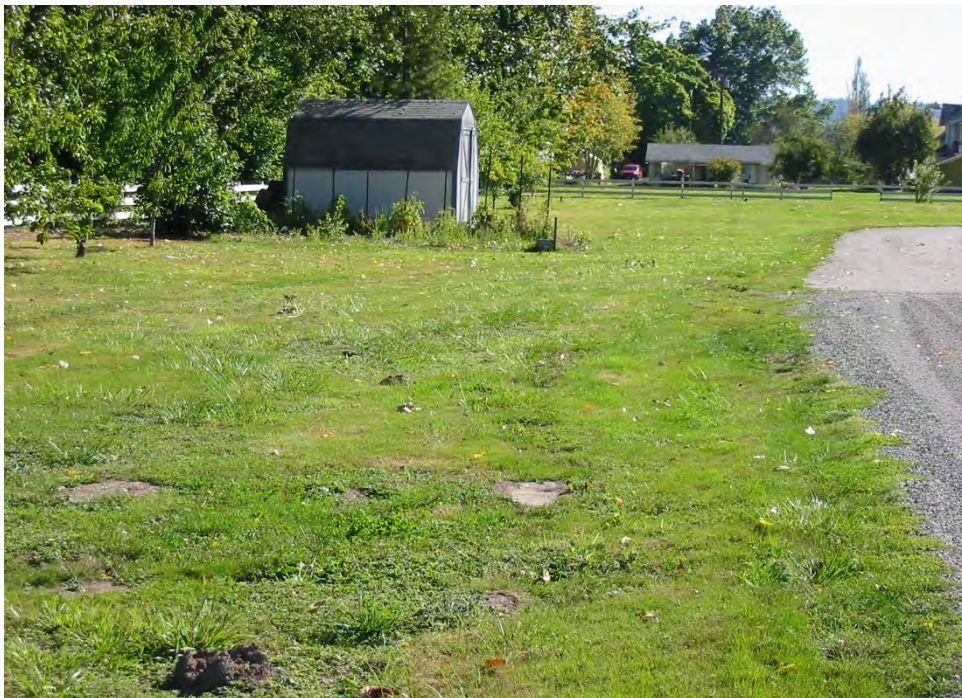
Photo #12: Looking east along the north side of the Sekyra Property, along the boundary of the 50-foot wide buffer (note a blue sign along fence in the background). The buffer boundary was approximately along the edge of the driveway on the right [see Figure 7 in report for details]. (IMG-041, Taken 9/13/16)

Please note that the total points for wetland function are 15 points for linear Wetland ‘A’. However, the habitat score for this wetland was very low at 3 points. We met with an Associate Planner at the City, and discussed buffer requirements and recommendation for a modified buffer width for the *Kilcha Sekyra Senior Housing Complex*. Basically, we agreed that the standard 50-foot buffer along the linear wetland may be modified to 40 feet (minimum width per the City code), if we propose adding native vegetation along the onsite portion of buffer where practicable (about 15 feet south of the north property line). This would provide adequate buffer protection and enhance the existing 20-foot wide densely vegetated forested upland buffer that exists between the edge of the offsite wetland and the northern property line (see photos in Appendix 4 for details of this area).

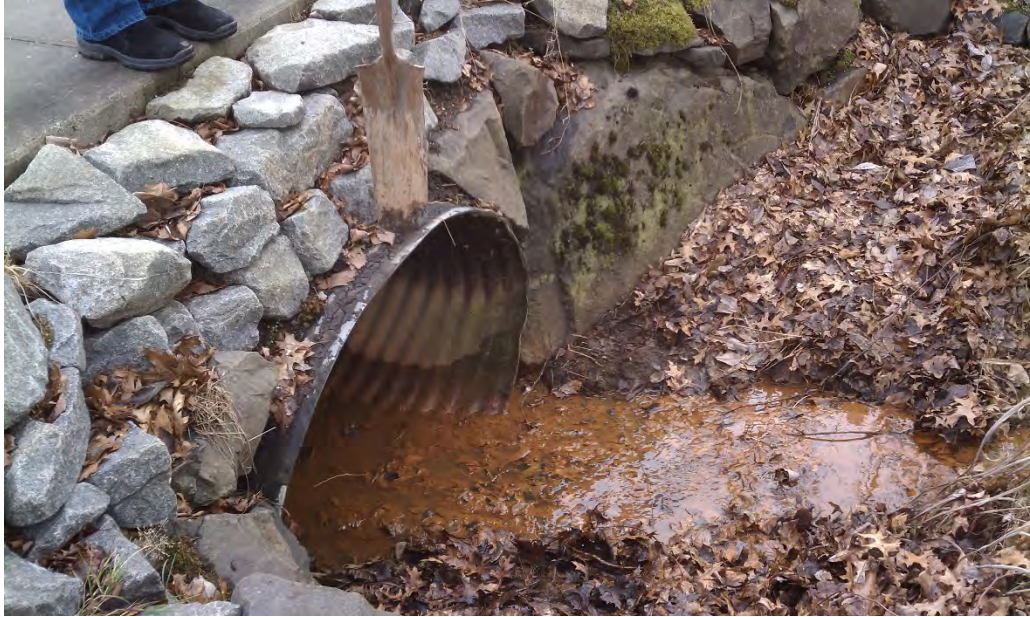
Photo #13: Looking at the inlet (upstream end) of the CMP Arch culvert under Pioneer Way where Wetland “A” drains unconstricted under the roadway to confluence with “Deer Creek” on the north side of the road. (Taken 2/25/13)

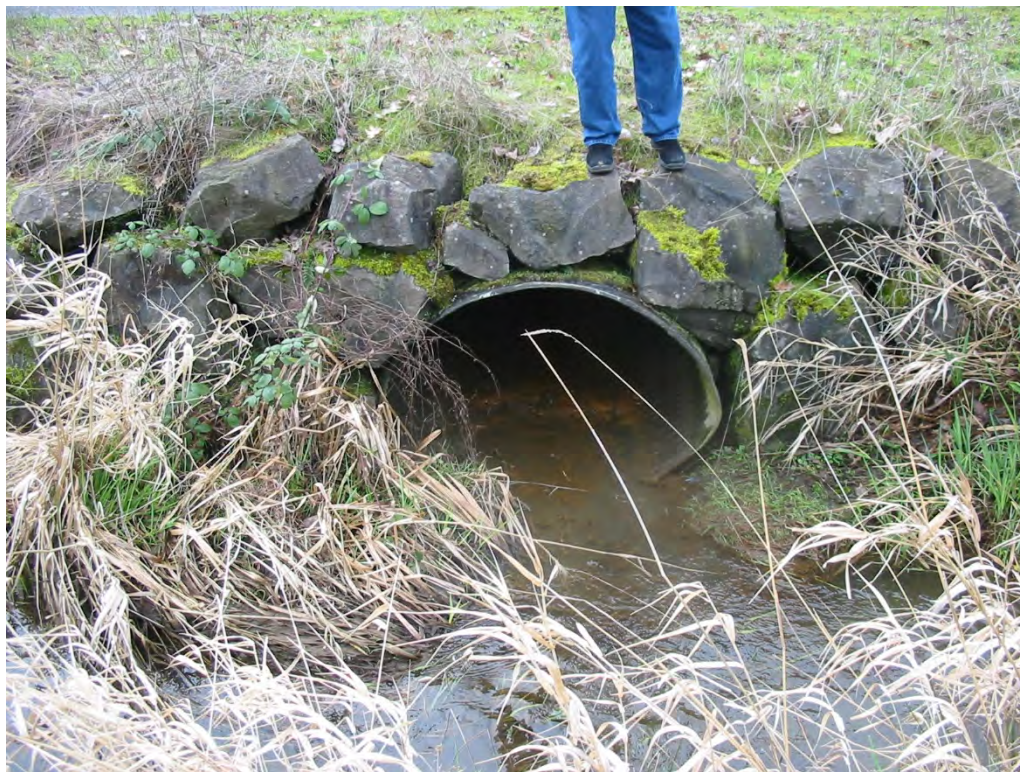
Photo #14: Looking at the outlet (downstream end) of the CMP Arch culvert under Pioneer Way where Wetland “A” drains unconstricted into “Deer Creek”. Note that the creek was in the foreground flowing from left to right in this photo. (Taken 2/15/13)
