# GEORESOURCES

1st DRT Review  
PLPSP20230080  
Oct 2023

Soils Report: Infiltration Feasibility  
Proposed Multi-Family Development  
xxx – 5<sup>th</sup> Street Southeast  
Puyallup, Washington  
PN: 0419036002, -6003  
Doc ID: EagleWorksLLC.5thStreetSE.SR

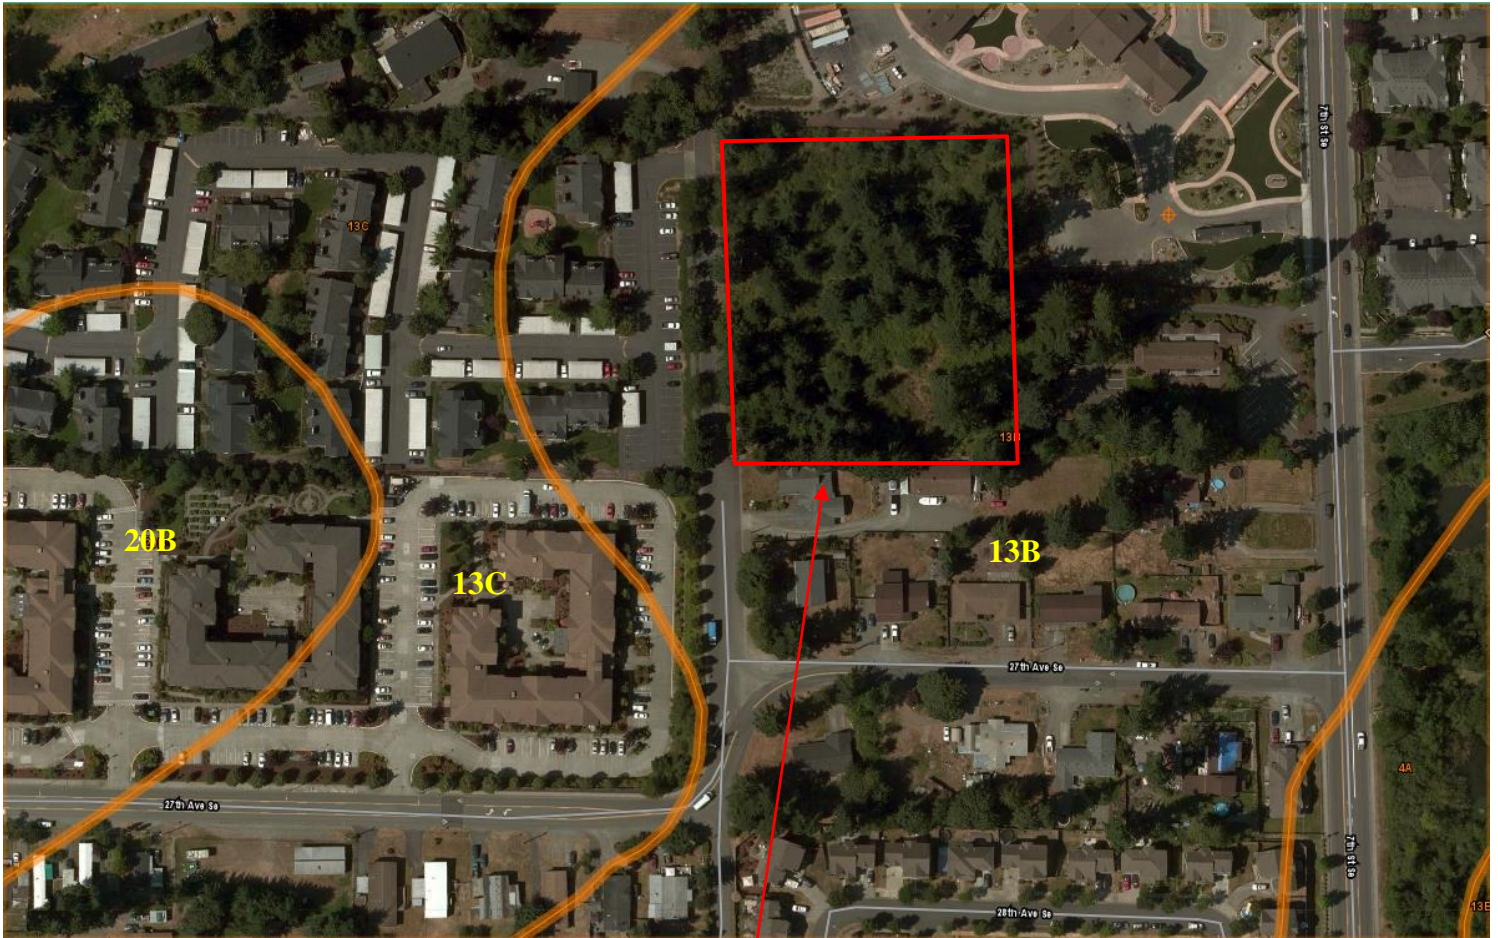
Figure 3

Soil Type	Soil Name	Parent Material	Slopes (%)	Erosion Hazard	Hydrologic Soils Group
13B	Everett very gravelly sandy loam	Sandy and gravelly glacial outwash	0 to 8	Slight	A
13C			8 to 15	Slight to Moderate	
20B	Kitsap silt loam	Glaciolacustrine deposits	2 to 8	Slight	C/D

### NRCS Soils Map

The USDA Natural Resource Conservation Service (NRCS) Web Soil Survey maps the site and surrounding areas as being underlain by Everett very gravelly sandy loam (13B) soils. The Everett soils are derived from sandy and gravelly glacial outwash and are included in hydrologic soils group A. The 13B soil type forms on slopes of 0 to 8 percent and have a “slight” erosion hazard when exposed. Our subsurface explorations generally confirm the NRCS map for the site. A copy of the NRCS Soil Survey Map for the site and surrounding area is included as Figure 3.
