November 2023
Freeman Road Logistics

Critical Areas Report

Prepared for Vector Development Company

Prepared by
Anchor QEA, LLC
1201 3rd Avenue, Suite 2600
Seattle, Washington 98101

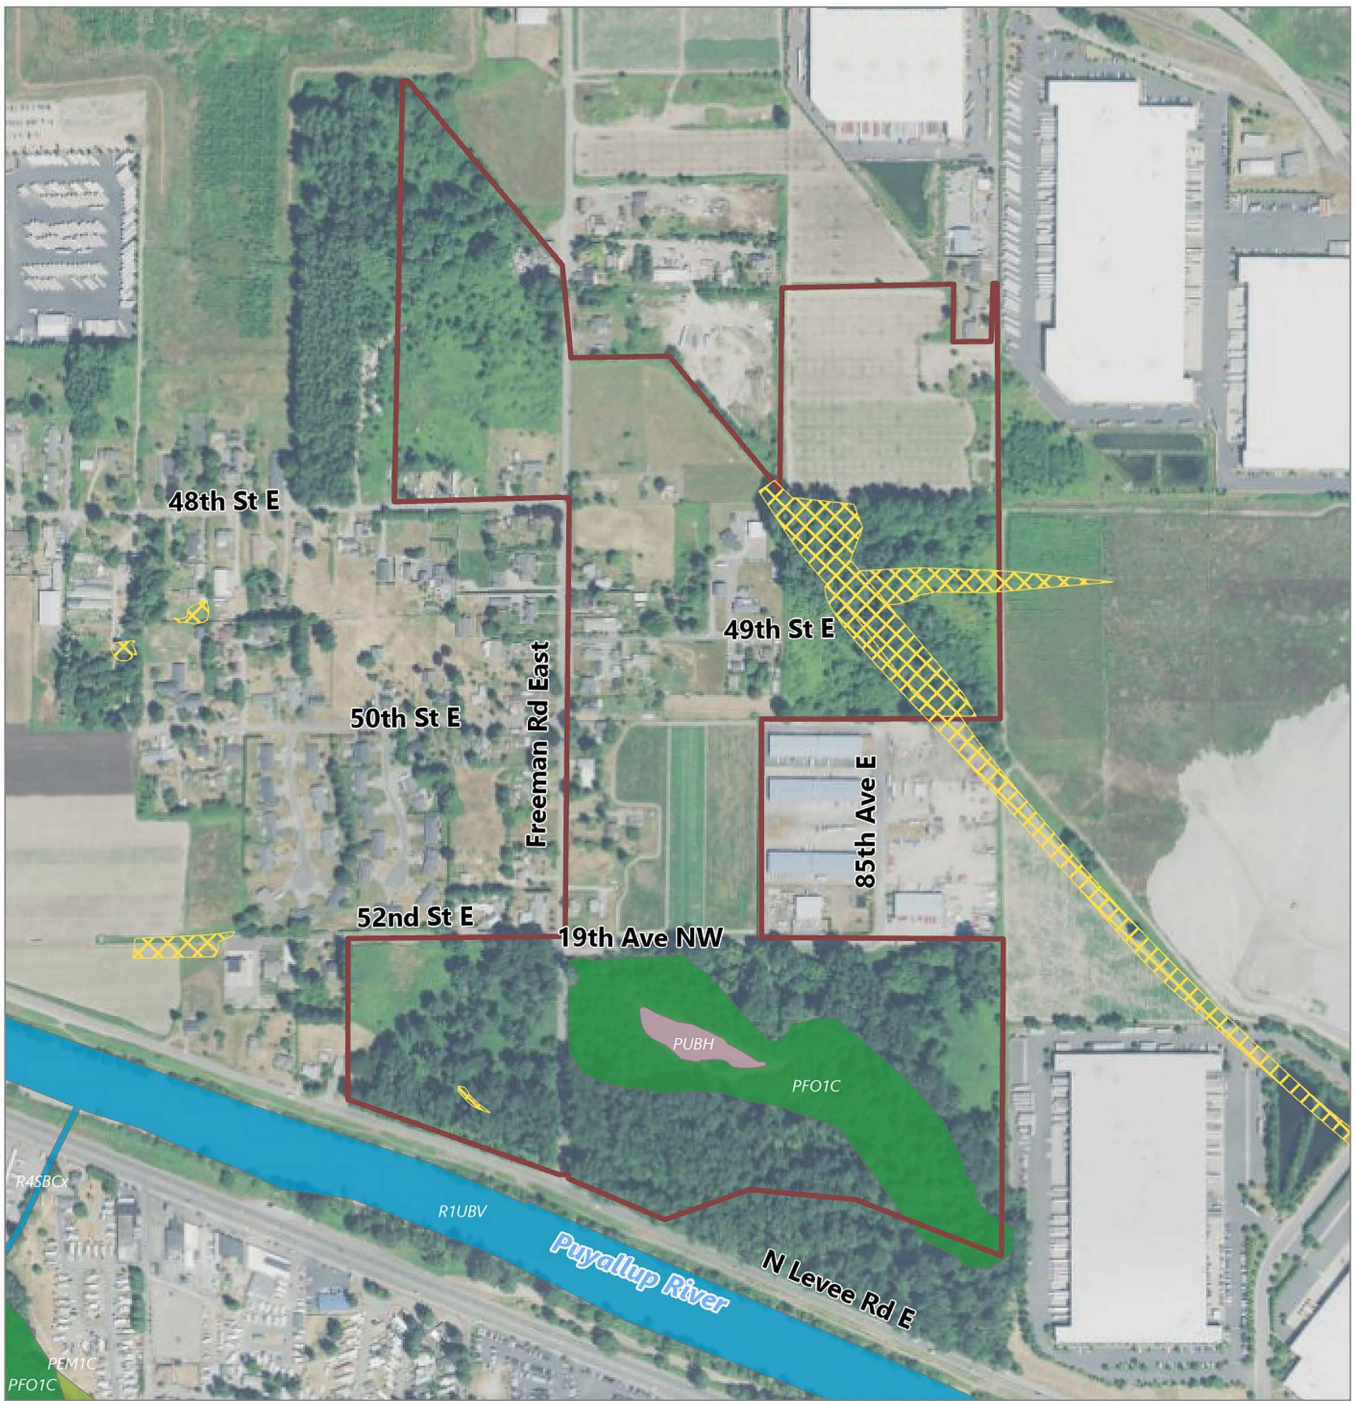
Figure 5
National Wetlands Inventory Map
 Critical Areas Report
 Freeman Road Logistics

- Study Area
- City of Puyallup Wetland (Unverified)
- NWI Wetlands**
- Freshwater Emergent Wetland
- Freshwater Forested/Shrub Wetland
- Freshwater Pond
- Riverine

Wetland conditions in this area are not documented by the City sensitive areas maps (City of Puyallup 2023b), Pierce County critical area maps (Figure 4; Pierce County 2023a), USFWS National Wetlands Inventory data (Figure 5; USFWS 2023a), or WDFW PHS data (WDFW 2023a), and do not identify wetland areas within at least 1,500 feet of the Study Area, except to the south of 19th Avenue Northwest at parcels 0420201008 and 0420201114.
