PRELIMINARY STORMWATER REPORT

Normandy Heights

2007 Shaw Road
Puyallup, WA 98374

January 25, 2024
Our Job No. 12663

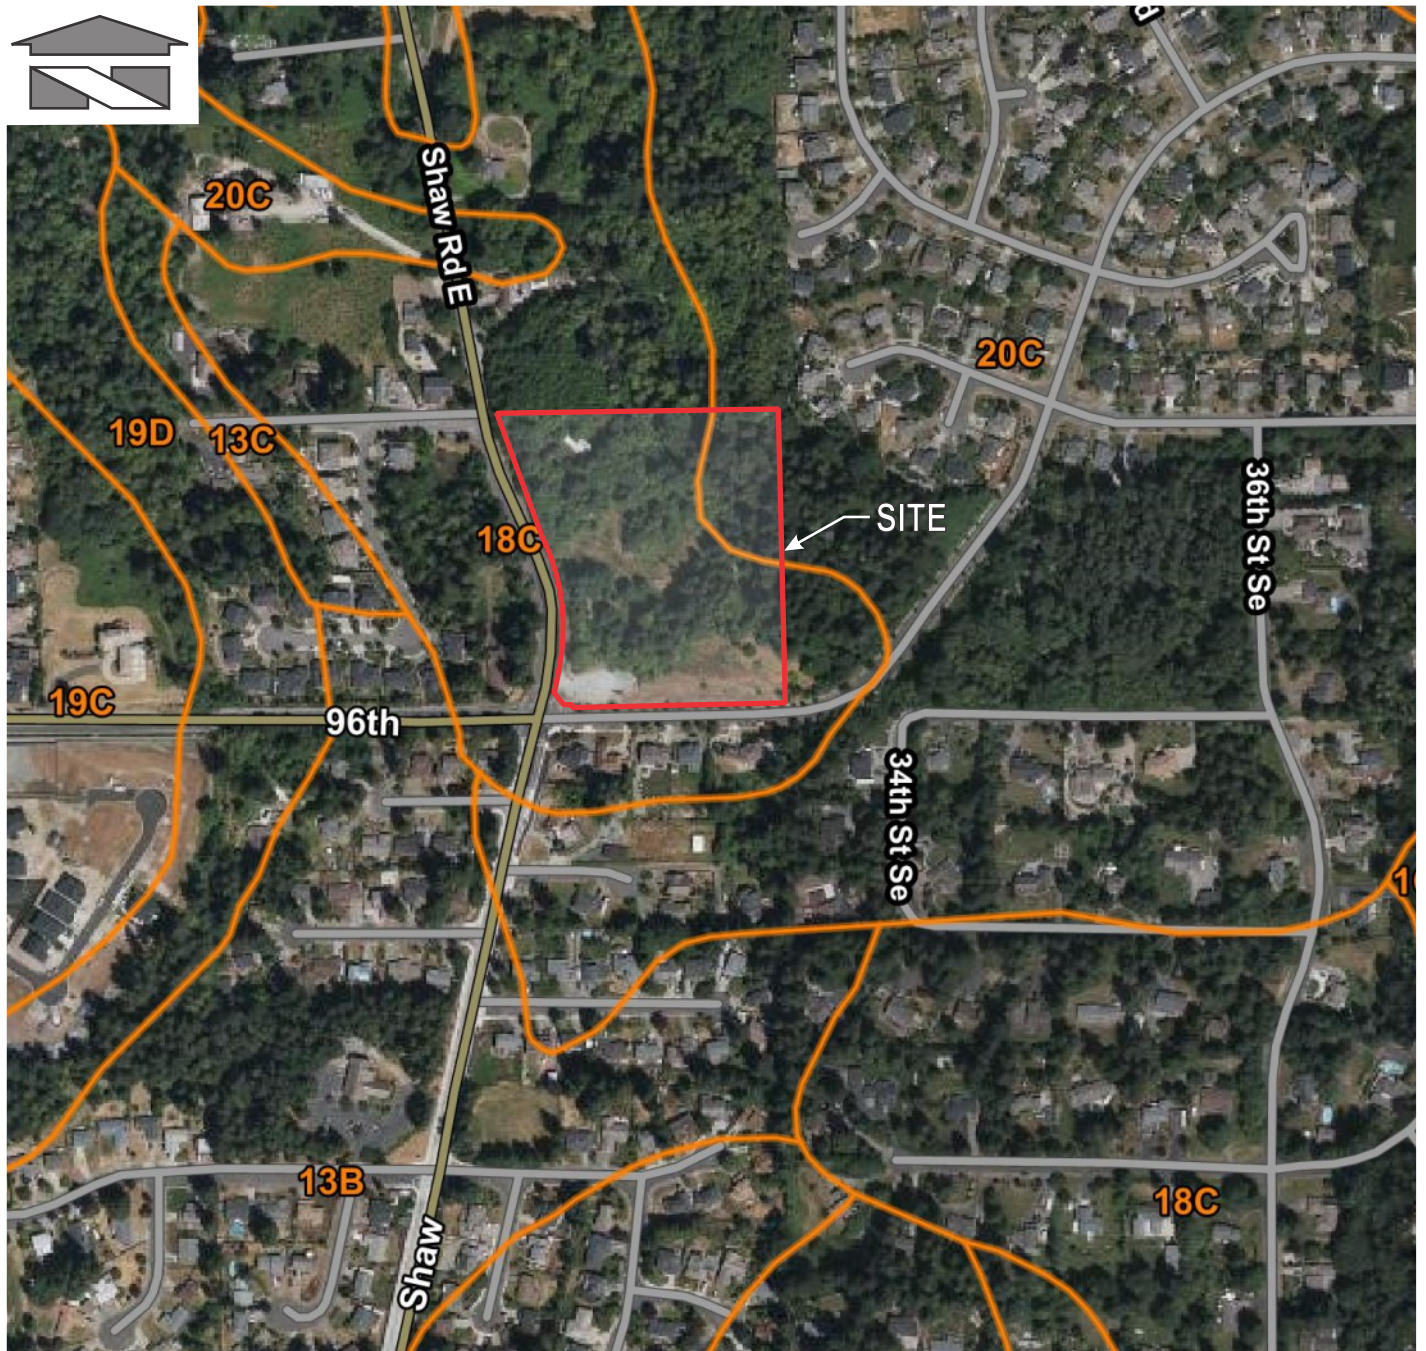
FIGURE 2

The National Resource Conservation Service (NRCS) Web Soil Survey identifies onsite soils as Indianola loamy sand, 5 to 15 percent slopes (Map Unit 18C) and Kitsap silt loam, 8 to 15 percent slopes (Map Unit 20C) which are consistent with soil conditions encountered during geotechnical fieldwork. Test pits generally encountered approximately 7-12 inches of topsoil underlain by a layer of medium dense, poorly graded sand and gravel. Several test sites were further underlain by dense silty sand with gravel glacial till deposits. Groundwater seepage was not observed at the time of fieldwork.

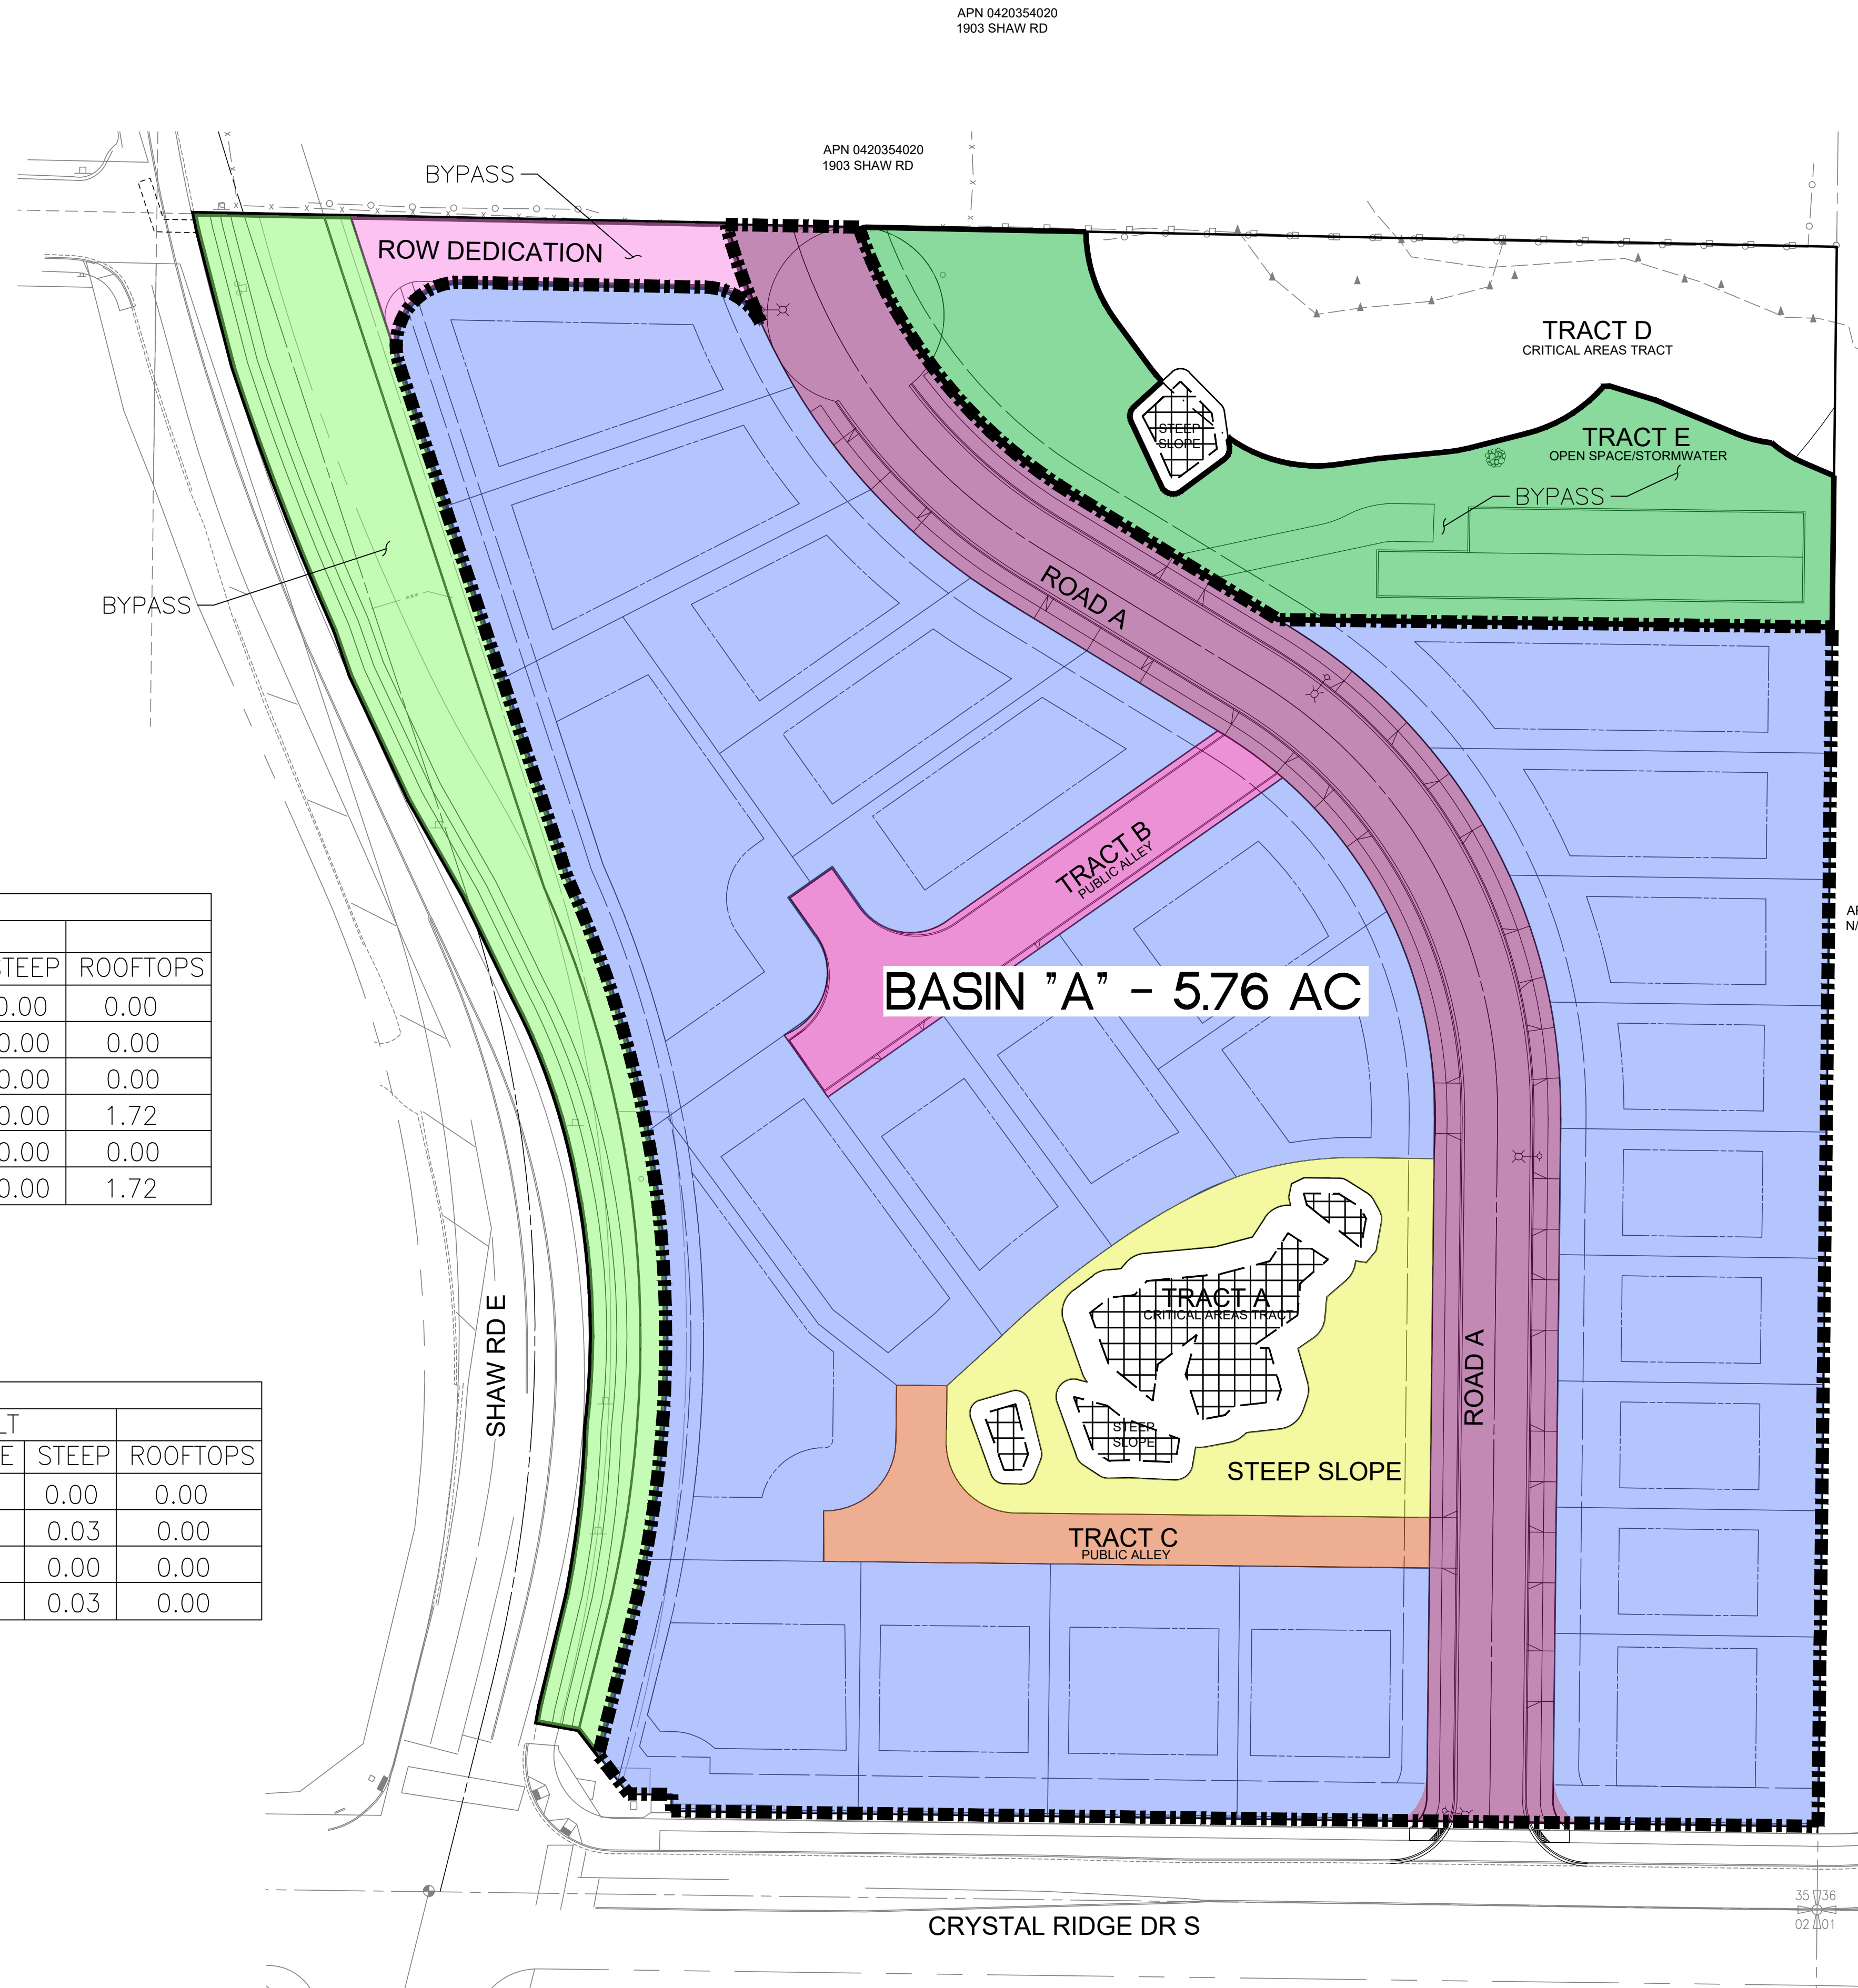
POSTDEVELOPED BASIN MAP EXHIBIT

BASIN "A" WWHM INPUT TABLE

AREA NAME	COLOR	AREA (AC)	PERVIOUS PASTURE			CONCRETE		IMPERVIOUS ASPHALT			ROOFTOPS
			FLAT	MODERATE	STEEP	FLAT	MODERATE	FLAT	MODERATE	STEEP	
TRACT B		0.18	0.01	0.00	0.01	0.00	0.00	0.02	0.13	0.00	0.00
TRACT C		0.14	0.00	0.00	0.00	0.00	0.00	0.09	0.05	0.00	0.00
ROAD A		0.87	0.08	0.11	0.00	0.07	0.09	0.22	0.30	0.00	0.00
LOTS		4.30	1.89	0.05	0.64	0.00	0.00	0.00	0.00	0.00	1.72
STEEP SLOPE		0.28	0.00	0.04	0.24	0.00	0.00	0.00	0.00	0.00	0.00
TOTAL ACRES		5.76	1.98	0.20	0.89	0.07	0.09	0.33	0.48	0.00	1.72

The project will be collecting the developed drainage from the roadway and rooftops in catch basins and convey the flows directly to the detention vault. The detention system was sized to match developed discharge durations to pre-developed durations for the range of pre-developed discharge rates from 50% of the 2-year peak flow up to the full 50-year peak flow. The pre-developed condition to be matched is the forested land cover. A tightline conveyance system outletting to a flow-spreader is proposed to serve as an outfall and emergency overflow route to the existing onsite wetland. Conveyance system analysis will be provided during final engineering.

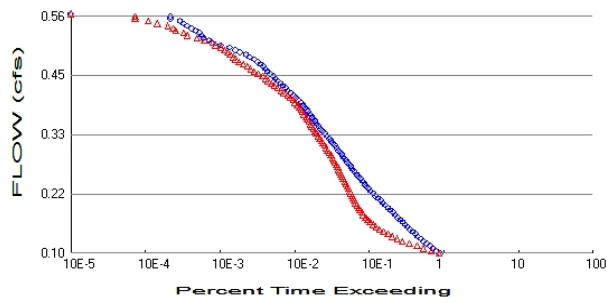
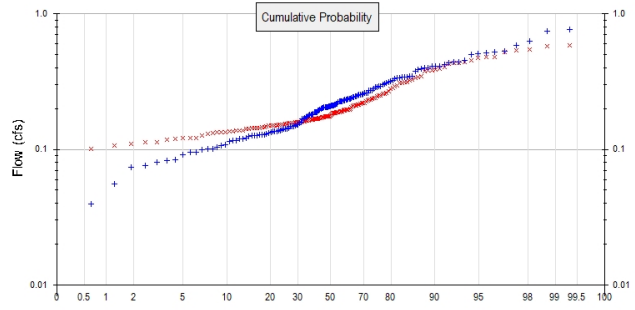
POC 1

+ Predeveloped x Mitigated

Flow(cfs)	Predev	Mit	Percentage	Pass/Fail
0.1049	48714	47717	97	Pass
0.1095	43645	37562	86	Pass
0.1141	39274	29451	74	Pass
0.1188	36132	24210	67	Pass
0.1234	32664	18964	58	Pass

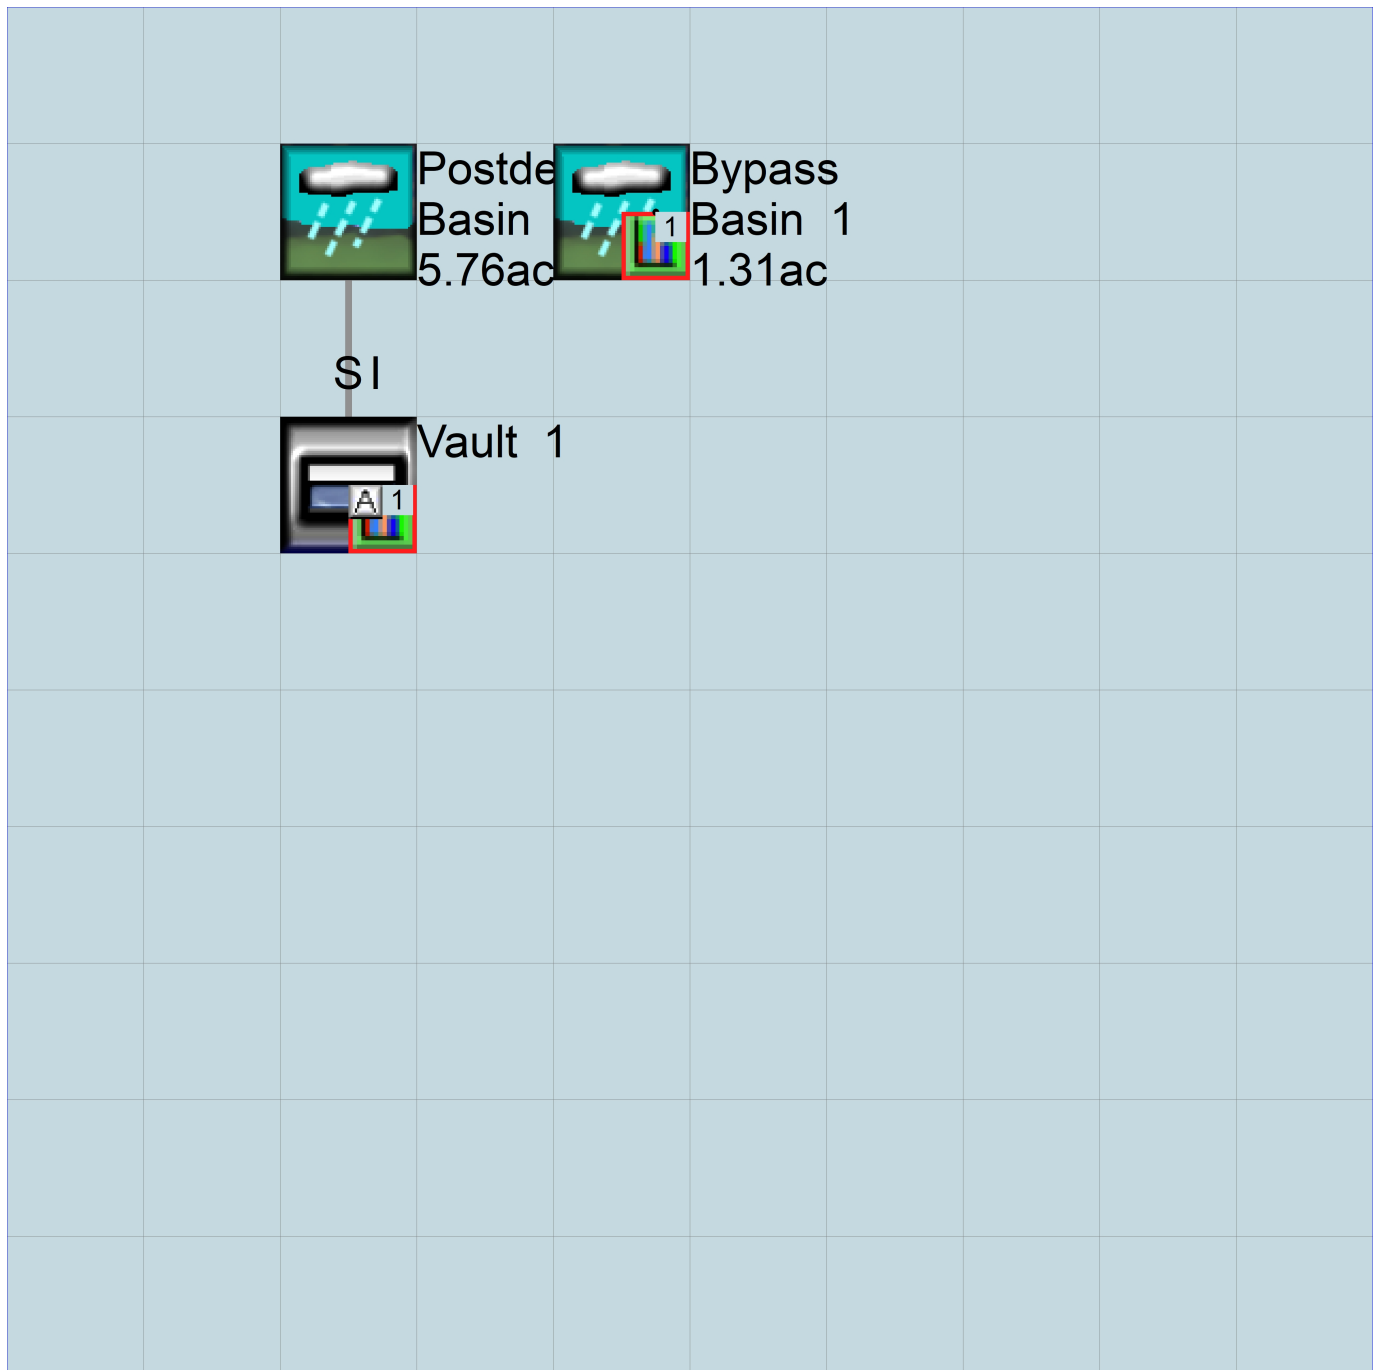
Mitigated Schematic

Predeveloped
Basin 1
7.07ac

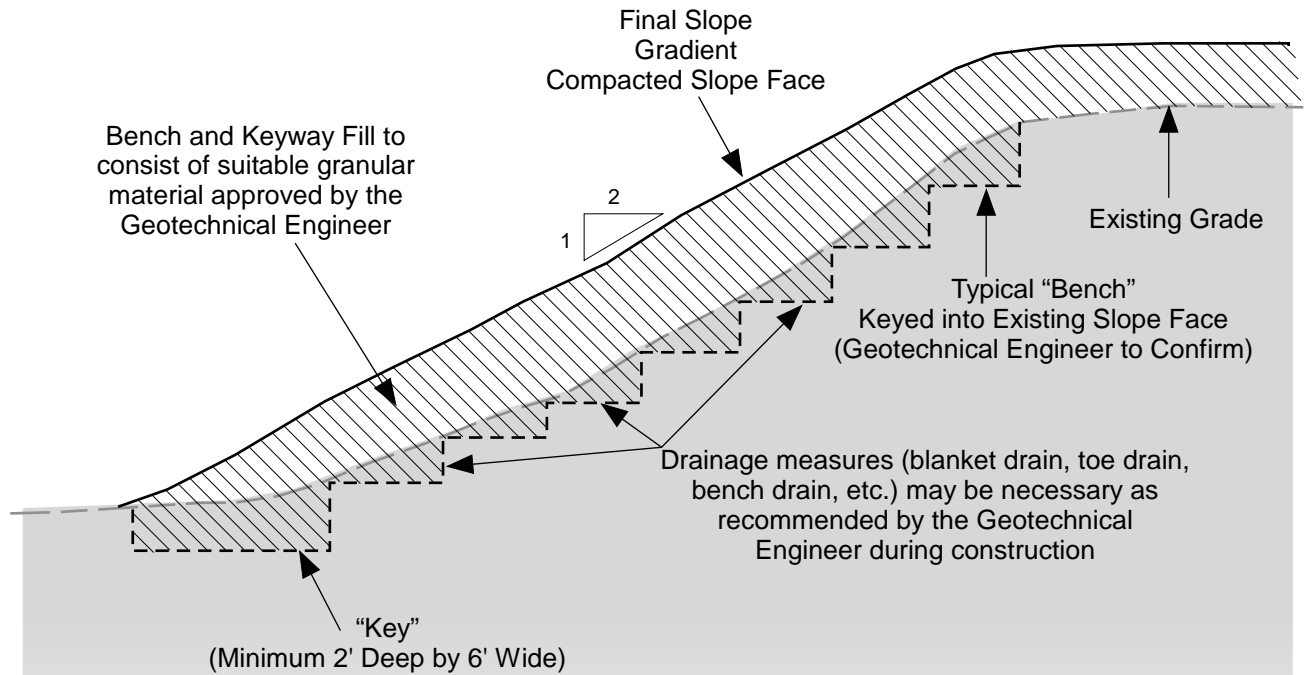
- Slope should be stripped of topsoil and unsuitable materials prior to excavating Keyway or benches.
- Benches will typically be equal to a bulldozer blade width of approximately 8 feet but shall be at least 4 feet.

Earth Solutions NW_{LLC} Geotechnical Engineering, Construction Observation/Testing and Environmental Services	
Slope Fill Detail Normandy Heights Puyallup, Washington			
Drwn. MRS	Date 05/02/2022	Proj. No. 0593	
Checked SSR	Date May 2022	Plate 3

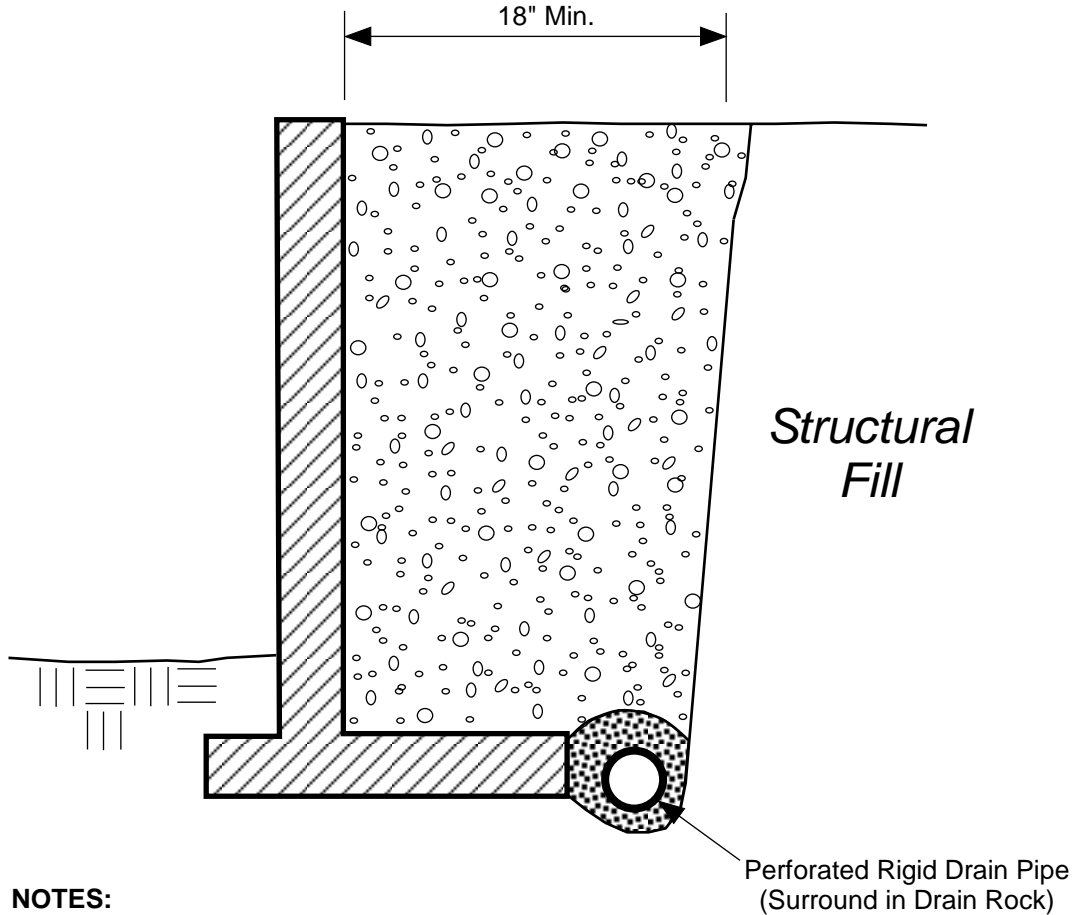
- Free-draining Backfill should consist of soil having less than 5 percent fines. Percent passing No. 4 sieve should be 25 to 75 percent.
- Sheet Drain may be feasible in lieu of Free-draining Backfill, per ESNW recommendations.
- Drain Pipe should consist of perforated, rigid PVC Pipe surrounded with 1-inch Drain Rock.

Earth Solutions NW_{LLC} Geotechnical Engineering, Construction Observation/Testing and Environmental Services	
Retaining Wall Drainage Detail Normandy Heights Puyallup, Washington			
Drwn. MRS	Date 05/02/2022	Proj. No. 0593	
Checked SSR	Date May 2022	Plate 4

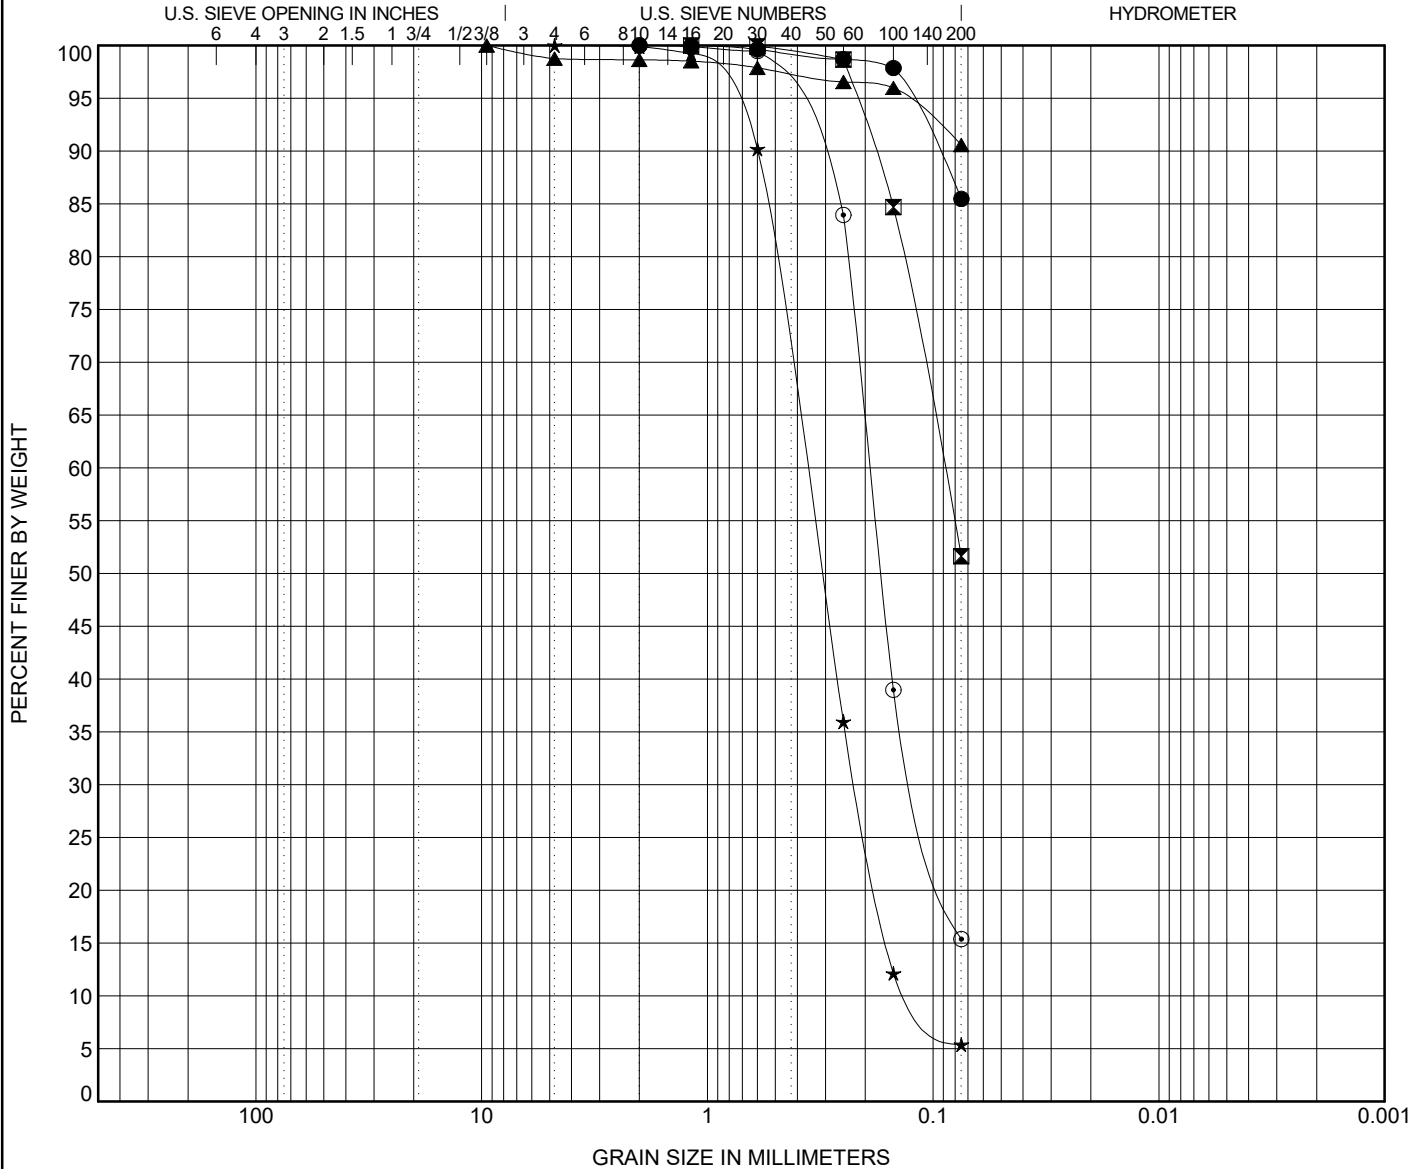
Specimen Identification	Classification						Cc	Cu
● B-01 5.00ft.	USDA: Brown Loam. USCS: ML.							
☒ B-01 15.00ft.	USDA: Gray Loam. USCS: Sandy ML.							
▲ B-02 10.00ft.	USDA: Brown Slightly Gravelly Loam. USCS: ML.							
★ B-02 20.00ft.	USDA: Gray Slightly Gravelly Sand. USCS: SP-SM.						1.09	3.06
⊙ B-03 10.00ft.	USDA: Gray Loamy Fine Sand. USCS: SM.

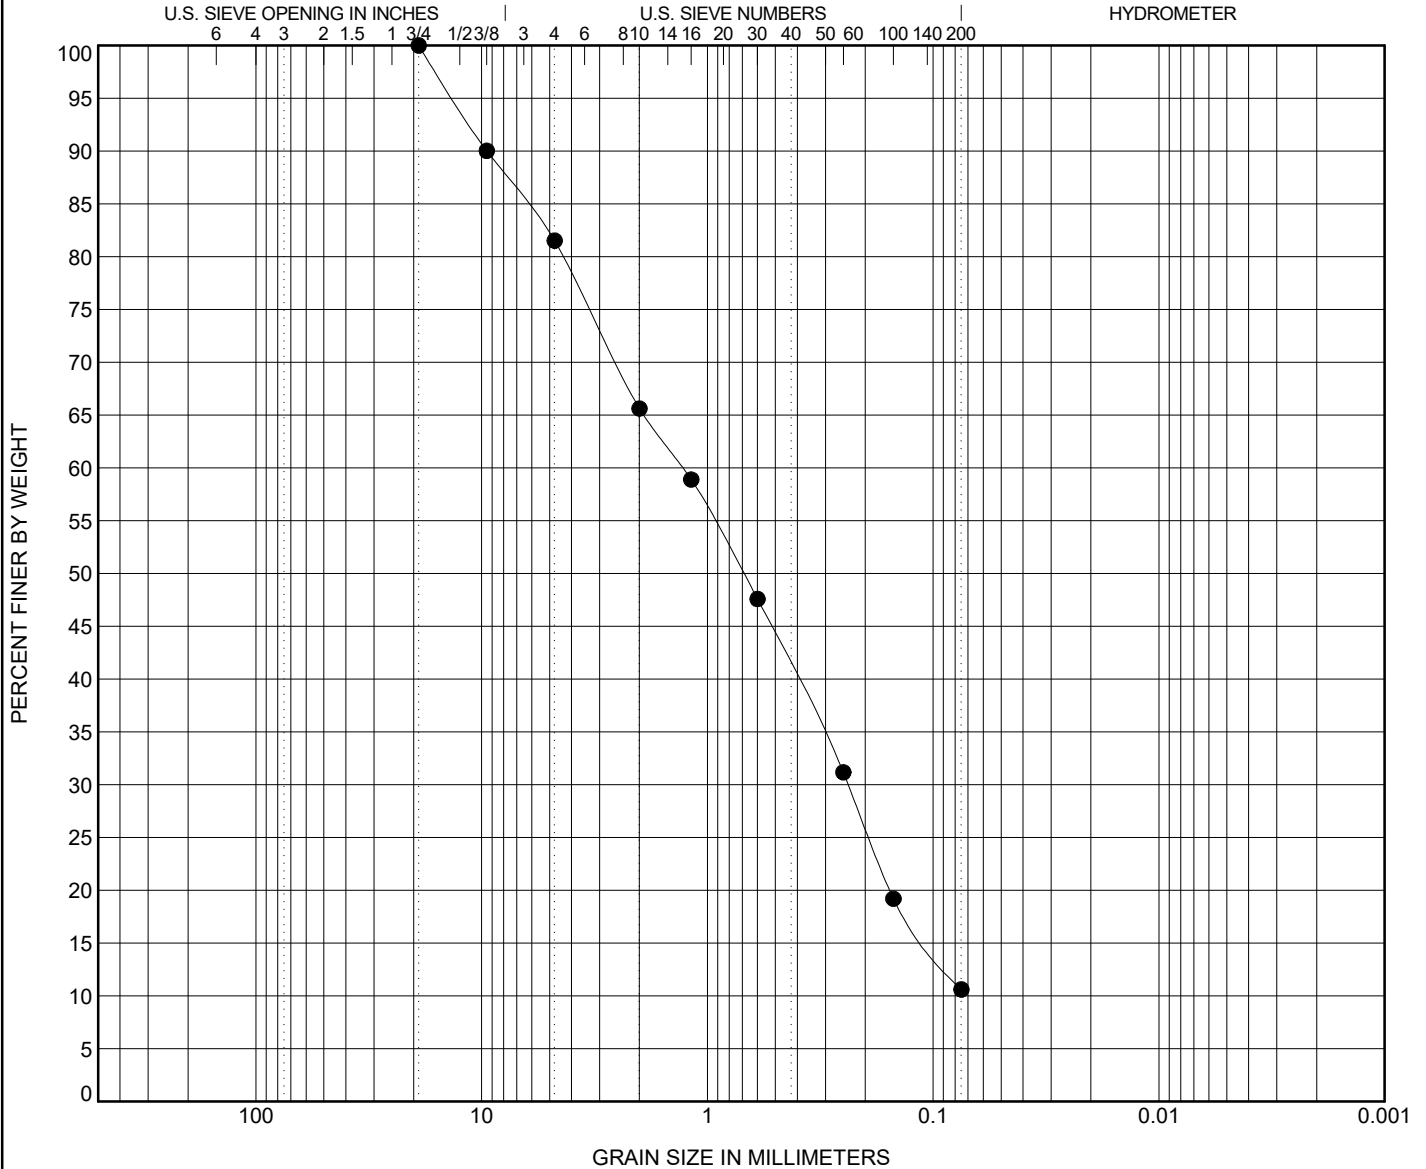
Specimen Identification	Classification							Cc	Cu
● B-03 20.00ft.	USDA: Gray Gravelly Loamy Coarse Sand. USCS: SP-SM with Gravel.							0.62	18.02

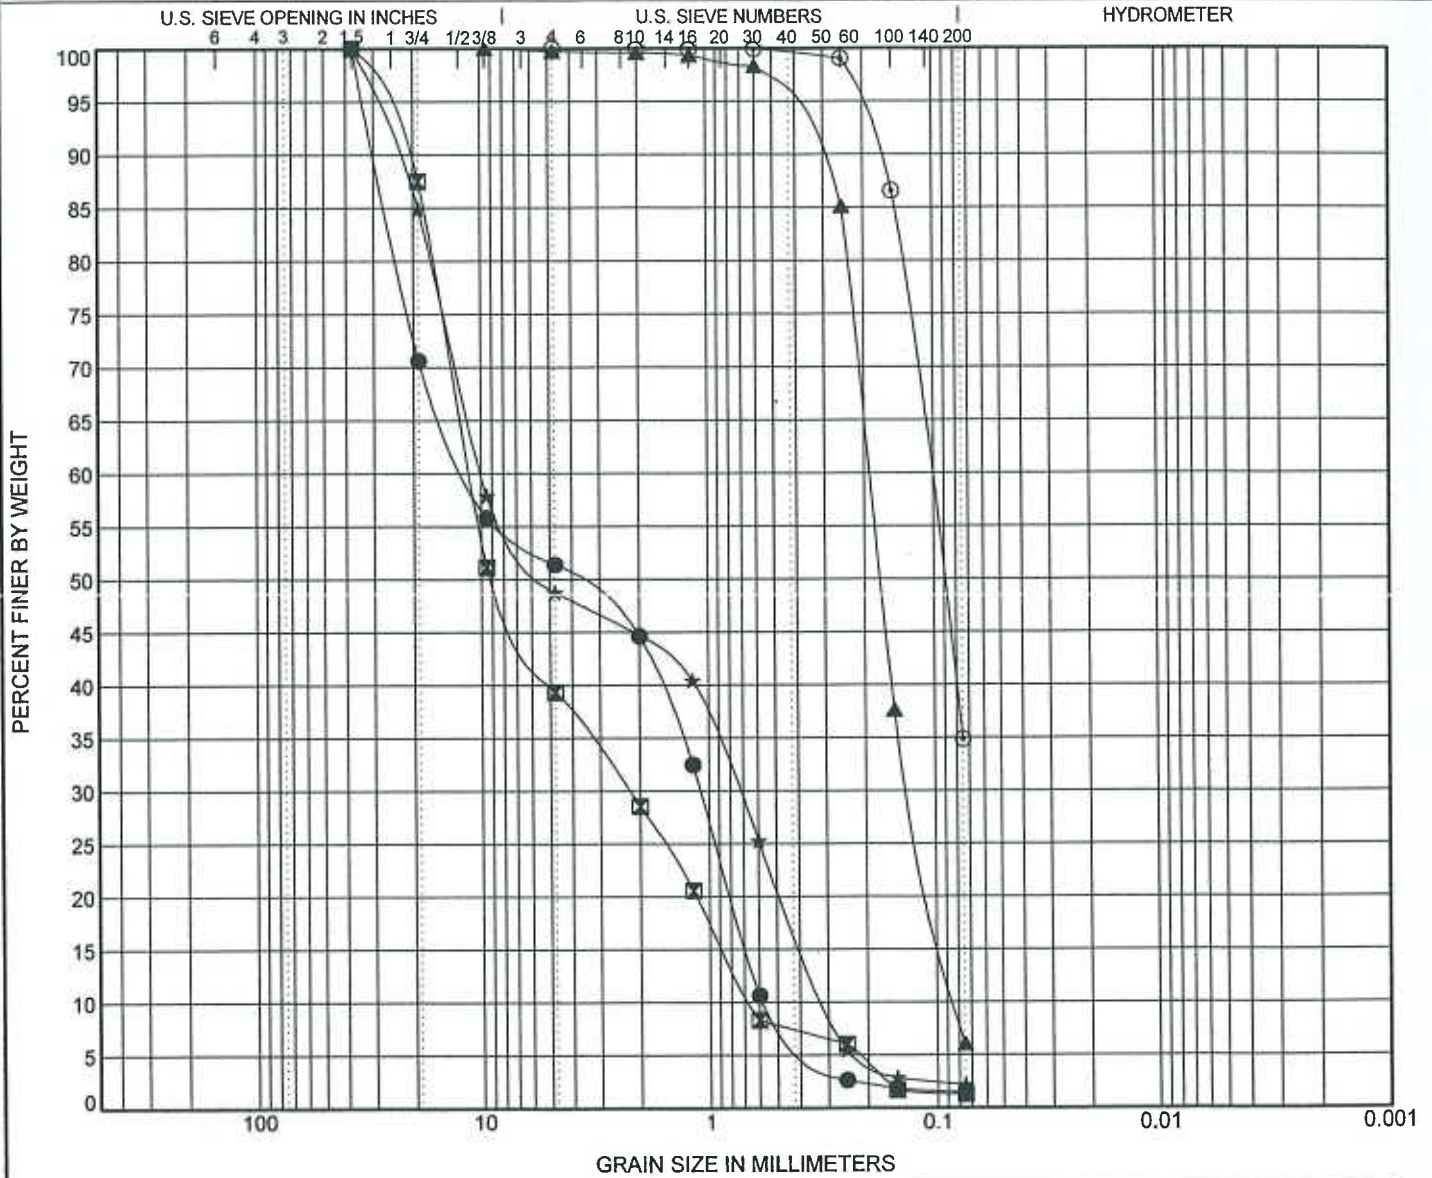
Specimen Identification	Classification					LL	PL	PI	Cc	Cu
● TP-01 10.0ft.	USDA: Brown very gravelly coarse sand, USCS: SP								0.18	20.63
☒ TP-01 17.0ft.	USDA: Light brown extremely gravelly coarse sand, USCS: GP								0.68	17.06
▲ TP-02 8.0ft.	USDA: Light brown fine sand, USCS: SP-SM								1.03	2.33
★ TP-02 11.0ft.	USDA: Gray very gravelly coarse sand, USCS: GP								0.18	32.81
⊙ TP-02 15.0ft.	USDA: Gray fine sandy loam, USCS: SM									
Specimen Identification	D100	D60	D30	D10	%Gravel	%Sand	%Silt	%Clay		
● TP-01 10.0ft.	37.5	11.554	1.093	0.56	48.6	49.9	1.5			
☒ TP-01 17.0ft.	37.5	11.246	2.248	0.659	60.7	38.1	1.3			
▲ TP-02 8.0ft.	9.5	0.191	0.127	0.082	0.3	93.7	6.1			
★ TP-02 11.0ft.	37.5	10.02	0.741	0.305	51.2	46.6	2.2			
⊙ TP-02 15.0ft.	4.75	0.105			0.0	65.2	34.8

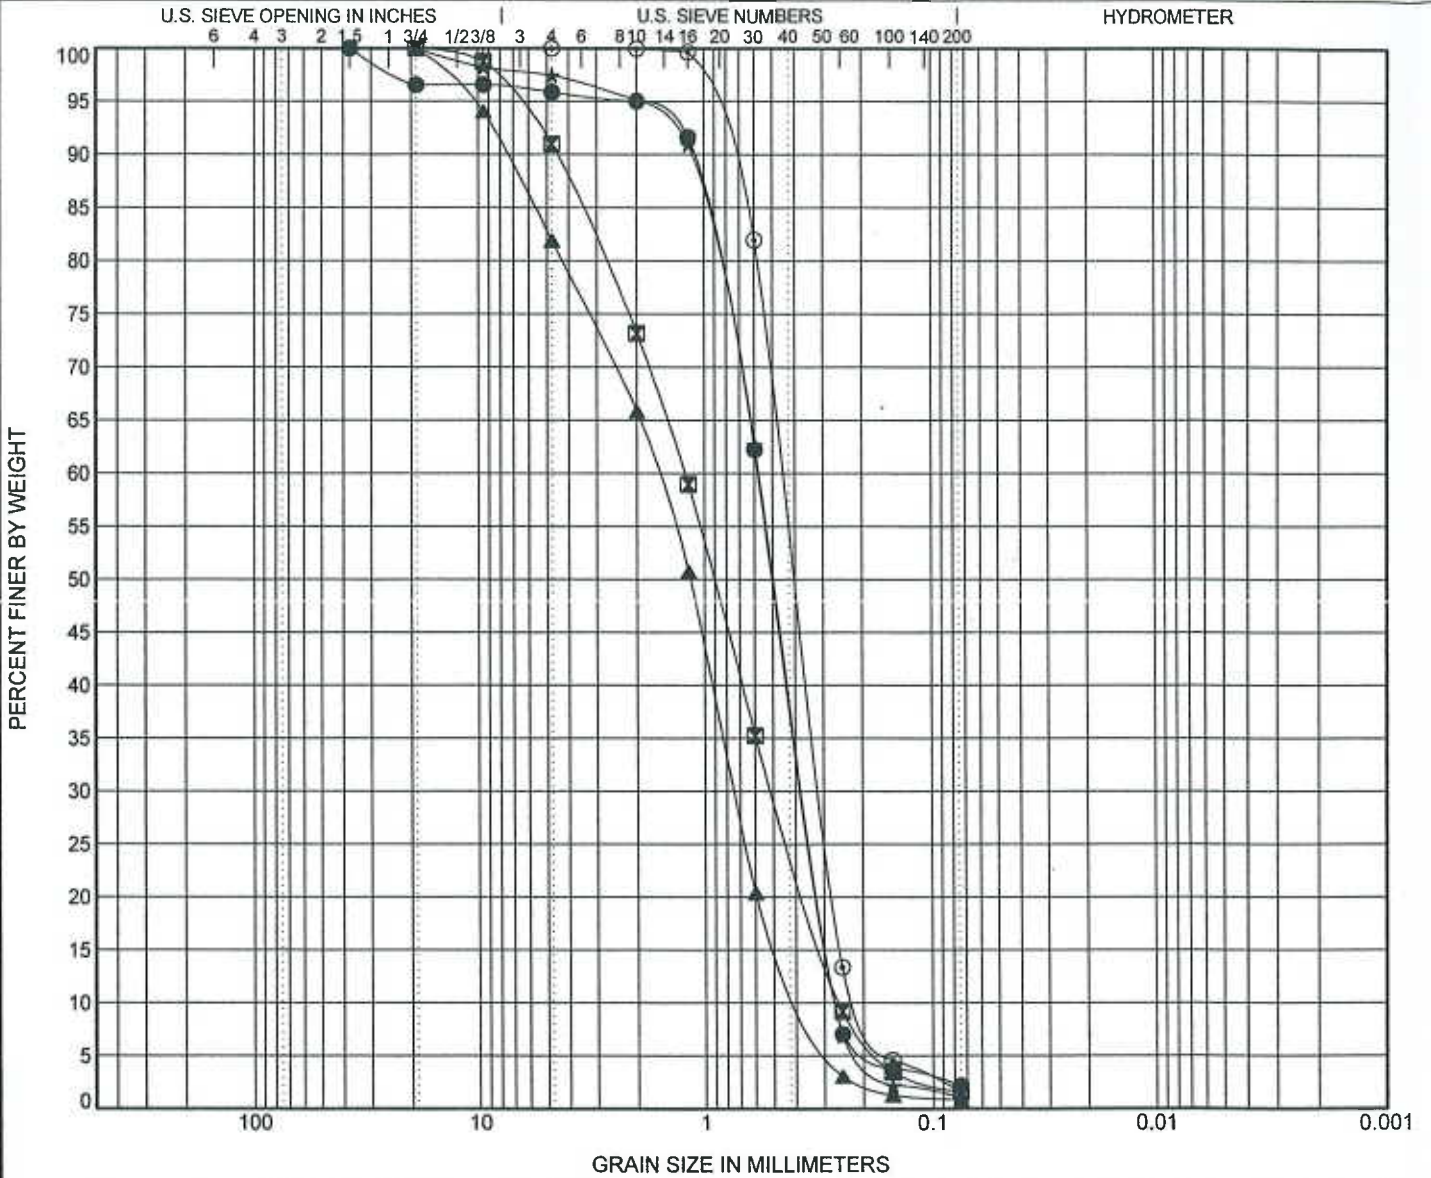
Specimen Identification	Classification					LL	PL	PI	Cc	Cu
● TP-03 3.0ft.	USDA: Light brown sand, USCS: SP								0.85	2.21
☒ TP-04 4.0ft.	USDA: Brown gravelly coarse sand, USCS: SP								0.80	4.77
▲ TP-06 4.0ft.	USDA: Light brown gravelly coarse sand, USCS: SP								0.95	4.59
★ TP-07 4.0ft.	USDA: Brown sand, USCS: SP								0.85	2.19
◎ TP-08 8.0ft.	USDA: Gray sand, USCS: SP								1.03	2.21
Specimen Identification	D100	D60	D30	D10	%Gravel	%Sand	%Silt	%Clay		
● TP-03 3.0ft.	37.5	0.579	0.36	0.262	4.1	93.7	2.2			
☒ TP-04 4.0ft.	19	1.226	0.503	0.257	9.0	89.4	1.6			
▲ TP-06 4.0ft.	19	1.631	0.743	0.355	18.1	81.1	0.8			
★ TP-07 4.0ft.	19	0.575	0.359	0.263	2.6	96.4	1.0			
◎ TP-08 8.0ft.	4.75	0.453	0.309	0.205	0.0	98.4	1.6

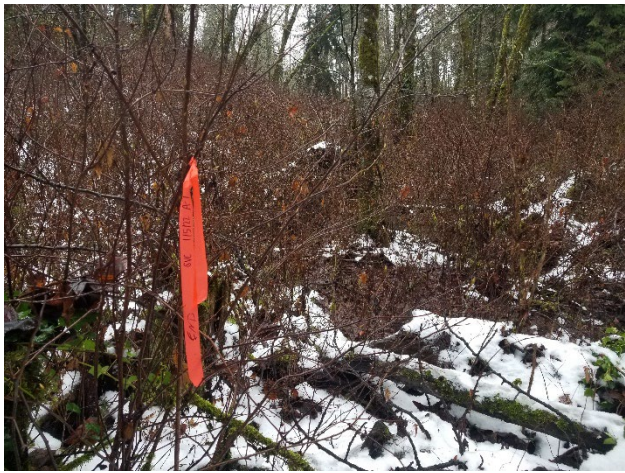
WETLAND A – INFORMATION SUMMARY		
Location:	Located in the northern portion of the subject property.

Local Jurisdiction	City of Puyallup
	WRIA	10 – Puyallup - White
	WSDOE 2014 Rating	III
	City of Puyallup rating	III
	Standard Buffer Width	80 feet
	Wetland Size	2,020 square feet
	Cowardin Classification	PSSAB
	HGM Classification	Depressional
	Wetland Data Sheet	DP-2W
	Upland Data Sheet	DP-3U
	Boundary Flag color	Orange
Dominant Vegetation	Wetland vegetation is dominated salmonberry, vine maple, youth on age, and buttercup.	
Soils	Hydric soil indicator A11 (Depleted Below Dark Surface) was observed.	
Hydrology	Hydrology for Wetland A is provided primarily by a seasonally high groundwater table, direct precipitation, and surface sheet flow from surrounding uplands. No evidence of overbank flooding from Stream Z was observed.	
Rationale for Delineation	Wetland boundaries were determined by a topographic drop, and the combined presence of hydric soils and hydrophytic vegetation.

Rationale for Local Rating	Wetland rating based on the current WSDOE wetland rating system for Western Washington (Hruby, 2014) per PMC 21.06.910(3).	
Wetland Functions Summary		
Water Quality	Wetland A has moderate potential to improve water quality due to the presence of persistent, ungrazed plants in 95 percent of the unit., the presence of septic systems within 250 feet of the wetland, and the presence of a TMDL in the watershed. However, water quality functions are limited due to the permanently flowing outlet, lack of seasonal ponding, and the wetland does not discharge into impaired waters. Wetland A’s score for Water Quality Functions is moderate (7).	
Hydrologic	Wetland A has low potential to provide hydrologic functions due to its small contribution of storage capacity within the contributing basin, lack of storage during wet periods, and lack of stormwater discharges or sources of runoff. However, the wetland provides some functions due to at least 25 percent intensive land uses within the contributing basin and presence of flooding downgradient. Wetland A’s score for Hydrologic Functions is moderate (5).

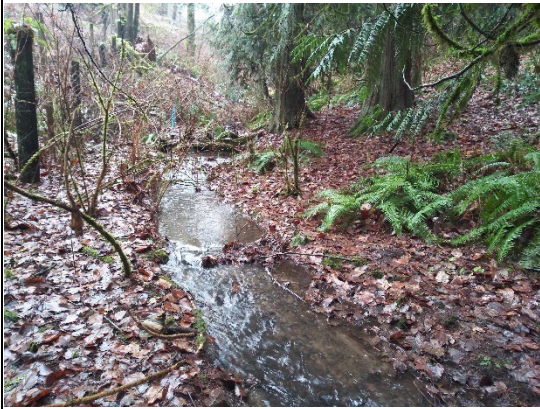
STREAM Z – INFORMATION SUMMARY

Feature Name	Stream Z
	WRIA	10 – Puyallup - White
	Local Jurisdiction	City of Puyallup
	DNR Stream Type	Type N
	Snohomish County Stream Rating	Type III
	Standard Buffer Width	50 feet
	Documented Fish Use	None
Location of Feature	Stream Z is located on the northeast corner of the subject property.	
Connectivity (where water flows from/to)	Based on local mapping inventories, Stream Z appears to begin approximately 0.5 linear mile upgradient of the site, to the south of 27 th Avenue Southeast. The stream flows in a southwesterly direction on the northeast portion of the site for approximately 200 linear feet and through Wetland A. The stream continues offsite to the north through several documented fish passage barriers before discharging into the Puyallup River 1.95 miles northwest of the site.	
Riparian/Buffer Condition	The onsite buffer is relatively intact with native vegetation but contains small amounts of non-native invasive Himalayan blackberry and English holly.

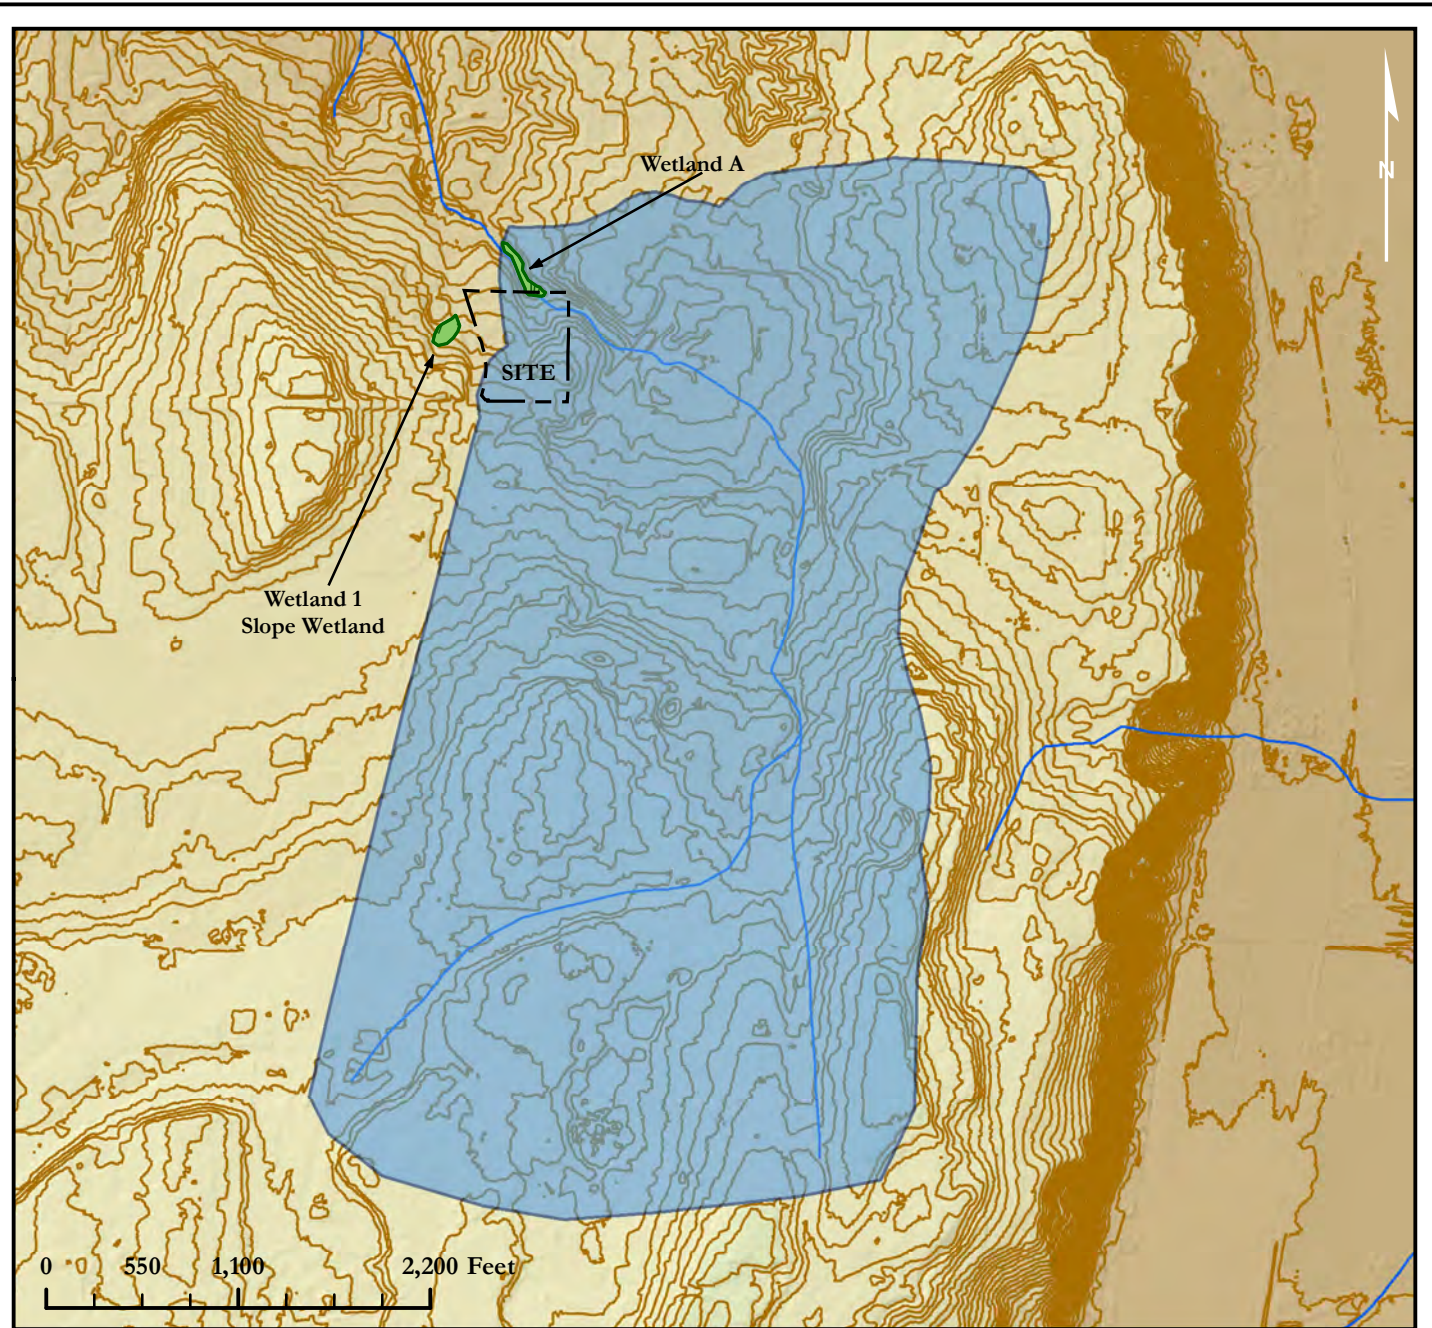
DEER CREEK - CONTRIBUTING BASIN MAP

D.4.0		
D.4.3		
	Area of Contributing Basin (SF)	17,784,895
	Area of Wetland A (SF)	15,732
	Percent of Wetland A within Contributing Basin	0.088%
D.5.0		
D.5.3		
	Is more than 25% of the Contributing Basin covered in Intensive Land Use?	YES

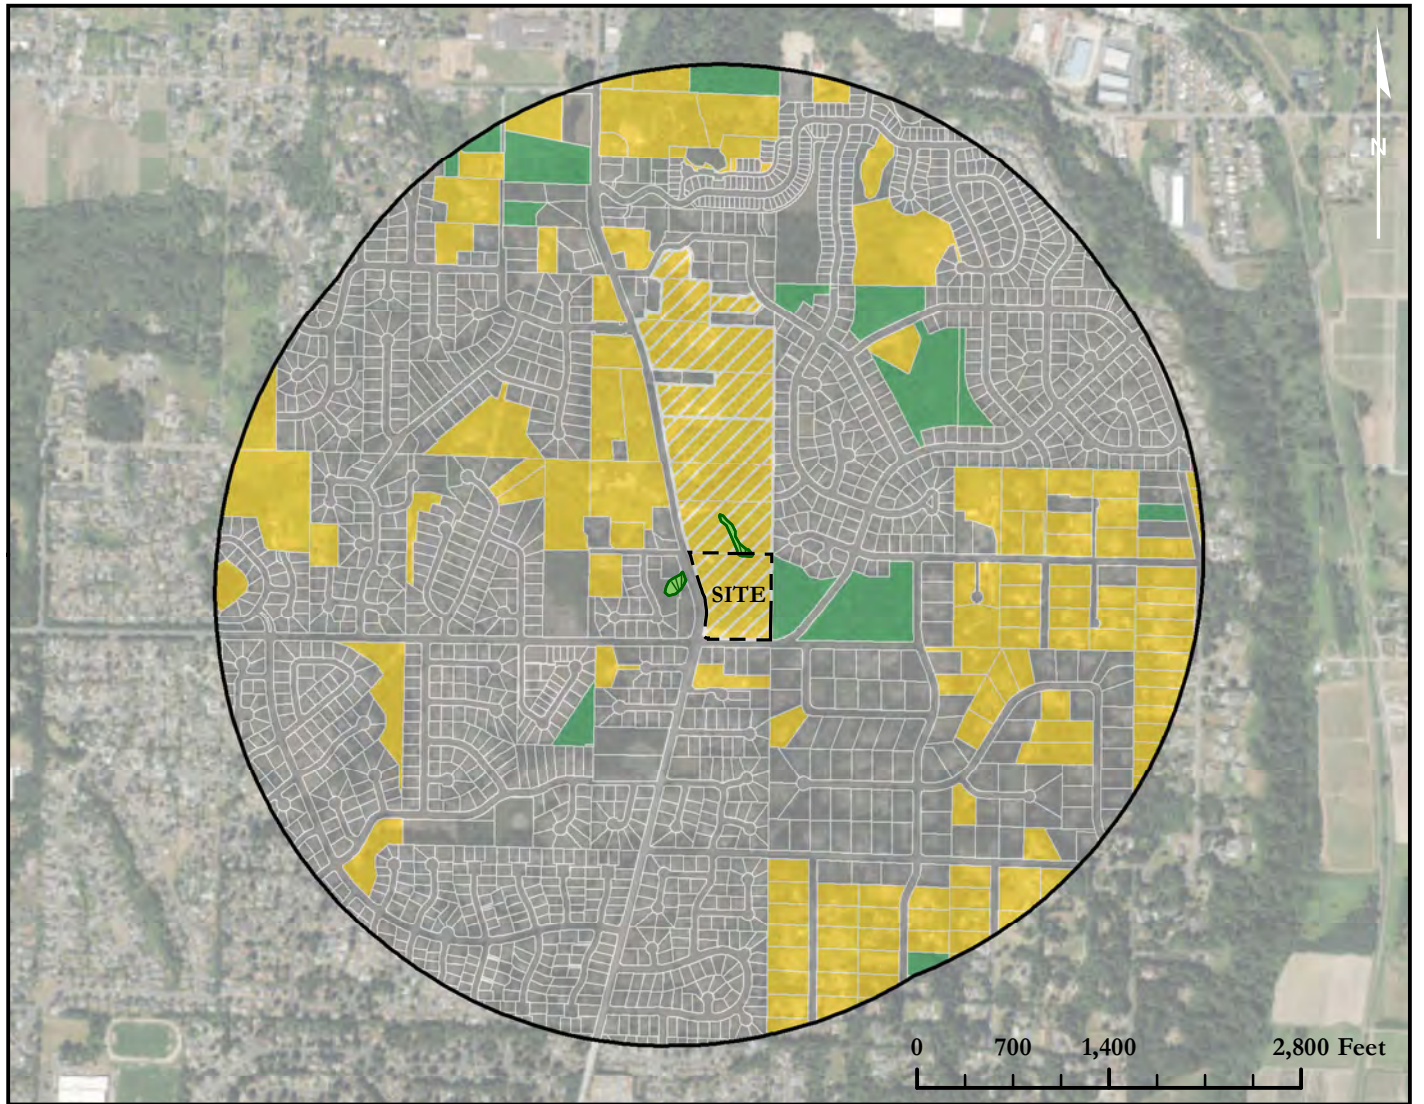
DEER CREEK - HABITAT MAP

H.2.0 Wetland A		
H.2.1		
	Abutting Undisturbed Habitat	0.00%
	Abutting Moderate & Low Intensity Land Uses	4.55%
	Accessible Habitat	2.27%
H.2.0 Wetland 1		
H.2.1		
	Abutting Undisturbed Habitat	0.00%
	Abutting Moderate & Low Intensity Land Uses	0.00%
	Accessible Habitat	0.00%
H.2.2		
	Undisturbed Habitat	4.24%
	Moderate & Low Intensity Land Uses	25.15%
	Undisturbed Habitat in 1 KM Polygon	16.82%
H.2.3		
	High Intensity Land Use in 1 KM Polygon	70.61%
