June 2024
Freeman Road Logistics

Critical Areas Report

Prepared for Vector Development Company

Prepared by
Anchor QEA
1201 3rd Avenue, Suite 2600
Seattle, Washington 98101

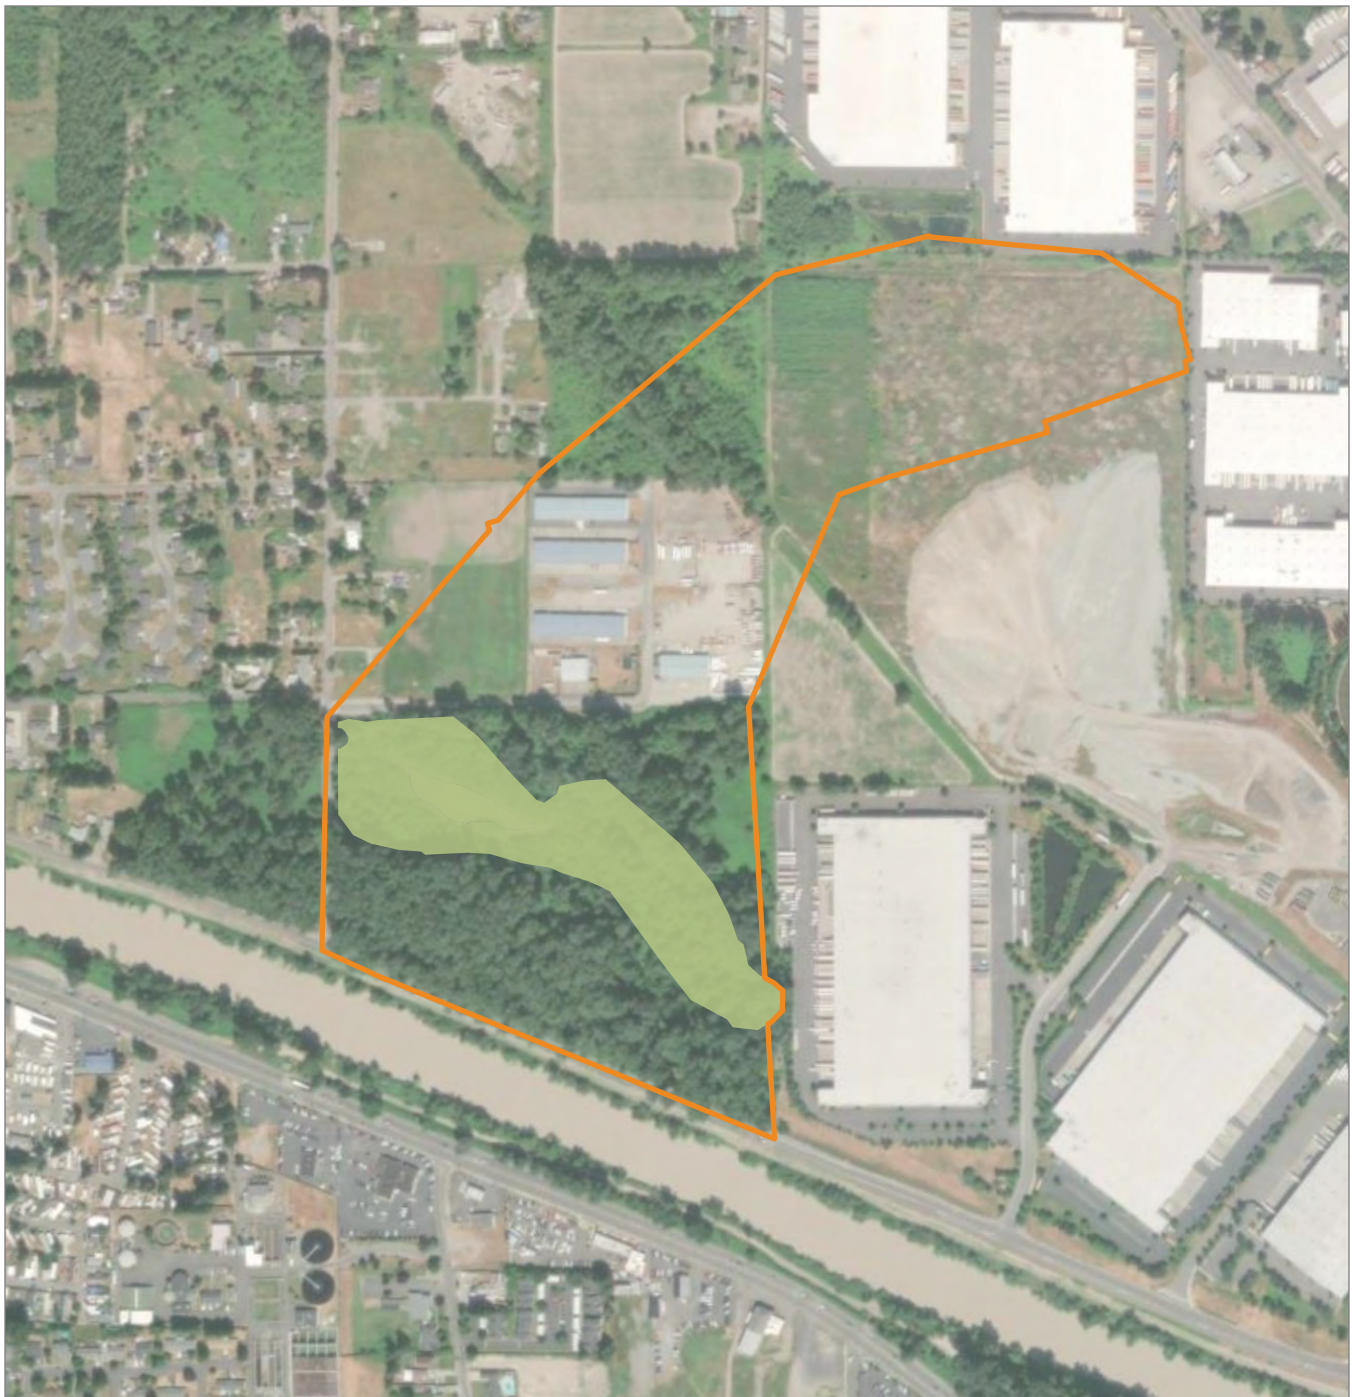
Figure 3
Wetland A - Map of the Contributing Basin

- Wetland A
- Contributing Basin
