Drainage Report

For the Dos Lagos Lot 'D' Parcel Number: 0419102107 & 0419106026 303 39th Ave SE Puyallup, Washington

LeRoy Surveyors & Engineers, Inc. P. O. Box 740 Puyallup, Washington 98371 (253) 848-6608

May 2021 Revised August 2023 Revised March 2024 Revised September 2024 Job No: 12896 I hereby state that this Preliminary Drainage Report for the Dos Lagos Lot 'D' Project has been prepared by me or under my supervision and meets the standard of care and expertise which is usual and customary in this community for professional engineers. I understand the City of Puyallup does not and will not assume liability for the sufficiency, suitability, or performance of drainage facilities prepared by me.

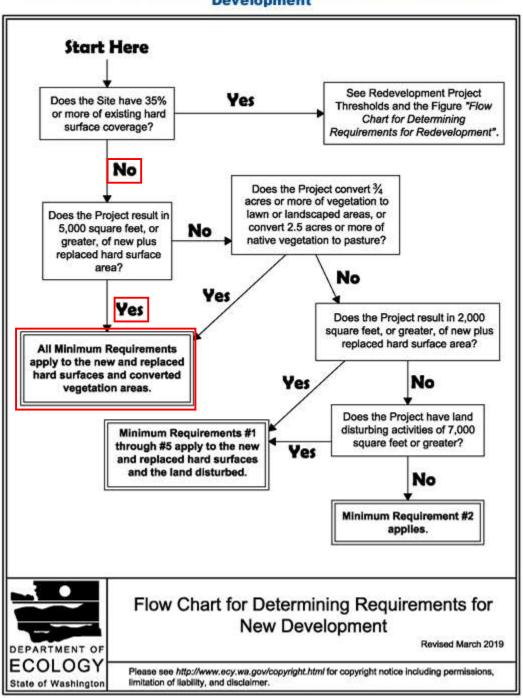
Figure 2: Flow Chart for Determining Requirements for New Development

The project shall comply with the requirements of the 2019 Stormwater Management Manual for Western Washington referred to hereon as 'The Manual', with amendments from City of Puyallup Municipal Code (PMC), Section 21.10. Less than 35% of the site consists of existing impervious coverage, and since more than 5,000 sq. ft. of new impervious surfaces are proposed to be added, minimum requirements 1 through 9 apply. The Washington State Department of Ecology (DOE) flow chart, "Figure I-2.4.1 – Flow Chart for Determining Requirements for New Development," is found in Figure 2 on the following page.

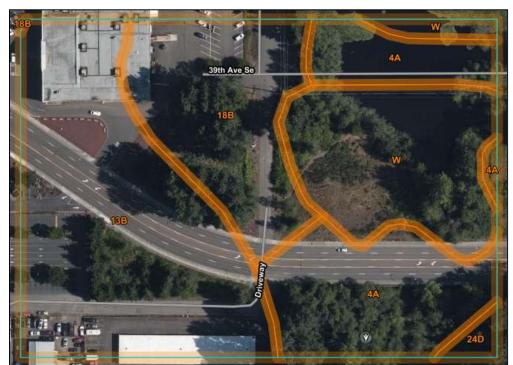
Figure 3: Site Position in NRCS soil mapping (excerpt)

Soil mapping was conducted using the United States Department of Agriculture Natural Resources Conservation Service (NRCS, The Survey) website. The site position within the NRCS soil map is illustrated in Figure 3 below. The soil map for all properties can also be found in the geotechnical report, along with soil descriptions and soil logs, in Appendix D.

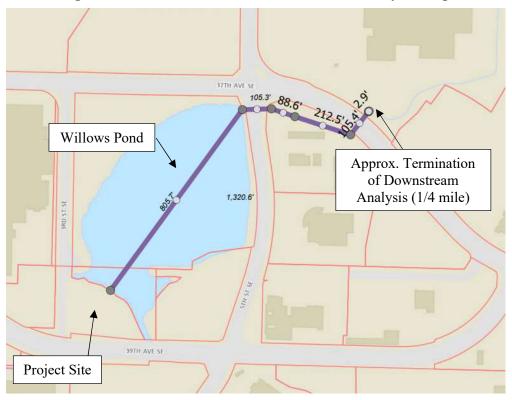
Figure 4: Willows Pond Basin Downstream Analysis Map

• East Willows Pond Basin: The study area for this project extends approximately ¹/₄ mile to a portion of the unnamed stream that is released from Willow's Pond, just north of its crossing under 37th Ave SE. This stream eventually drains into Bradley Lake, then downstream for an unspecified distance (see Figure 4).

A downstream (offsite) analysis has been completed by LS&E for this project. Offsite analysis study area definition maps are shown below. As there are two basins present as part of this project, two downstream analyses were completed.

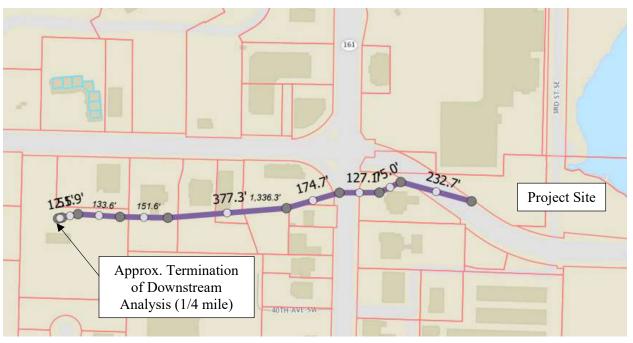
Figure 5: Black Swamp Basin Downstream Analysis Map

• West Black Swamp Basin: For the western portion of the site, there is an existing inlet that collects surface water and conveys it through piping to the west. Eventually the piping discharges into a conveyance ditch to the west of the site, which eventually discharges to the Pierce County Black Swamp Pothole.

No adverse impacts to downstream waters are anticipated as stormwater runoff from new hard surfaces will first be infiltrated through porous pavement before routing to the appropriate basin. These facilities have been sized using the MGSFlood continuous runoff model program.

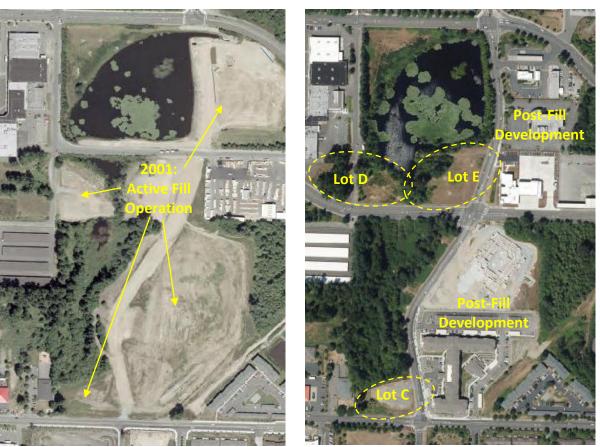
Figure 2: Satellite View of Site (GIS) 2001

2020

An aerial photograph of the site parcels prior to the City's fill project is shown in Figure 1 below. Figure 2 juxtaposes aerial photographs from 1990 (during the fill operation) and the contemporary setting (2020). Dos Lagos Asset, LLC Updated Geotechnical Report – Lot C, D & E Small Scale Pit Infiltration Test – Permeable Pavement Feasibility June 9, 2022, *Revised 9/23/2024* Page 3 of 12

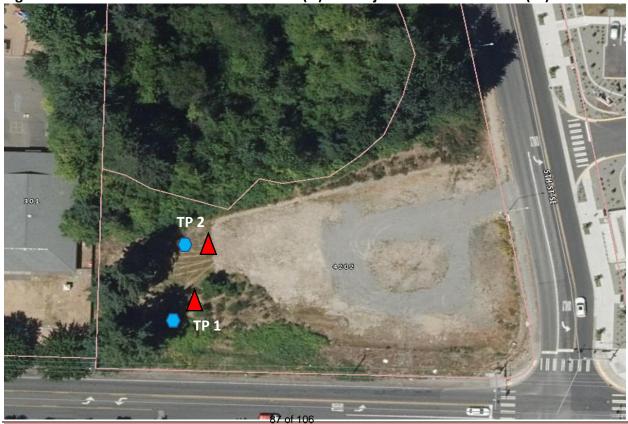
- At the end of soaking period, water was added to the extent to maintain level at 12 inches for 1 hour.
- The volume of water consumed to maintain the level at the same point each time was recorded every 15 minutes. The volume and instantaneous flow rate were determined.

- At 1 hour, water was stopped and the drop rate per inch was recorded every hour until the PIT emptied.
- Finally, a test PIT adjacent to the PIT was excavated to determine if water was mounding laterally. This step is intended for sites with restrictive layers. The practice of adjacent excavation satisfies the requirement to over-excavate the test PIT to examine the groundwater mounding.

Figure 3: Lot-C *Corrected* Infiltration Test PIT () and Adjacent observation PIT () Locations

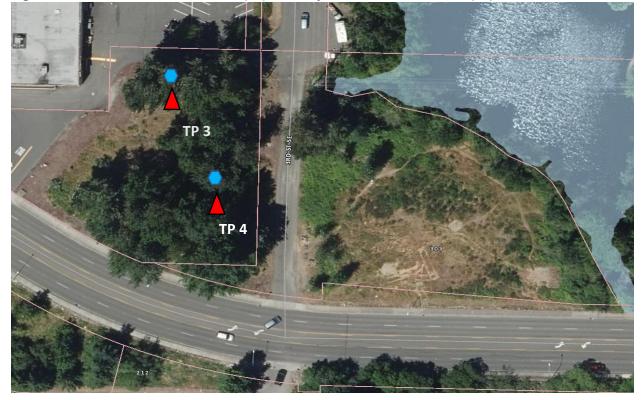
Figure 4: Lot-D Infiltration Test PIT () and Adjacent observation PIT () Locations

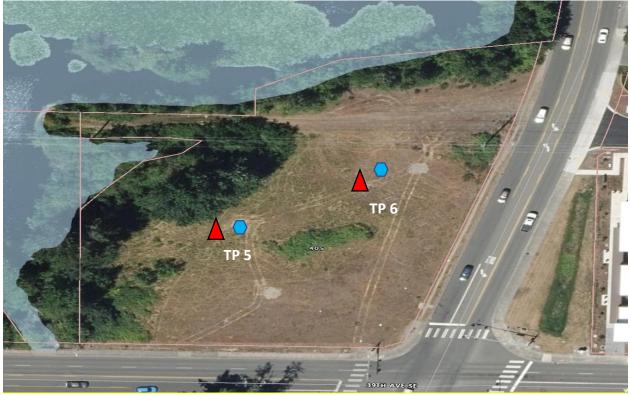
Figure 5: Lot-E Infiltration Test PIT (
) and Adjacent observation PIT (
) Locations

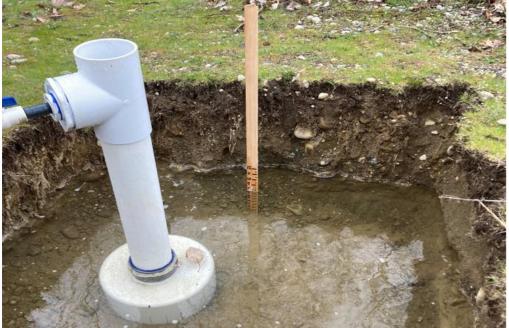
Figure 6: Infiltration Test in Progress PIT 1, Lot C

Figures 6 through 10 provide sampling of the PIT Test photographs.

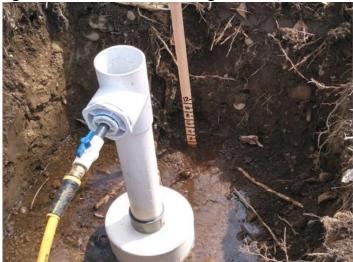
Figure 9: Infiltration Test in Progress PIT 5, Lot E

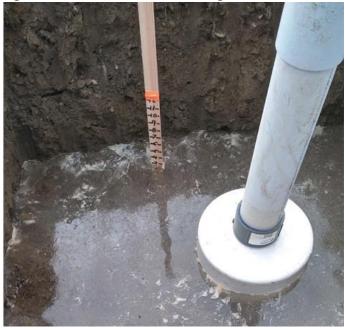
Figure 10: Infiltration Test in Progress PIT 6, Lot E

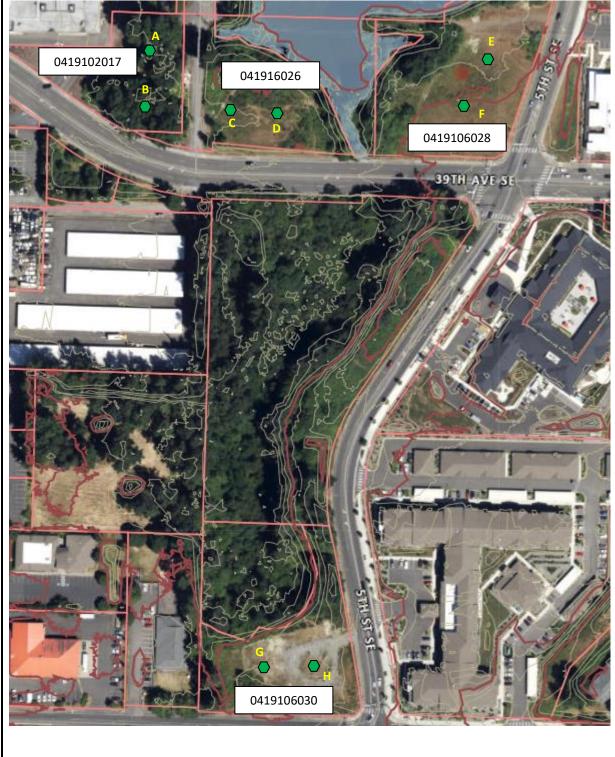
The determination of organic percentage per the ASTM D2974 test method can be used to determine the moisture content, ash content, and percent organic matter in soil. Figure 1 illustrates the test locations over the four parcels.

Figure 1: CEC and Organic Soil Sampling Locations (🔵) and Associated Parcel Numbers
