PRELIMINARY
STORM DRAINAGE REPORT
FOR
SUNSET POINTE

**Sunset Pointe
Puyallup, Washington**

REPORT #04148.7

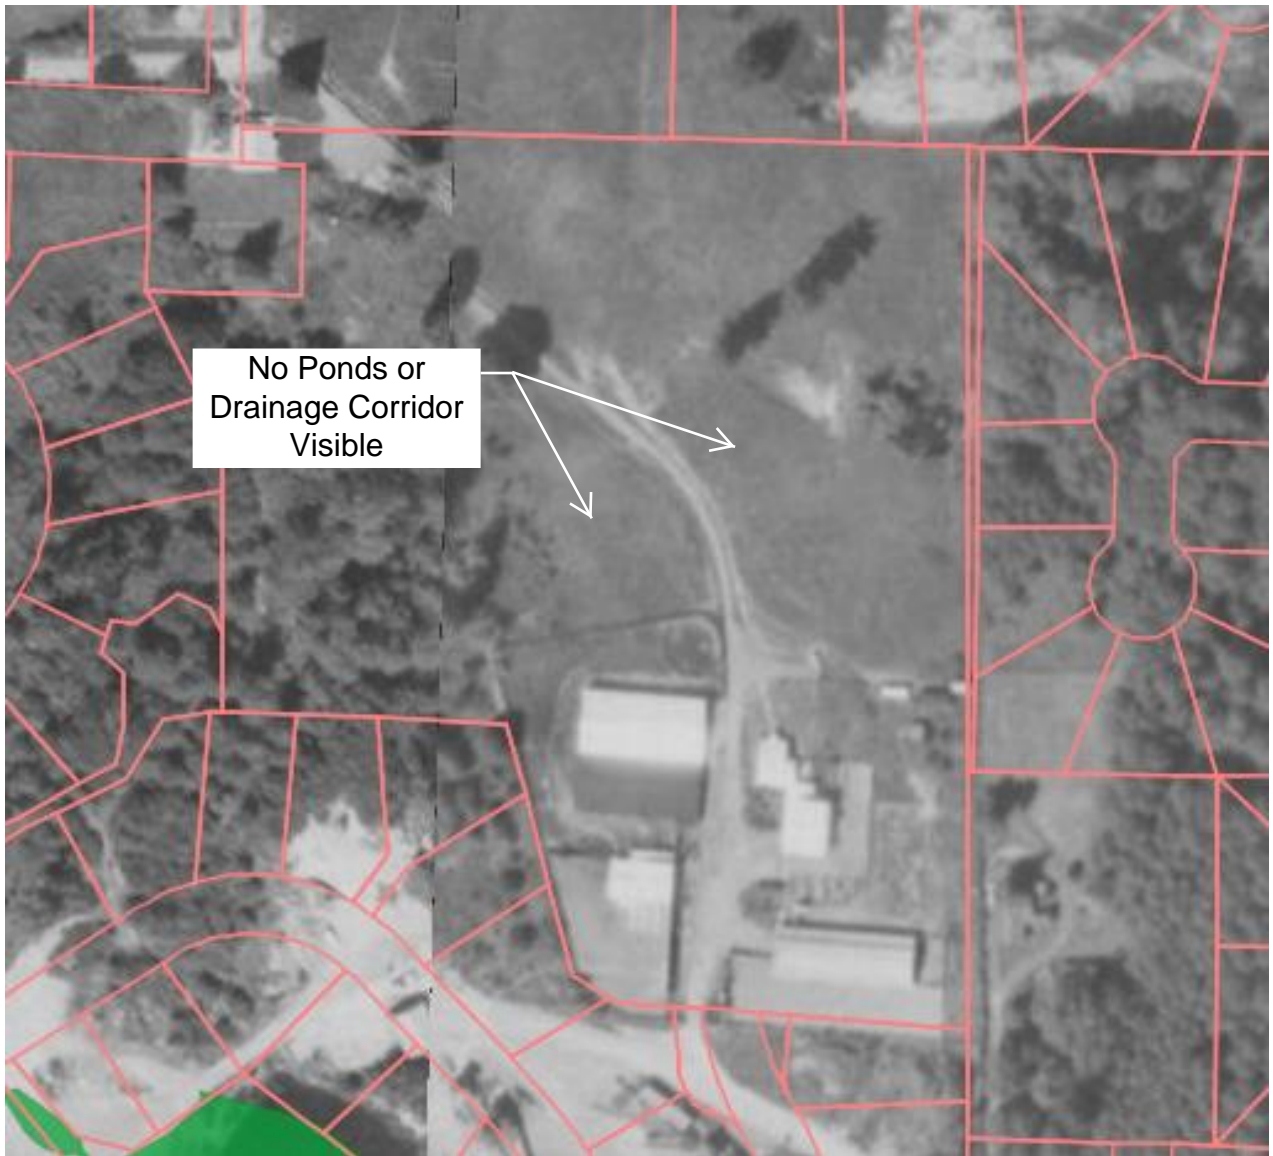
Photo 1: 1970 Aerial photo with no excavated ponds present.

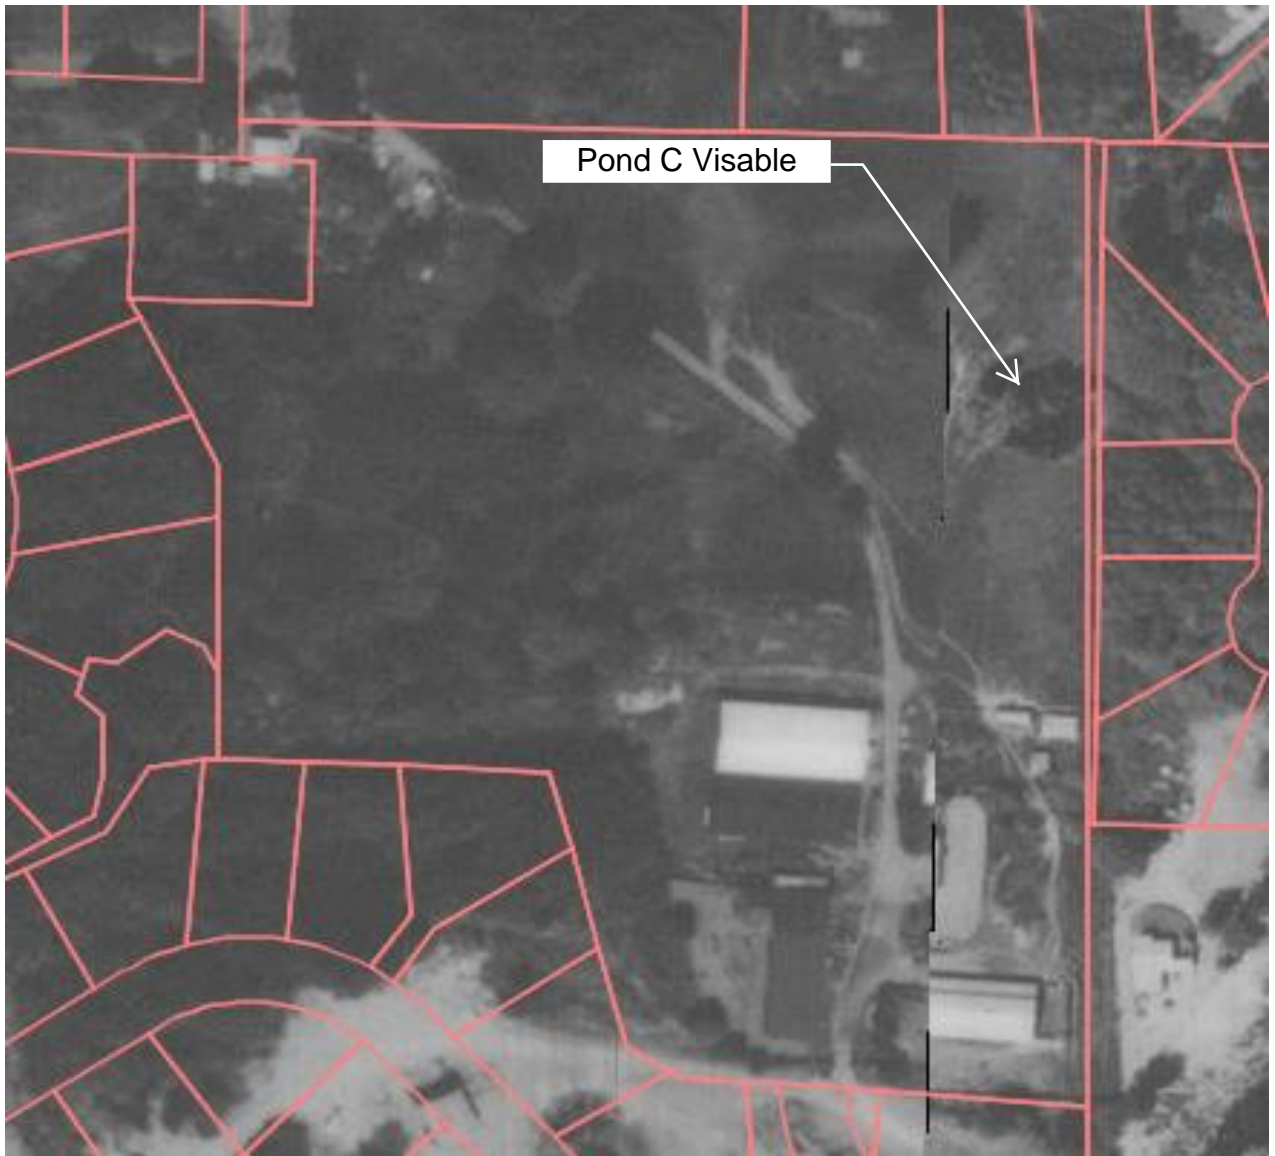
Photo 2: 1985 Aerial photo with eastern most pond no excavated ponds present.

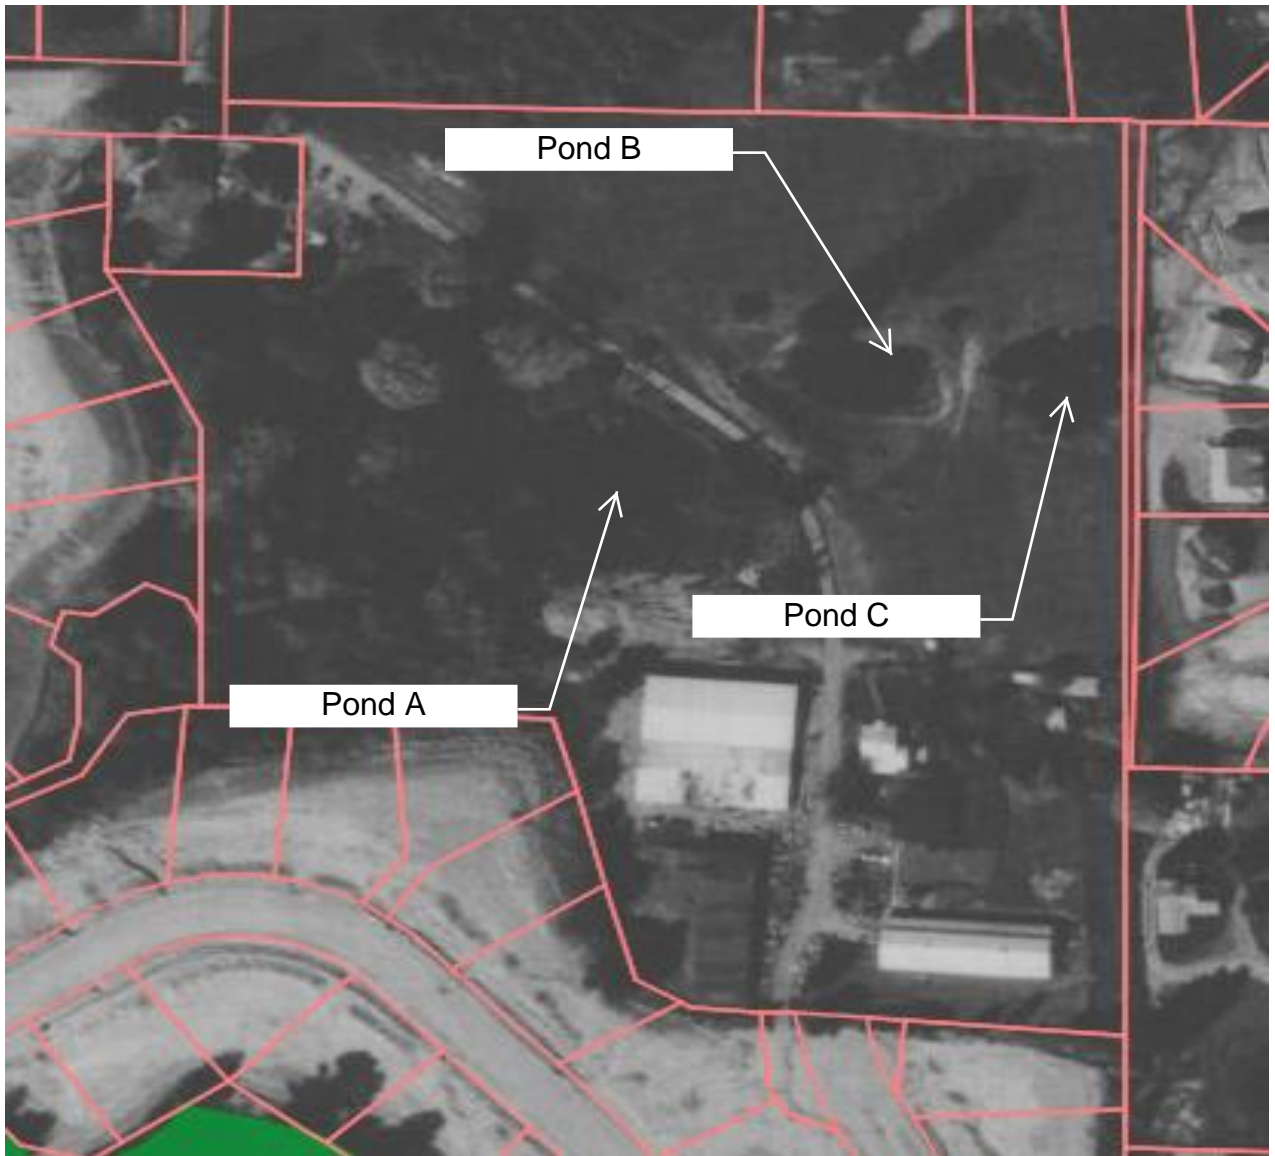
Photo 3: 1995 Aerial photo with three (3) excavated ponds present.

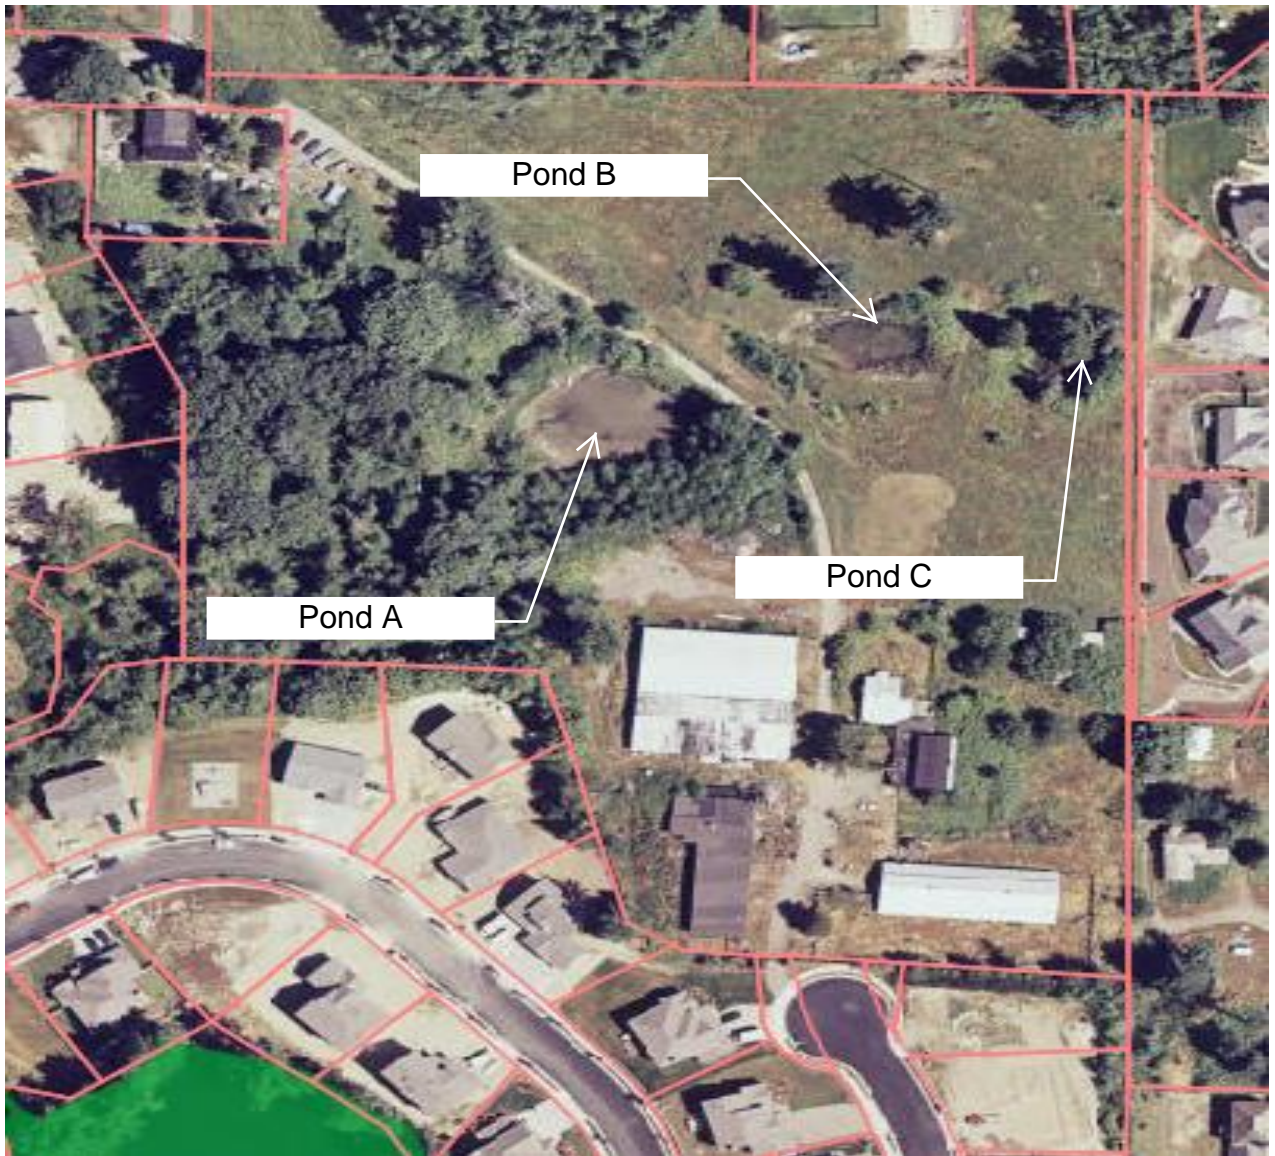
Photo 4: 1998 Aerial photo (color) with three (3) excavated ponds present.
