- Preliminary Tree Protection Plan -

## 43<sup>rd</sup> AVENUE MULTI-FAMILY

701 43<sup>rd</sup> Avenue SW  
Puyallup, WA

Report Date: August 29, 2024

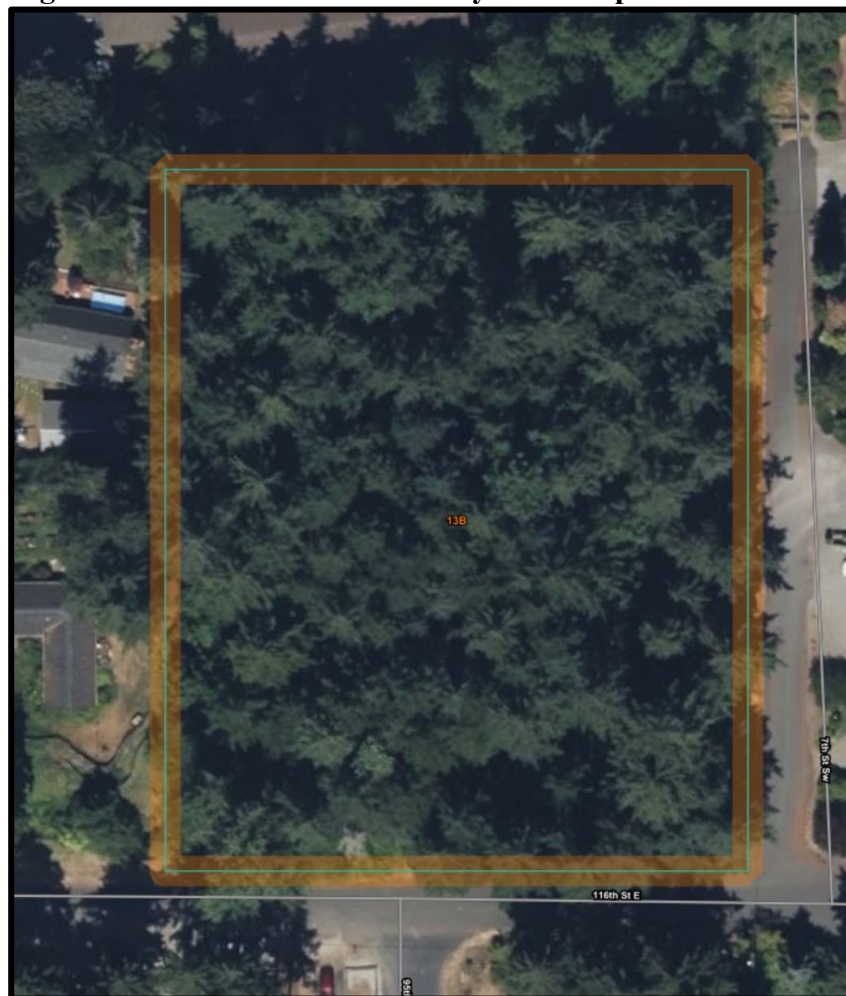
**Figure 1. 43<sup>rd</sup> Avenue Multi-family Soils Map.**

According to the USDA Web Soil Survey, the one soil type on the site is the Everett very sandy loam, a very deep, somewhat excessively drained soil found on terraces and outwash plains. It formed in glacial outwash. Permeability is rapid. Plant available water capacity is low. The effective rooting depth is 60 inches or more and the hazard of runoff and erosion is slight. The potential for windthrow of trees is slight under normal conditions. Seedling mortality is severe and new trees require irrigation to establish.

**13B – Everett very gravelly sandy loam**
