# PRELIMINARY STORMWATER REPORT

## Normandy Heights

2007 Shaw Road  
Puyallup, WA 98374

Our Job No. 12663

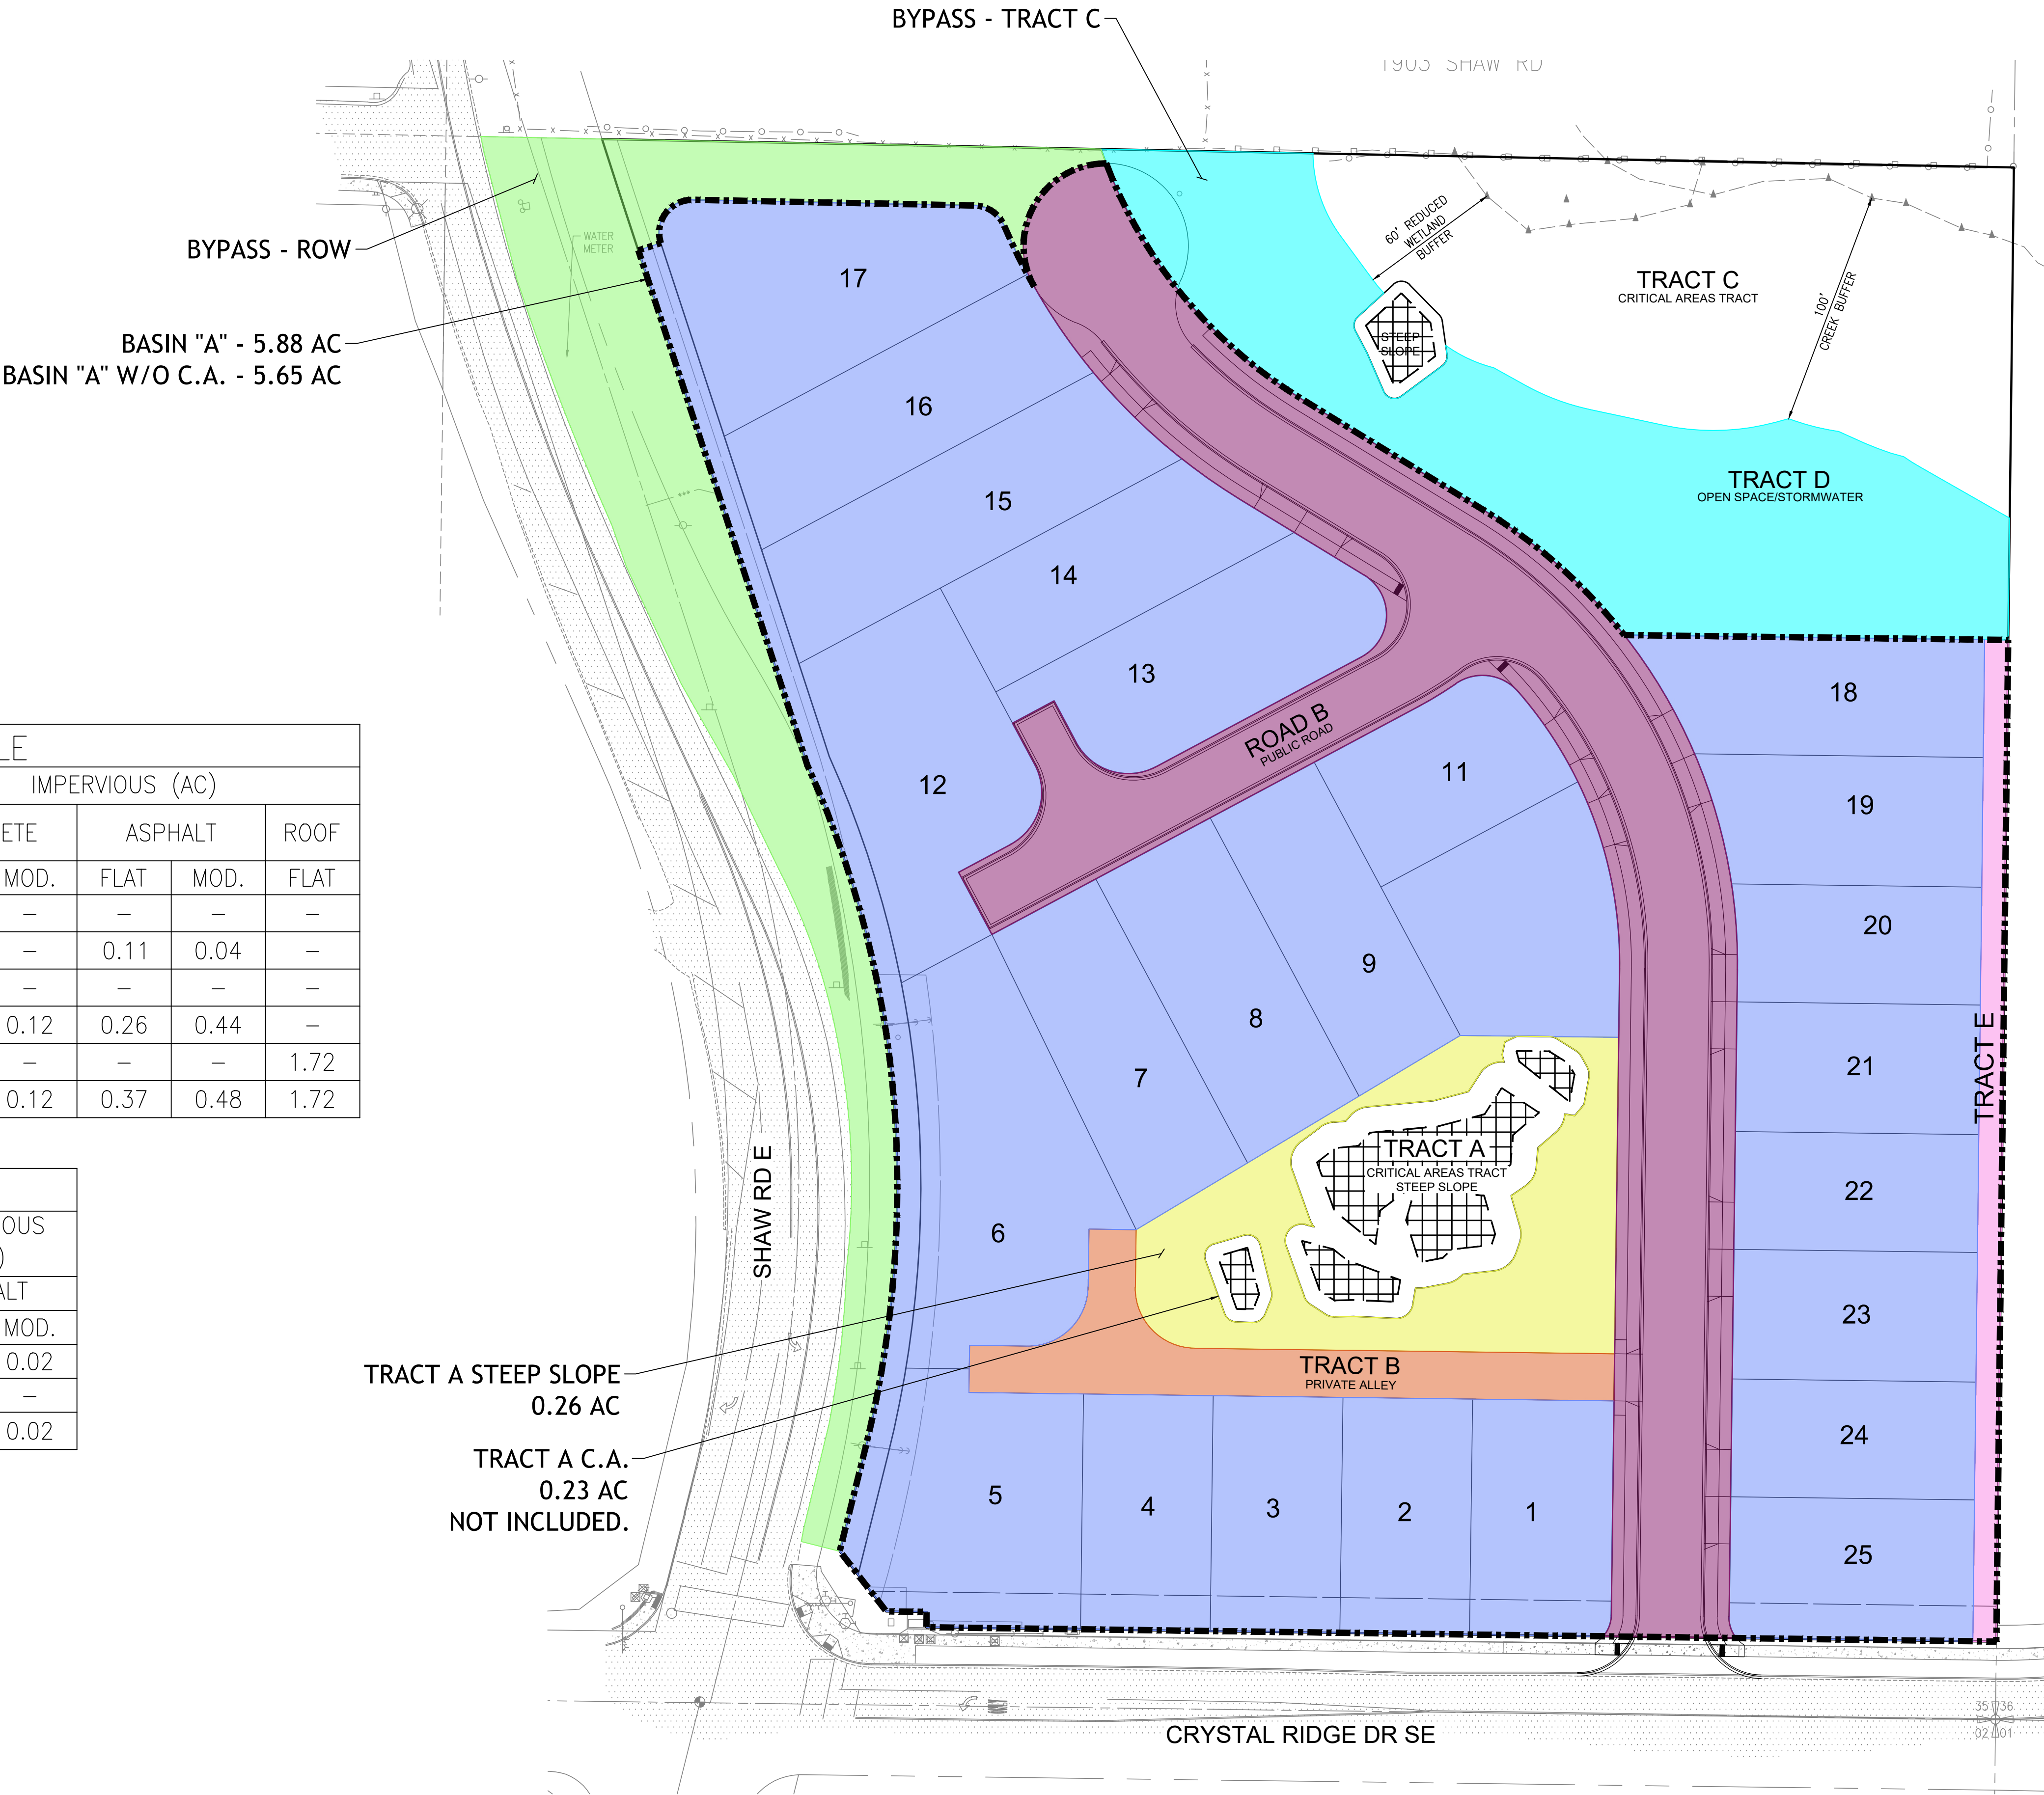
POSTDEVELOPED BASIN MAP EXHIBIT

In order to bypass areas that merge within a quarter mile (not separate TDAs) the detention must be enlarged so the merged discharge meets the flow standard.

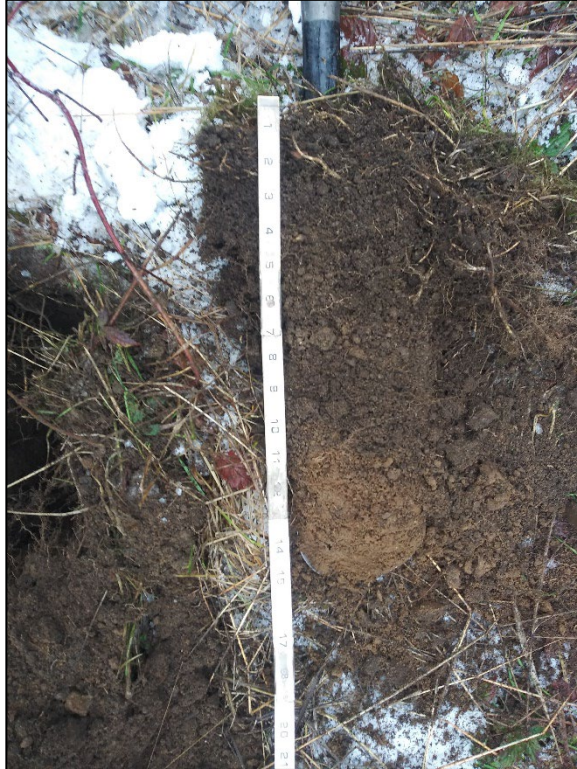
**Photo 5: Soil profile at DP-1.**

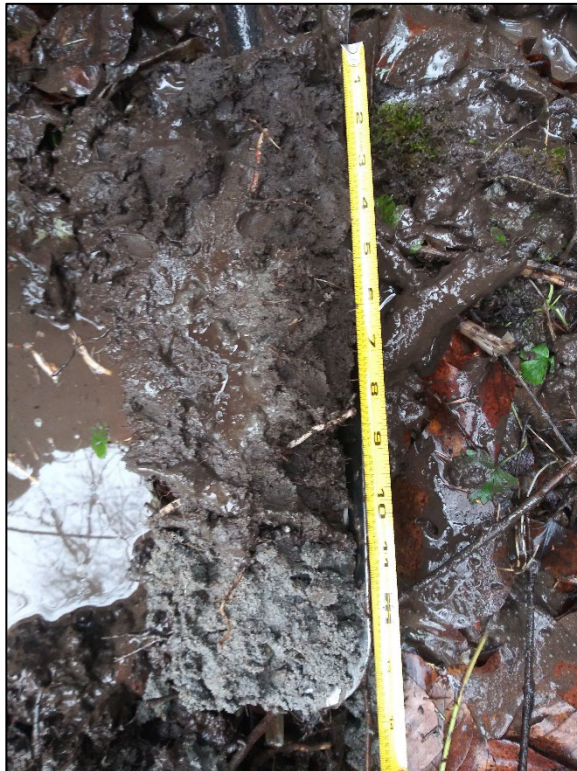
**Photo 6: Soil profile at DP-2.**

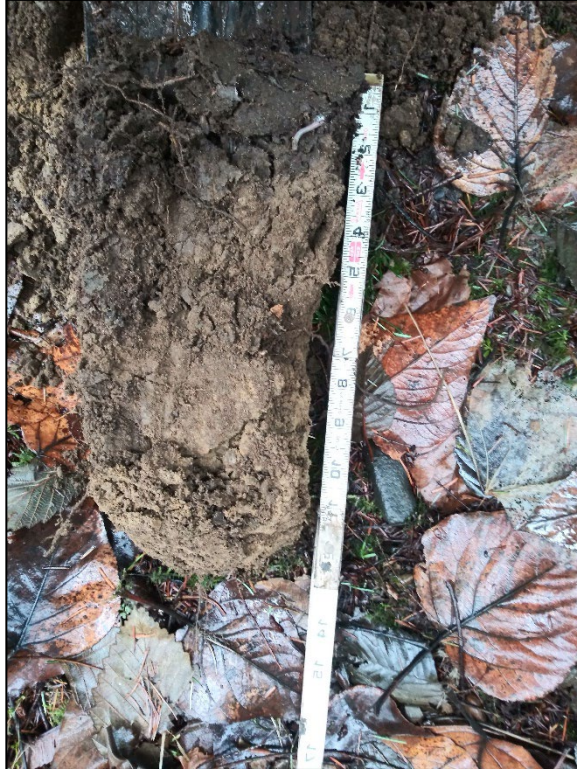
**Photo 7: Soil profile at DP-3**

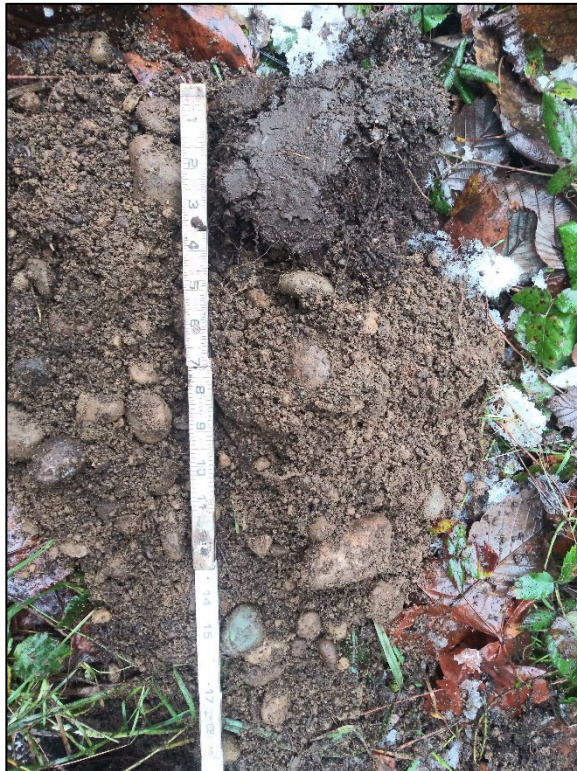
**Photo 8: Soil profile at DP-4.**
