PRELIMINARY STORMWATER REPORT

Normandy Heights

2007 Shaw Road
Puyallup, WA 98374

Our Job No. 12663

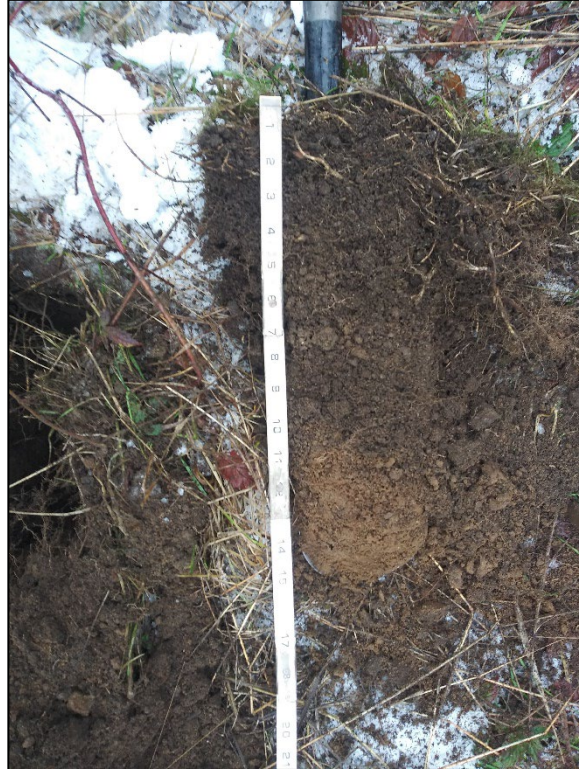
Photo 5: Soil profile at DP-1.

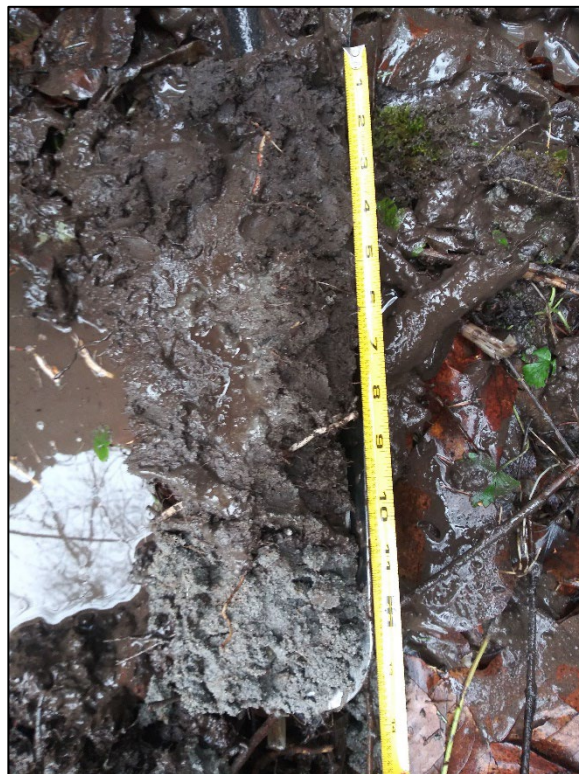
Photo 6: Soil profile at DP-2.

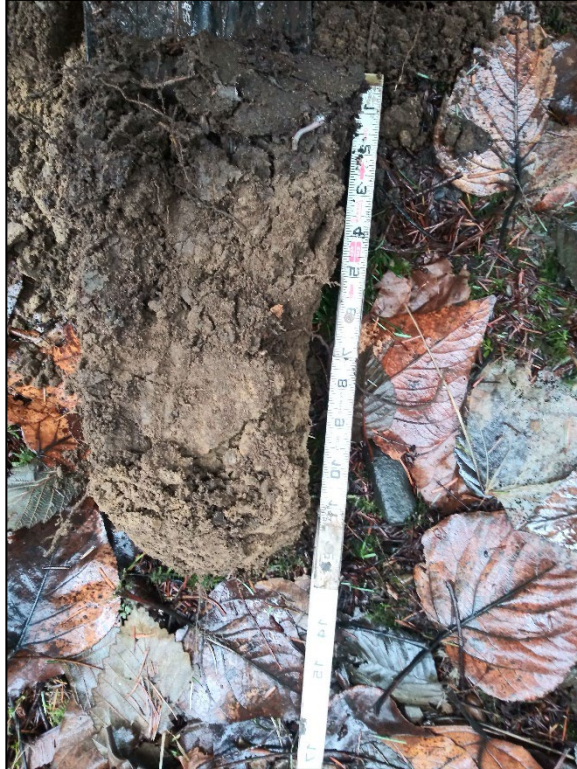
Photo 7: Soil profile at DP-3

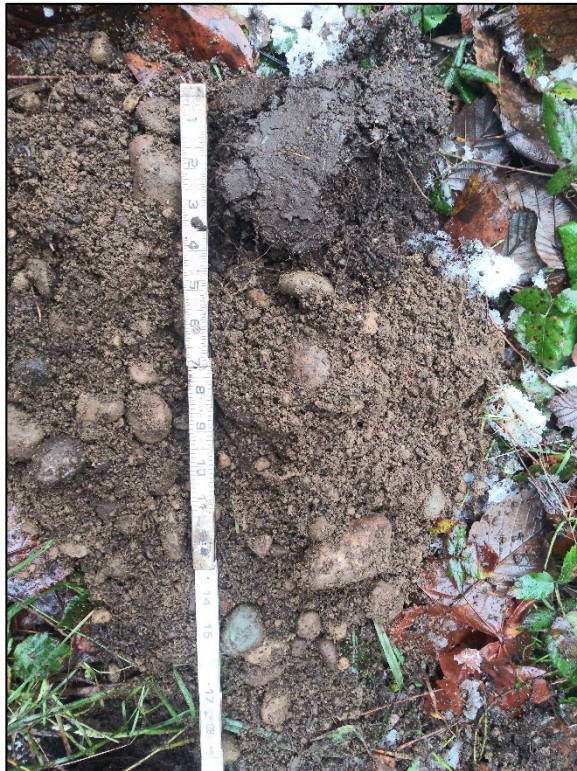
Photo 8: Soil profile at DP-4.

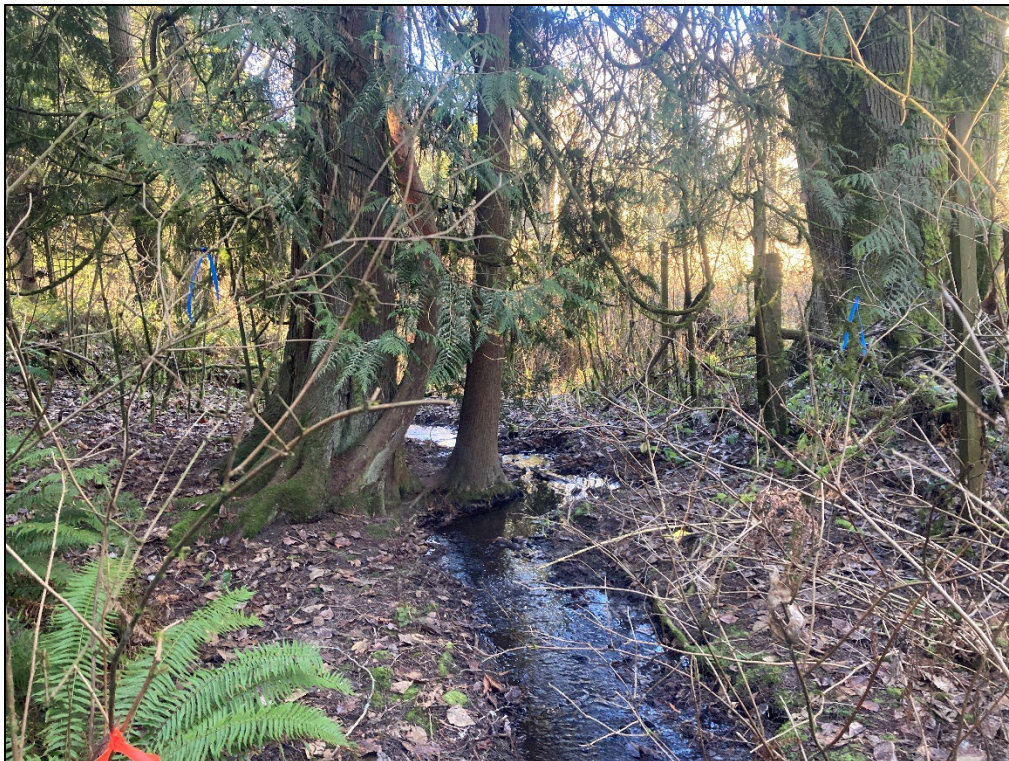
Photo 11: OHWM on either side of Stream Z
