PRELIMINARY
STORM DRAINAGE REPORT
FOR
SUNSET POINTE

**Sunset Pointe
Puyallup, Washington**

REPORT #04148.7

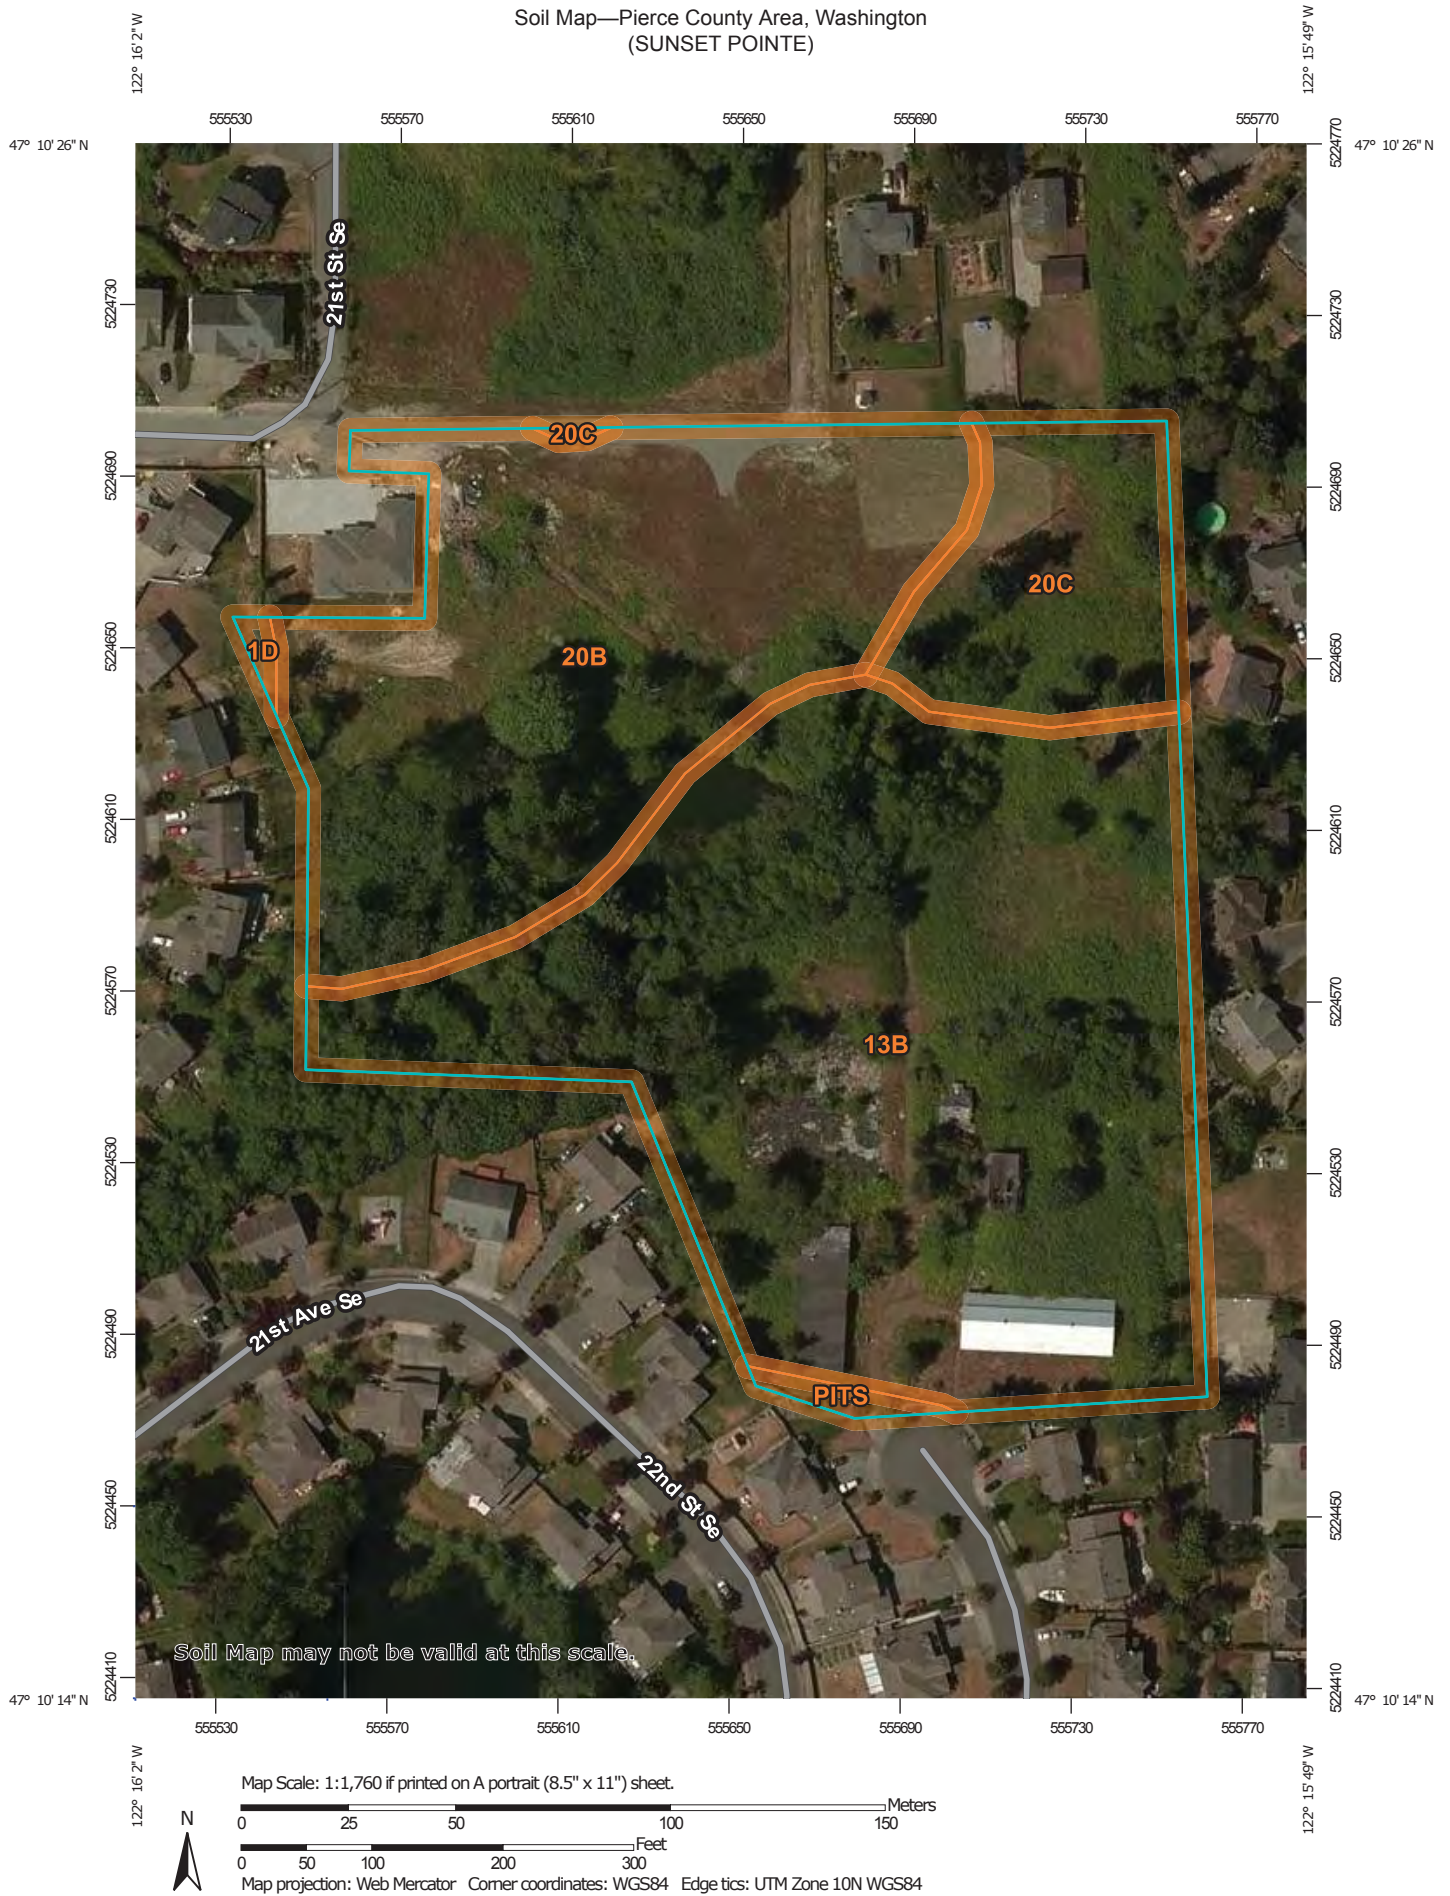
SOILS MAP

Soil Map—Pierce County Area, Washington (SUNSET POINTE)

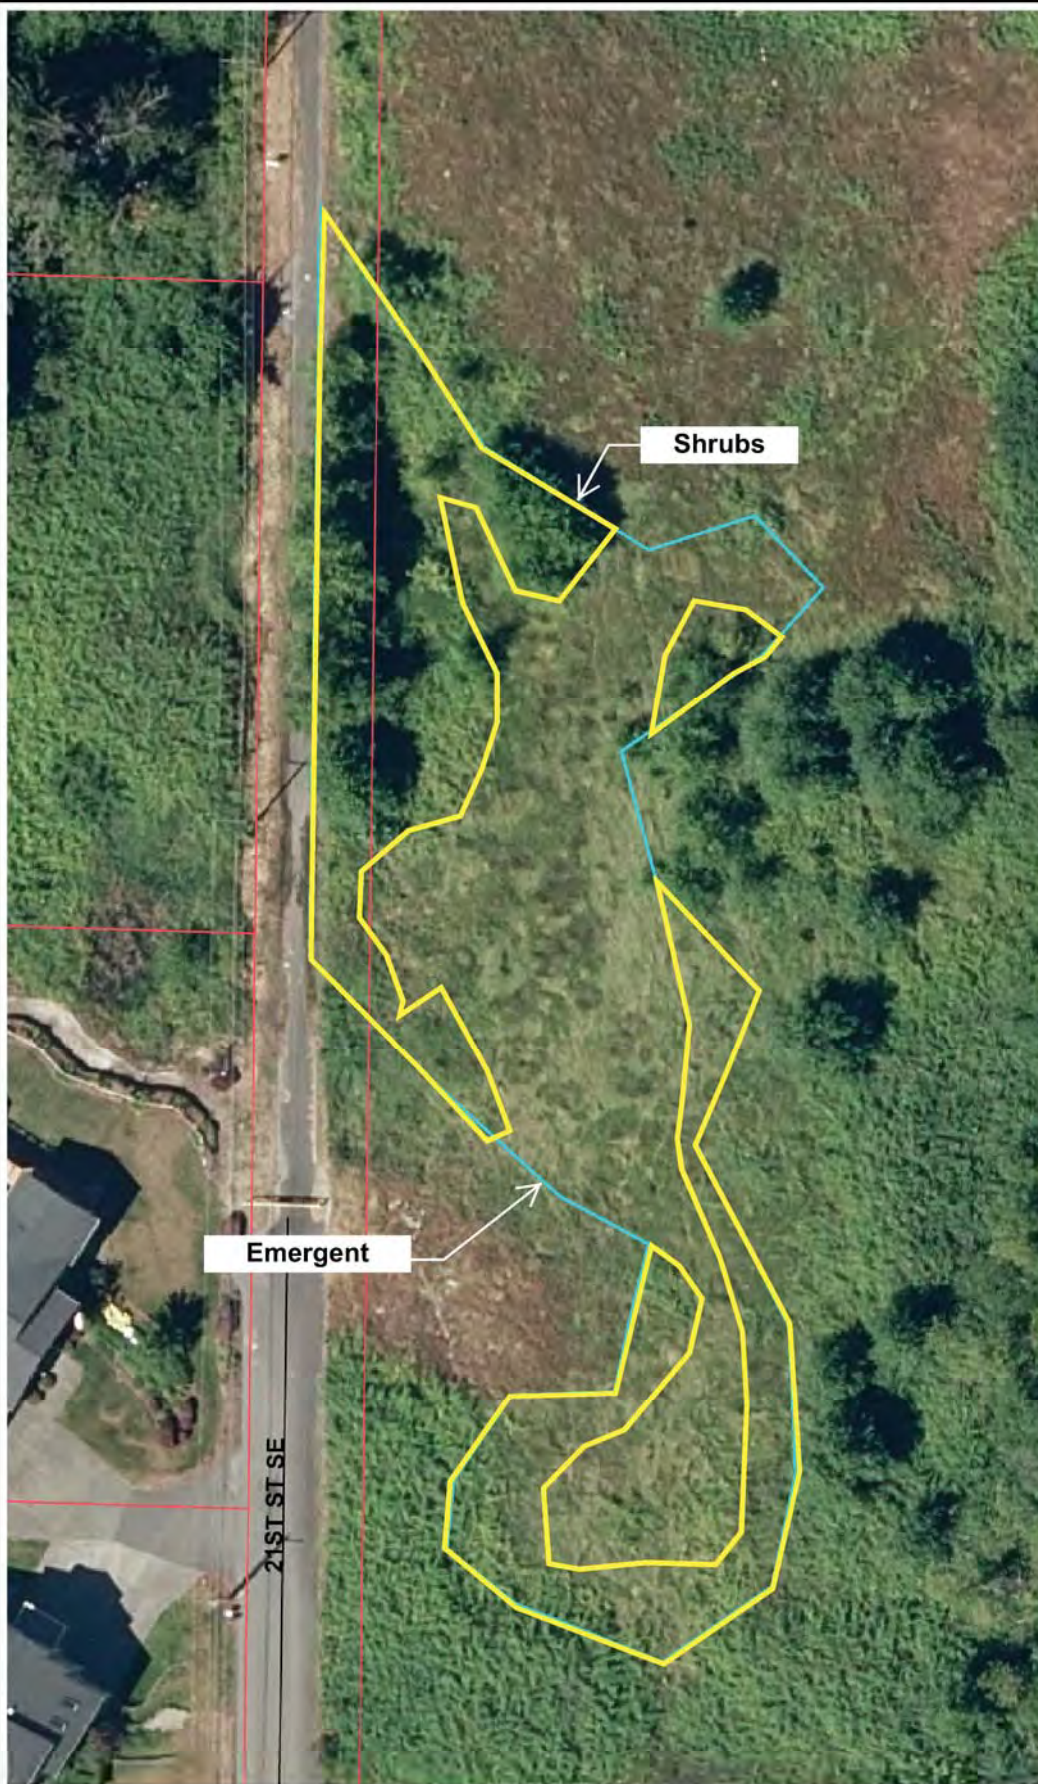
Figure E1

- Wetland E
- Tax Parcels
- ~ Streams - Puyallup
- ~ Drainage - Main Lines
- ~ Roads
- ~ Major Roads
- County - 2014 - Ortho
