**Re: 808 14<sup>th</sup> Street SW: Third-Party Review of Critical Areas Assessment – Biological Evaluation**

This memorandum includes the results from the third-party review of the October 2021 Critical Areas Assessment – Biological Evaluation letter (the letter) created for the Mullan property at 808 14<sup>th</sup> Street SW, Puyallup, WA 98371 (tax parcel number 5505300831) by Habitat Technologies. Confluence Environmental Company (Confluence) biologists reviewed the letter (Habitat Technologies 2021) and conducted a site visit to the project property on March 2, 2022. Site photos from this visit are included in Attachment A. The following sections include our findings and recommendations based on the site visit and our review of the letter.

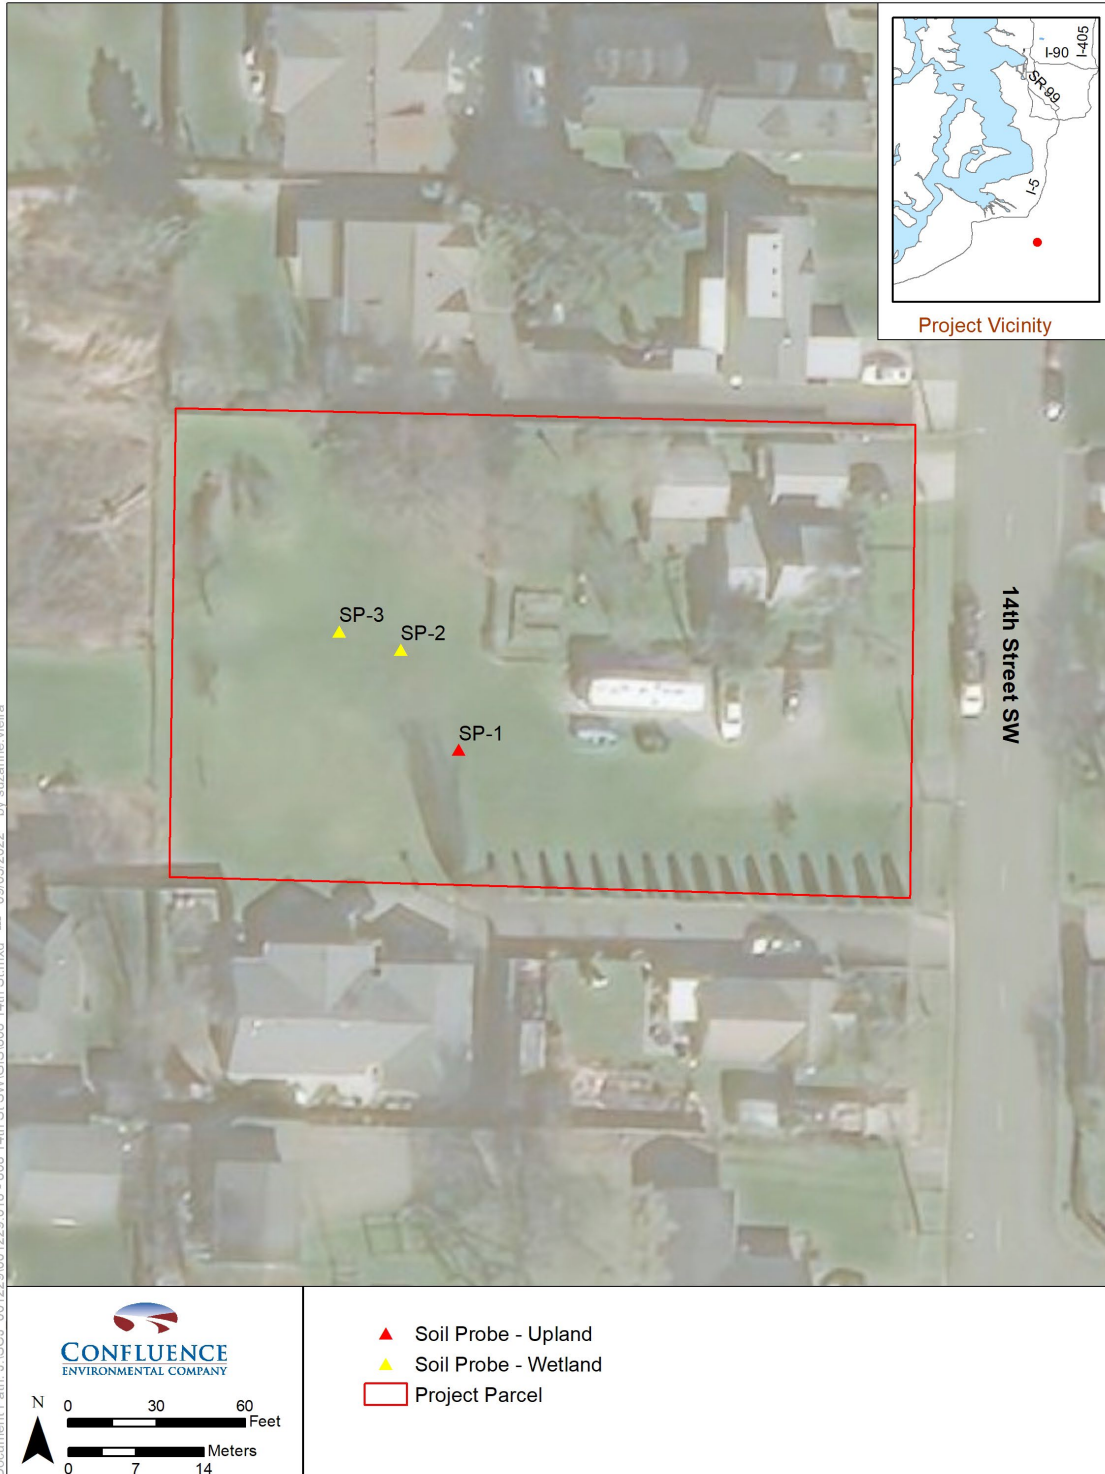
Figure 1. Soil Probe Locations

During the site visit, Confluence biologists observed and noted the soil, hydrology, and vegetation conditions at 3 soil probe locations within the project parcel, as shown in Figure 1.

These sampling locations were based at the central portion of the existing lot in a topographical depression that was flooded.

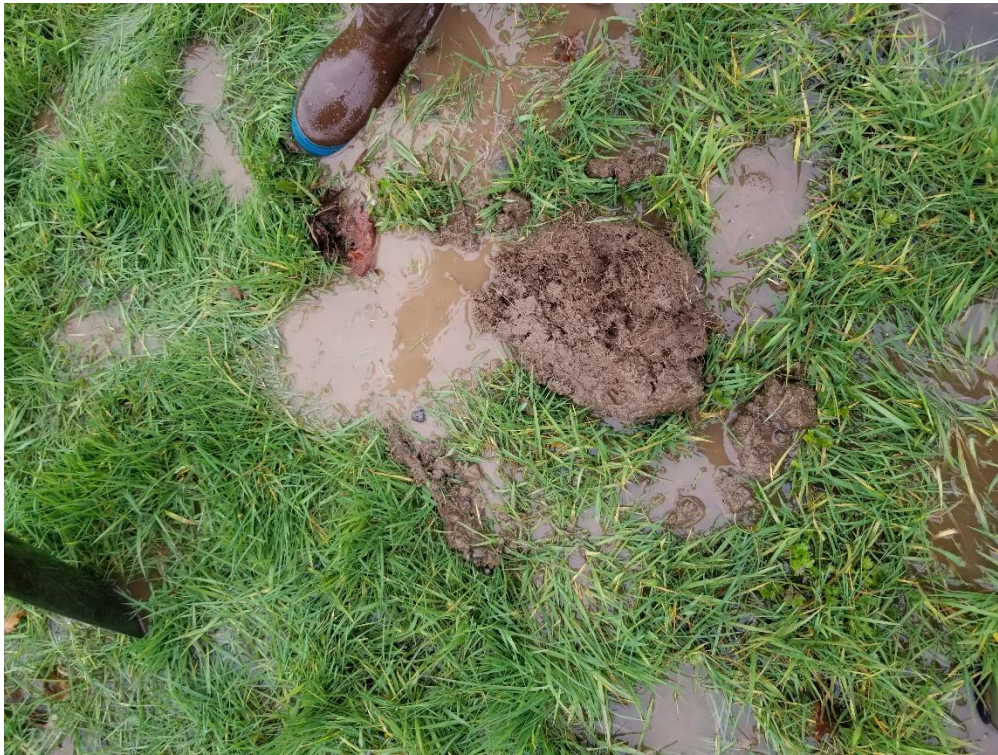
Soil Probe (SP)-1 was located in the central lawn area of the parcel in an area dominated by lawn grasses. The soils were brown (10YR 4/3) with less than 2% redoximorphic features. The water table was observed to the soil surface, and locations immediately adjacent to SP-1 had surface ponding. These findings indicate a lack of hydric soil indicators; therefore, SP-1 is representative of an upland area.

**Photo 1—Soils and hydrology at Soil Probe (SP)-1.**

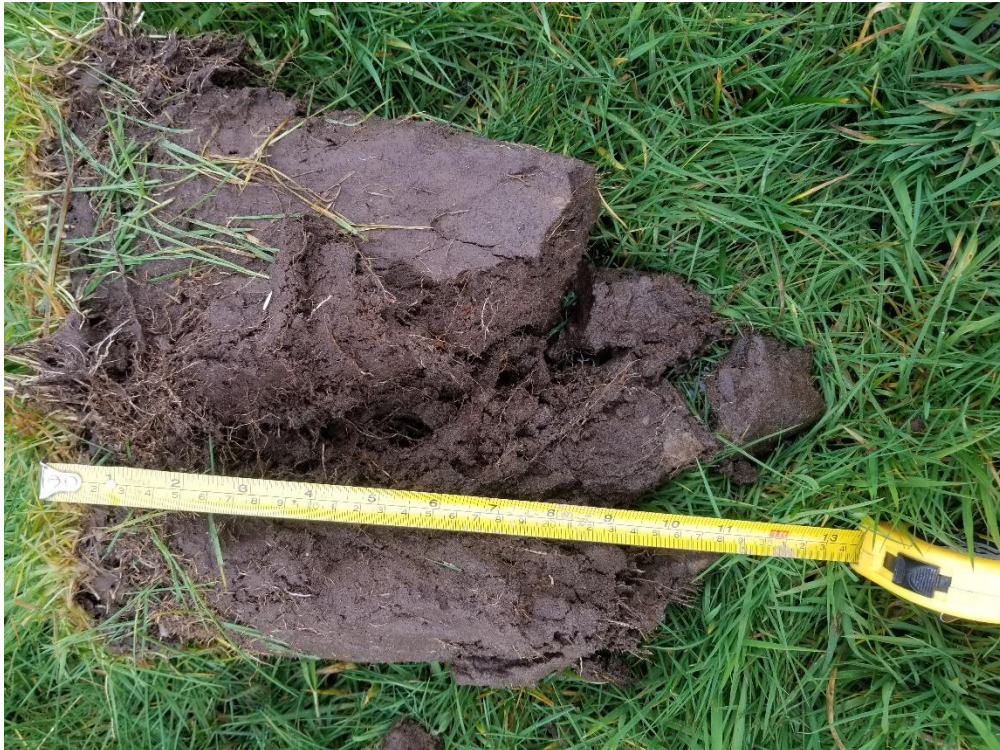
SP-2 was located to the northwest of SP-1 in an area dominated by lawn grasses. The soils were very dark grayish brown (10YR 3/2) with 5% reddish brown (5YR 4/4) redoximorphic concentrations along the pore linings and in the matrix starting at 5 inches from the soil surface. This soil profile meets the requirements for the Redox Dark Surface (F6) hydric soil indicator. The water table was observed to the soil surface, and locations immediately adjacent to SP-2 had surface ponding. Additionally, oxidized rhizospheres along living roots were observed at 4 inches below the soil surface. These findings indicate wetland conditions at SP-2.

**Photo 6—Soil profile at SP-2.**

- Evidence of the presence or absence of wetlands within the vicinity of SP-2 and SP-3, which will require further site evaluation.
- An analysis of any impacts to wetlands and wetland buffers if the presence of wetlands is confirmed.
- All wetland determination forms and a map of all sample plots.
- An updated site plan based on the results of the requested additional field investigation. The site plan may also need to be updated to address floodplain storage concerns.
- Qualifications of persons conducting the work and preparing the report.
- A discussion of design alternatives and additional avoidance and minimization measures, as appropriate.
- Proposed project effects on flood storage capacity and proposed compensatory restoration.
- Proposed impacts to flood storage volume and the compensatory storage proposed to offset project impacts to the floodplain.

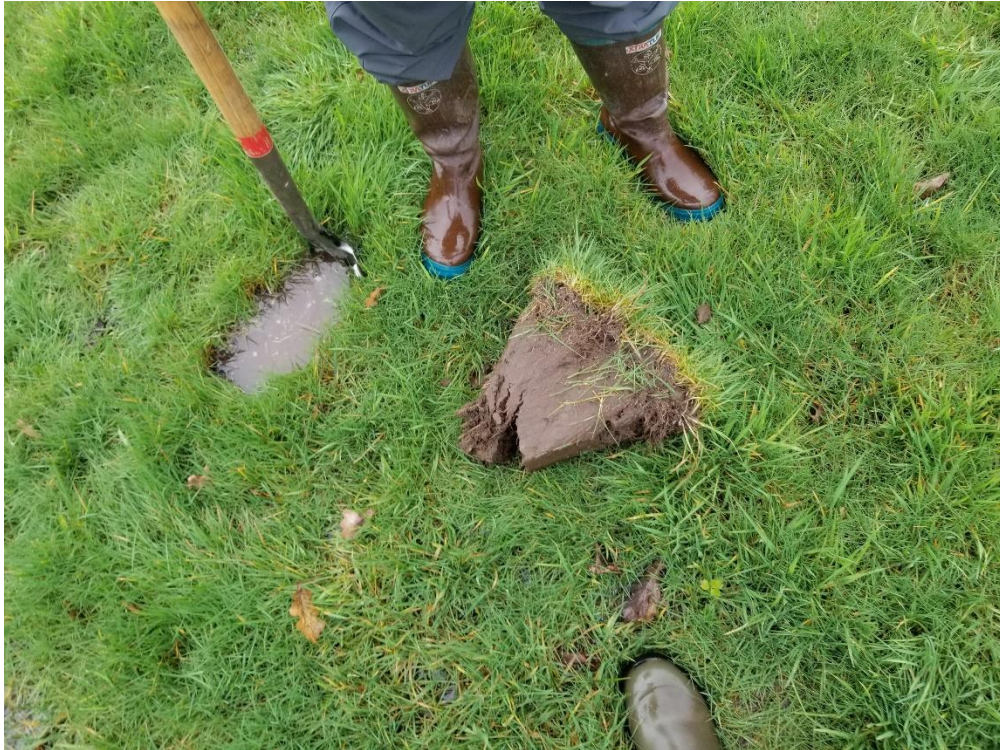
**Photo 7—Soils and hydrology at SP-2.**

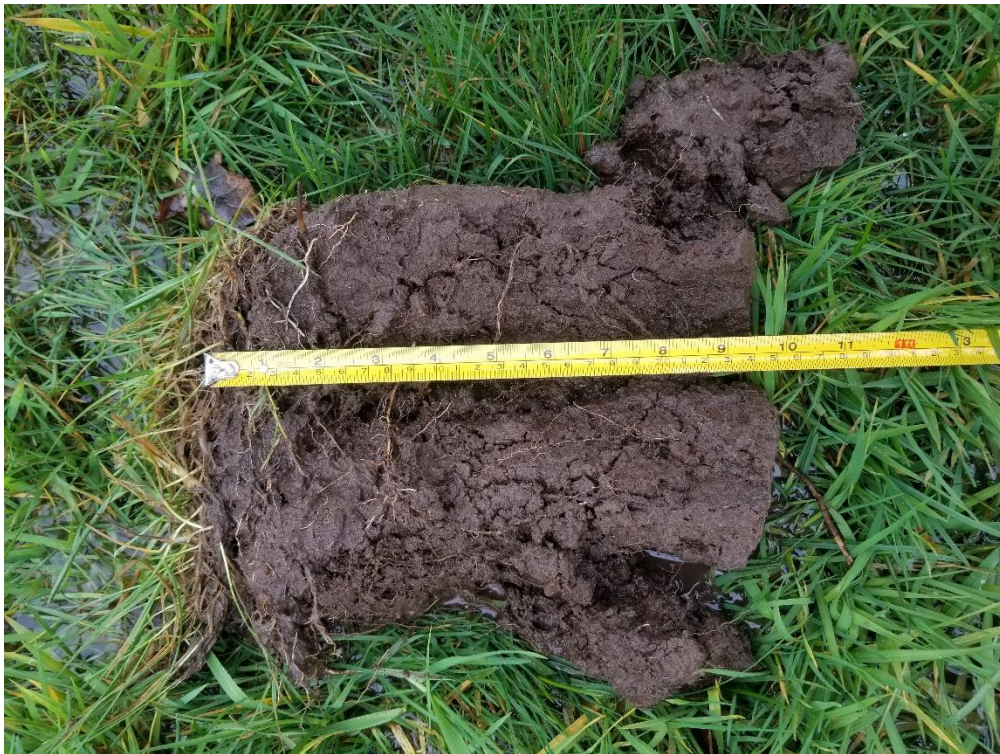
SP-3 was located to the west of SP-2 in an area dominated by lawn grasses and creeping buttercup (*Ranunculus repens*). The soils were very dark grayish brown (10YR 3/2) with 5% reddish brown (5YR 4/4) redoximorphic concentrations in the matrix. This soil profile meets the requirements for the Redox Dark Surface (F6) hydric soil indicator. The water table was observed to the soil surface, and locations immediately adjacent to SP-3 had surface ponding. Additionally, oxidized rhizospheres along living roots were observed at 6 inches below the soil surface. These findings indicate wetland conditions at SP-3.

**Photo 12—Soil profile at SP-3.**

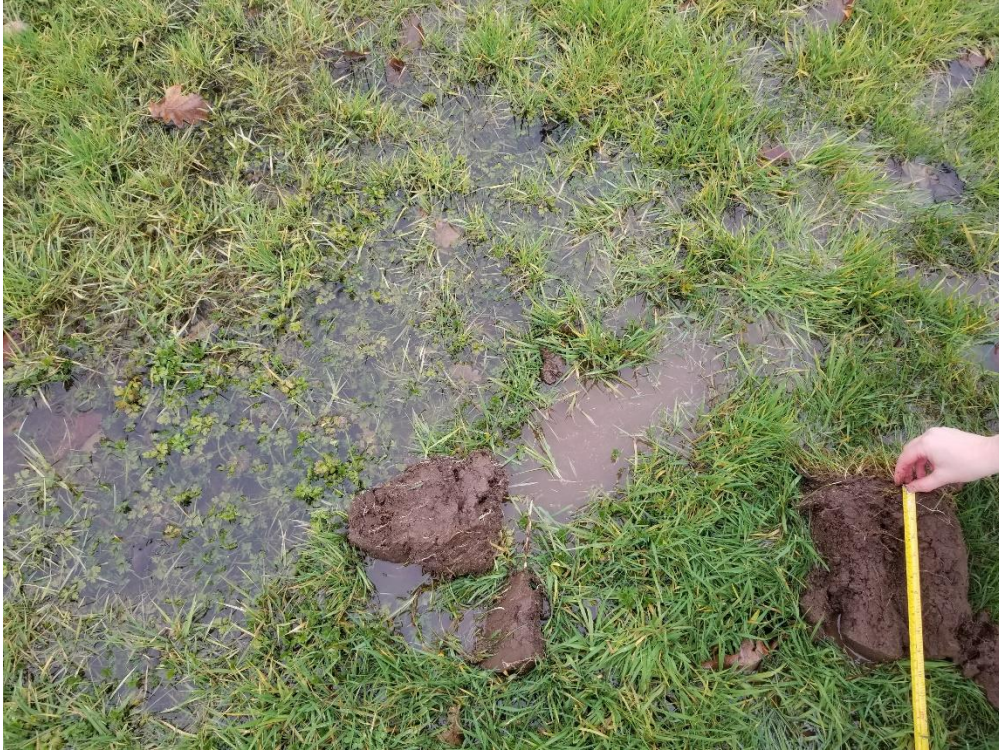
**Photo 13—Hydrology at SP-3.**

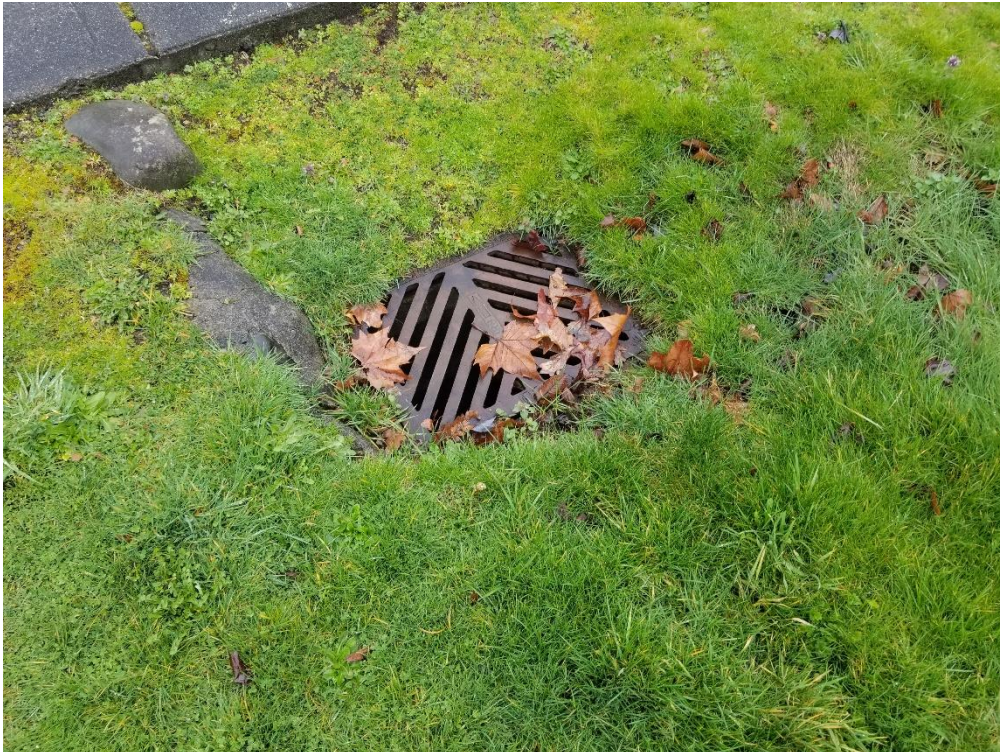
**Photo 20—Catch basin inlet near 14<sup>th</sup> Street SW.**
