## TECHNICAL MEMORANDUM

File No.: 6156.001

Re: Aliza Property – Feasibility Assessment

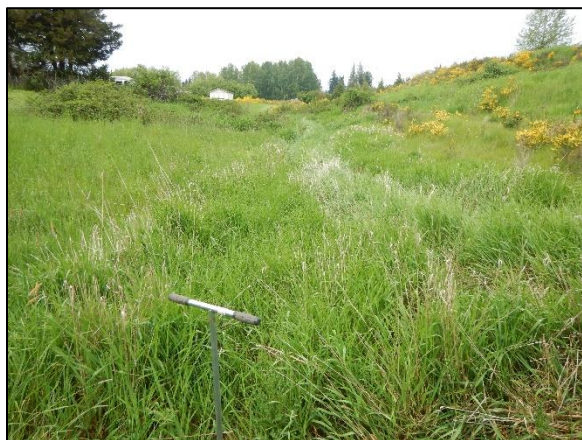
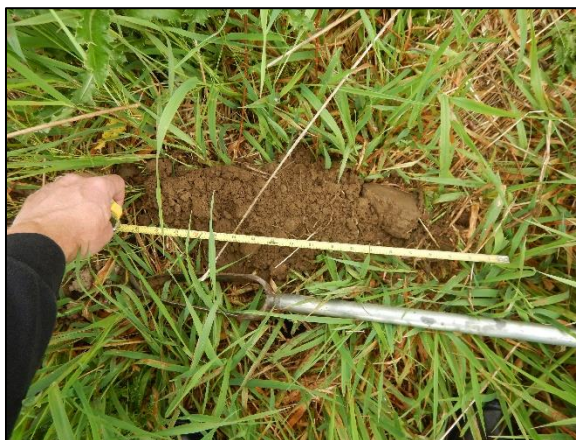
**Figure 2. General Conditions – Investigated Area**

During the site assessment, Grette Associates identified a large stockpile mound that appears to be the spoils excavated during the construction of the neighboring Costco development and the construction of the large offsite storm pond situated north of the subject property. The stockpile mound occupies a significant portion of the subject property (see Attachment G, Topographic Survey prepared by Sitts & Hill Engineers (May 2022)).

In addition to the stockpile mound, Grette Associates identified a shallow depressional area located in the southeast portion of the subject property adjacent to the stockpile mound. Grette Associates collected wetland delineation data within the central portion of the shallow depressional area where vegetation suggests potential wetland conditions may be present (Figure 2). Conditions were evaluated according to the criteria defined in the USACE's *Manual* (1987) and the USACE's *Regional Supplement* (2010). See Field Datasheet, Attachment H).

The depressional area predominantly consisted of reed canarygrass (*Phalaris arundinacea*), which meets the wetland criteria for hydrophytic vegetation. Soil conditions observed in this area consisted of an upper soil layer (0-8 inches) of very dark grayish brown (10YR3/2) gravelly loam with a layer (8-19 inches) of very dark grayish brown (10YR3/2) gravelly loam containing approximately five percent strong brown redox concentrations beneath. These soil conditions meet the *Redox Dark Surface* hydric soil indicator. No indicators of wetland hydrology were observed in the depressional area and soils were observed dry to a depth of approximately 19 inches.

In summary, the shallow depressional area did not meet all three wetland criteria defined in the USACE's *Regional Supplement* (2010). In addition, Grette Associates did not identify any natural water features within the subject property, including the area where WDNR maps a Type F stream.

Based on Grette Associates' observations, it appears that the area where vegetation suggests potential wetland conditions may be present is a manmade depressional area intended to manage stormwater that falls within the subject property and that these conditions have likely established due to the previous grading and fill activities and the lack of regular site maintenance.

during site preparation. Based on Grette Associates' observations it appears that the areas along the margins of the stockpile mound were graded to prevent stormwater from flowing towards the adjacent stormwater pond and to offsite areas once stockpiling was finished. The depressional area identified in the southeast portion of the subject property adjacent to the stockpile mound appears to have been graded to intercept any surface stormwater that falls on the stockpile mound and to prevent it from flowing offsite onto neighboring properties.

Although the depressional area contains wetland vegetation and hydric soil indicators, no primary wetland hydrology indicators (e.g., surface water, shallow groundwater table, soil saturation) were observed. According to climate data collected at the Seattle-Tacoma Weather Station (Station No. 457473)<sup>1</sup>, May received approximately 3.82 inches of rainfall which is approximately 200 percent above the average precipitation (1.88 inches) that occurs in a normal May. Given the absence of surface water, shallow groundwater table, or soil saturation in a period with abnormally wet conditions, it is Grette Associates' professional opinion that the vegetation and soil conditions observed are artificially supported by stormwater runoff associated with previous grading activities and that the depressional area is not wetland given the absence of necessary supporting hydrology.

In addition, Grette Associates observed recent tracks through the central portion of the depressional area that appear to be associated with the work truck(s) accessing installed monitoring wells that were placed within the subject property approximately a month ago. No indication such as ruts or muddy vegetation were observed to suggest this area is supported by shallow groundwater.

In conclusion, based on the information summarized above, it is Grette Associates' professional opinion that the depressional area adjacent to the stockpile mound is a manmade feature that was constructed to manage surface stormwater runoff after stockpiling was completed and that the vegetation and hydric soil indicators observed have established as a result of the previous grading and fill activities. In summary, no wetland areas (USACE 2010) or natural waters (PMC 21.06.210) are located within Parcel B.
