## **Location and Existing Conditions**

## **Methodology**

## Existing Documentation

This *Preliminary Soils Report* summarizes our site observations and geotechnical data review, and addresses the feasibility of stormwater infiltration for the proposed restaurant to be constructed at 1115 and 1129 East Main in Puyallup, Washington. The approximate site location is shown on Figure 1.

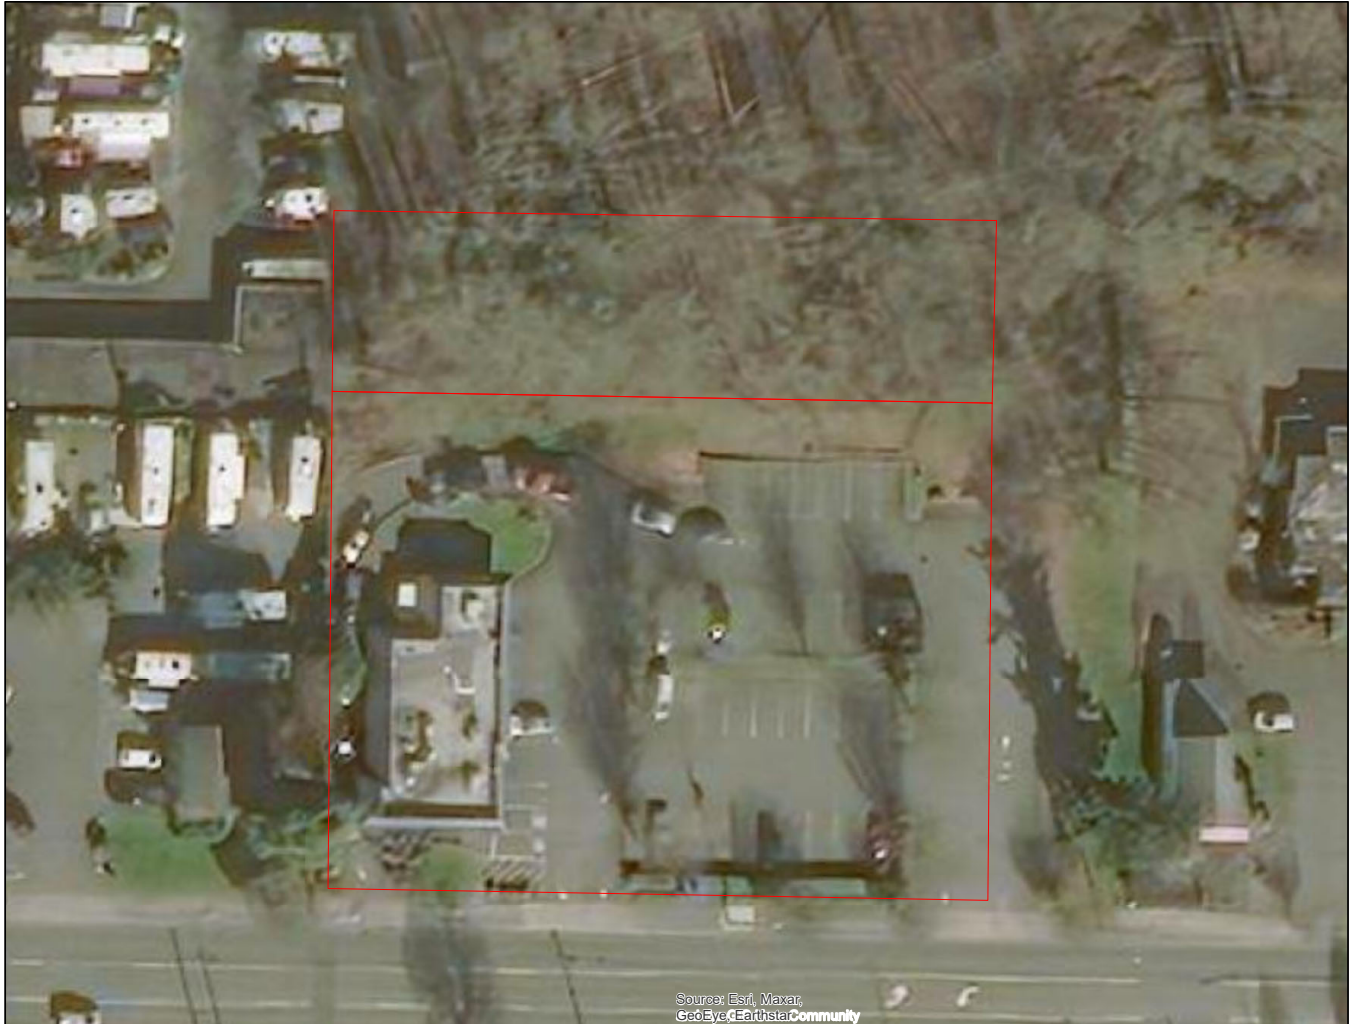
Figure 2. Existing condition

This site is rectangular, approximately 59,507 sq. ft. The southern parcel is developed to a restaurant, and the northern parcel is vacant and currently undeveloped. Commercial parcels occur east, west, and south of the site. The site is bounded on the north by the riparian corridor of the Puyallup River.

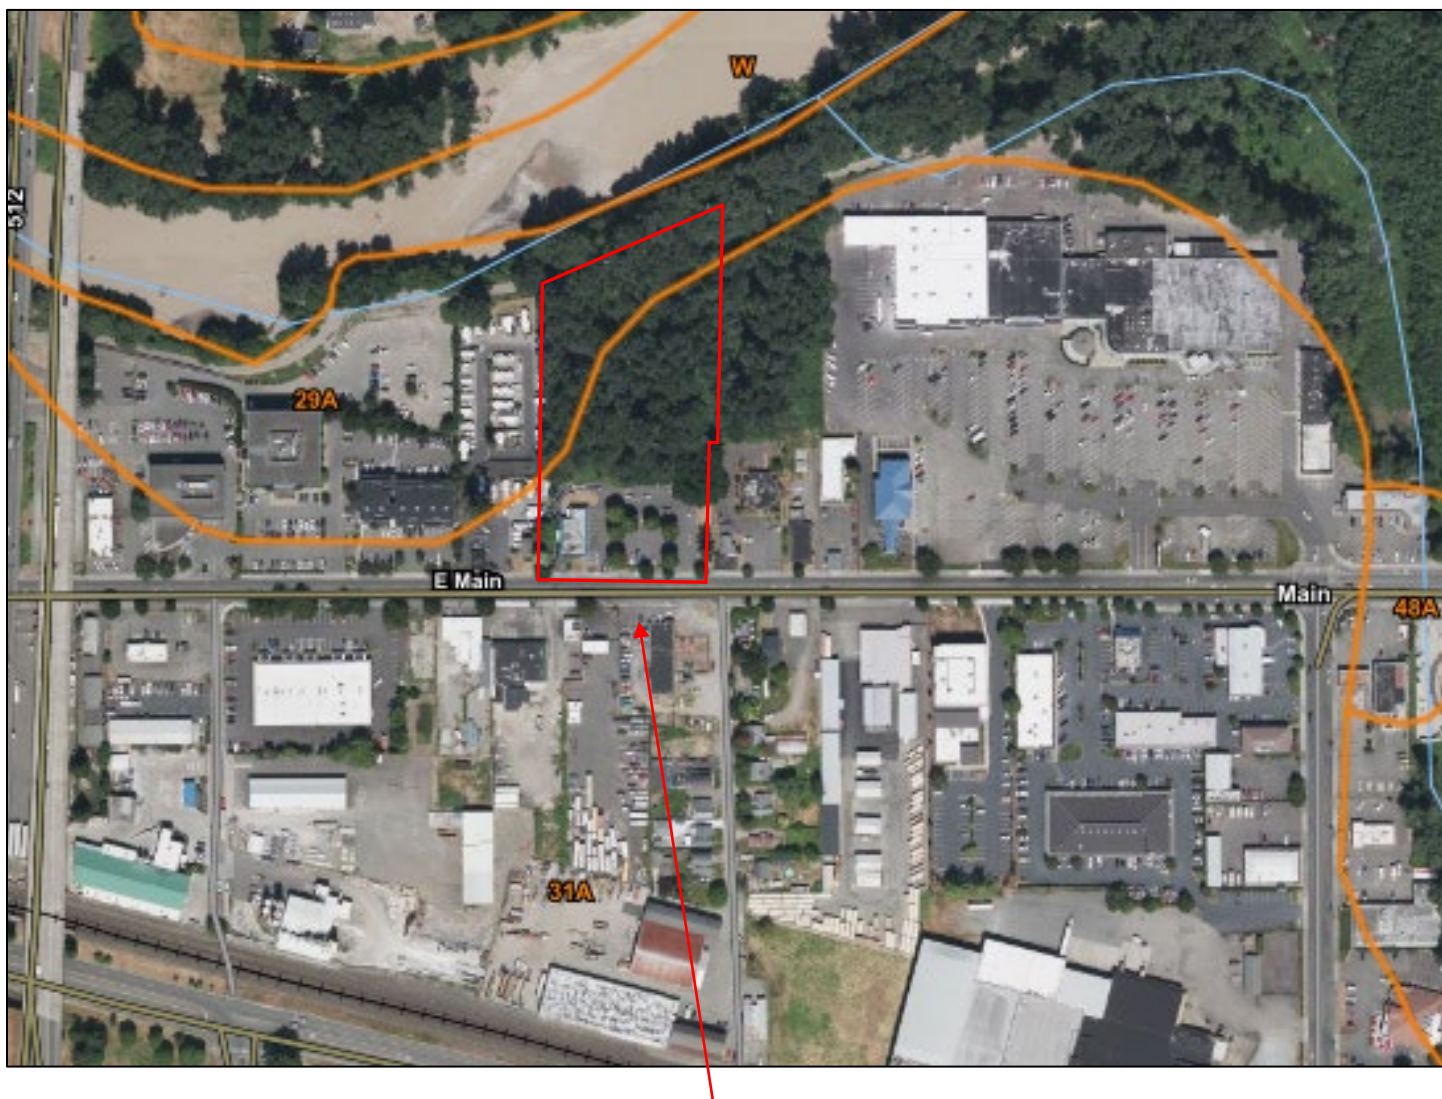
Figure 3

The Natural Resource Conservation Service (NRCS) Web Soil Survey maps the site as being underlain by Pilchuck fine sandy loam (29A) and Puyallup sandy loam (31A). The Pilchuck soils are mapped across the northern portion of the site, are derived from mixed alluvium under hardwoods and conifers, form on slopes of less than 3 percent, have a "none" erosion hazard when exposed, and are included in hydrologic soils group C. The Puyallup fine sandy loam soils are mapped across the southern portion of the site, are derived from alluvium, form on slopes of 0 to 3 percent, have a

“slight” erosion hazard when exposed, and are included in hydrologic soils group A. A copy of the NRCS soils map is included as Figure 3.
