PRELIMINARY STORMWATER SITE PLAN

Mullan Short Plat
808 14th Street S.W.
Puyallup, Washington 98371

City File No. P-21-0067

September 12, 2022

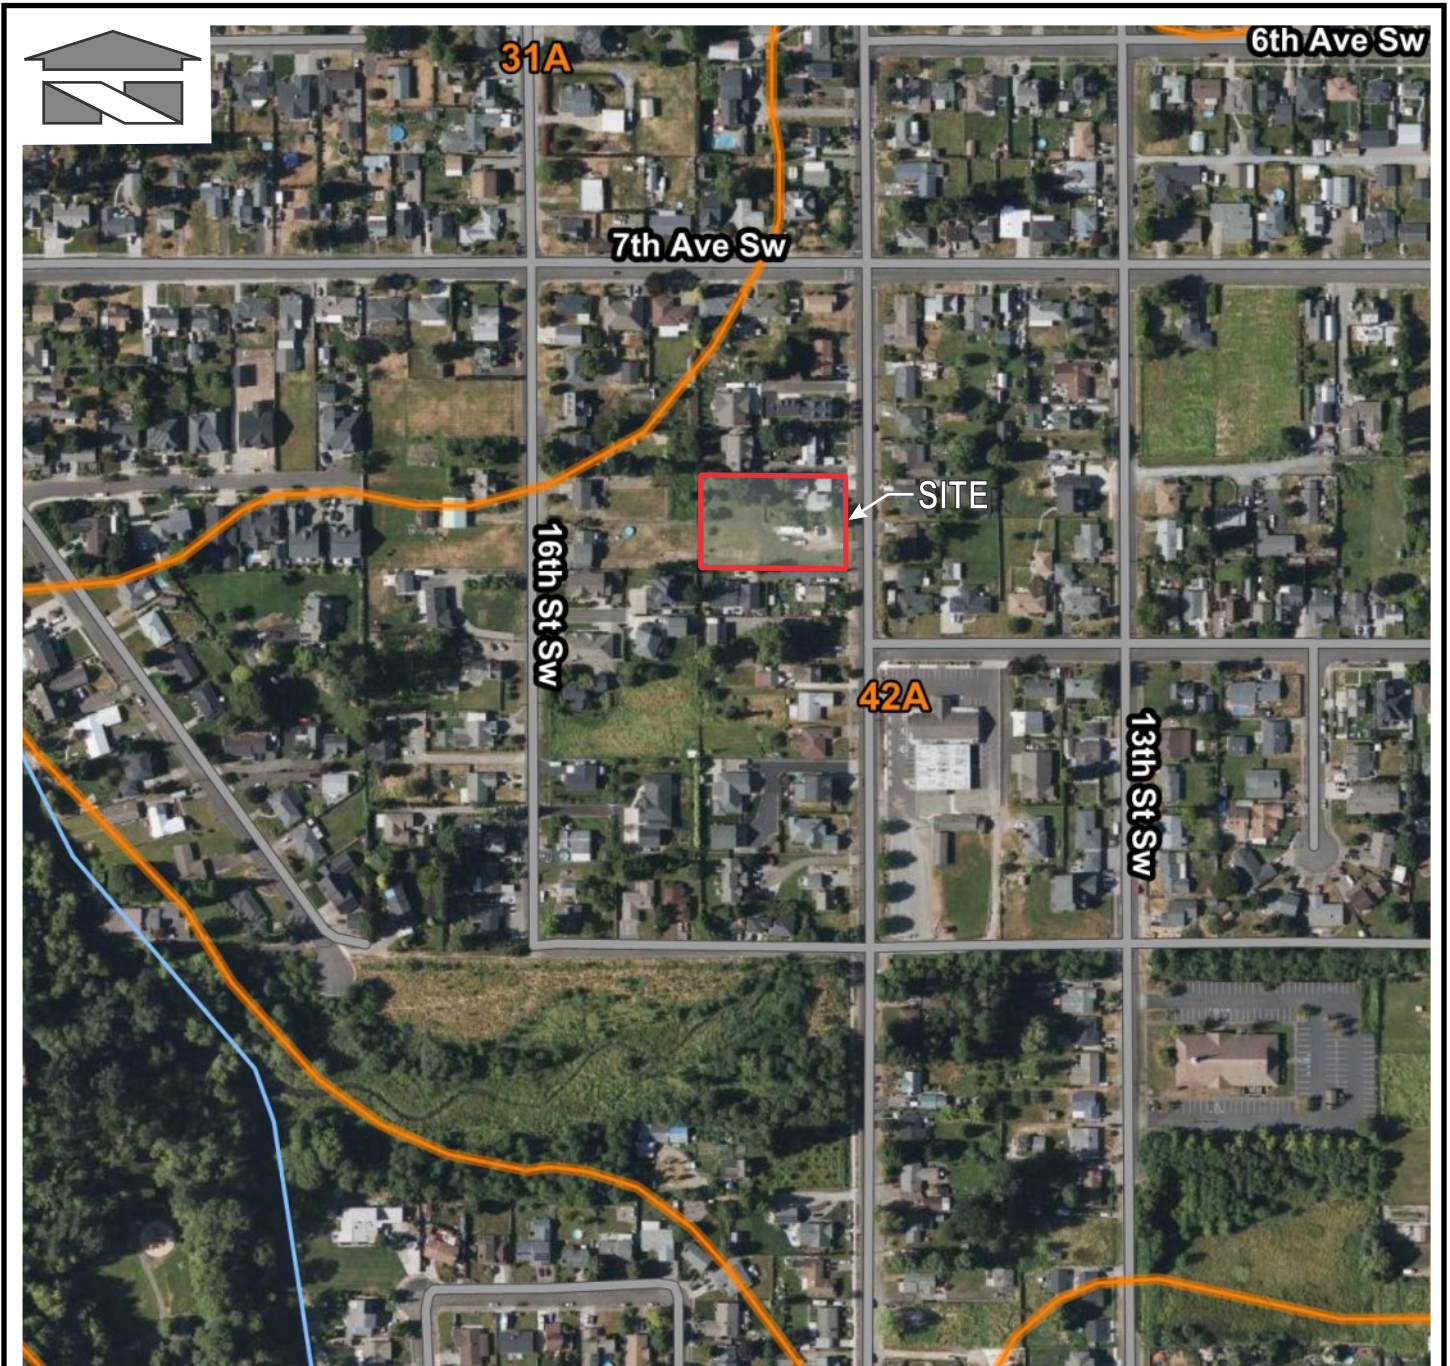
Figure 3.0.3

REFERENCE: USDA, Natural Resources Conservation Service

LEGEND: HSG
42A = Sultan silt loam C/D

The USDA Web Soil Survey for this area shown in Figure 3.0. indicates that the on-site soils are considered Sultan Silt Loam. The Geotechnical Evaluation prepared by Earth Solutions NW identified the underlying native soil as silty sand and sandy silt.

The existing conditions of the project site consist of mostly open space lawn area with an existing home, garage and office building located near the northeast corner of the property. There is also an existing gravel road used to access the existing home from 14th St SW located directly east of the site. The site consists of a single drainage basin with topography sloping in a southeast manner at a relatively flat grade. According to the Geotechnical Report prepared by Earth Solutions NW, the on-site native soil was identified as silty sand and sandy silt. This matches the soil classification indicated in the USDA Web Soil Survey (Figure 3.0.3) which identifies the native soils as Sultan Silt Loam.

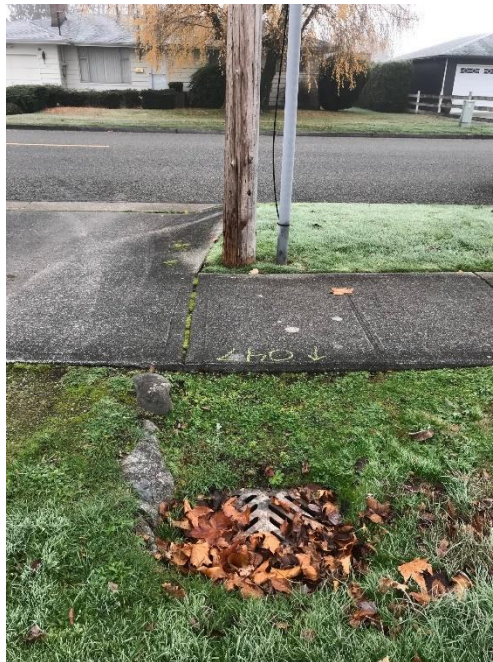
The above photo (looking east) shows the existing catch basin located near the southeast corner of the site. Any runoff that does not infiltrate into the on-site native soil is collected by this catch basin and conveyed southward along 14th St SW for approximately 170 feet before reaching the intersection of 14th St SW and 9th Ave SW.

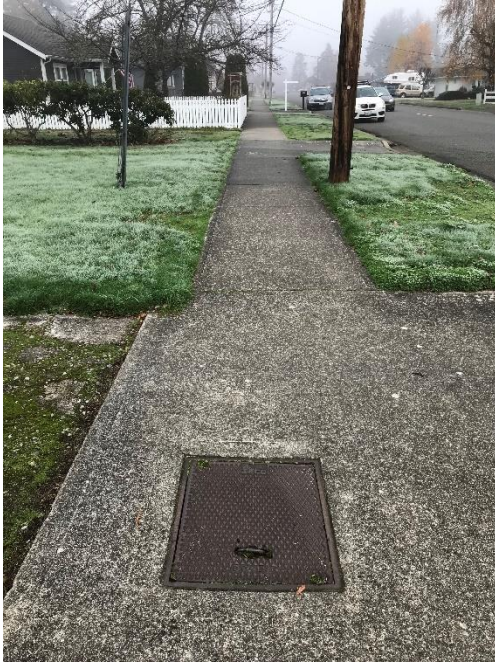
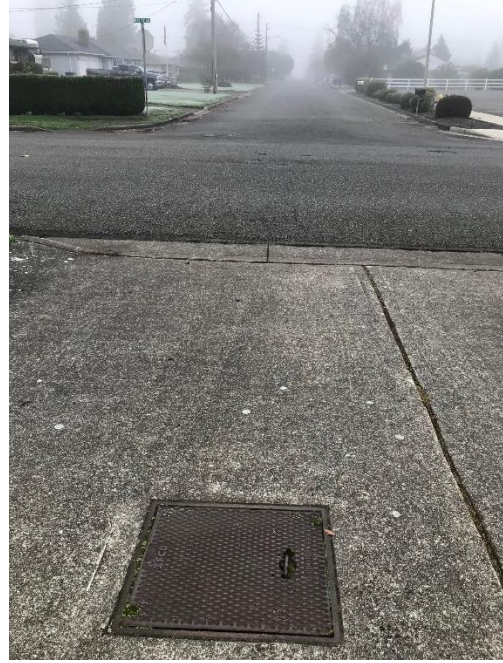
The above photos show the downstream catch basin at the intersection of 14th St SW and 9th Ave SW. Once runoff reaches this catch basin, it begins to flow east along 9th Ave SW for approximately 250 feet. The above right picture shows the catch basin looking east towards 9th Ave SW.

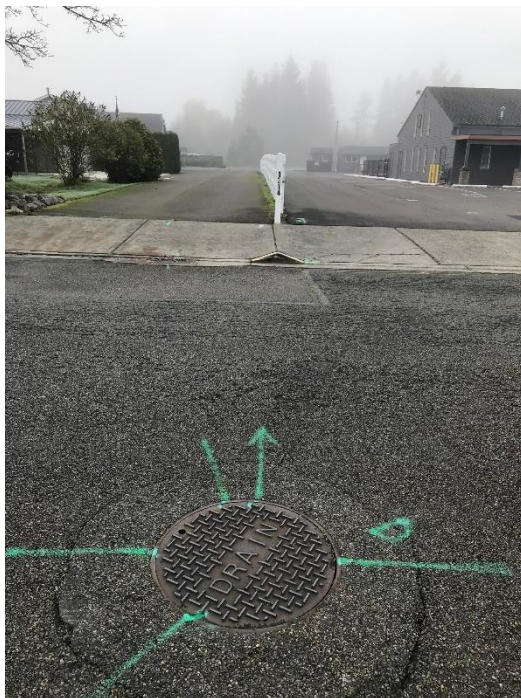
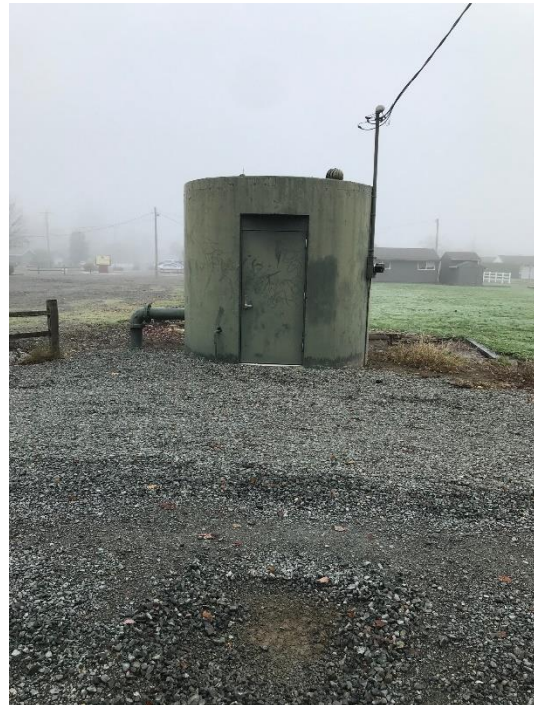
The above left photo shows the existing storm manhole located on 9th Ave SW approximately 250 feet east of the intersection. Once runoff reaches this manhole, it begins to flow south for approximately 500 feet through an existing public storm easement running along the Puyallup Community Baptist Church property. Runoff then flows westward for approximately 80 feet and enters the existing pump station shown in the above right photo.

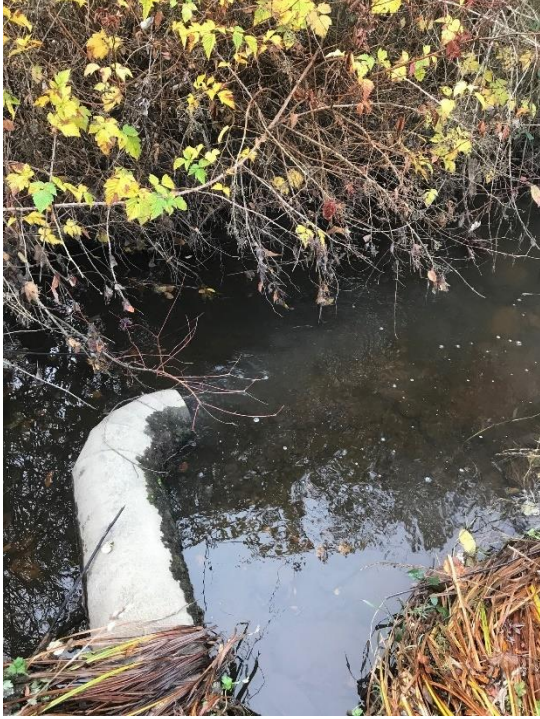
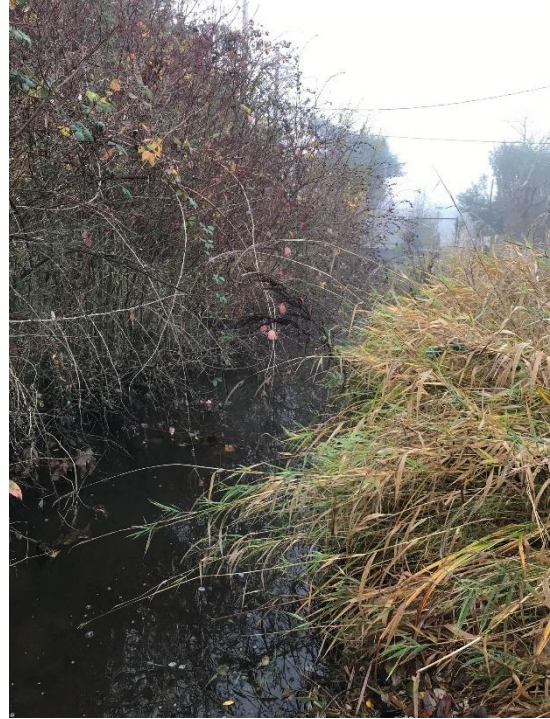
Once runoff enters the pump station, it is slowly released to Meeker Creek located approximately 50 feet to the south. The controlled discharge is shown in the above left photo. Runoff will continue to flow westward along Meeker Creek and eventually reach 1/4 mile downstream of the project site.

There were no flooding or overtopping issues observed on the existing conveyance system and Meeker Creek. In addition, there were no capacity deficiencies observed in the existing conveyance system. Because of this, it can be confidently determined that the development of this project will not impact the downstream system.

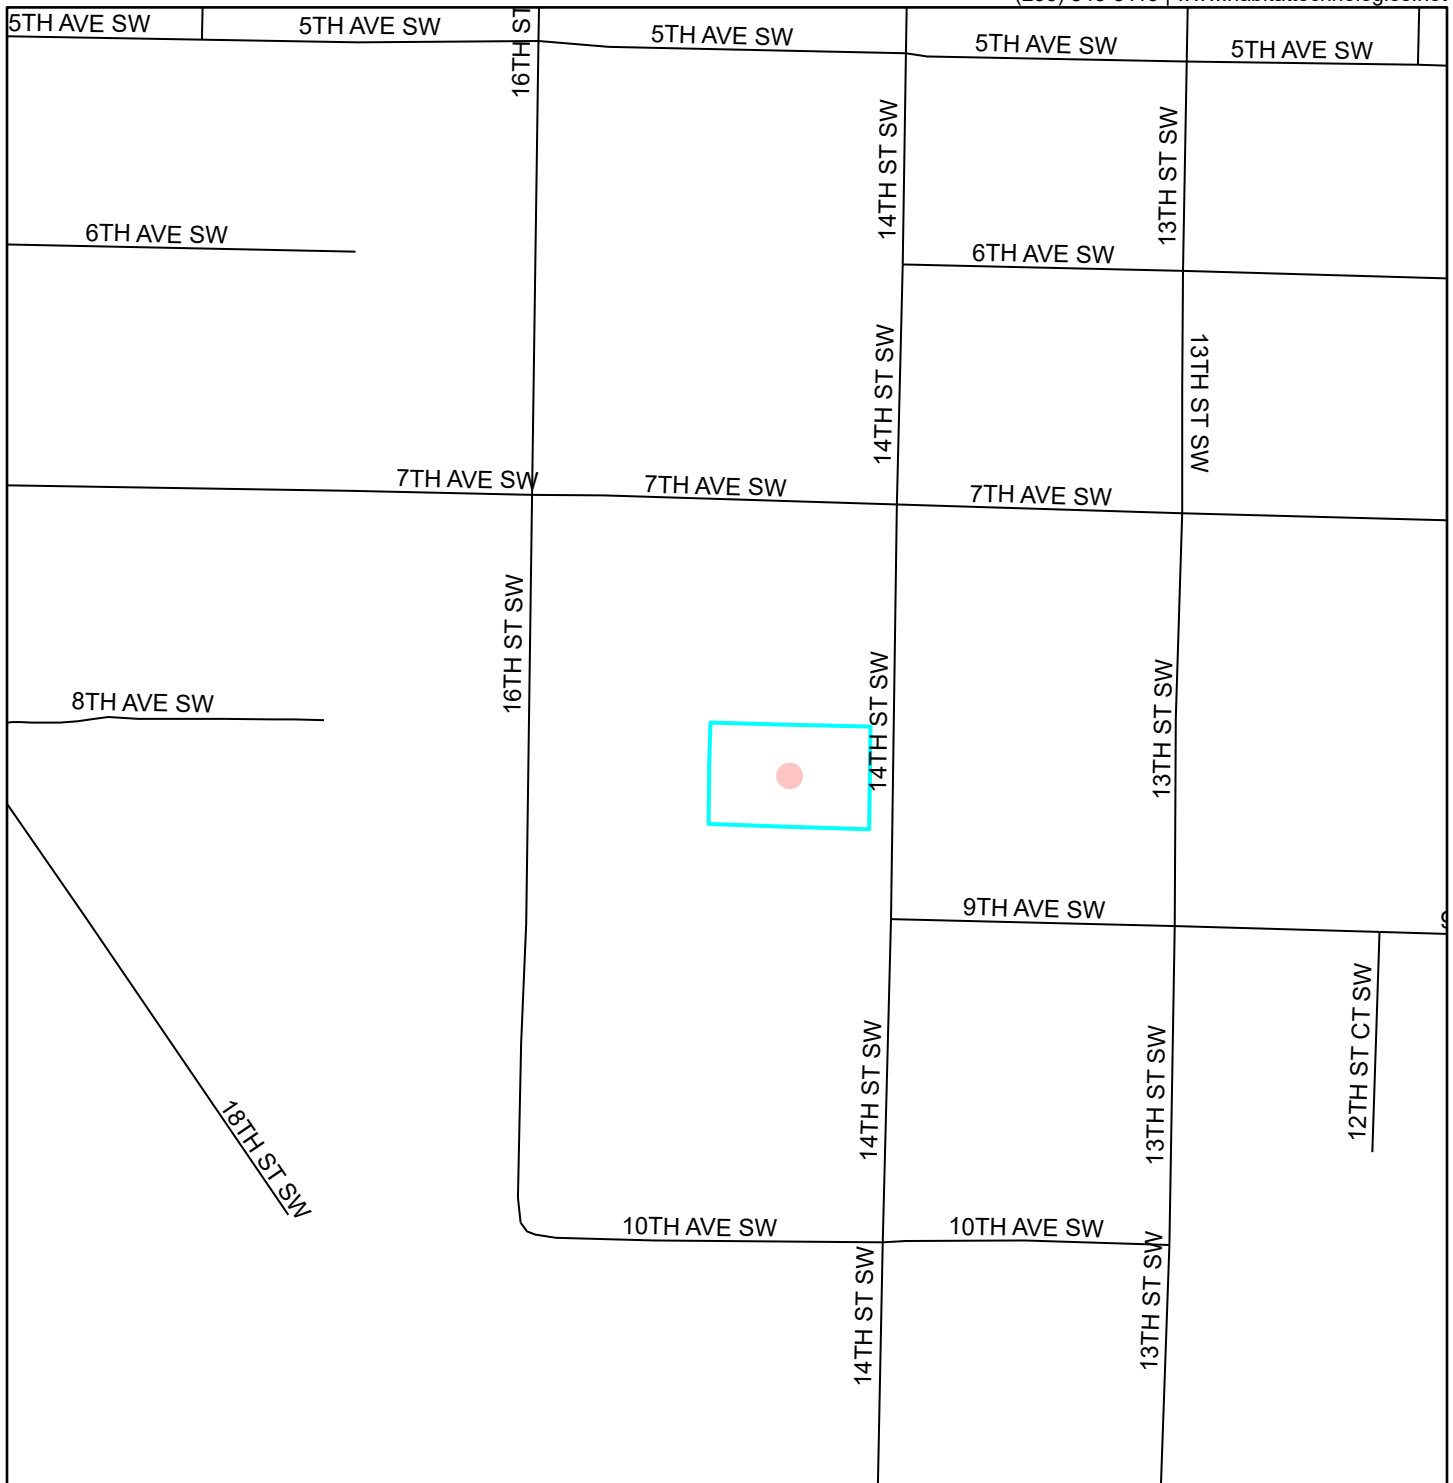
Figure 2 NWI Mapping

The *National Wetland Inventory (NWI) Mapping* completed by the U.S. Fish and Wildlife Service was reviewed as a part of this assessment (Figure 2). This mapping resource did not identify any wetlands or surface water drainages within or immediately adjacent to the project site.

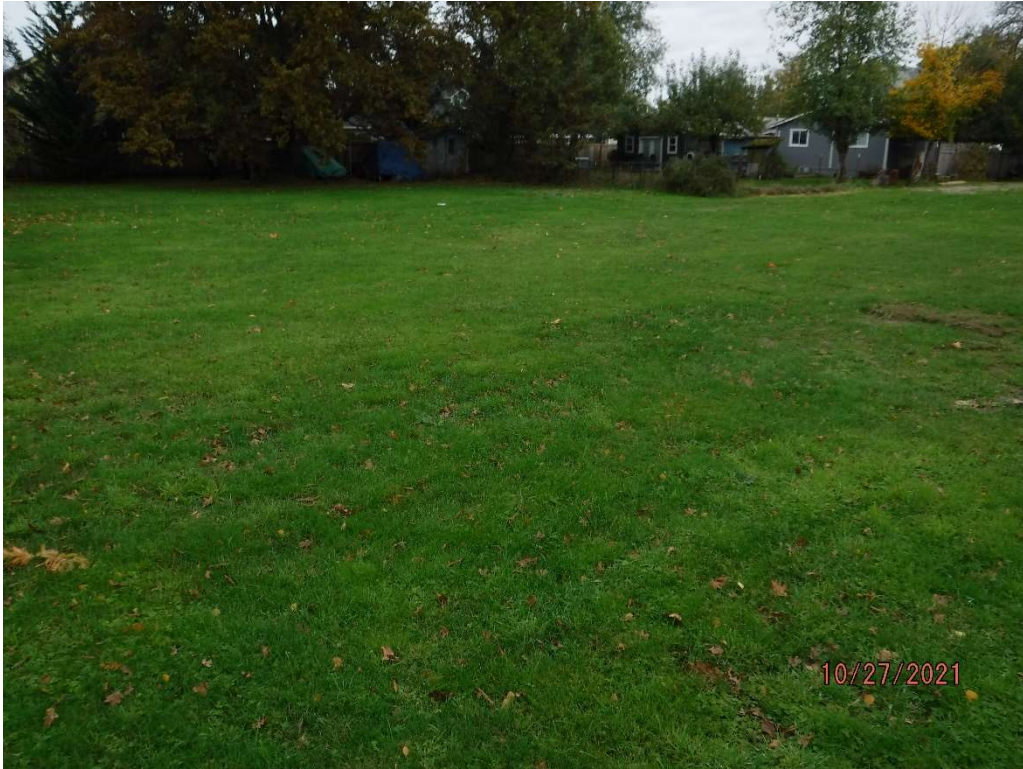
View northeasterly from the southwestern corner. The existing homesite shown in this photo will be retained in the first of the newly created parcels.

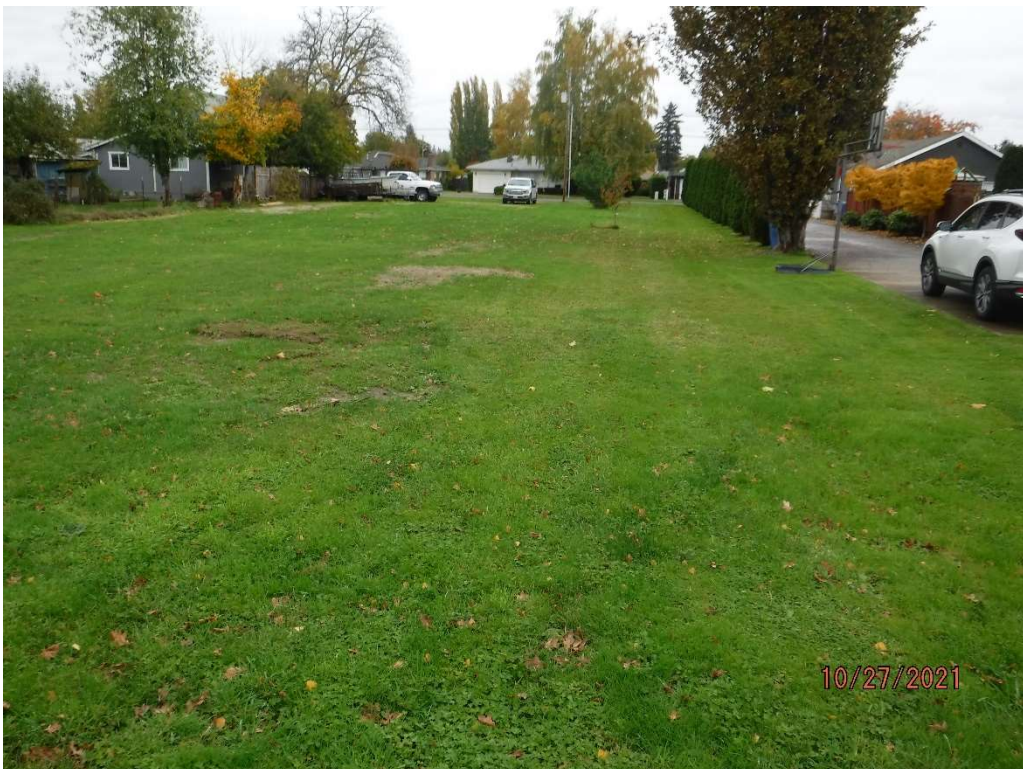
View easterly from the southwestern corner of the project site. The proposed new homesite would likely be located in the eastern portion of the new parcel.

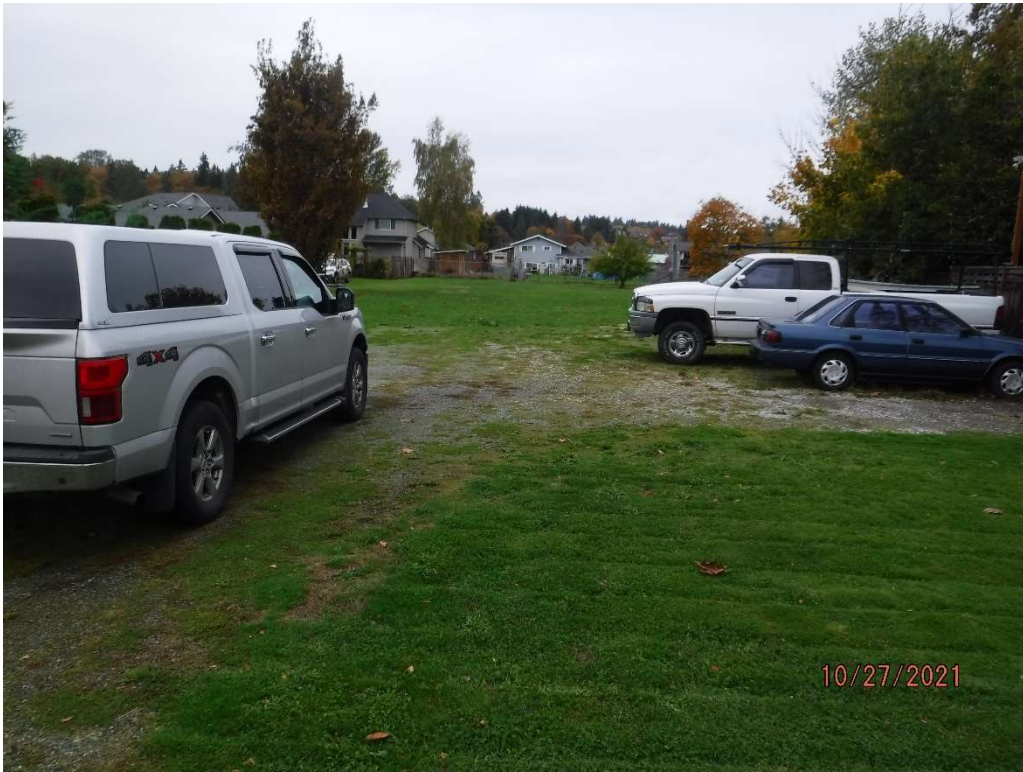
View westerly from the eastern boundary of the project site at the likely location for the new single family homesite.

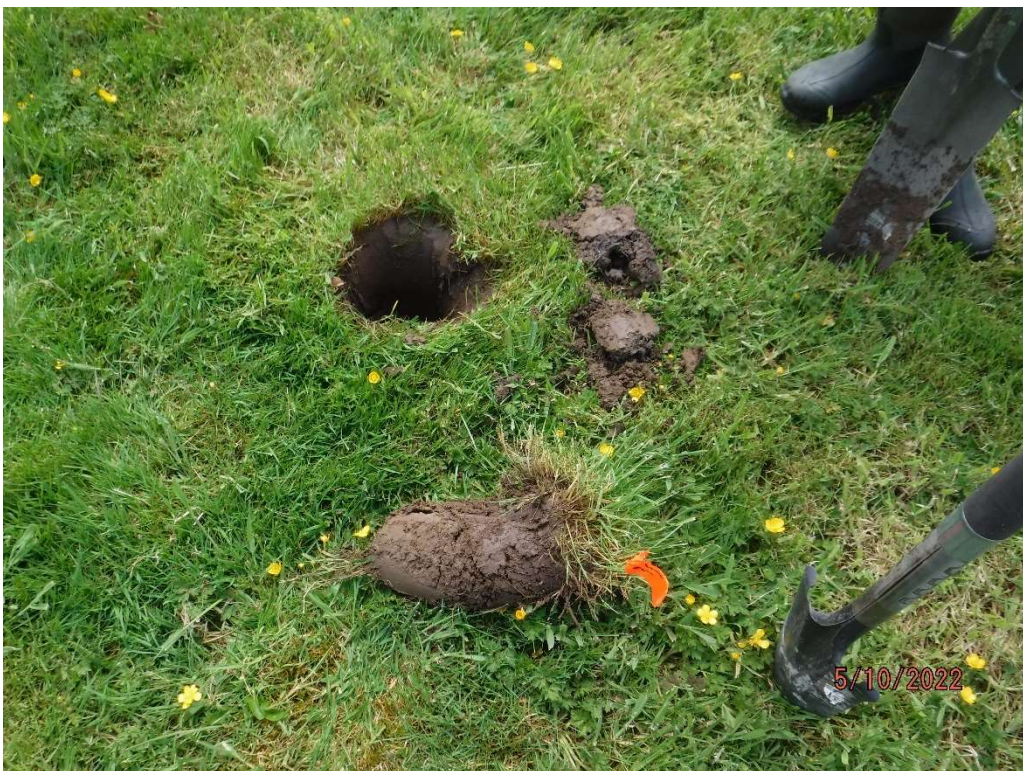
Typical hydrology, soil, and plant community monitoring plot – spring 2022.

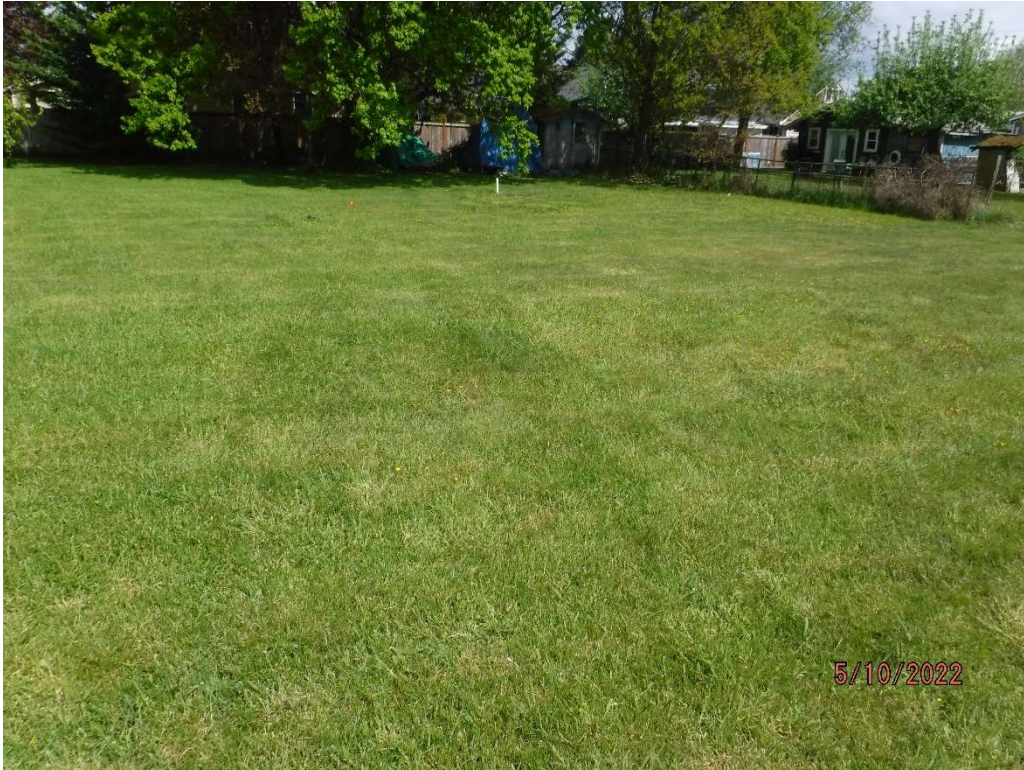
View northward across the western portion of the project site. Spring 2022
