# **PRELIMINARY DRAINAGE REPORT**

## **VALLEY AVE CONTRACTOR'S YARD CITY OF PUYALLUP, WASHINGTON**

**AUGUST 2022**

**Project # 21-247**

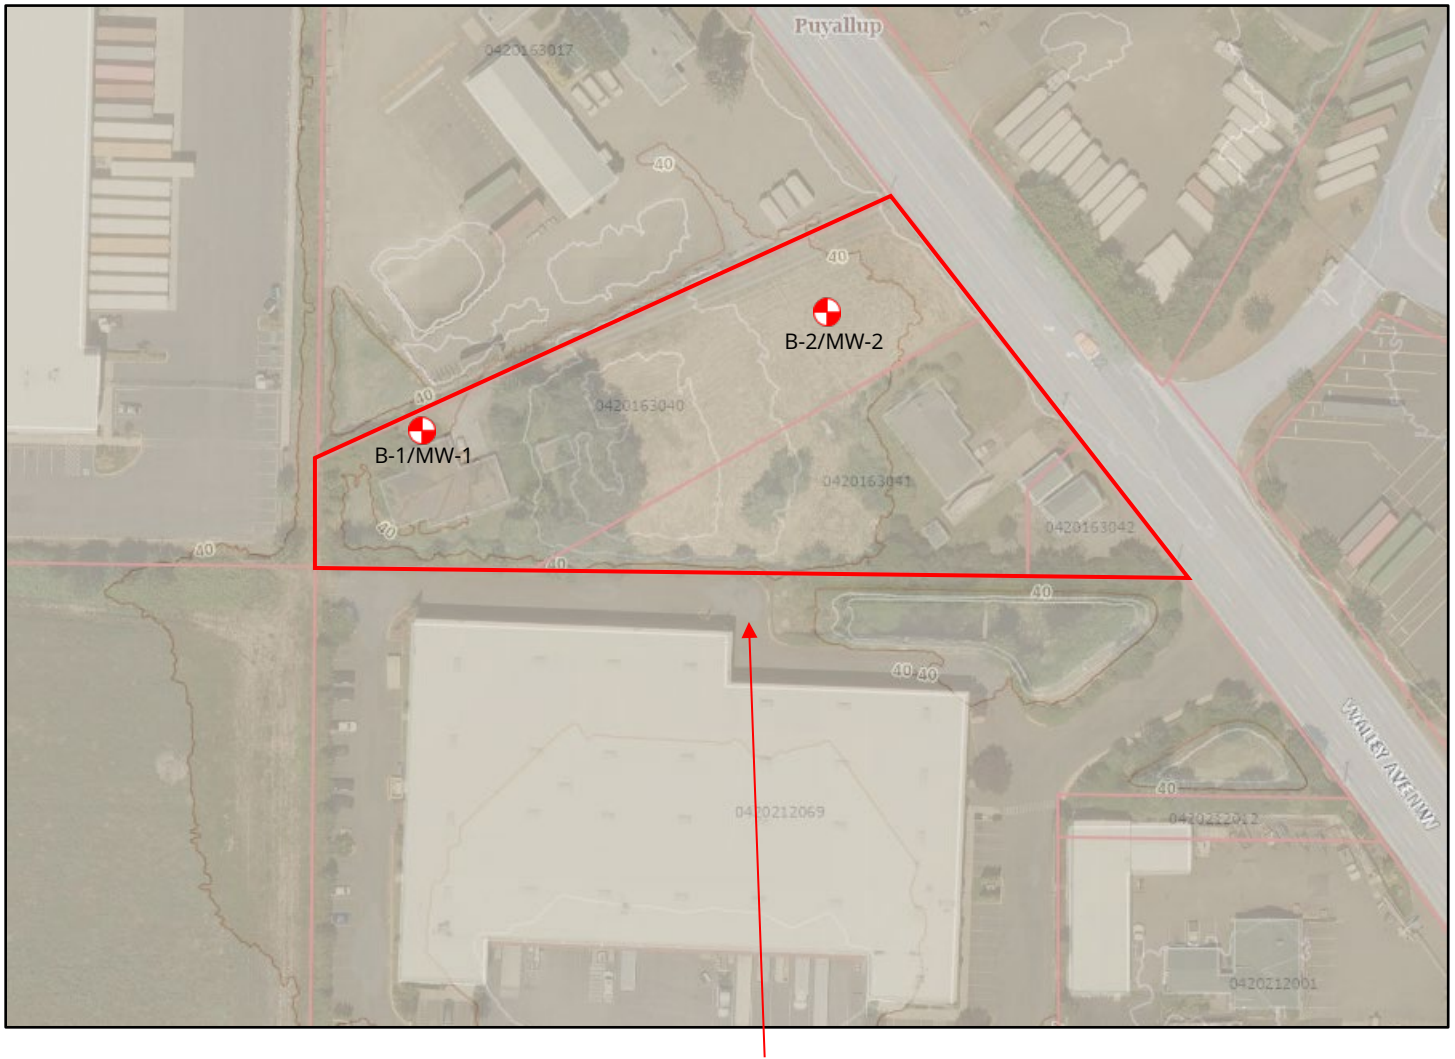
Figure 3

### Site & Exploration Map

Groundwater monitoring wells were installed at the site on December 10, 2021. The locations of the observation wells are shown on the Site & Exploration Map, Figure 2. At the time of drilling, groundwater was encountered at about 4.5 to 5.8 feet below the ground surface (Elevation 34.3 to 34.4 feet). Groundwater readings for the observation wells were manually measured on a bi-monthly basis from December 10, 2021 to March 21, 2022.

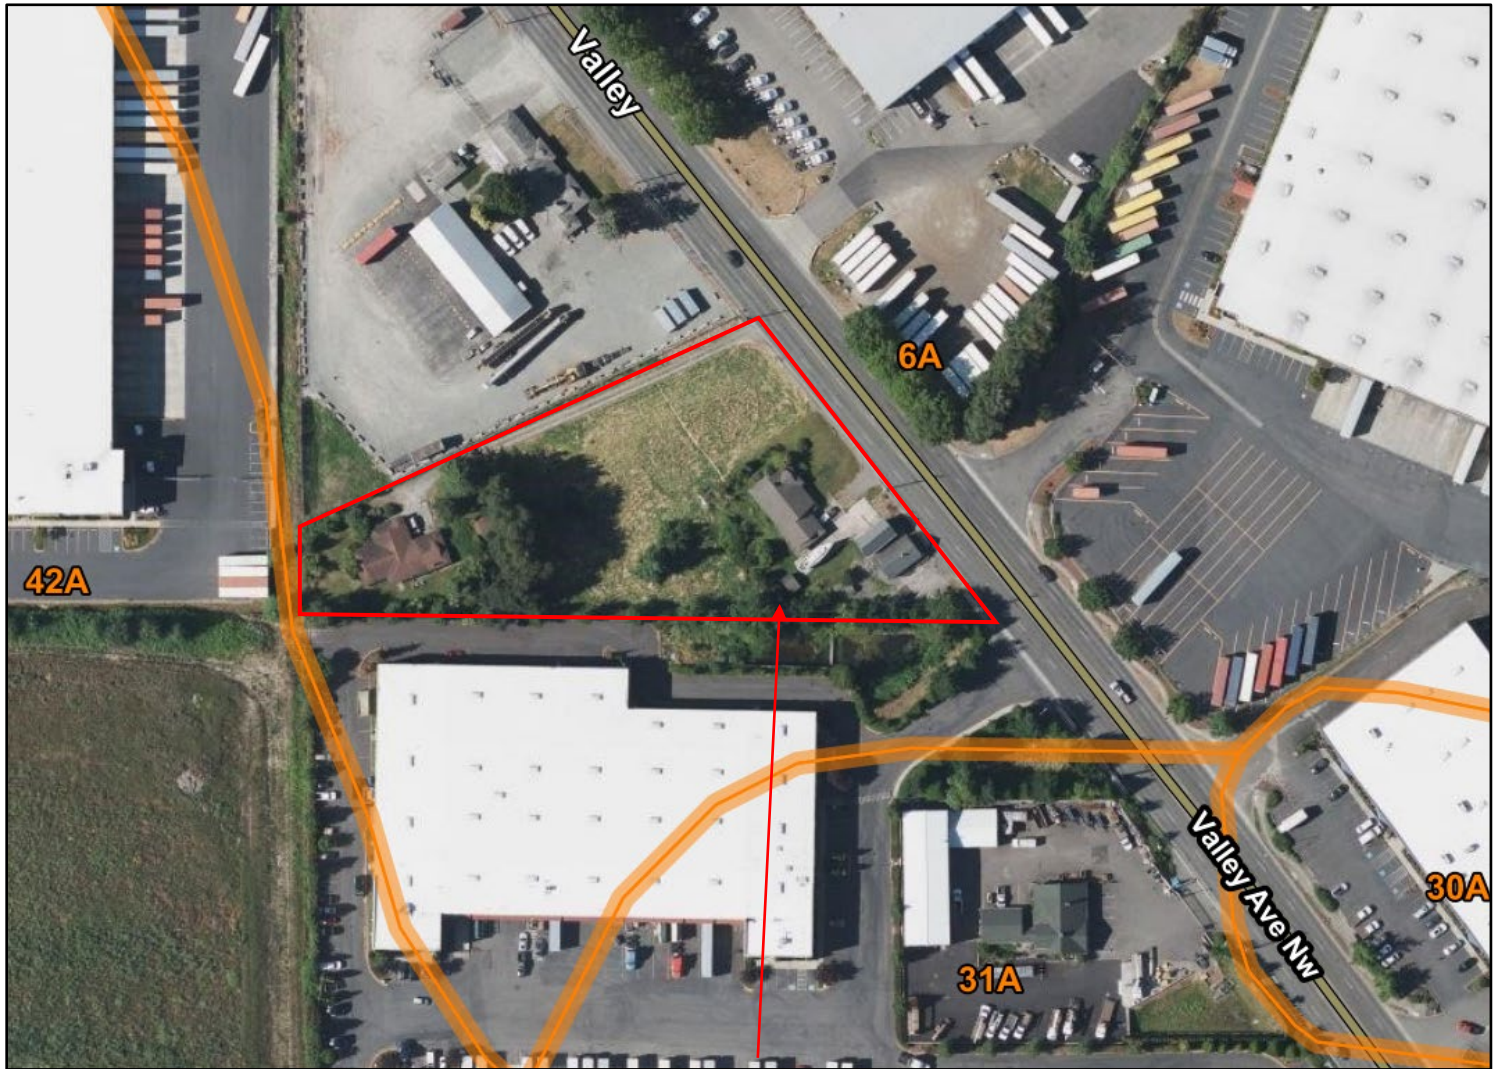
Figure 4

Soil Type	Soil Name	Parent Material	Slopes	Erosion Hazard	Hydrologic Soils Group
6A	Biscot Loam	Alluvium	0 to 2	Slight	B/D
30A	Puget silty clay loam	Alluvium	0 to 2	None	C/D
31A	Puyallup fine sandy loam	Alluvium	0 to 3	Slight	A
42A	Sultan silt loam	Alluvium	0 to 2	Slight	C/D

### NRCS Soils Map

- *Briscot Loam (6A)*: These soils are derived from alluvium and form on slopes of 0 to 2 percent. The Briscot Loam soils have a “slight” erosion hazard when exposed and are included in hydrologic soils group B/D.
