PRELIMINARY STORMWATER SITE PLAN

Mullan Short Plat
808 14th Street S.W.
Puyallup, Washington 98371

City File No. P-21-0067

November 30, 2022

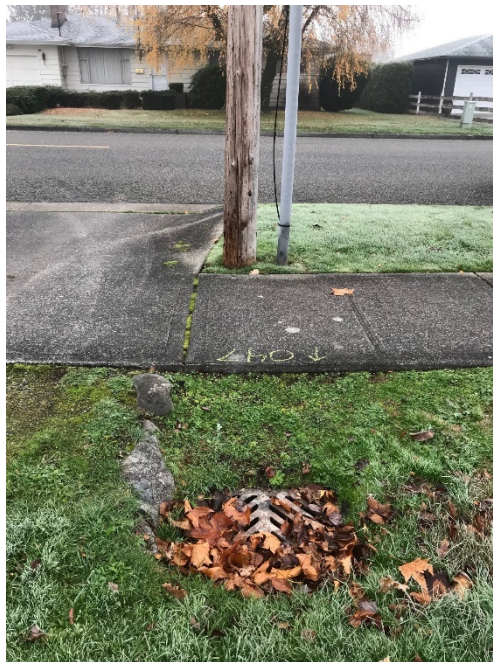
The above photo (looking east) shows the existing catch basin located near the southeast corner of the site. Any runoff that does not infiltrate into the on-site native soil is collected by this catch basin and conveyed southward along 14th St SW for approximately 170 feet before reaching the intersection of 14th St SW and 9th Ave SW.

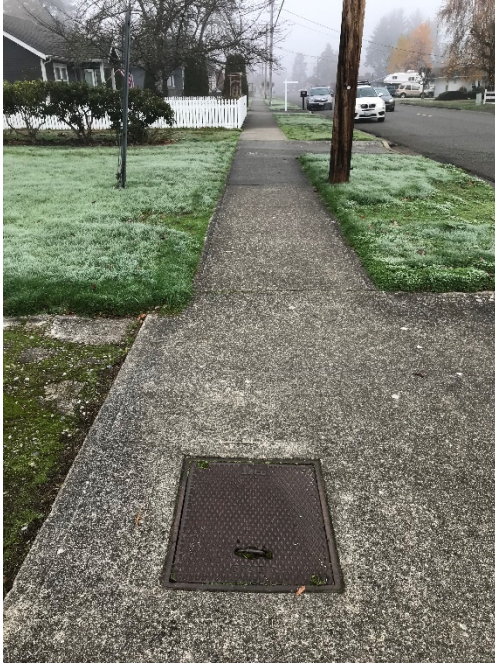
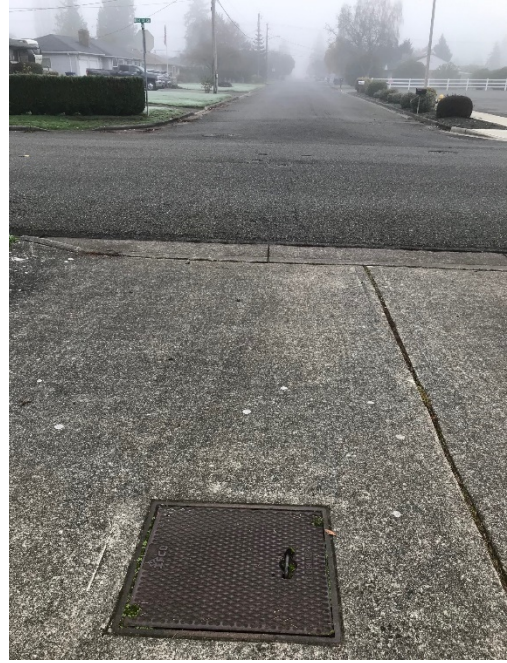
The above photos show the downstream catch basin at the intersection of 14th St SW and 9th Ave SW. Once runoff reaches this catch basin, it begins to flow east along 9th Ave SW for approximately 250 feet. The above right picture shows the catch basin looking east towards 9th Ave SW.

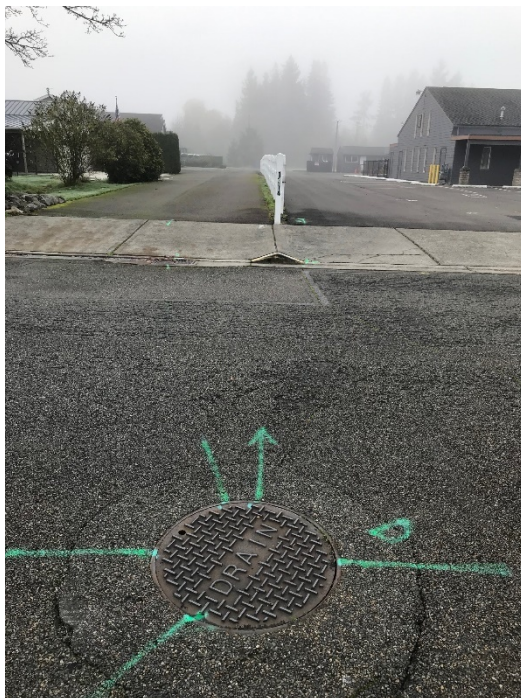
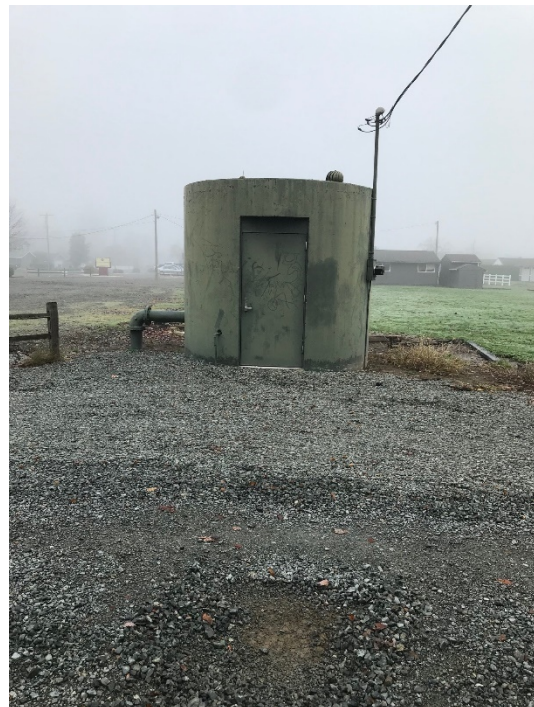
The above left photo shows the existing storm manhole located on 9th Ave SW approximately 250 feet east of the intersection. Once runoff reaches this manhole, it begins to flow south for approximately 500 feet through an existing public storm easement running along the Puyallup Community Baptist Church property. Runoff then flows westward for approximately 80 feet and enters the existing pump station shown in the above right photo.

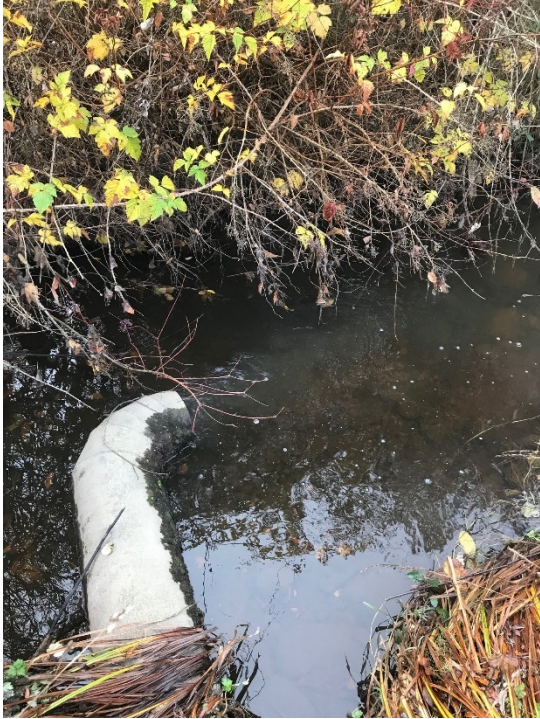
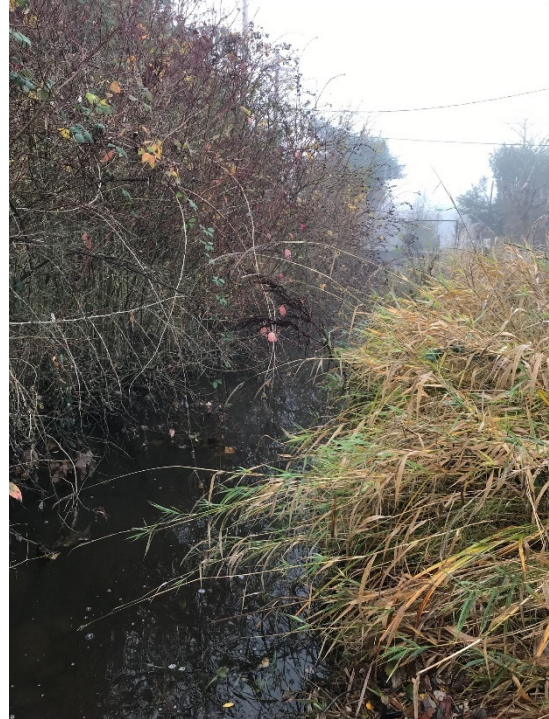
Once runoff enters the pump station, it is slowly released to Meeker Creek located approximately 50 feet to the south. The controlled discharge is shown in the above left photo. Runoff will continue to flow westward along Meeker Creek and eventually reach 1/4 mile downstream of the project site.

There were no flooding or overtopping issues observed on the existing conveyance system and Meeker Creek. In addition, there were no capacity deficiencies observed in the existing conveyance system. Because of this, it can be confidently determined that the development of this project will not impact the downstream system.

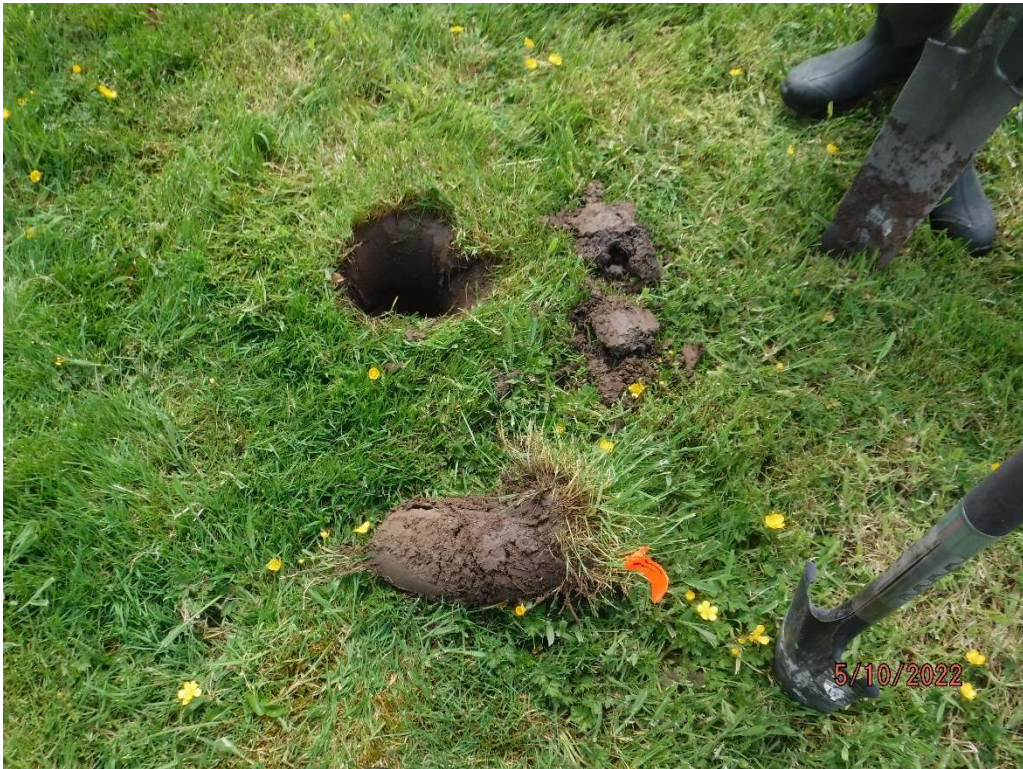
Typical hydrology, soil, and plant community monitoring plot – spring 2022.
