May 17, 2023

**RE: Sunset Pointe Residential Community (P-18-0040)
City of Puyallup, Pierce County, Washington**

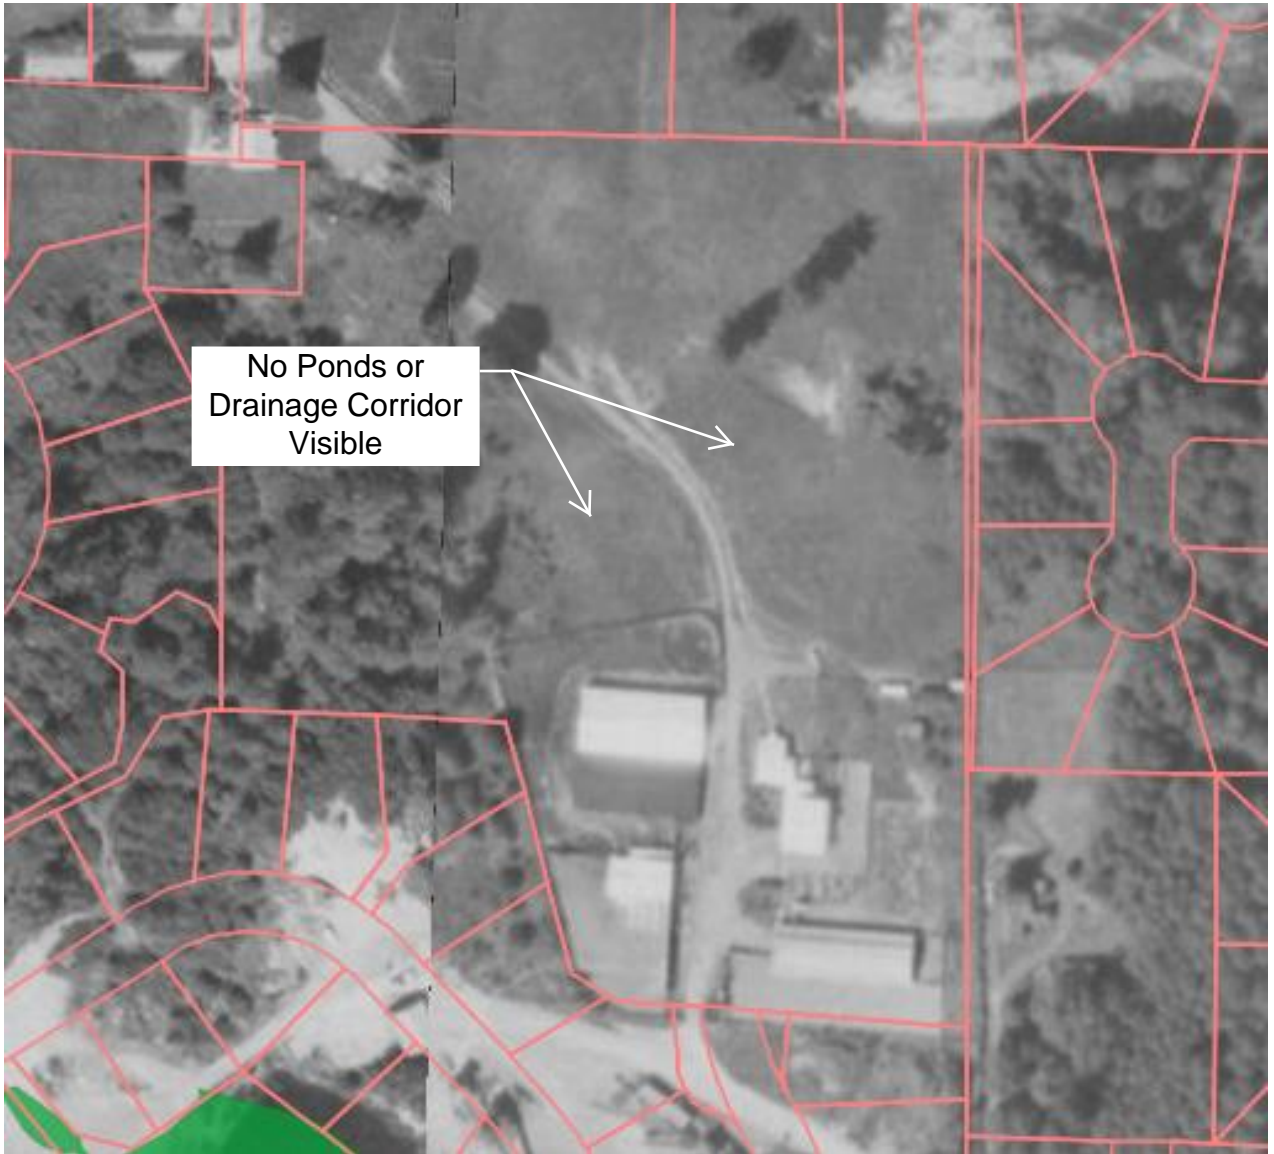
Photo 1: 1970 Aerial photo with no excavated ponds present.

As outlined in the revised report by Habitat Technologies dated September 21, 2018, the excavated ponds within the southern portion of the project site were defined as intentionally created features. As viewed in the 1970 historical aerial photo, no ponds or drainage corridor were evident in the southern portion of the project site (See Photos). The easternmost pond (Pond C) only become evident in and after the 1985 aerial photo. In the 1995 aerial photo along with subsequent photos, two (2) additional excavated ponds are present (Ponds A and B) southwesterly of Pond C. The 1998 aerial color photo has the best resolution and clearly shows all three ponds.

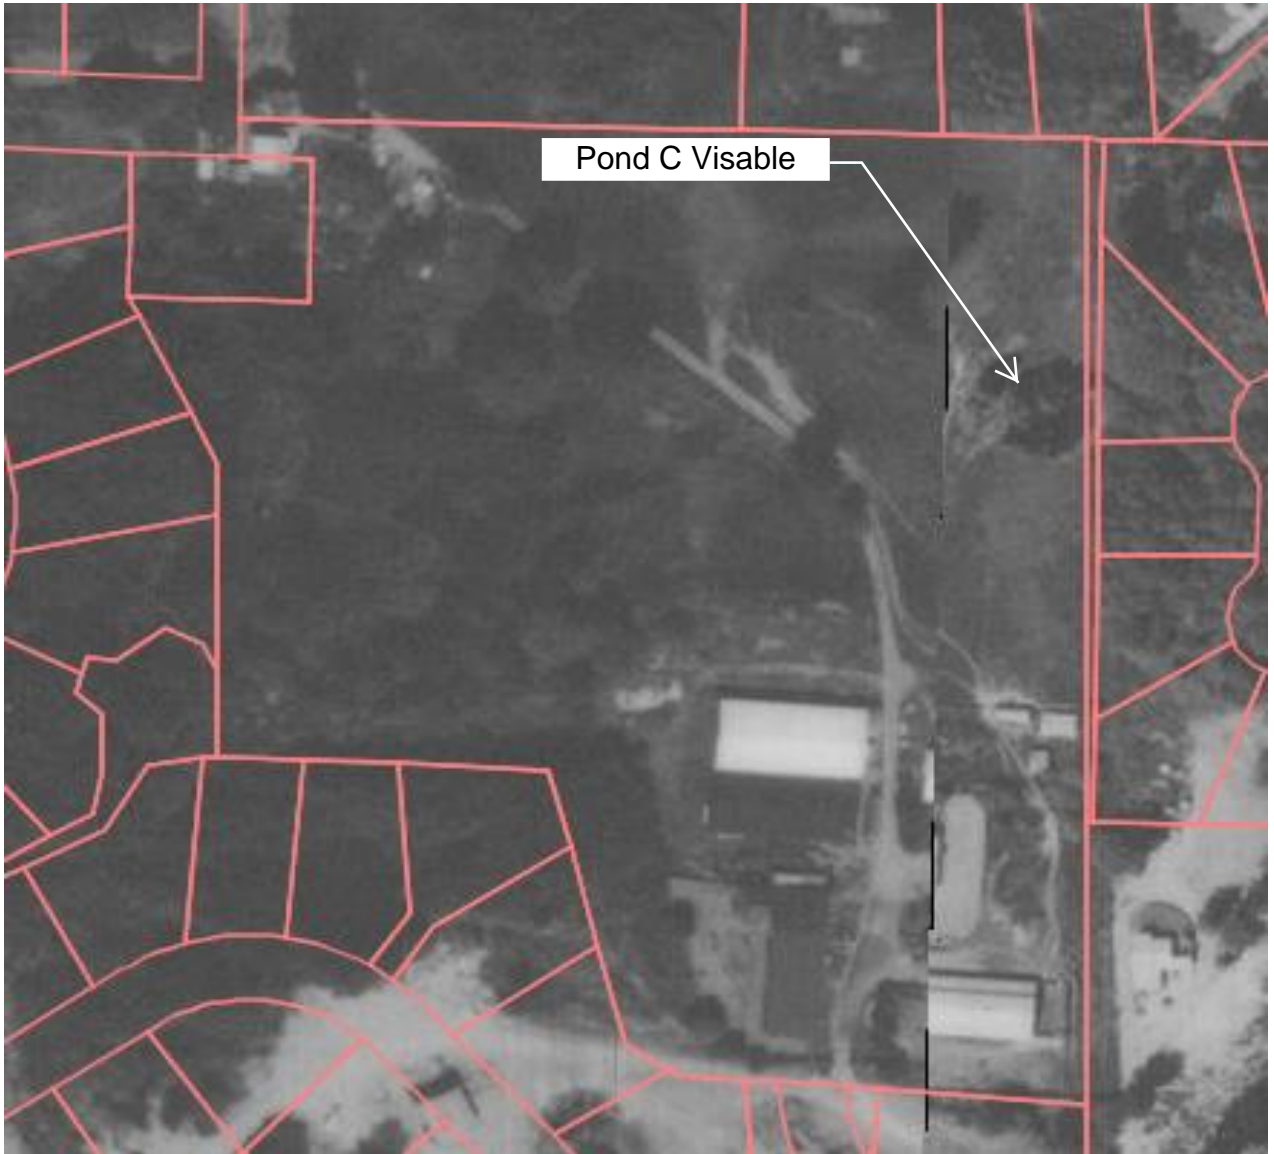
Photo 2: 1985 Aerial photo with eastern most pond no excavated ponds present.

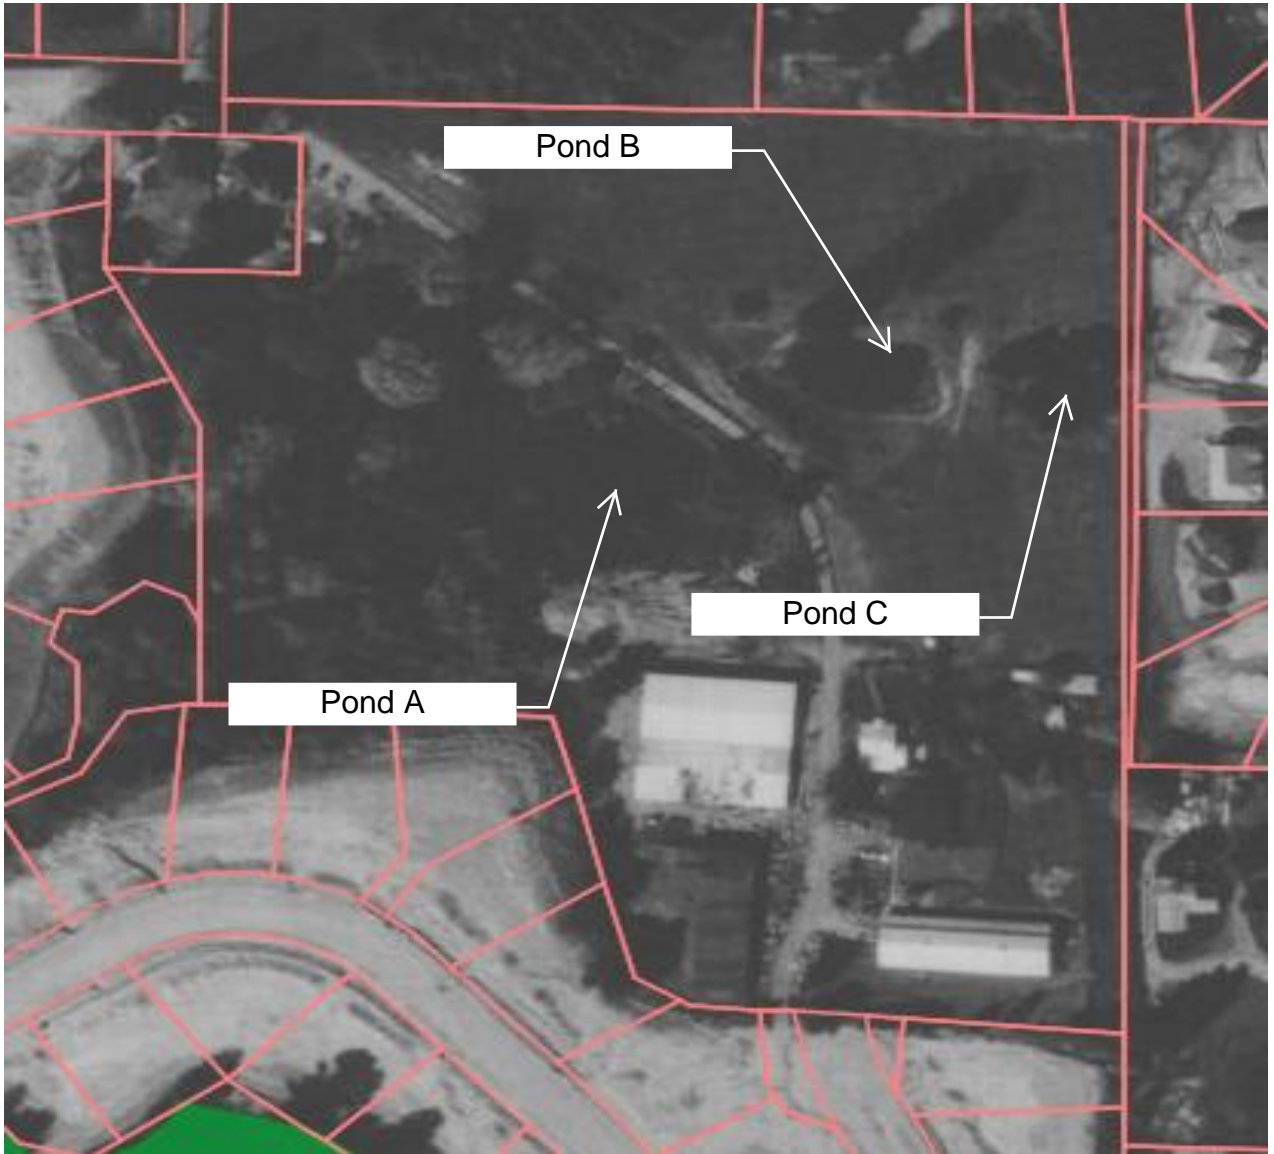
Photo 3: 1995 Aerial photo with three (3) excavated ponds present.

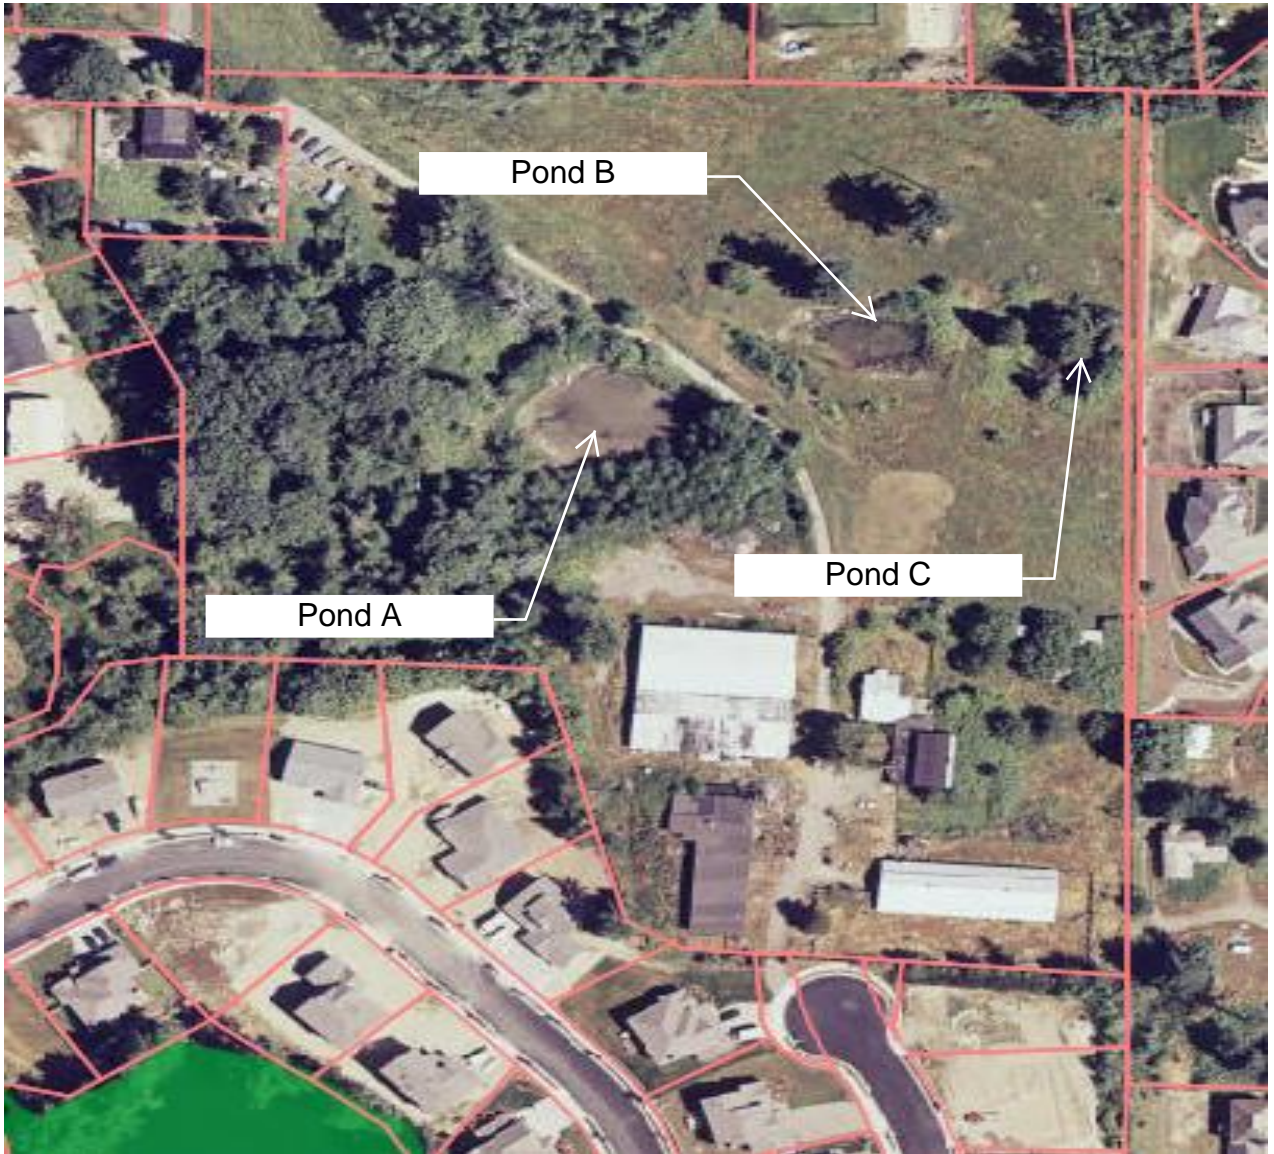
Photo 4: 1998 Aerial photo (color) with three (3) excavated ponds present.
