Appendix 2

Ecolube Recovery Puyallup Site (T)
213 - 10th Street SE
Puyallup, WA

Tank Number	3
Owner	EcoLube LLC
Design Standard	Unknown
Tank Location	Puyallup, WA
Product	Deicer
Specific Gravity	1.28
Manufacturer	Unknown
Manufacture Date	1988
Cathodic Protection	No
Data Plate Present	No
Data Plate Condition	N/A

4.0 Summarized Recommendations

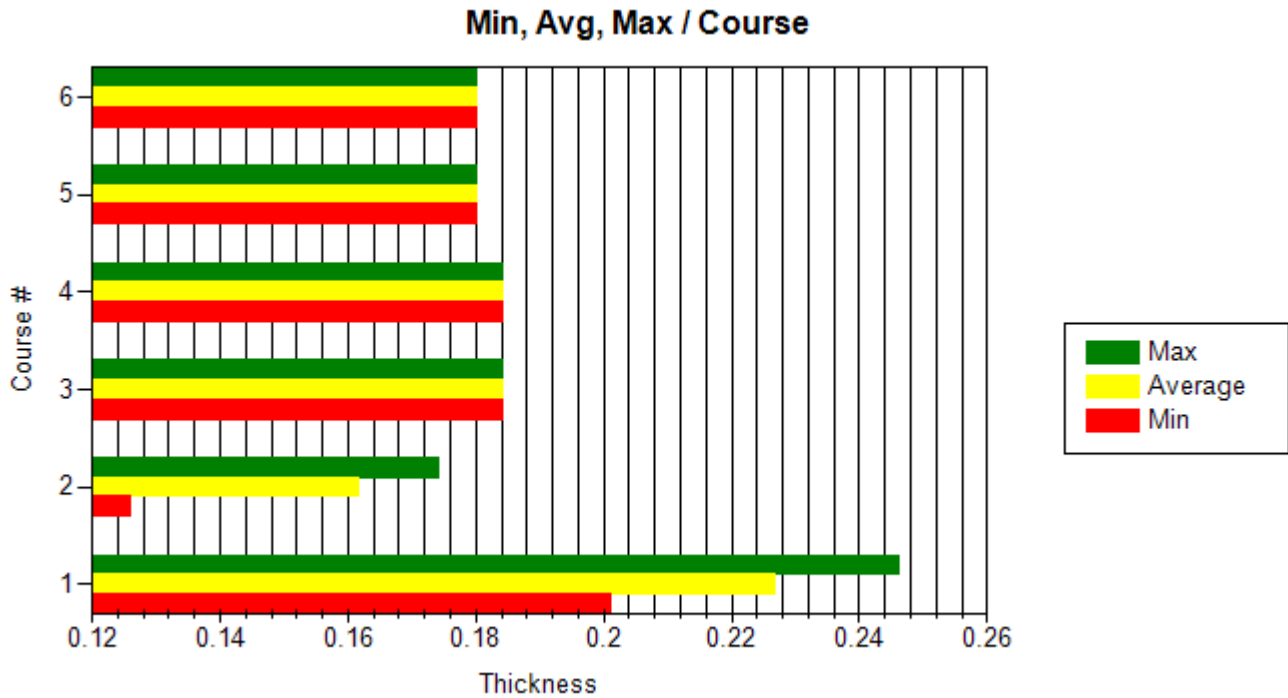
The following chart depicts the average thickness reading (in) on the shell plates versus the course number.

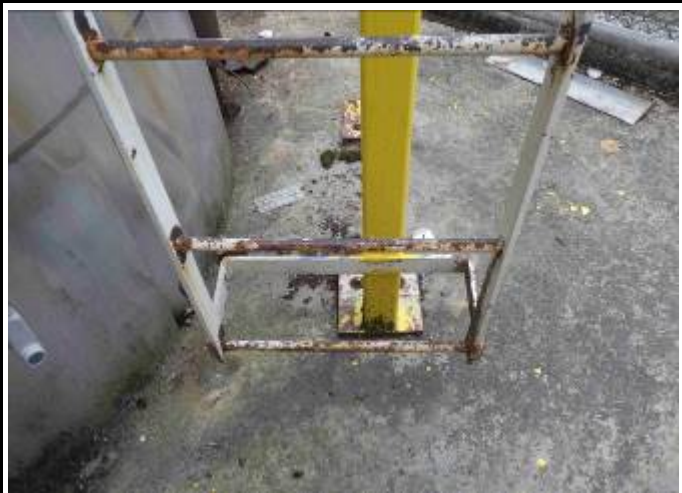
Ladder Base

- 18) The cage ladder rungs had notable coating wear and failure throughout. The client should clean and recoat the affected areas in the future.

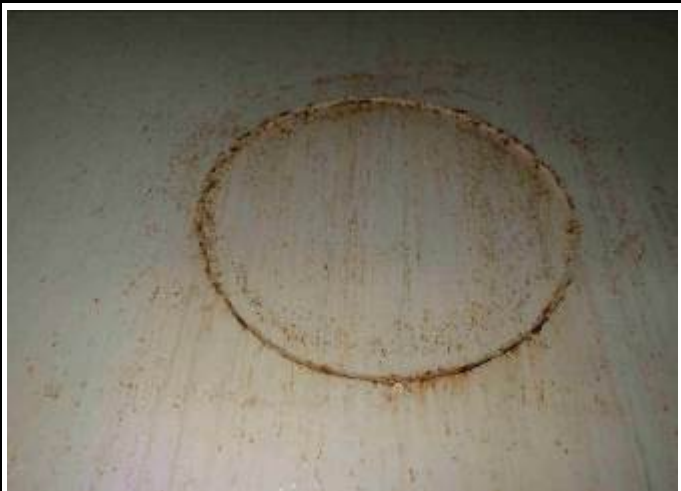
Lower Shell Large Coating Failure

- 9) There are areas of heavy internal coating degradation present with scale buildup and non-measurable corrosion forming. The client should prep and recoat the affected area at the next opportunity. **Note: If an internal liner is required for the new intended service, this recommendation would be mandatory.**
