VVOLDEN

STRUCTURAL

July 12, 2022

Re: Foundation Assessment and Repair Recommendations for the Ross Family Residence at 110 9th Street SW in Puyallup, Washington

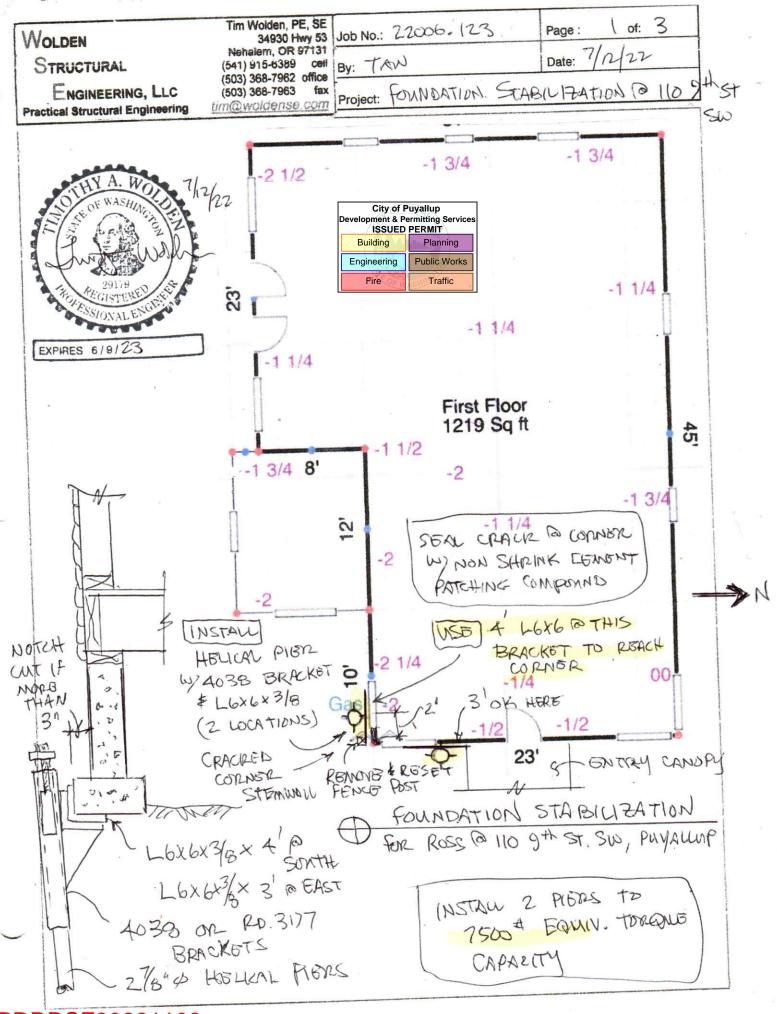
Cracked Foundation at the Southeast Corner - Two Piers and Angles under this Corner

In conclusion, I found that the southeast corner of the Ross Family residence at 110 9<sup>th</sup> Street SW in Puyallup, Washington has experienced up to 2½-inches of settlement and the cracked foundation for this single-story residence should be stabilized to prevent increased settlement or damage to the foundation. Please refer to my attached repair plan for repair/stabilization recommendations possible with two hydraulically driven helical piers with foundation brackets placed under the footings of the home and steel angles placed on top of the brackets.

I recommend that the southeast corner be supported on two (2) helical piers; one at the front or east side and one at the south side wall shown above. These piers will use the standard foundation bracket (4038) or the modified RD 3177 brackets. In addition to the brackets, I have shown the use of 6x6 steel angles placed on top of the brackets to ensure that the lifting force is applied uniformly along the wall in order to support the cracked corner and to prevent more cracking as it is unlikely the footings are reinforced.

These piers will allow this structure to be lifted enough to ensure the load of the home is on the piers as this is only a stabilization project. The piers will ensure that this portion of the foundation is stabilized against future settlement. Once the piers are installed and loaded, I recommend that the crack be sealed with a non-shrink cement grout (hydraulic cement) to seal it against pest infiltration or spalling from freezing water in the crack. The locations of the piers are shown in the attached repair plan.
