wallace
design
collective

Location/WOs: Walmart Store #2403 in Puyallup, WA
Wallace Project No. 2210879, Client Project No. 37554607

Purpose: Preconstruction Meeting

Preconstruction Meeting Photos

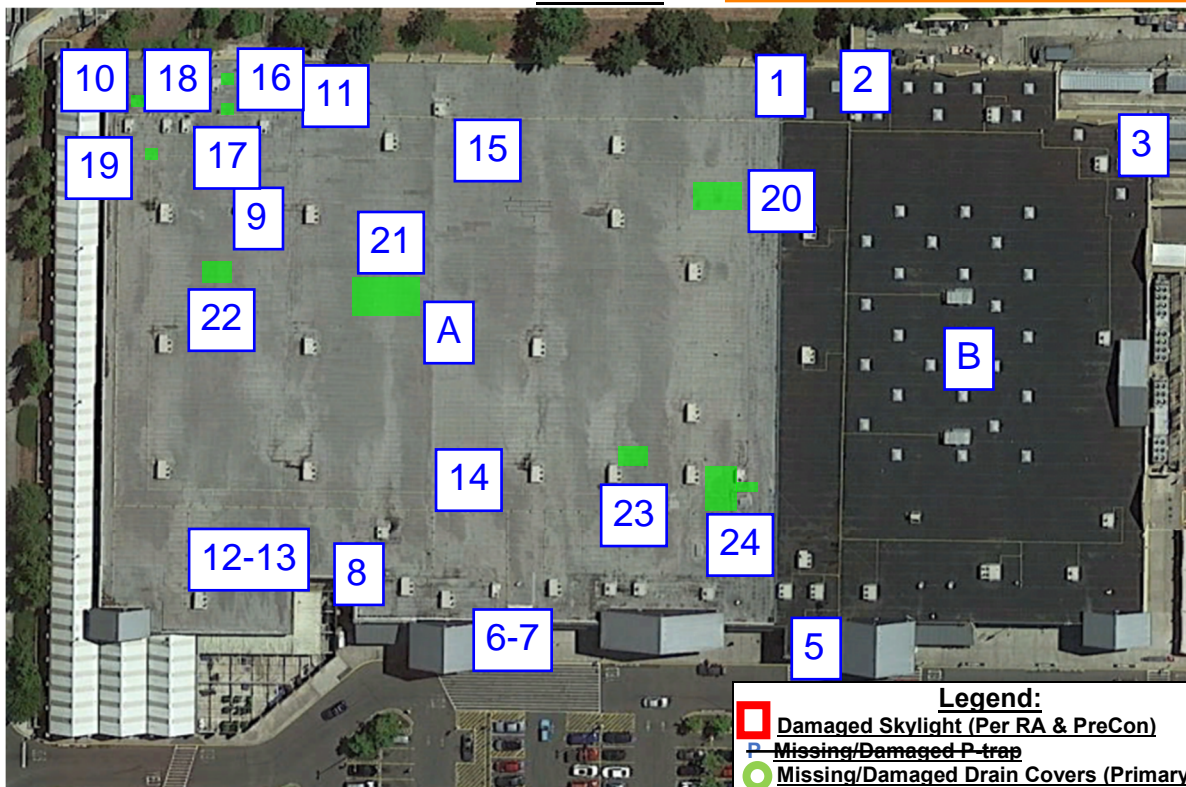
KEYPLAN

L.7 Wet insulation that will require replacement as indicated and marked on roof during IR scan (total 1400 sq. ft.)

Description:
L.7 Wet insulation that will require replacement as indicated and marked on roof during IR scan (total 1400 sq. ft.)
Action: Repair as noted
L.7 Submit CO if added insulation is above amount included in bid, with usage documentation per submitted unit price
