Re: *Fire Construction Permit Application*
CUP Modification
Reuse of Storage Tank 5 & 6 for Used Oil

Tank Inspection Report – Mistras

SP001 Formal Internal Inspection

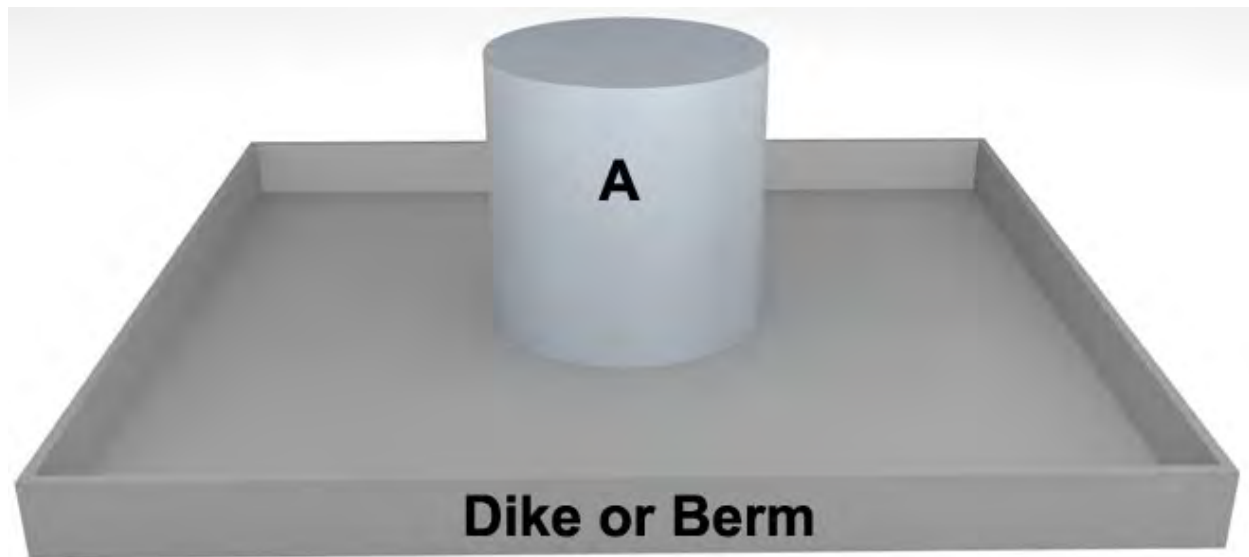
3. Spill Prevention Assessment Vertical Tank

Dikes or firewall should be constructed to contain, at a minimum, the volume of the largest tank enclosed plus an allowance for rainwater (normally, 10 percent additional tank volume) for a total of 110%. The secondary containment area meets the required volume of 110%.

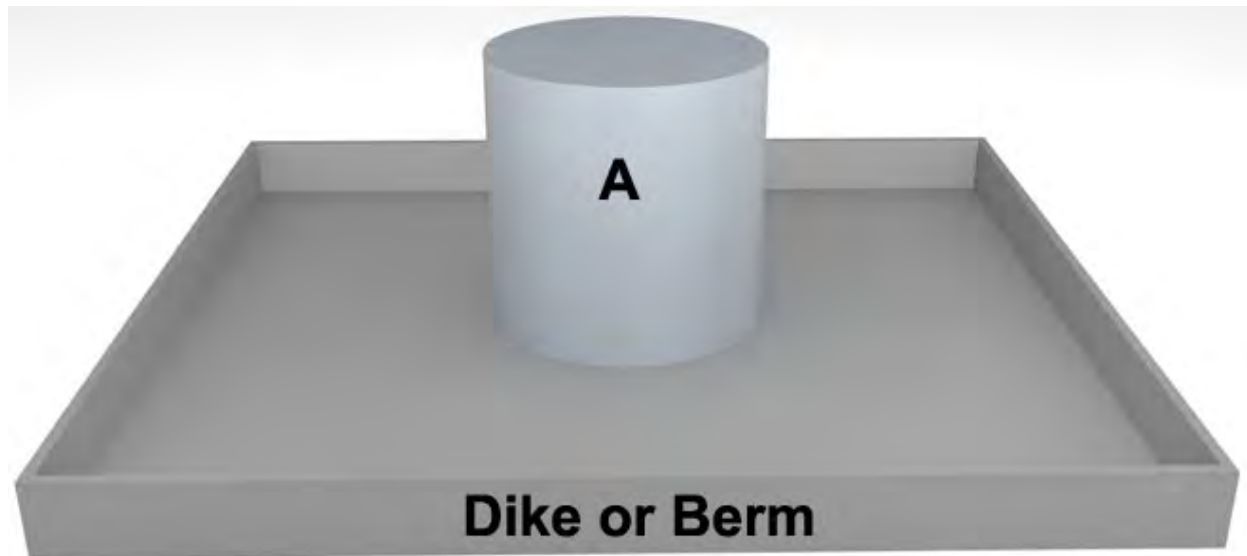
Dikes or firewall should be constructed to contain, at a minimum, the volume of the largest tank enclosed plus an allowance for rainwater (normally, 10 percent additional tank volume) for a total of 110%. The secondary containment area meets the required volume of 110%.
