Artz Site and Soil Evaluation

Parcel No. 0419095003, 5004 & 5022
Site Address 409, 427 and 433 43rd AV SW
Site Observations January 20, 2020

Introduction

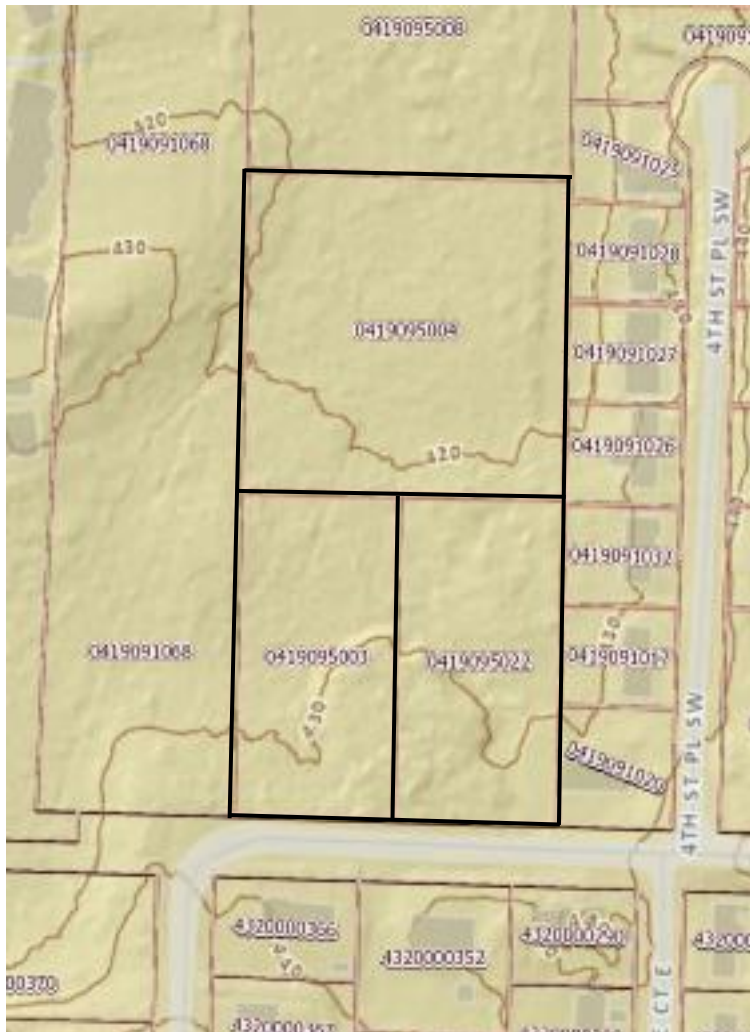
The vacant land is covered with berry vines and a few hardwood and conifer trees. Topographically the surface of the three lots is best described as nearly level with a rolling surface descending gently to the northeast and northwest. There are isolated areas with short moderate slopes with grades measured in the field of less than 5%.
