LEROY SURVEYORS & ENGINEERS, INC.

Dos Lagos Asset, LLC
810 E. Pico Blvd, Unit B24
Los Angeles, CA. 90021
213-614-8887

August 6, 2020
Updated April 23, 2021

Geotechnical Soil Observation Report
Parcel No. 0419102118, 0419106024,
0419106025, 0419106026, 0419106028,
0419106030
Site Address – 405 39th Ave SE
LS&E Job No. 12896
Assessments Performed: 7/7/2020

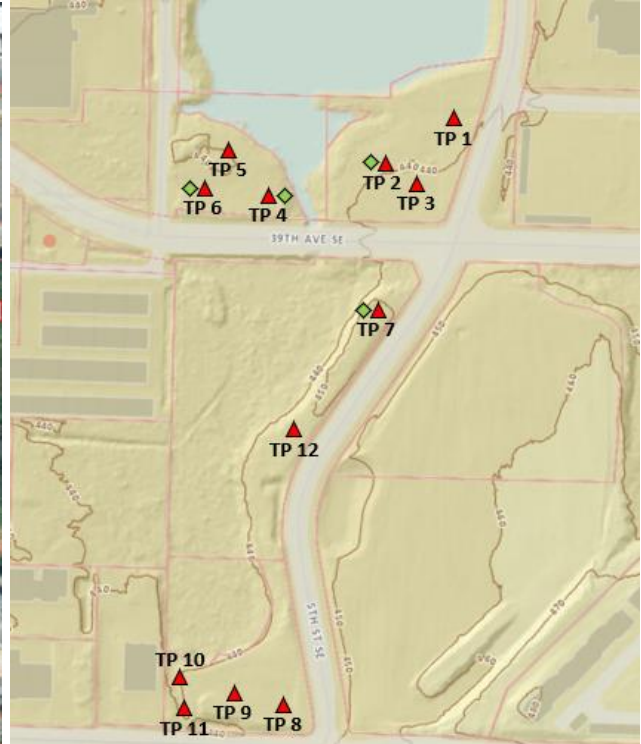
Figure 2: Test Pit (▲) and CEC Sample (◆) Locations

The sites in this project are in the City of Puyallup and situated on glacial till, flood, lacustrine, or outwash deposits. Figure 1, below, illustrates the location of individual parcels and sites of the project and Figure 2 illustrates the test locations on the sites. The site descriptions are as follows:

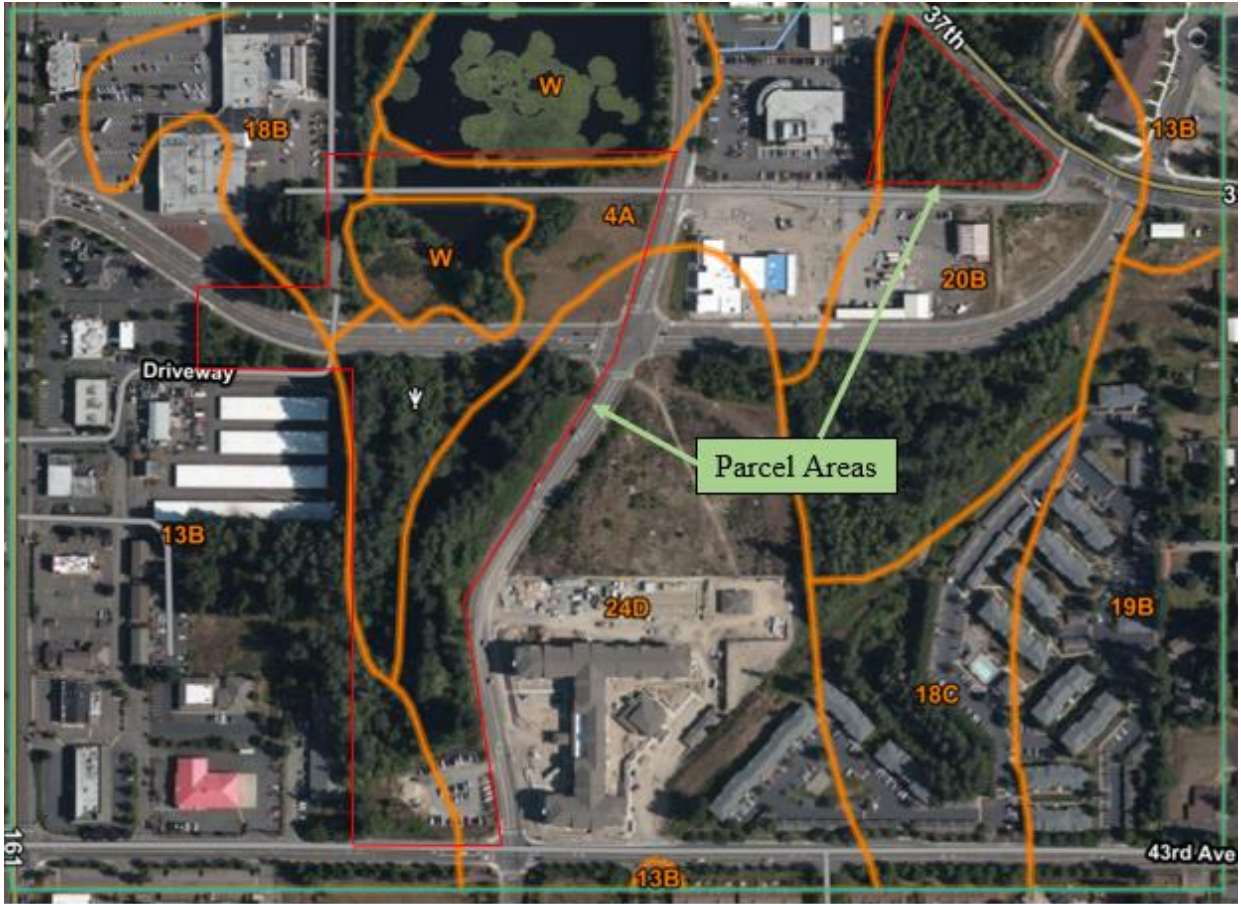
Figure 3: Site Position in NRCS Soil Mapping

As discussed in the 'Published Information Accuracy' section above; on-site reconnaissance is necessary to verify soil conditions on specific properties. Both the Survey and the geologic map describe materials of similar characteristics and origin. Per the Survey, the type of soil in Site B is Indianola loamy sand in the extreme western portion and Bellingham silty clay loam in the rest of the site; Site C is Everett very gravelly sandy loam; Site D is Bellingham silty clay loam in the lower, western portion, and Neilton gravelly loamy sand in the higher, eastern bench area (the soils found in the 8-10' depths in Site D are most likely found throughout the next lowest bench elevation on the site); Site E is Everett very gravelly sandy loam in the lower, western portion, and Neilton gravelly loamy sand in the higher, eastern portion. Our in-situ examination of soil supports the Survey and USGS findings (soil log forms to be included in final report, see Appendix A for transcribed soil logs), except that much of Site B and Site E have 3-5 feet of fill with occasional debris placed on top of the native soil. Below this is the native layers described above. Site C was not examined on-site for in-situ soil properties at this time. Find individual Test Pit Soil Log descriptions in "Attachments." Figure 3 below illustrates the site position within the soil environment.

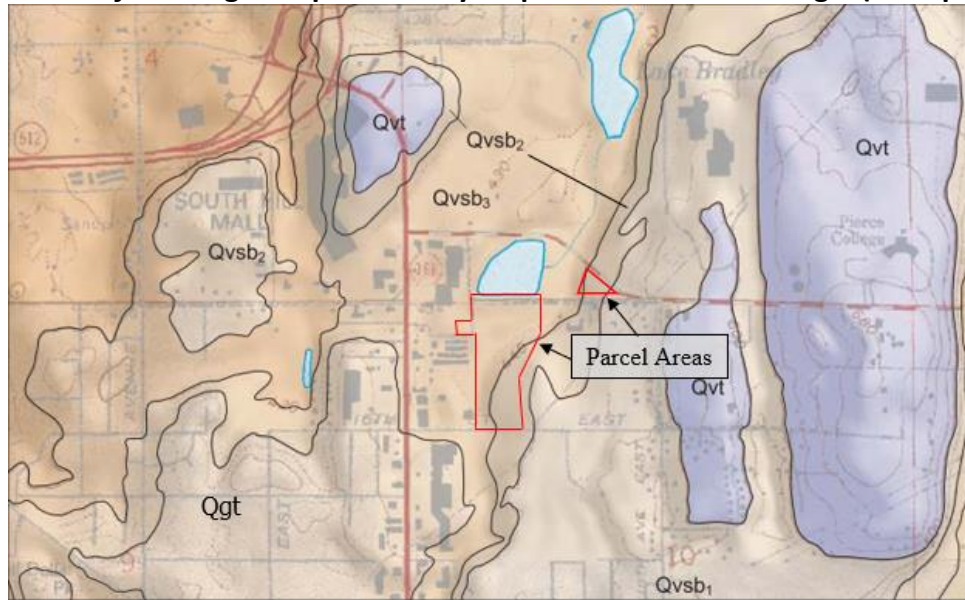
Figure 4: USGS Draft Geologic Map of the Puyallup 7.5 Minute Quadrangle (Excerpt)

The property is situated on the broad deposit of glacial outburst flood deposits that occurred during and at the end of the Vashon Stade of the Fraser glaciation period. As glacial Lake Puyallup, located at the base of the Cascade Range foothills, would fill with seasonal runoff, the valley glaciers (acting as a natural dam) would repeatedly fail releasing vast amounts of water that would erode the lowland formations and subsequently deposit new sediment as floodwater abated. This local landscape still includes Kettle depressions formed by portions of ice blocks that were trapped in place. Outwash deposits surrounded the ice blocks. Figure 4 below illustrates the site position in the regional geology.
