**SUF**  
**SOUND URBAN FORESTRY, LLC**

10/13/2025

RE: 204 4<sup>th</sup> St SW/Bell Place Tree Risk Assessment

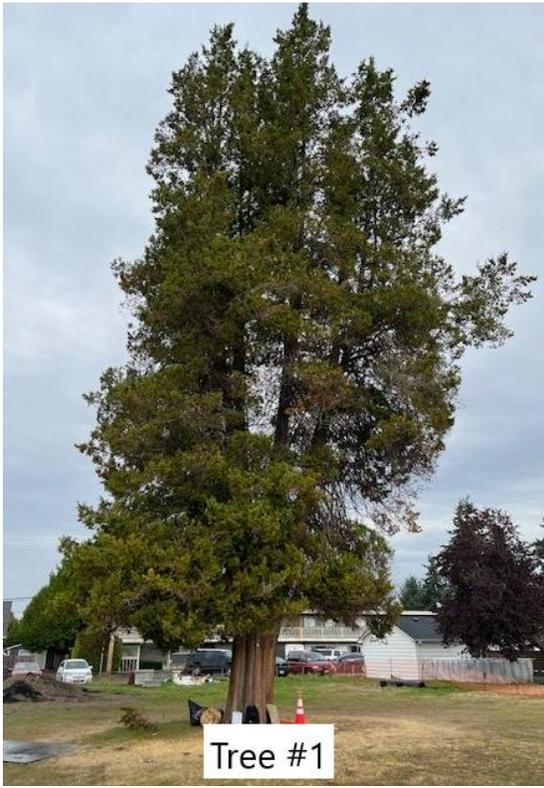
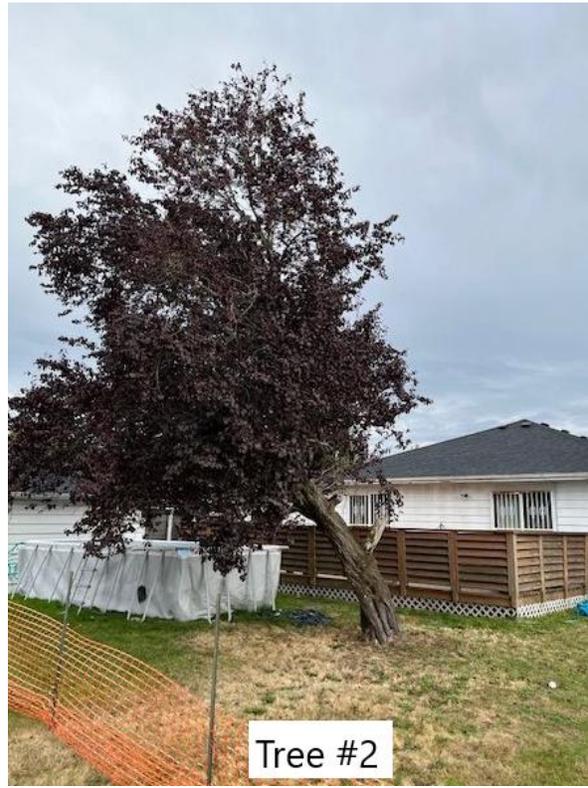
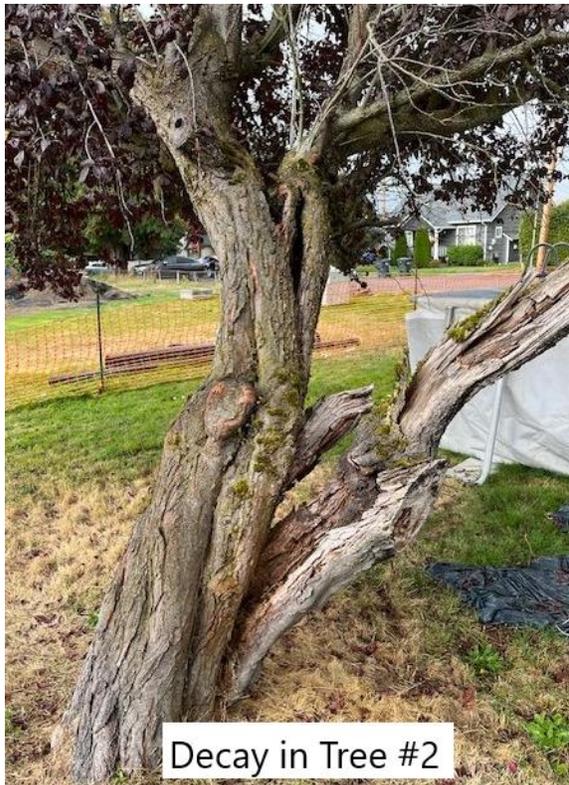
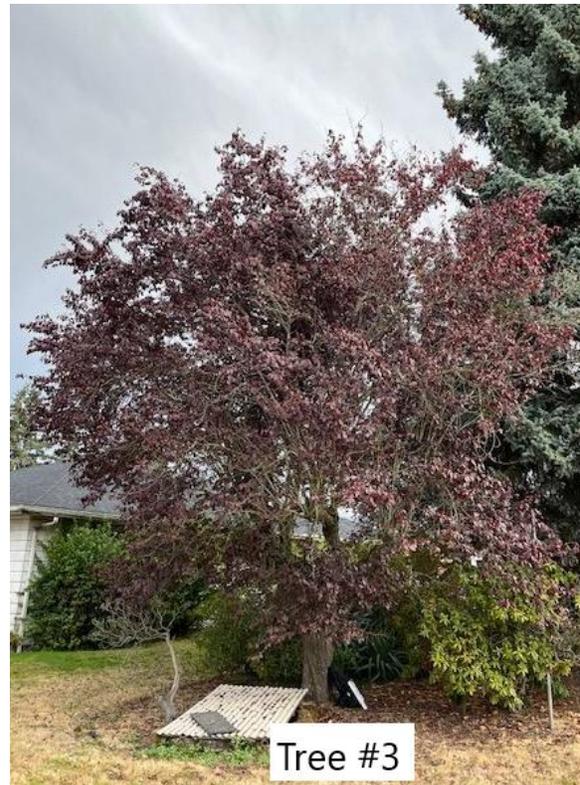
Photos

ID#	Species	DBH Height Live Canopy Ratio	Current Target(s)	Condition	Risk Rating	Comments
1	Sawara Cypress	40" 100' 35%	None	Poor	Low	Tree has been topped in the past at 45' resulting in poor upper structure. Trunk soundings indicated decay at the base on the NW side. Multiple co-dominant stems at 11' with significant inclusions (2-4') at the unions. No signs of active separation.
2	Purple Plum	15" 27' 15%	Pool Garage	Poor	Moderate	Extensive decay within the base and main stem.
3	Purple Plum	17" 25' 10%	House	Poor	Moderate	Topped in the past at 9'. Decay is found within the scaffold unions with the main stem. Trunk soundings did not indicate internal stem decay at 4' above grade.
4	Colorado Blue Spruce	22" 60' 40%	House	Poor	High	Past main stem failure at 40'. Multiple leaders originating at that point with 2' of inclusion. Trunk soundings did not indicate internal stem decay. Overall poor and unstable structure.

ID#	Species	DBH Height Live Canopy Ratio	Current Target(s)	Condition	Risk Rating	Comments
5	Colorado Blue Spruce	23" 62' 40%	House Sidewalk Street	Poor	Moderate	Past main stem failure at 50'. Co-dominant stems at that point with 3' of inclusion.
6	Purple Plum	17" 20' 10%	House	Poor	Moderate	Previously topped at 10'. Extensive decay found within the main stem and scaffold branches. Grows at an angle toward the house.

The risk ratings assigned to the assessed trees reflect their current conditions and targets. I would recommend the removal of all six trees.
