Artz Site and Soil Evaluation

Parcel No.	0419095003, 5004 & 5022
Site Address	409, 427 and 433 43rd AV SW
Site Observations	January 20, 2020

Project Description

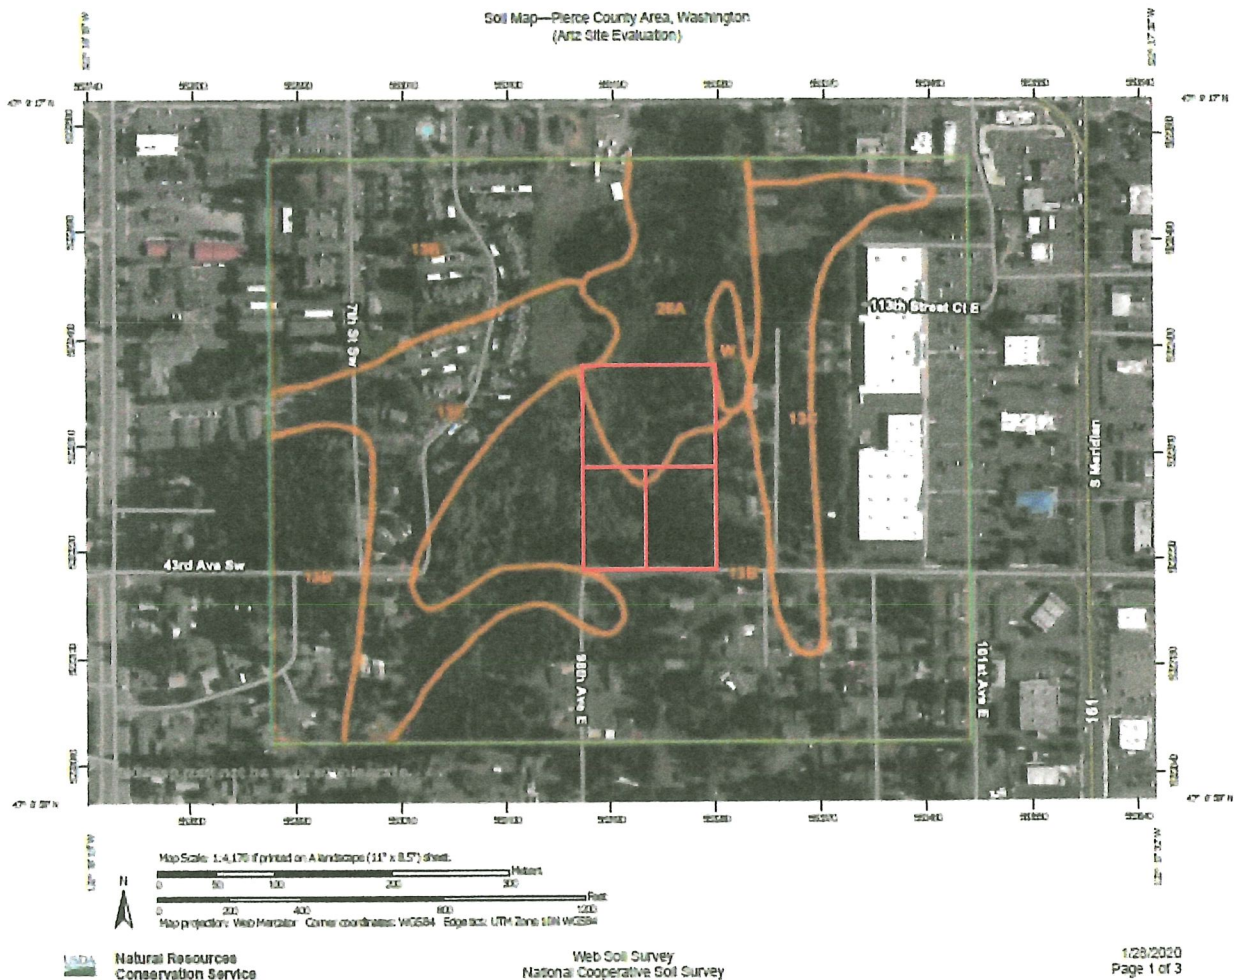
NRCS Soil Map

As discussed in the 'Published Information Accuracy' section above, on-site reconnaissance is necessary to verify soil conditions on specific properties. The NRCS identifies the soil on the two southern lots as Everett gravelly sandy loam (13B) In this case; test pits excavated north and east of the proposed structure as a

portion of the wastewater permitting phase confirmed soil typical of Everett gravelly sandy loamy.

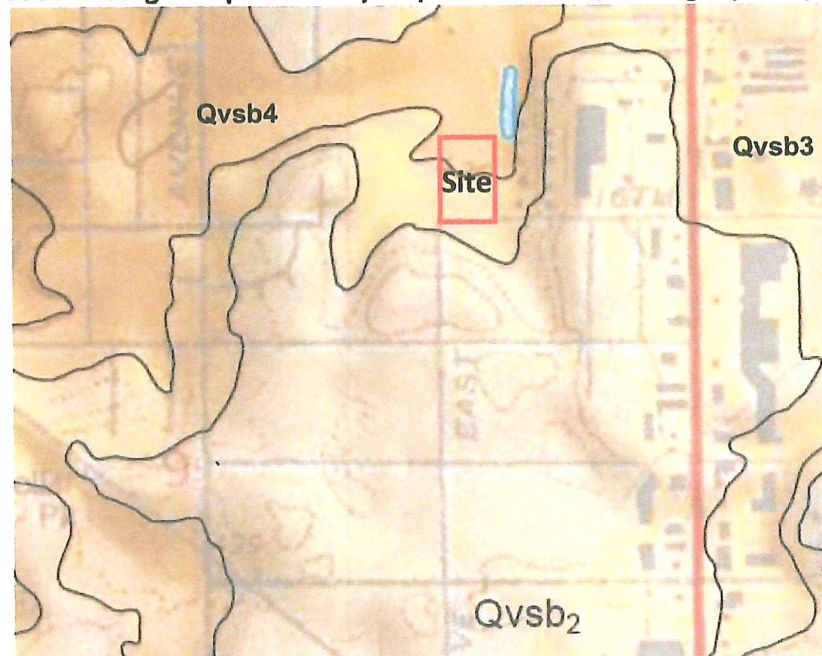
USGS Geologic Map of the Puyallup 7.5 Minute Quadrangle (Excerpt)

Troost, K.G. (In Review)

Qvs	Steilacoom Gravel of Walters and Kimmel (1968)—Sandy gravel and cobbles; clean to silty; poorly to well sorted; horizontally to cross bedded; loose to dense. Deposits vary from veneer of 1 to 15 m (3 to ~ 50 ft) thick. Deposited by multiple outburst floods from subsequently lower elevations of Glacial Lake Puyallup. Locally subdivided first by channel affiliation (Clover Creek or Bradley) and secondarily by relative age in descending series of deposits; higher number denotes younger (lower) deposit. Clover Creek channel (Bretz, 1913) begins in section 8, T19N, R4E. Bradley channel; herein named for Lake Bradley in section 3, T19N, R4E; begins in section 2, T19N, R4E. Numbering system contiguous w/adjacent Tacoma South quadrangle where multiple Clover Creek deposits are mapped (Troost, 2006). Mappable deposits consist of:
Qvs c1	Clover Creek deposit at elevation ~380 ft
Qvs b4	Bradley deposit at elevation ~400 ft

According to the USGS *Draft* Geologic Map of the Puyallup 7.5 Minute Quadrangle in Figure 2 below: this plateau region was formed by the gradual emplacement glacial drift stratigraphy; followed by the erosion of the previously emplaced glacial drift deposits by channelized glacial meltwater incision along the west side, and by ice lobe truncation within the Puyallup valley. The map shows that the slope section dipping to the northeast provides a depositional record of the pre-vashon mixed fine and coarse deposits, overlain by the Vashon advance outwash, overlain by the Vashon till, and finally overlain by the Vashon recessional outwash. The slope face represents the location where the much larger glacier within the valley truncated the slope face thus exposing a stratigraphic record of deposits. Figure 2 illustrates the site's position relative to the geology.
