Larson & Associates
surveyors, engineers and planners
9027 Pacific Avenue, Suite 4
Tacoma, WA 98444

VELASQUEZ PROPERTY

STORMWATER SITE PLAN

March 8, 2023

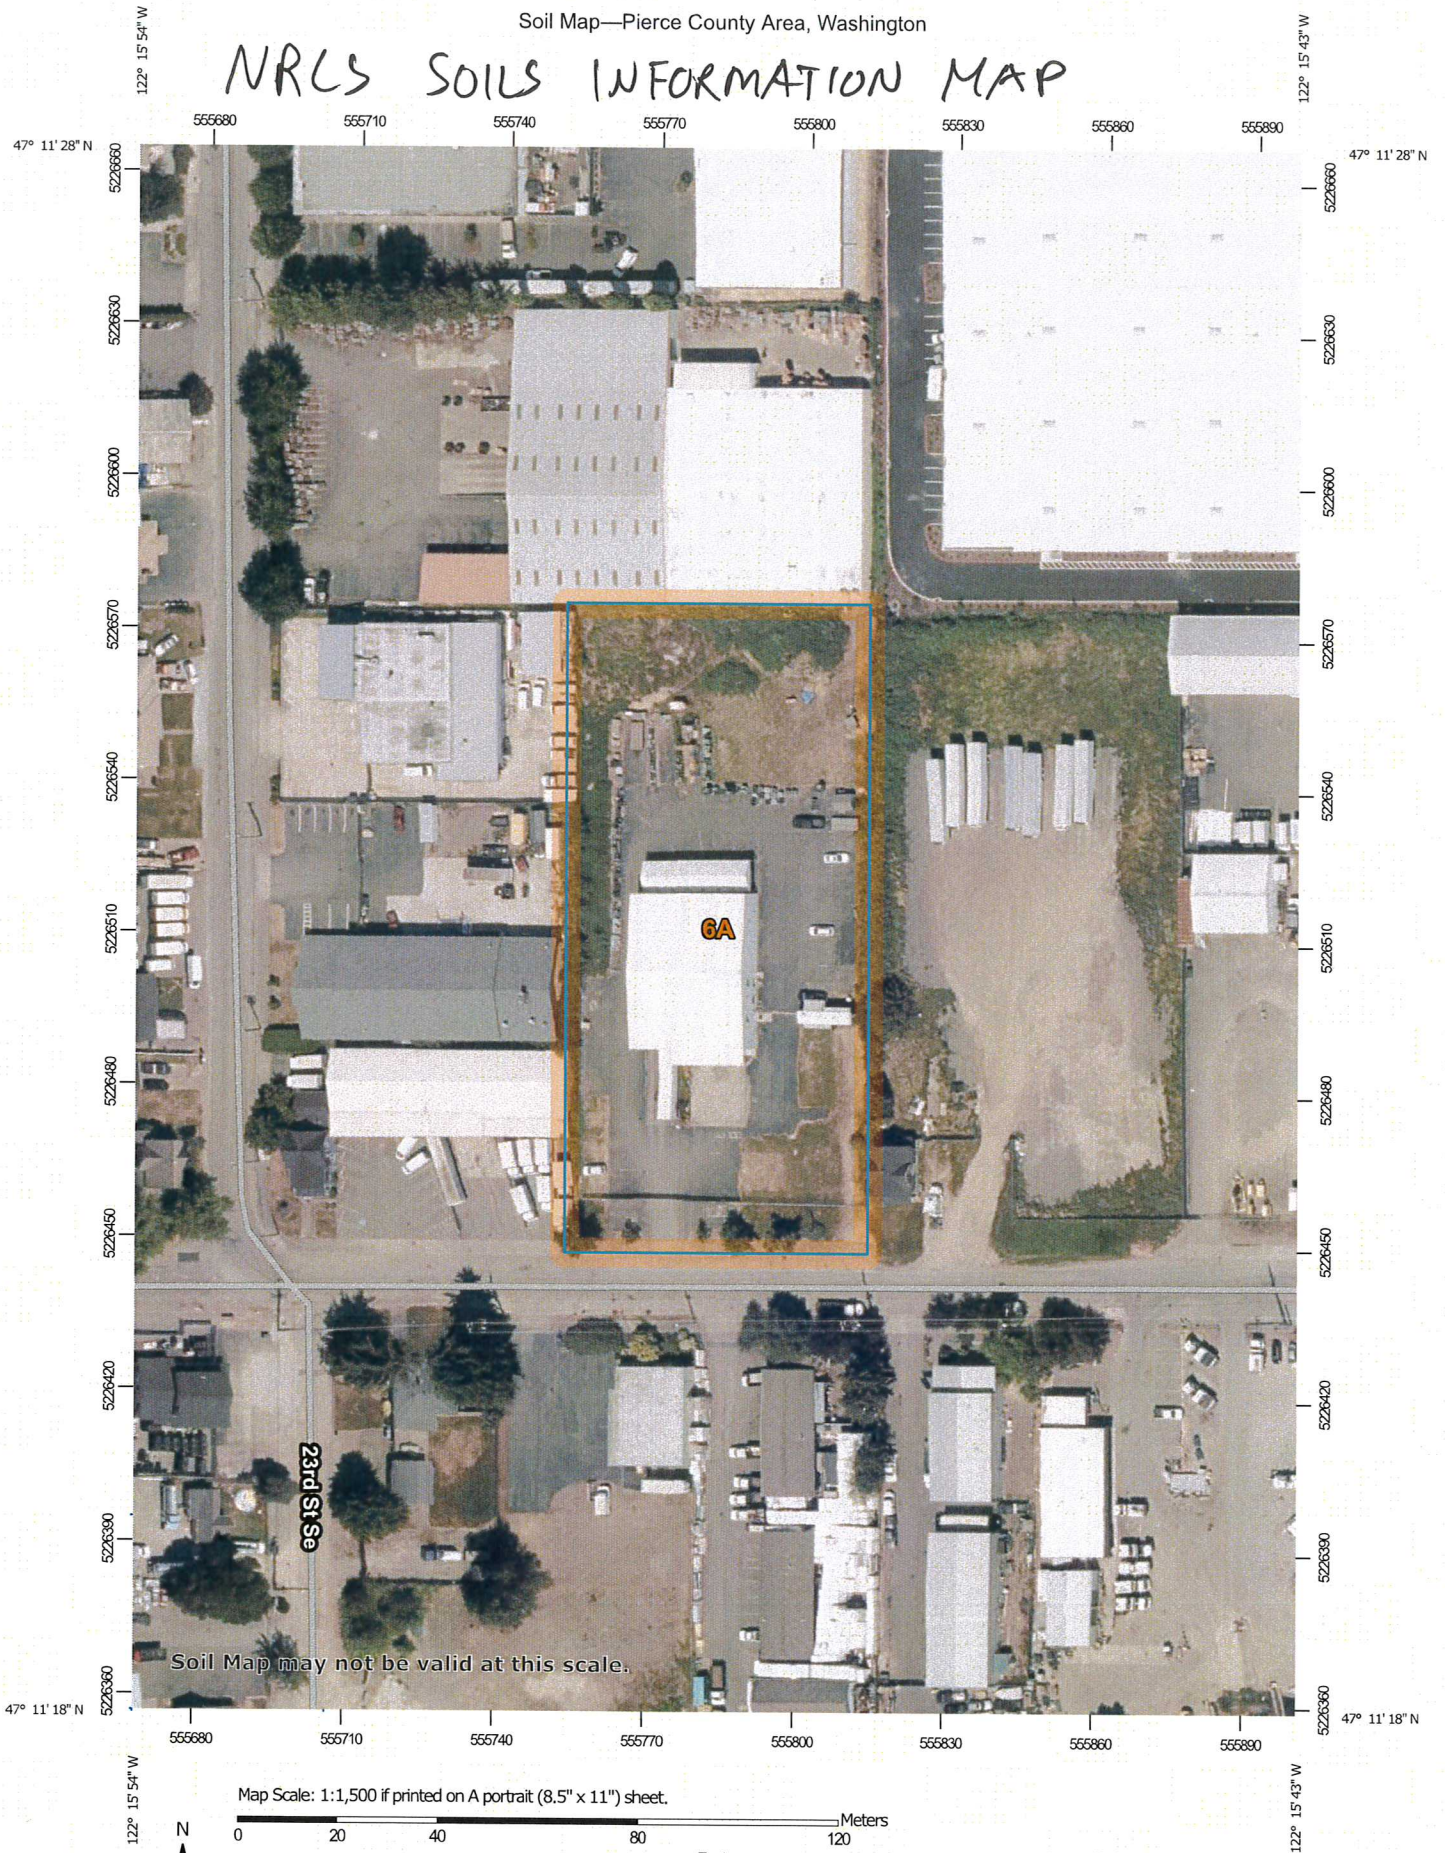
NRCS SOILS INFORMATION MAP

Map Scale: 1:1,500 if printed on A portrait (8.5" x 11") sheet.

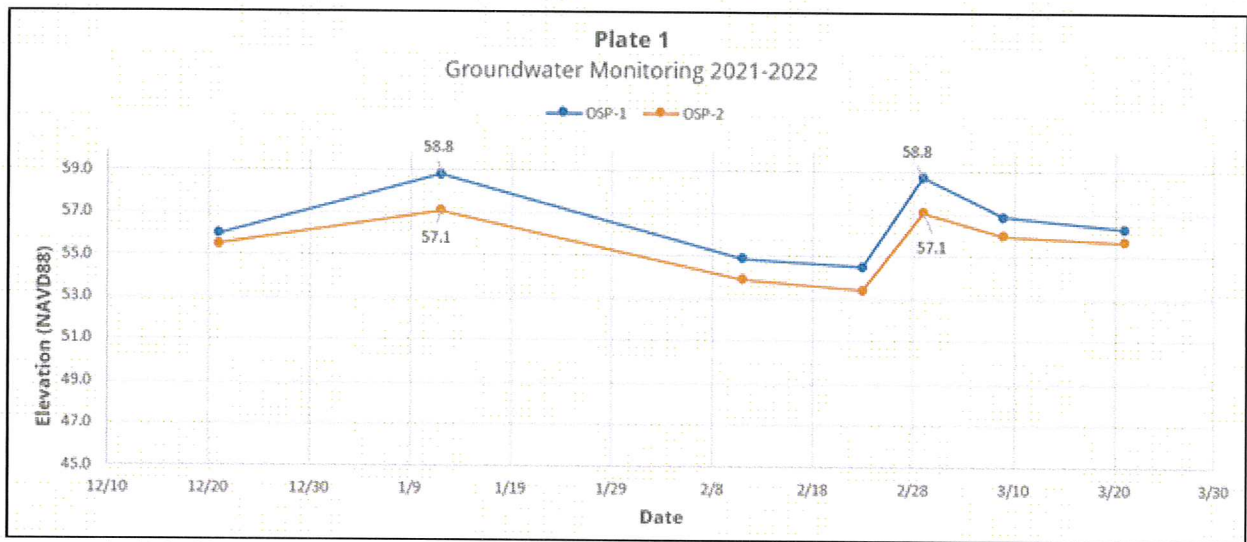
Based on our wet season monitoring, it appears that seasonal high groundwater occurs at about Elevation 59 feet (NAVD 88) at the locations monitored, approximately 1.2 feet below the ground surface. These levels were recorded on January 12, 2022 and March 1, 2022. Plate 1, below, summarizes the groundwater levels recorded as part of our groundwater monitoring program during our monitoring period.

At the time of exploration, groundwater seepage was observed at depths of 4 to 4.5 feet below existing grades. Groundwater monitoring wells were installed at the site at the time of exploration. The locations of the observation wells are shown on the Site & Exploration Plan, Figure 2. Groundwater readings for the observation wells were manually measured on a bi-monthly basis from December 21, 2021 to March 21, 2022.

We anticipate fluctuations in the local groundwater levels will occur in response to precipitation patterns, off site construction activities, and site utilization. As such, water level observations made at the time of our field investigation may vary from those encountered during the construction phase. Analysis or modeling of anticipated groundwater levels during construction is beyond the scope of this report.

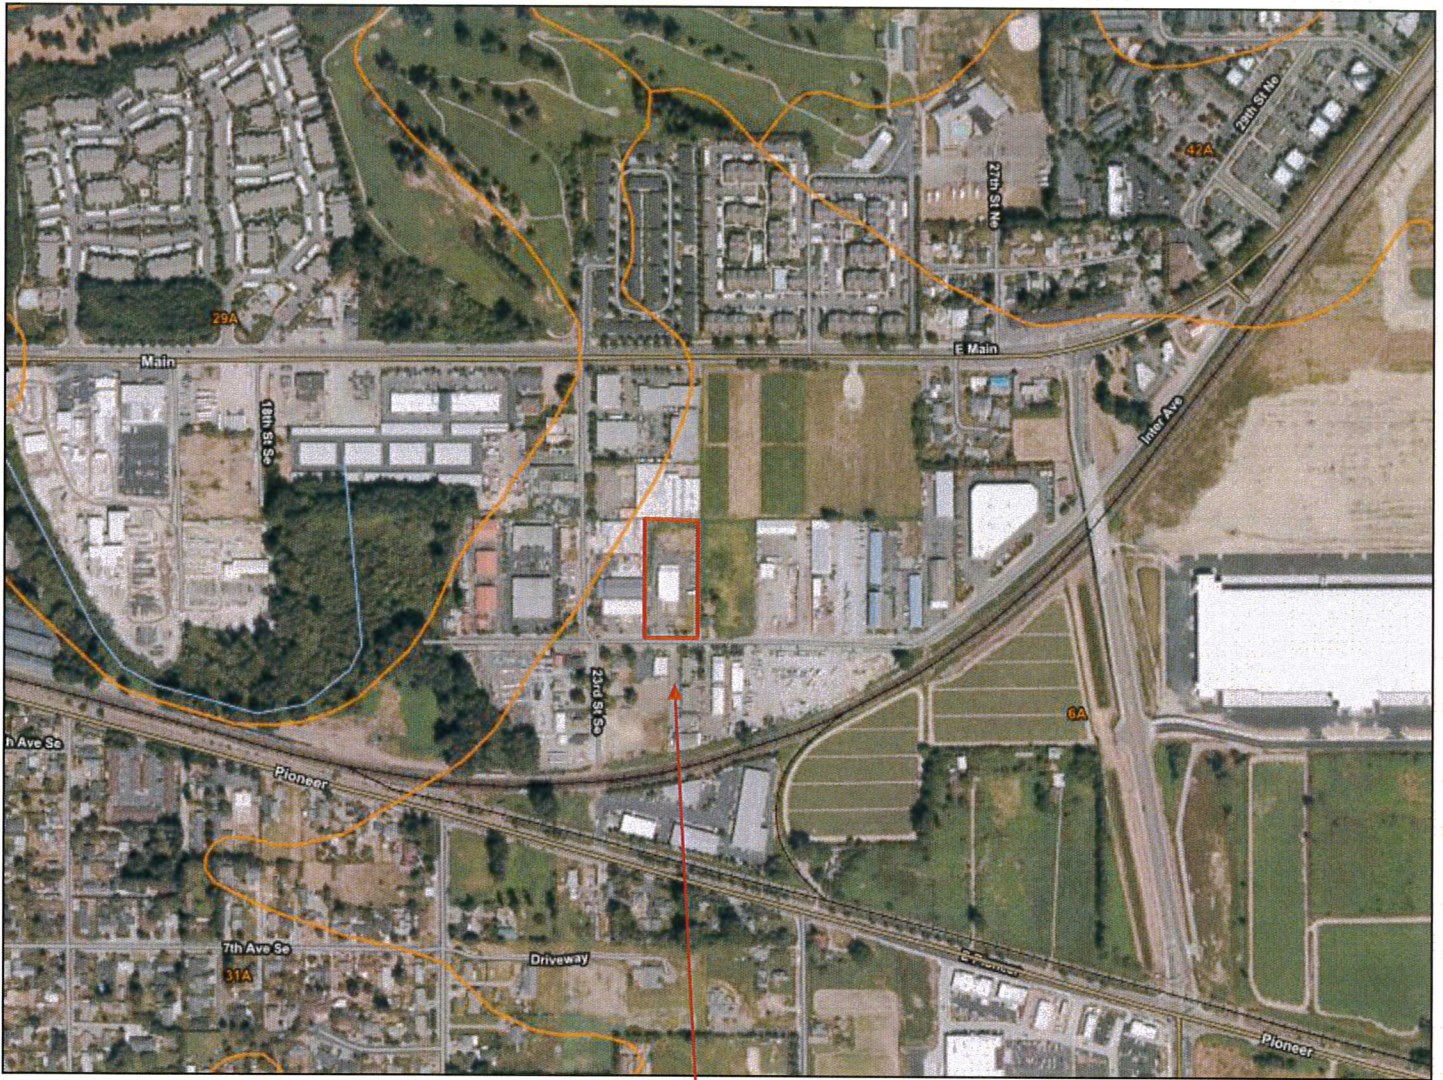
Figure 3

Approximate Site Location

Map created from Web Soil Survey (<http://websoilsurvey.sc.egov.usda.gov/App/WebSoilSurvey.aspx>)

NRCS Soils Map
 Proposed Commercial Development
 2315 Inter Avenue
 Puyallup, Washington
 PN: 2105200140

The USDA Natural Resource Conservation Services (NRCS) Web Soil Survey maps the site as being underlain by Briscot loam soils (6A). The Briscot soil type 6A is derived from alluvium, form on slopes of 0 to 2 percent and has a "slight" potential for erosion when exposed. The upper, weathered soil horizons are listed in hydrologic soils group B, while the deeper soil horizons are listed in hydrologic soils group D. A copy of the referenced NRCS Soils Map for the site area is included as Figure 3.
