February 3, 2023

Taco Time Northwest  
3401 Lind Avenue SW  
Renton, Washington 98057

Updated Soils Report  
Proposed Restaurant  
1115 & 1129 East Main  
Puyallup, Washington  
PN: 7845100032 & 0420271171  
Doc ID: TacoTimeNorthwest.EMainSt.SRu

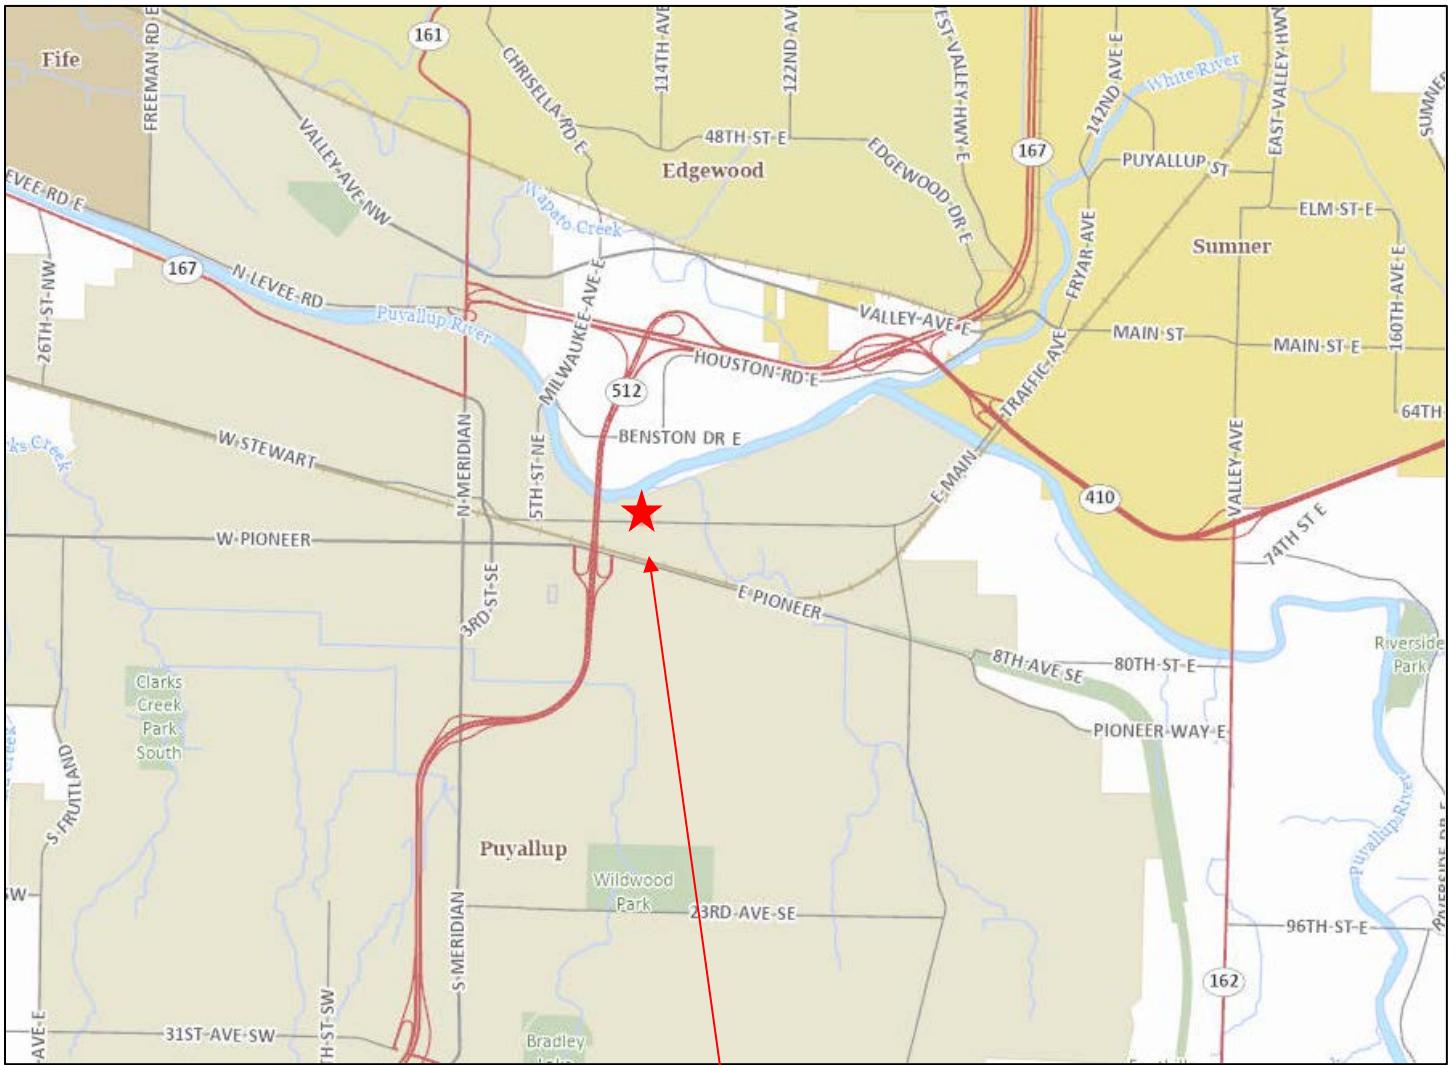
**Site Location Map**

**Approximate Site Location**

Map created from Pierce County Public GIS (<https://matterhornwab.co.pierce.wa.us/publicgis/>)

This *Updated Soils Report* summarizes our site observations and geotechnical data review, and addresses the feasibility of stormwater infiltration for the proposed restaurant to be constructed at 1115 and 1129 East Main in Puyallup, Washington. The approximate site location is shown on Figure 1.

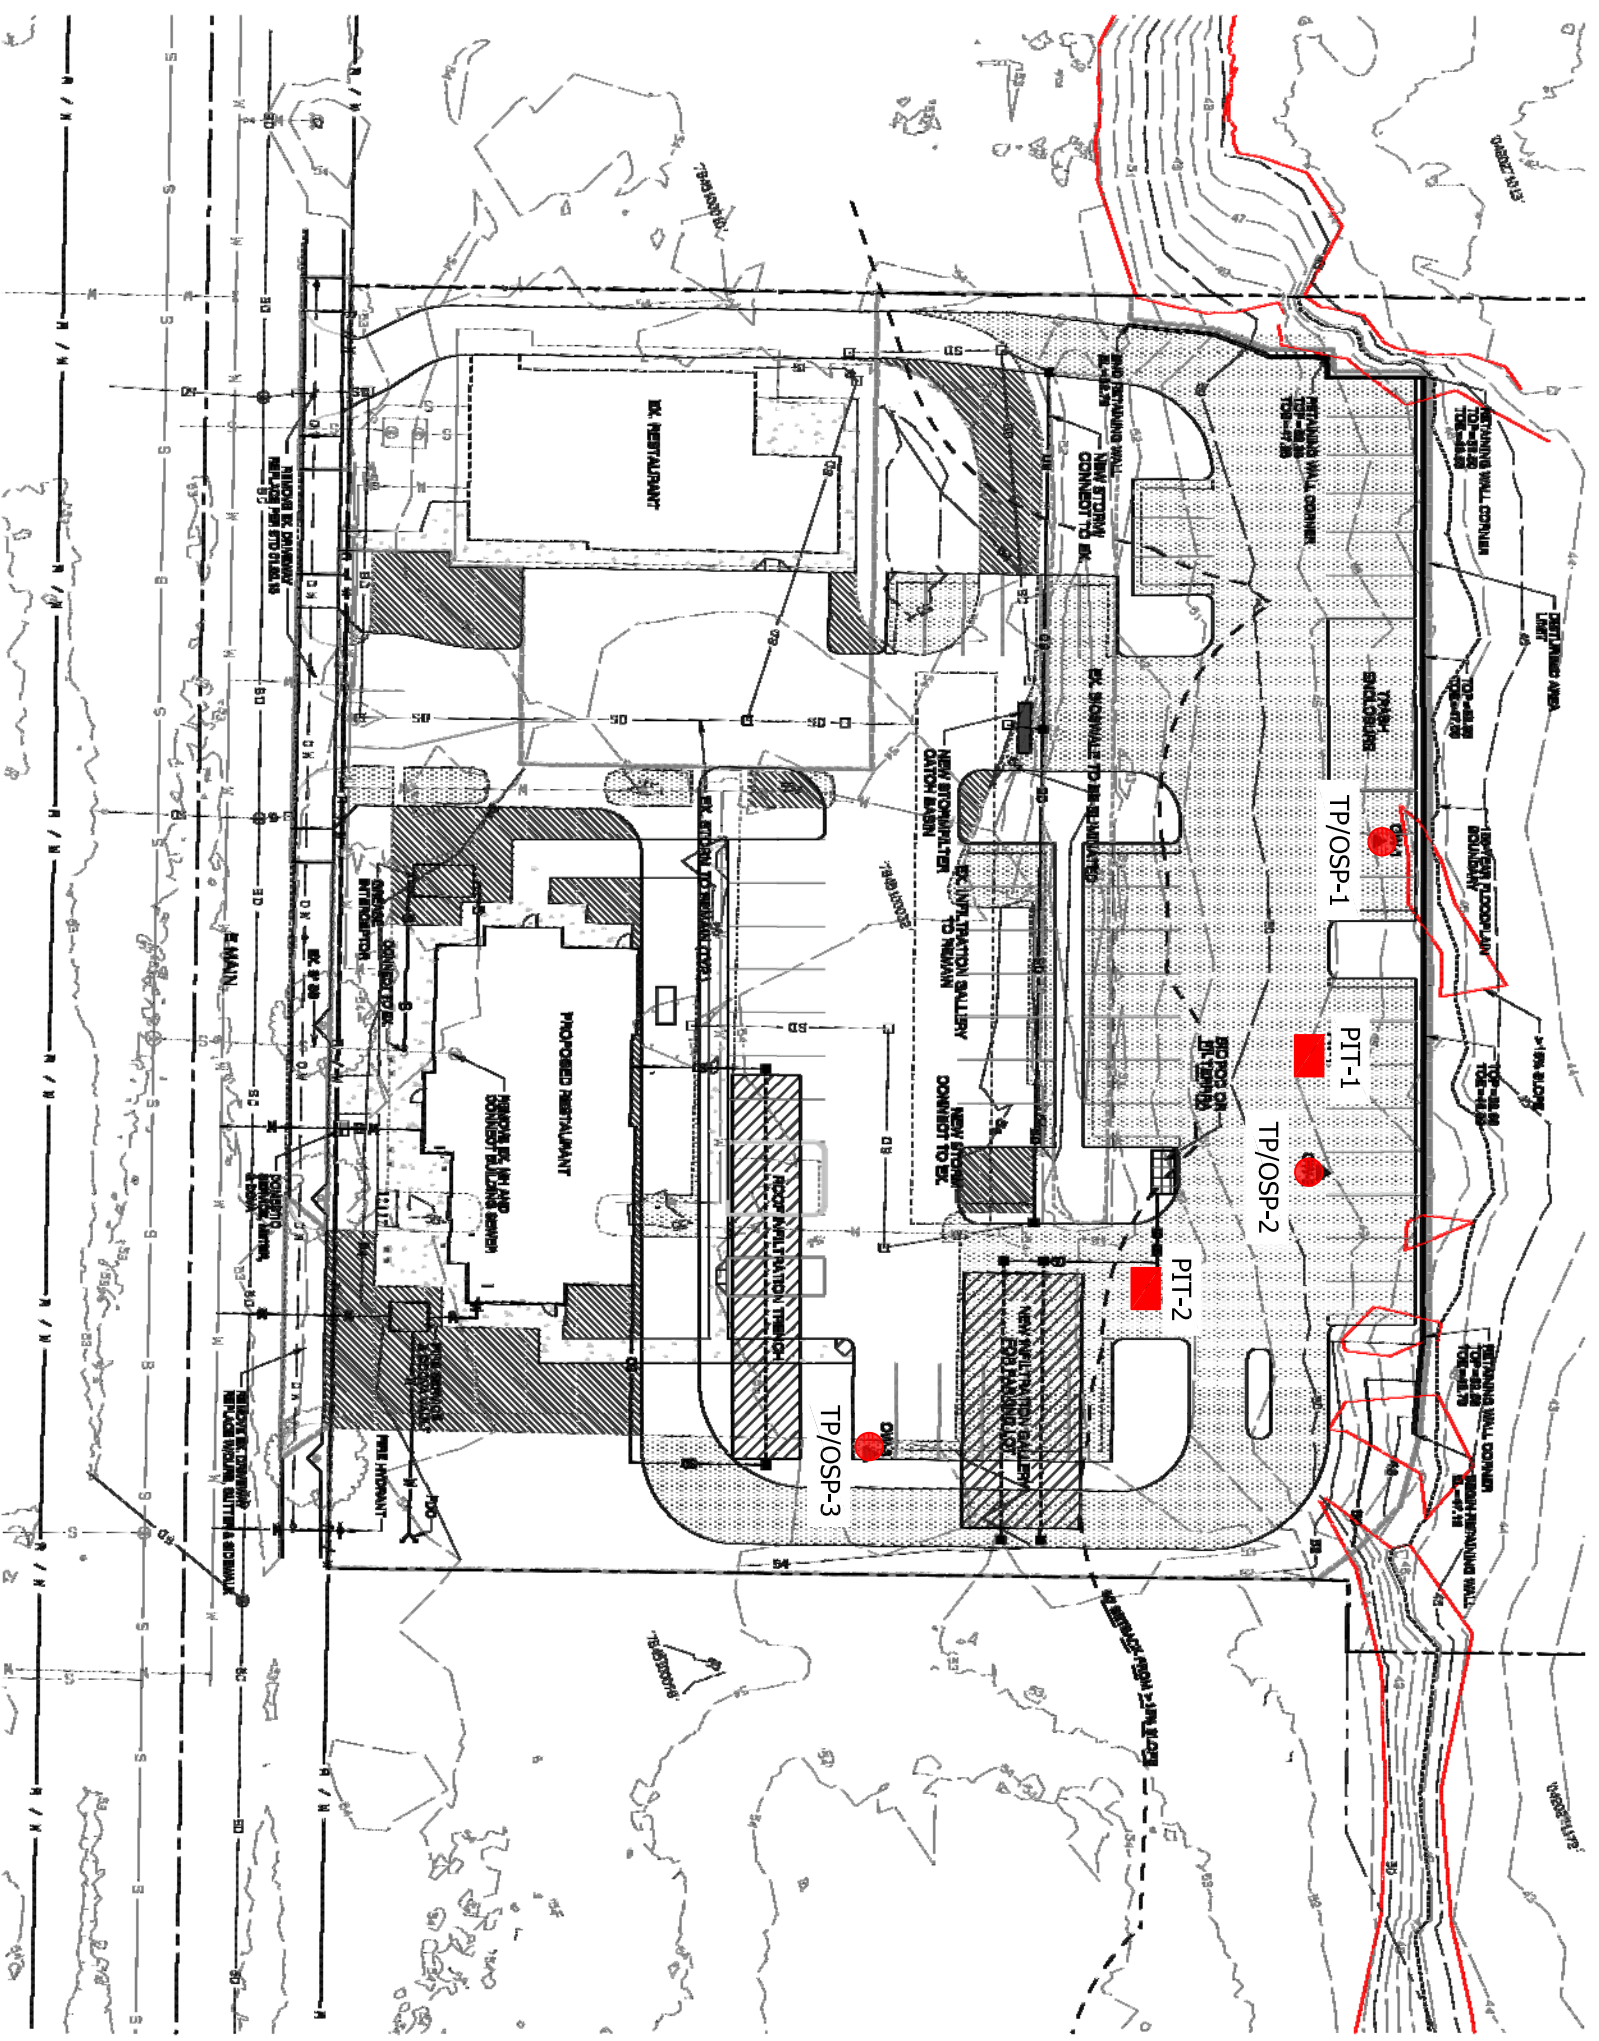
Site & Exploration Plan  
 1115 & 1129 East Main  
 Puyallup, Washington  
 PN: 7845100032 & 0420271171

- TP/OSP - # Test Pit/ Open Standpipe Piezometer number and approximate location
- PIT - # Pilot Infiltration Test number and approximate location

Notes:  
 Site plan prepared by Azure Green  
 Consultants dated February 2,  
 2023.

Based on topographic information obtained from Pierce County Public GIS and our site observations, the ground surface of the site generally slopes down to the north. In the southern portion of the site, in the area of the existing commercial development, the ground surface is relatively level. In the central portion of the site, the ground surface slopes down to the north at approximately 4 to 8 percent. These slopes continue at similar inclinations throughout the northern portion of the site. The total topographic relief of the site is on the order of approximately 15 feet. The existing site configuration and topography are shown on the Site & Exploration Map, Figure 2 and Site Vicinity Map, Figure 3.

indicated on the attached Site & Exploration Map, Figure 2. The USCS is included in Appendix A as Figure A-1, while the descriptive logs of our test pits and PITs are included as Figures A-2 through A-4.

We performed two small scale Pilot Infiltration Tests (PITs) in the area of the parking lot infiltration gallery (PIT-1) and the proposed roof Infiltration area (PIT-2) in accordance with the 2019 SWMMWW. The approximate location of each Small-Scale PIT is labeled on the attached Site & Exploration Plan, Figure 2.

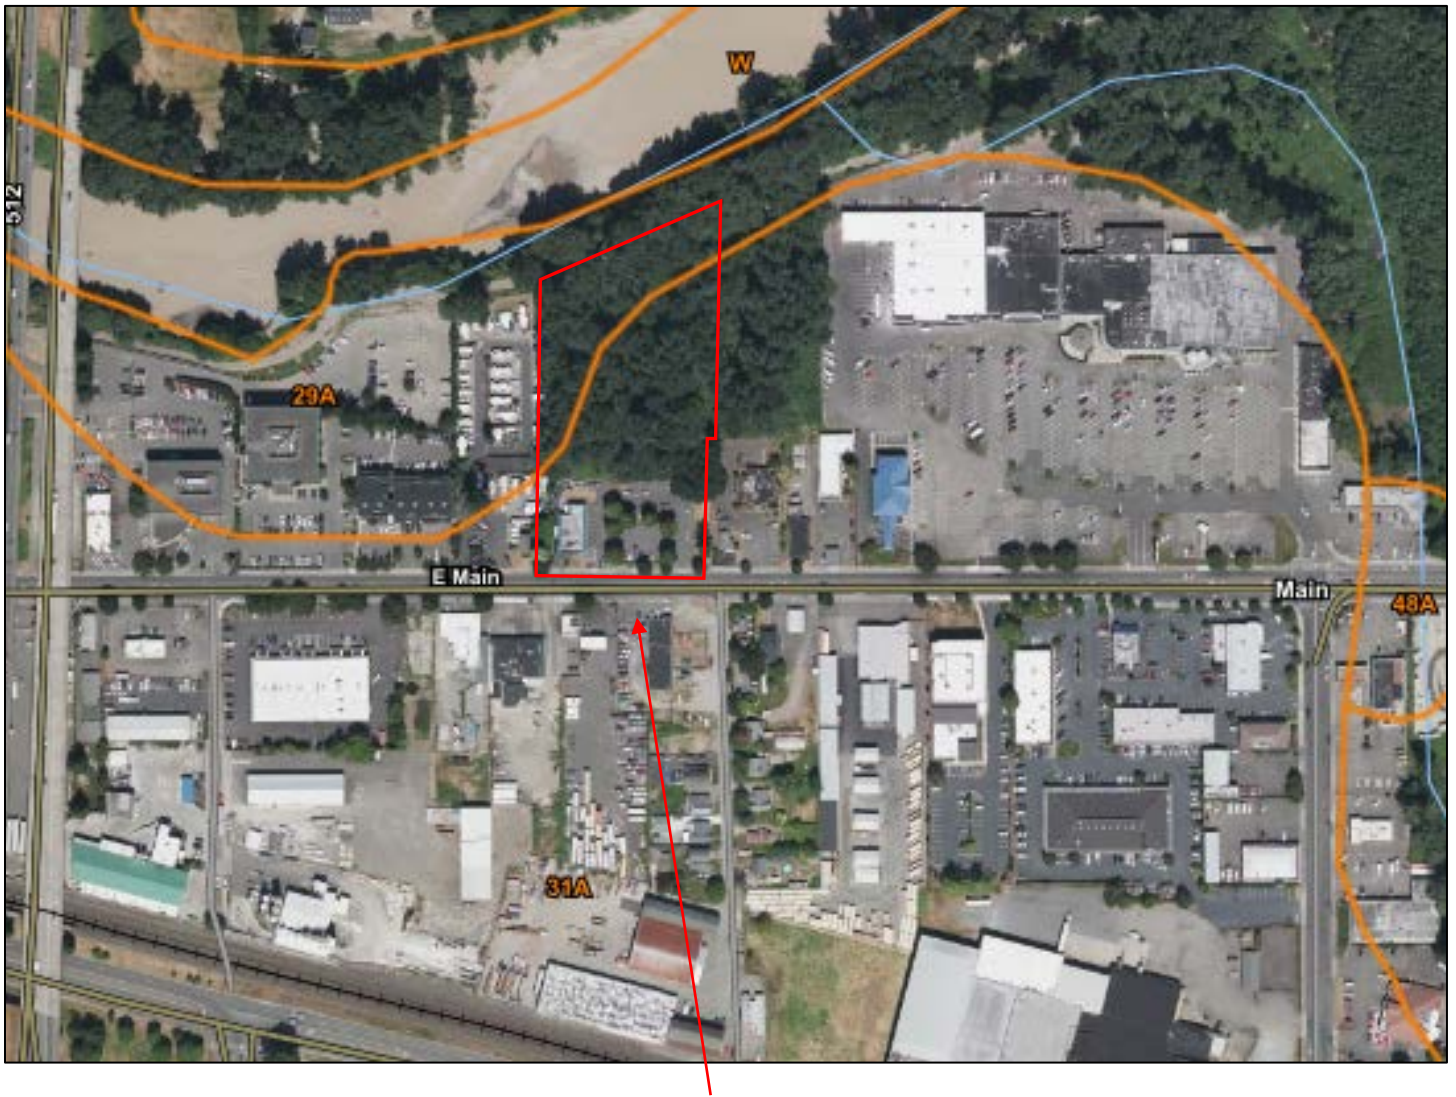
**NRCS Soils Map**  
 Proposed Taco Time  
 1115 & 1129 East Main  
 Puyallup, Washington  
 PN: 7845100032 & 0420271171

### Approximate Site Location

Map created from Web Soil Survey (<http://websoilsurvey.sc.egov.usda.gov/App/WebSoilSurvey.aspx>)

Soil Type	Soil Name	Parent Material	Slopes	Erosion Hazard	Hydrologic Soils Group
W	Water	-	-	-	-
29A	Pilchuck fine sandy loam	Mixed alluvium under hardwoods and conifers	<3	None	C
31A	Puyallup fine sandy loam	Alluvium	0 to 3	Slight	A

The Natural Resource Conservation Service (NRCS) Web Soil Survey maps the site as being underlain by Pilchuck fine sandy loam (29A) and Puyallup sandy loam (31A). Detailed descriptions of the above listed soil types are included below. A copy of the NRCS soils map is included as Figure 4.

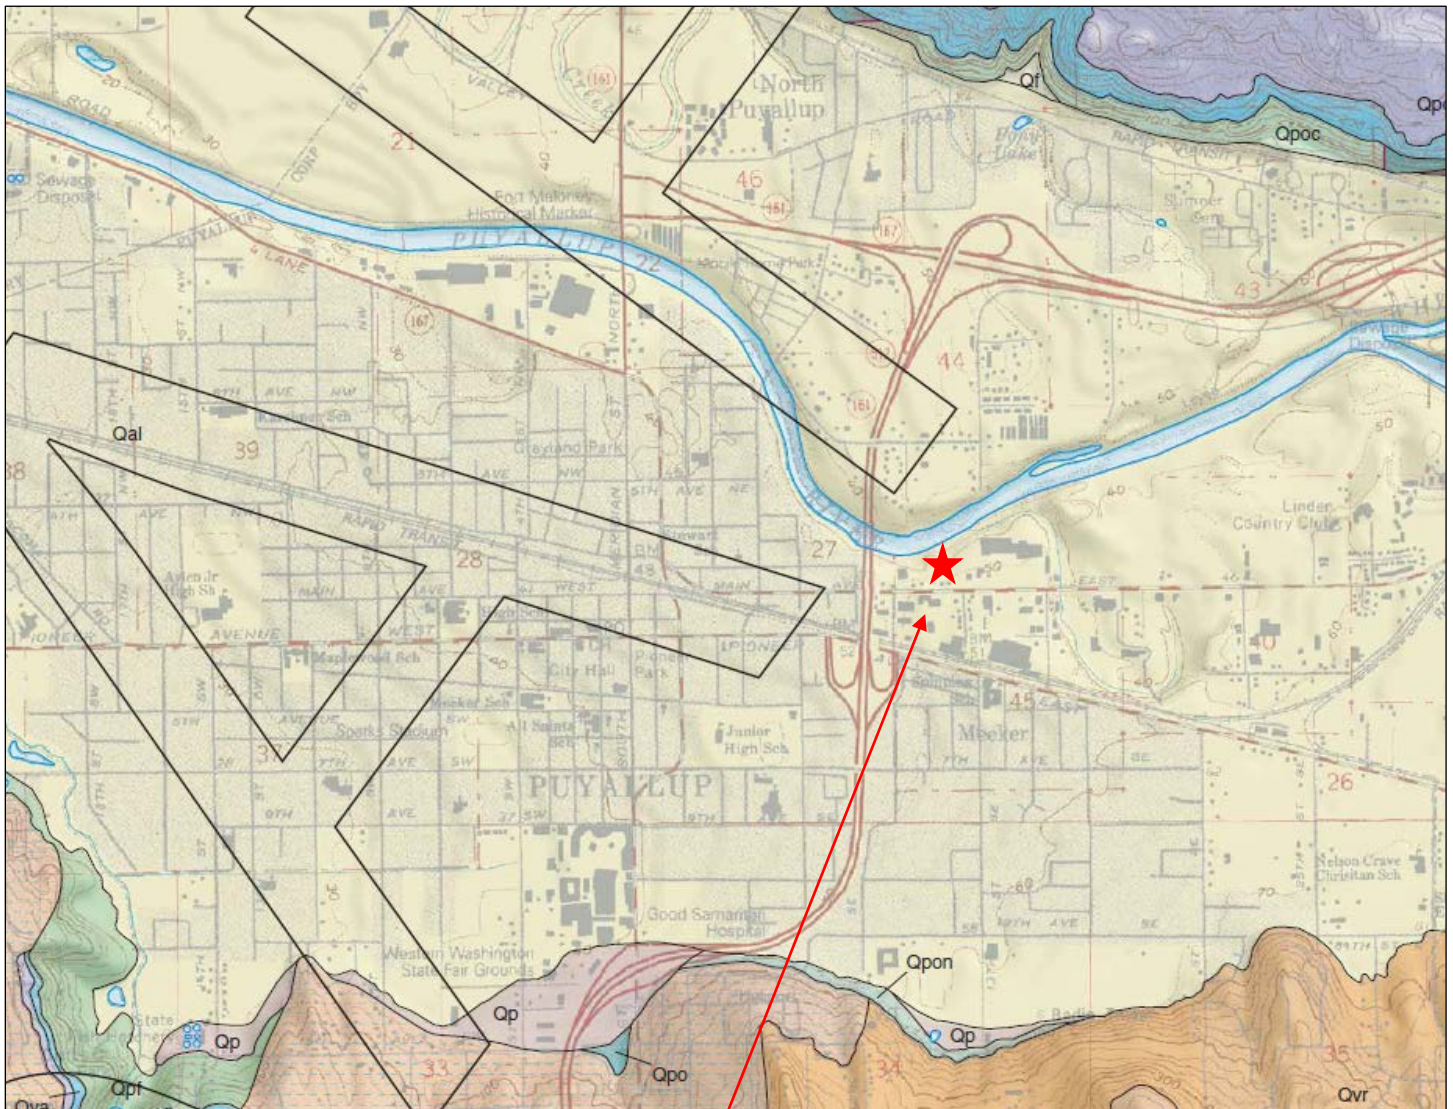
**Geologic Map**

**Approximate Site Location**

Excerpt from the draft *Geologic Map of the Puyallup 7.5-Minute Quadrangle, Washington*  
 By Troost, K.G. (in review)

According to the *draft Geologic map of the Puyallup 7.5-minute Quadrangle, Washington* by Troost, (in review) the site is mapped as being underlain by Quaternary Alluvium (Qal). A detailed description of the geologic unit is included below. An excerpt from the geologic map is included as Figure 5.

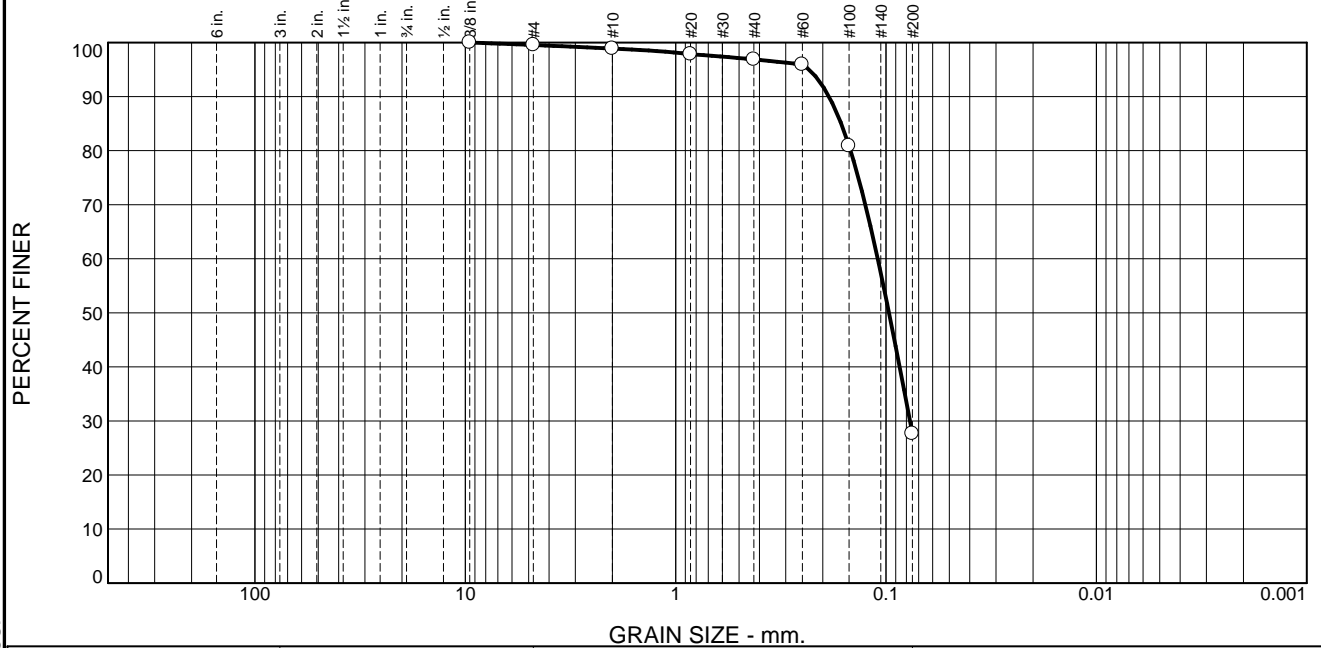
# Particle Size Distribution Report

% +3"	% Gravel		% Sand			% Fines	
	Coarse	Fine	Coarse	Medium	Fine	Silt	Clay
0.0	0.0	0.5	0.6	2.0	69.2	27.7

Test Results (ASTM D 6913 & ASTM D 1140)			
Opening Size	Percent Finer	Spec.* (Percent)	Pass? (X=Fail)
0.375	100.0		
#4	99.5		
#10	98.9		
#20	97.8		
#40	96.9		
#60	95.9		
#100	80.9		
#200	27.7
