> Updated Soils Report Proposed Restaurant 1115 & 1129 East Main Puyallup, Washington PN: 7845100032 & 0420271171 Doc ID: TacoTimeNorthwest.EMainSt.SRu

This **Updated** Soils Report summarizes our site observations and geotechnical data review, and addresses the feasibility of stormwater infiltration for the proposed restaurant to be constructed at 1115 and 1129 East Main in Puyallup, Washington. The approximate site location is shown on Figure 1.

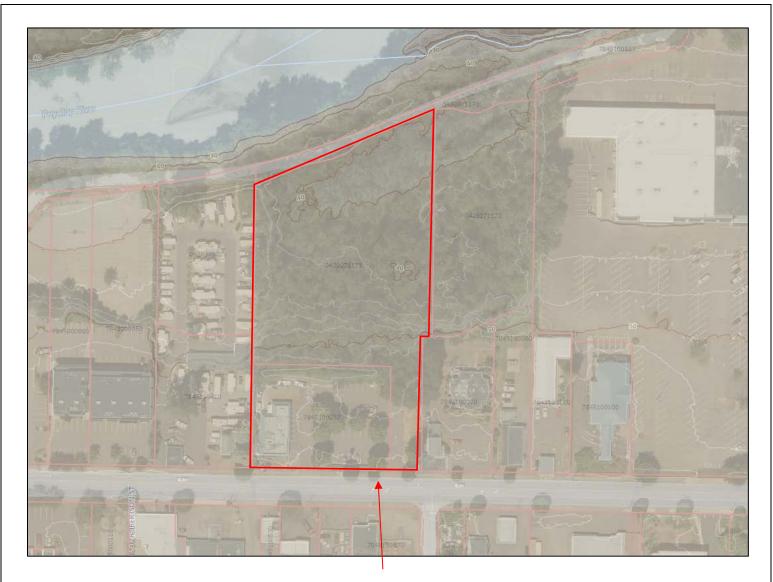
Figure 3

### **Approximate Site Location**

Map created from Peirce County Public GIS (https://matterhornwab.co.pierce.wa.us/publicgis/)

Based on topographic information obtained from Pierce County Public GIS and our site observations, the ground surface of the site generally slopes down to the north. In the southern portion of the site, in the area of the existing commercial development, the ground surface is relatively level. In the central portion of the site, the ground surface slopes down to the north at approximately 4 to 8 percent. These slopes continue at similar inclinations throughout the northern portion of the site. The total topographic relief of the site is on the order of approximately 15 feet. The existing site configuration and topography are shown on the Site & Exploration Map, Figure 2 and Site Vicinity Map, Figure 3.

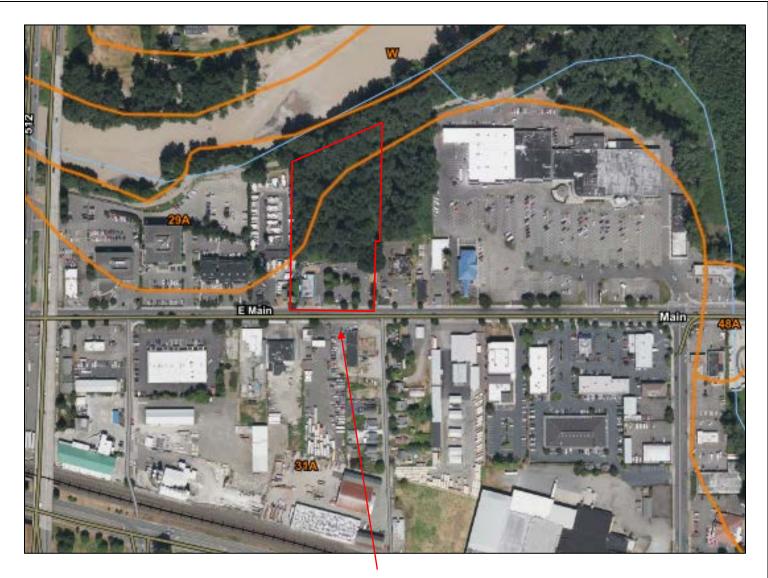
Figure 4

Map created from Web Soil Survey (http://websoilsurvey.sc.egov.usda.gov/App/WebSoilSurvey.aspx)

Soil Type	Soil Name	Parent Material	Slopes	Erosion Hazard	Hydrologic Soils Group	
w	Water	-	-	-	-	
29A	Pilchuck fine sandy loam	Mixed alluvium under hardwoods and conifers	<3	None	С	
31A	Puyallup fine sandy loam	Alluvium	0 to 3	Slight	А

The Natural Resource Conservation Service (NRCS) Web Soil Survey maps the site as being underlain by Pilchuck fine sandy loam (29A) and Puyallup sandy loam (31A). Detailed descriptions of the above listed soil types are included below. A copy of the NRCS soils map is included as Figure 4.
