# STORMWATER SITE PLAN REPORT

## STEP BY STEP EARLY LEARNING CENTER

C&A PROJ # 21-003

JULY 9, 2024

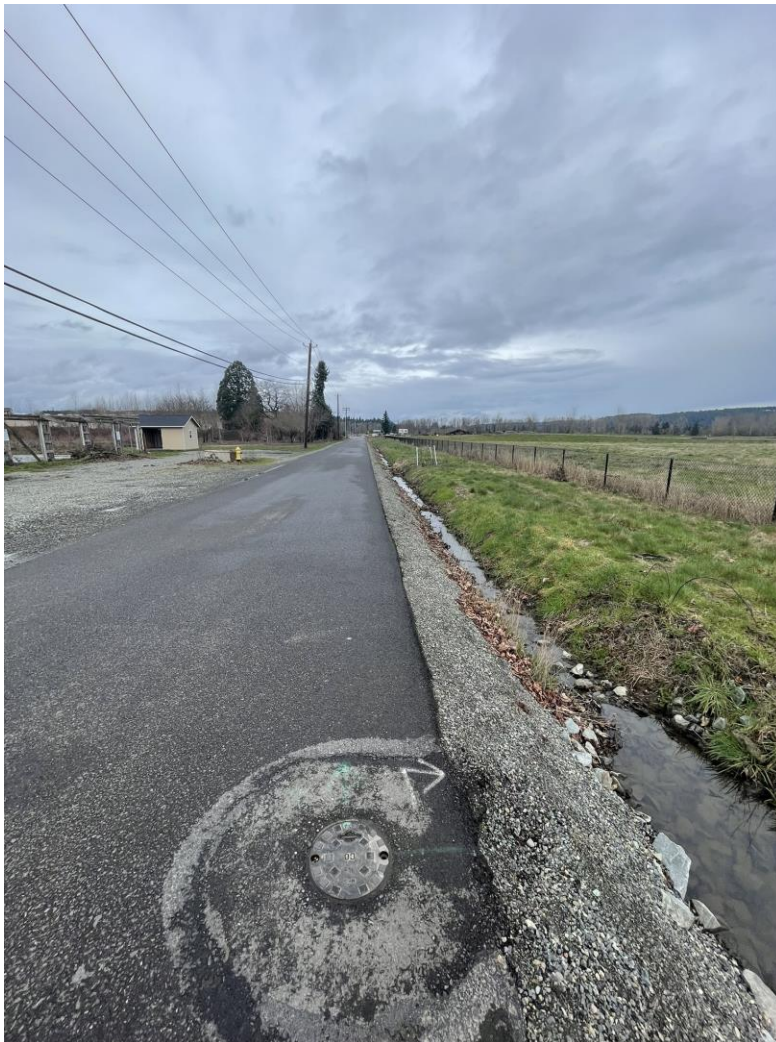
A photo looking north along 33<sup>rd</sup> Street SE from the project outfall is shown below.

The site discharges via culvert on the east side of 33<sup>rd</sup> Street SE and flows north for approximately 680–feet to the 5<sup>th</sup> Avenue SE intersection. There the ditch drains into a relatively new 24–inch diameter storm line that conveys runoff north for approximately 700–feet where to the 75<sup>th</sup> Street E intersection (3–way intersection). Runoff turns west in a 36–inch diameter line for approximately 30–feet. Then turns north again in a 42–inch line. Runoff generally continues in a 42–inch storm line until it discharges to the Puyallup River.

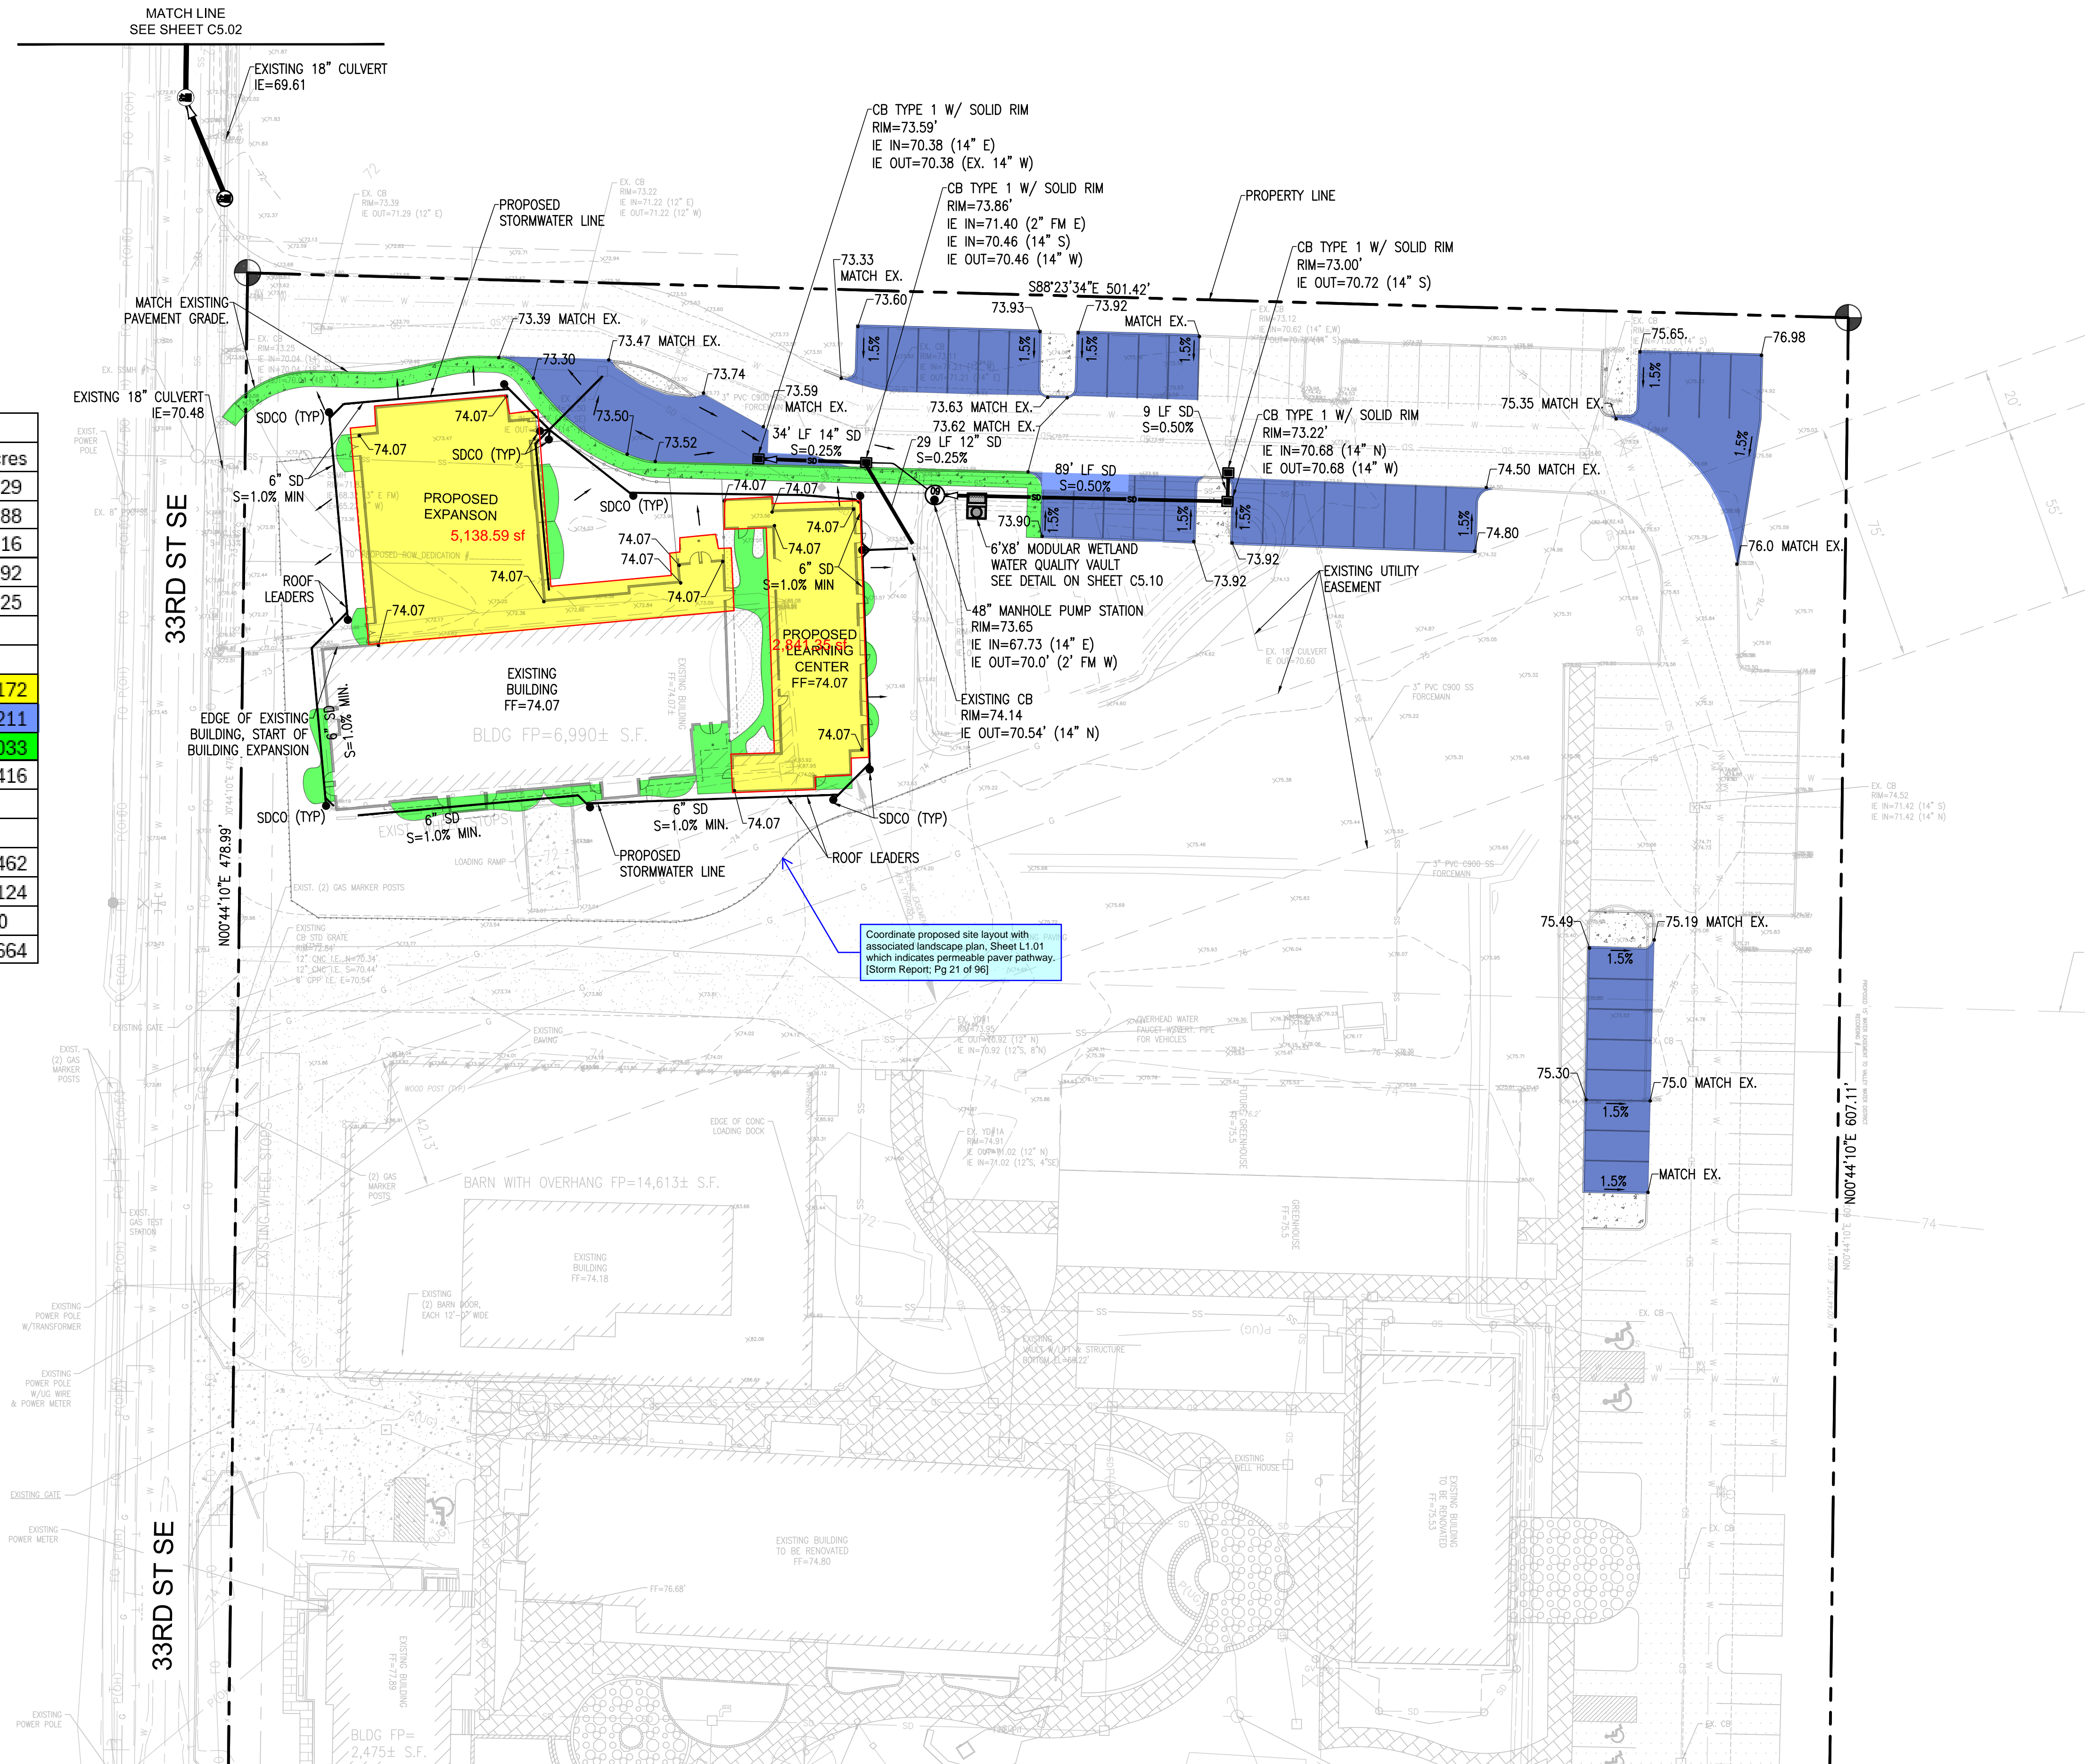
Existing Site Characteristics		
	SF	Acres
Roof Area		1.29
Other Hard Surface Area		1.88
Pond Area		0.16
Vegetated Area		2.92
Total Site		6.25
Project Improvements		
New Roof Area	7,490	0.172
New Parking Area	9,185	0.211
New Walkway Area	1,431	0.033
Total New Impervious Area	18,106	0.416
Developed Site Characteristics		
Roof Area		1.462
Other Hard Surface Area		2.124
Pond Area		0
Vegetated Area		2.664

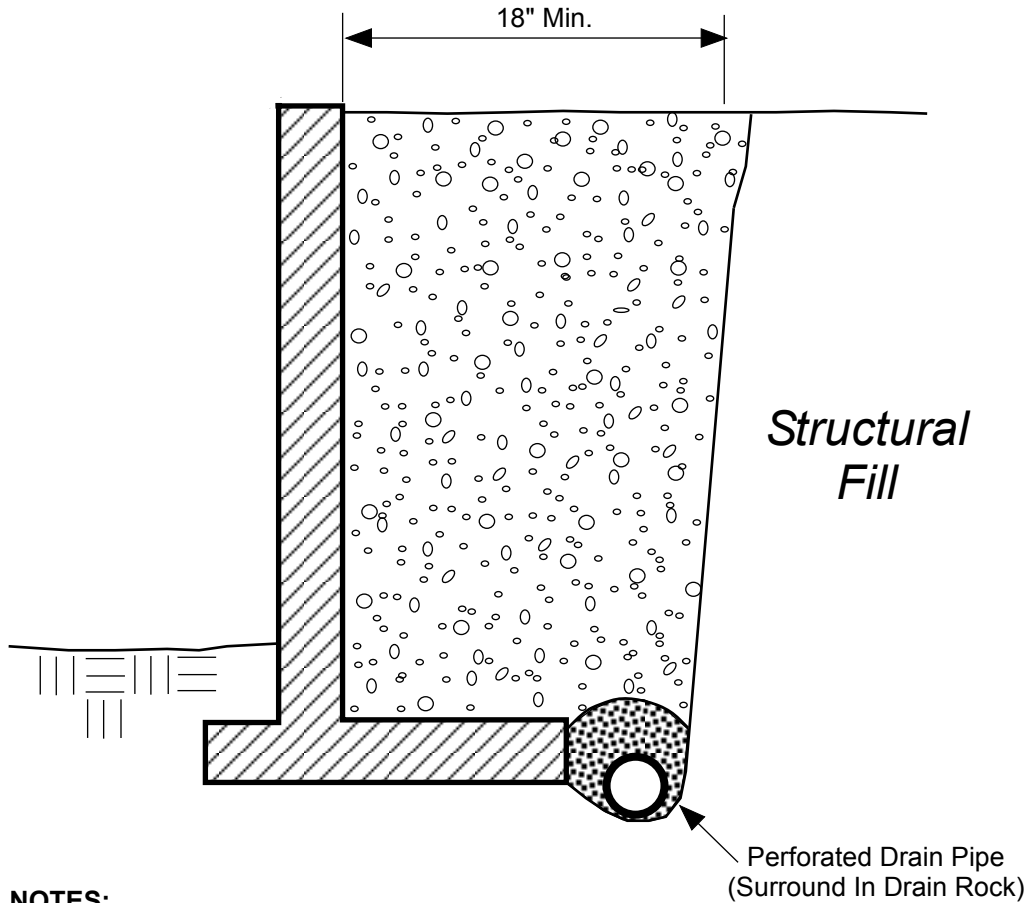
<b>Earth Solutions NW LLC</b> Geotechnical Engineering, Construction Monitoring and Environmental Sciences		
<b>RETAINING WALL DRAINAGE DETAIL</b> Germaine Korum Center Puyallup, Washington		
Drwn. MRS	Date 03/14/2017	Proj. No. 4960
Checked BJP	Date Mar. 2017	Plate 3

- Free Draining Backfill should consist of soil having less than 5 percent fines. Percent passing #4 should be 25 to 75 percent.
- Sheet Drain may be feasible in lieu of Free Draining Backfill, per ESNW recommendations.
- Drain Pipe should consist of perforated, rigid PVC Pipe surrounded with 1" Drain Rock.

Retaining walls should be backfilled with free-draining material that extends along the height of the wall and a distance of at least 18 inches behind the wall. The upper 12 inches of the wall backfill can consist of a less permeable soil, if desired. A perforated drainpipe should be placed along the base of the wall and connected to an approved discharge location. A typical retaining wall drainage detail is provided on Plate 3. If drainage is not provided, hydrostatic pressures should be included in the wall design.

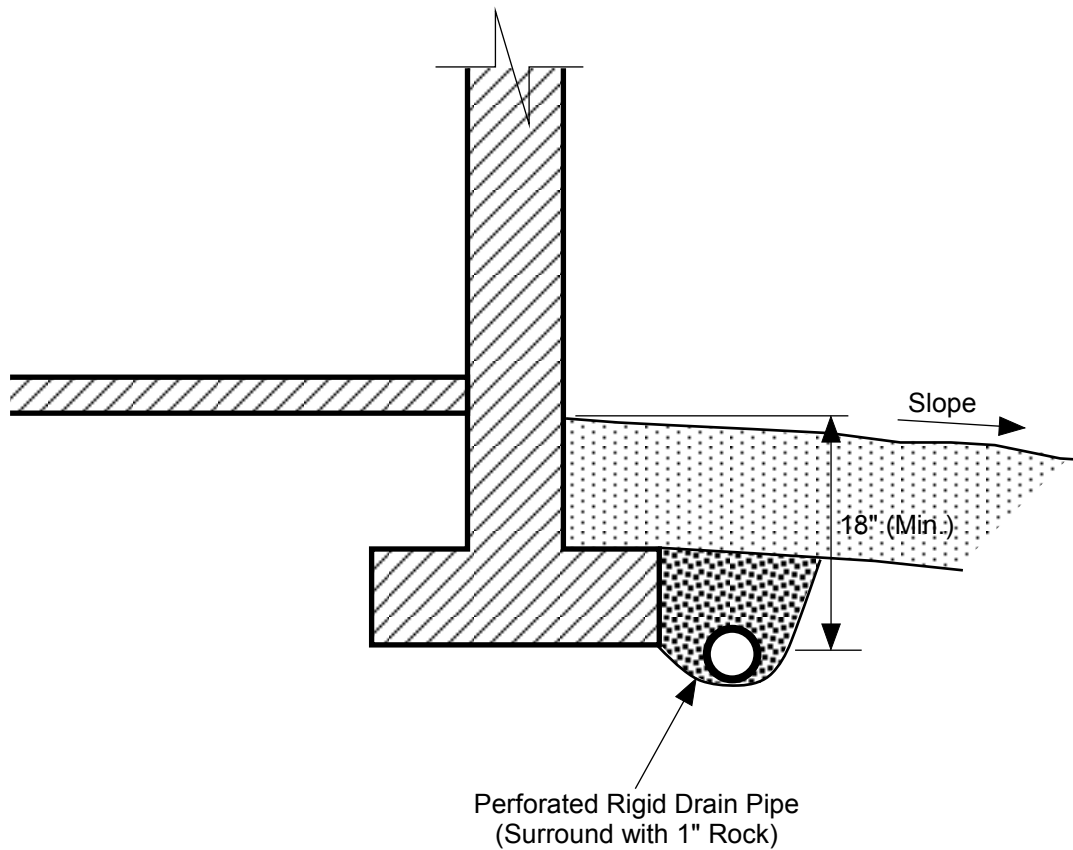
<p><b>Earth Solutions NW LLC</b> Geotechnical Engineering, Construction Monitoring and Environmental Sciences</p>	
<p>FOOTING DRAIN DETAIL Germaine Korum Center Puyallup, Washington</p>		
Drwn. MRS	Date 03/14/2017	Proj. No. 4960
Checked BJP	Date Mar. 2017	Plate 4

- Do NOT tie roof downspouts to Footing Drain.
- Surface Seal to consist of 12" of less permeable, suitable soil. Slope away from building.

Finish grades must be designed to direct surface drain water away from structures. Water must not be allowed to pond adjacent to structures, slopes or walls. In our opinion, foundation drains should be installed along building perimeter footings. A typical foundation drain detail is provided on Plate 4.

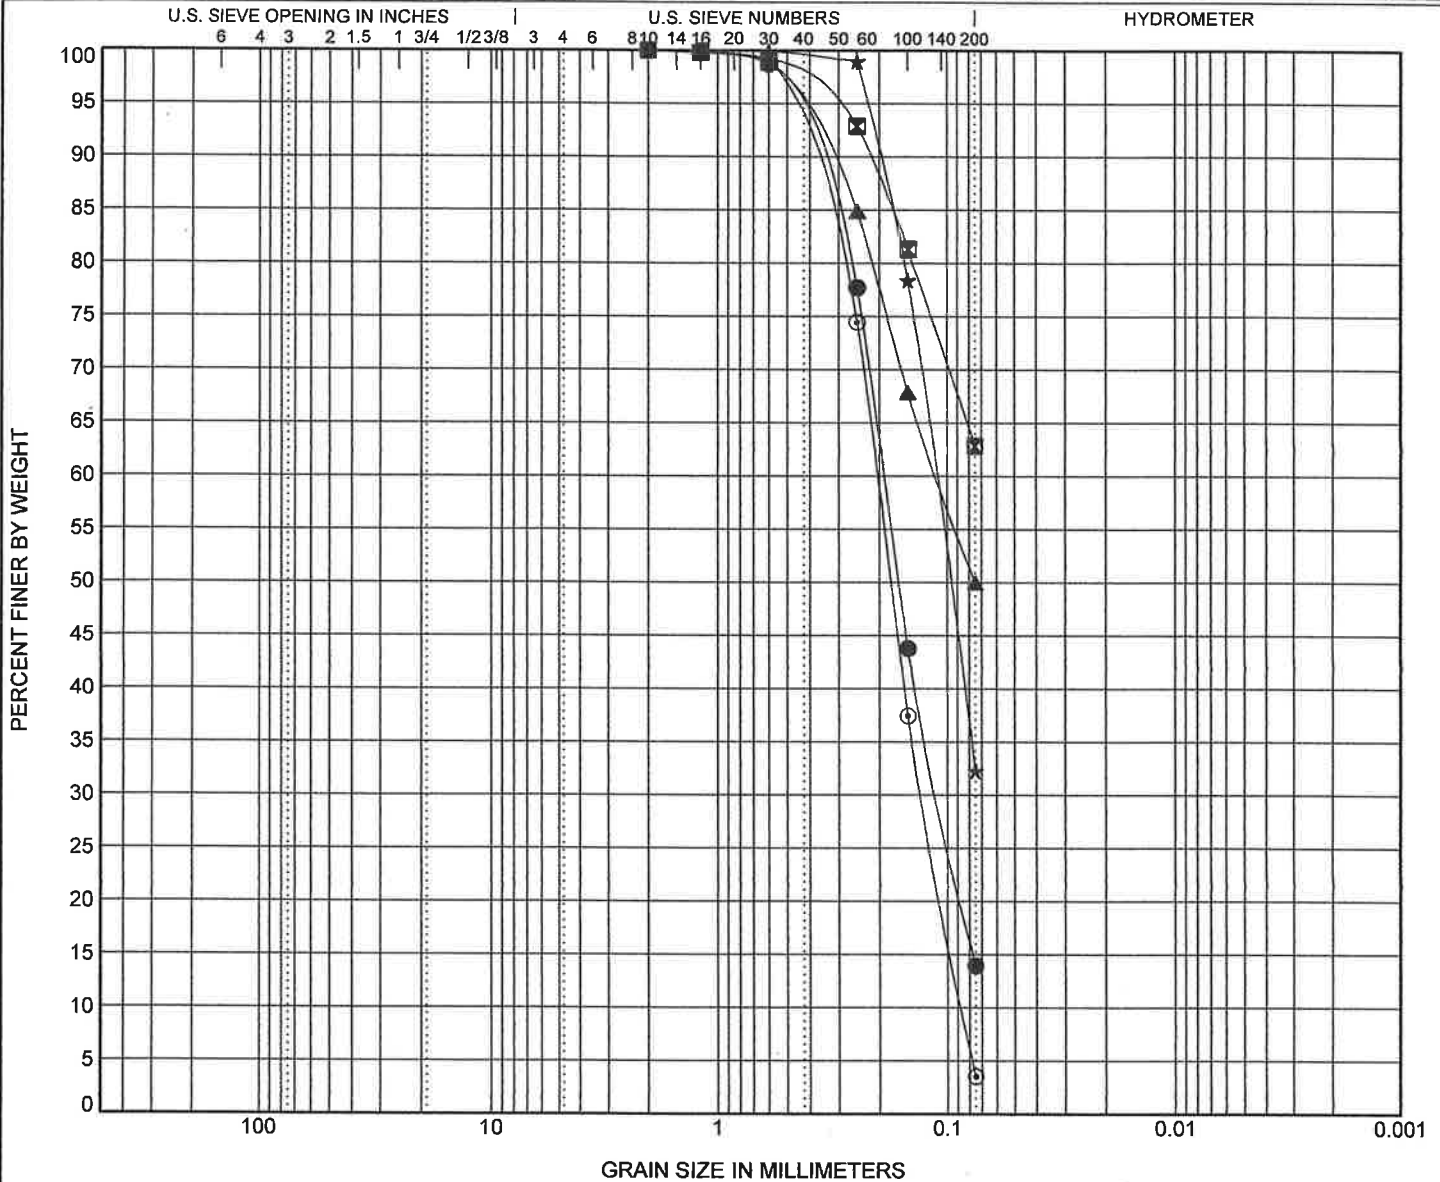
Specimen Identification	Classification	Cc	Cu						
● TP-1 3.00ft.	USDA: Gray Sand. USCS: SM.								
☒ TP-2 1.50ft.	USDA: Brown Loam. USCS: Sandy ML.								
▲ TP-3 2.50ft.	USDA: Brown Fine Sandy Loam. USCS: SM.								
★ TP-4 10.00ft.	USDA: Gray Very Fine Sandy Loam. USCS: SM.								
⊙ TP-5 6.00ft.	USDA: Gray Sand. USCS: SP.	0.95	2.39						
Specimen Identification	D100	D60	D30	D10	LL	PL	PI	%Silt	%Clay
● TP-1 3.0ft.	2	0.191	0.109					14.0	
☒ TP-2 1.5ft.	2							62.9	
▲ TP-3 2.5ft.	2	0.111						50.0	
★ TP-4 10.0ft.	2	0.114						32.3	
⊙ TP-5 6.0ft.	2	0.205	0.129	0.086				3.5

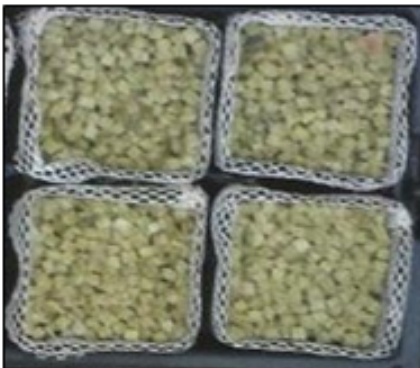
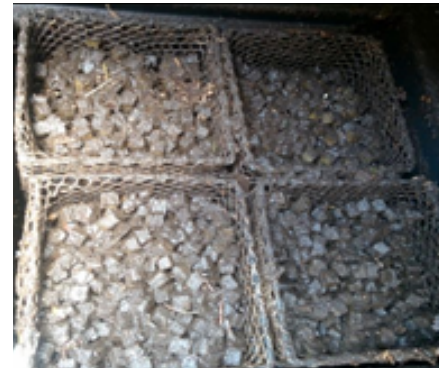
5. Through visual observation, inspect the condition of the pre-filter cartridges. Look for excessive build-up of sediment on the cartridges, any build-up on the tops of the cartridges, or clogging of the holes. Record this information on the inspection form. The prefilter cartridges can be further inspected by removing the cartridge tops and assessing the color of the BioMediaGREEN filter cubes (requires entry into pre-treatment chamber - see notes previous notes regarding confined space entry). Record the color of the material. New material is a light green color. As the media becomes clogged, it will turn darker in color, eventually becoming dark brown or black. The closer to black the media is the higher percentage that the media is exhausted and is in need of replacement.

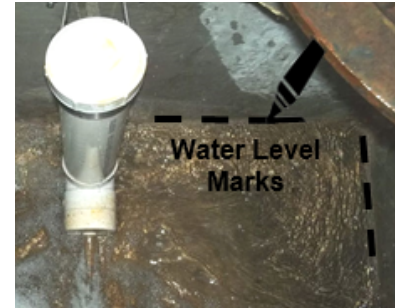
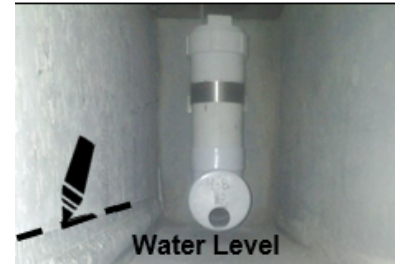
*NOTE: During the first few storms, the water level in the outflow chamber should be observed and a 6" long horizontal watermark line drawn (using a large permanent marker) at the water level in the discharge chamber while the system is operating at 100% capacity. The diagram below illustrates where the line should be drawn. This line is a reference point for future inspections of the system.*

*Water level in the discharge chamber is a function of flow rate and pipe size. Observation of the water level during the first few months of operation can be used as a benchmark level for future inspections. The initial mark and all future observations shall be made when the system is at 100% capacity (water level at maximum level in the pre-treatment chamber). If future water levels are below this mark when the system is at 100% capacity, this is an indicator that maintenance to the pre-filter cartridges may be needed.*

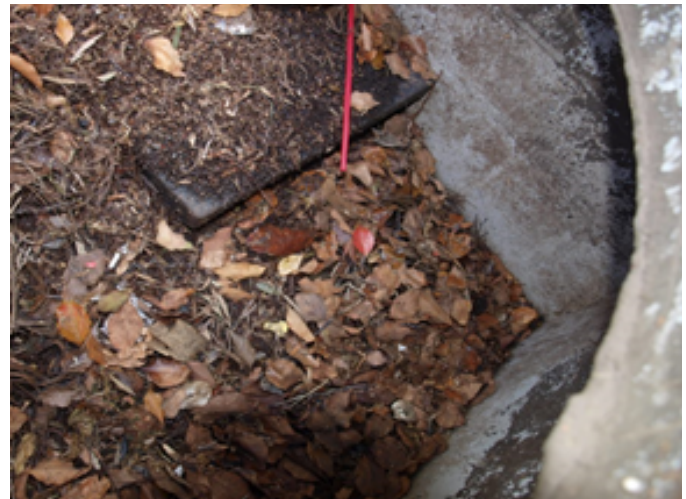
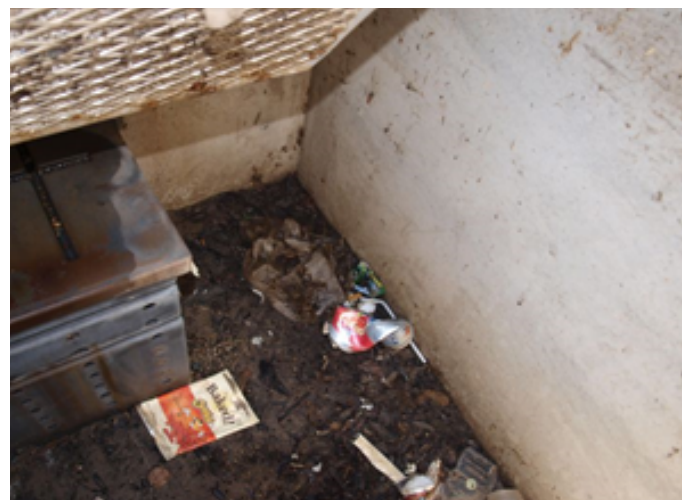
- Excessive accumulation of sediment in the pretreatment chamber of more than 6" in depth.
- Excessive accumulation of sediment on the BioMediaGREEN media housed within the pretreatment cartridges. The following chart shows photos of the condition of the BioMediaGREEN contained within the pre-filter cartridges. When media is more than 85% clogged, replacement is required.

- Excessive accumulation of sediment on the BioMediaGREEN media housed within the pretreatment cartridges. When media is more than 85% clogged, replacement is required. The darker the BioMediaGREEN, the more clogged it is and in need of replacement.

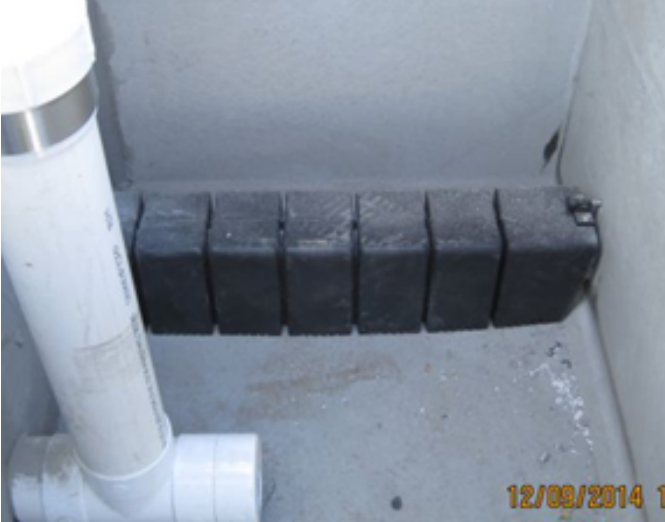
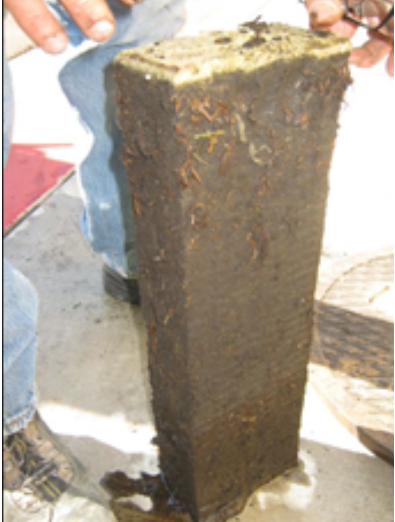
- Excessive accumulation of sediment on the BioMediaGREEN media housed within the drain down filter (California only - older models). The following photos show the condition of the BioMediaGREEN contained within the drain down filter. When media is more than 85% clogged, replacement is required.

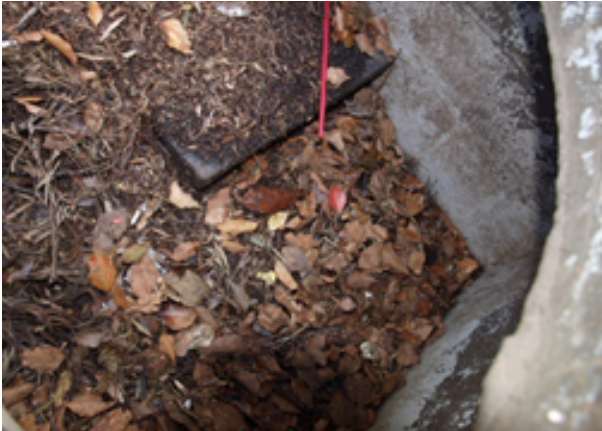
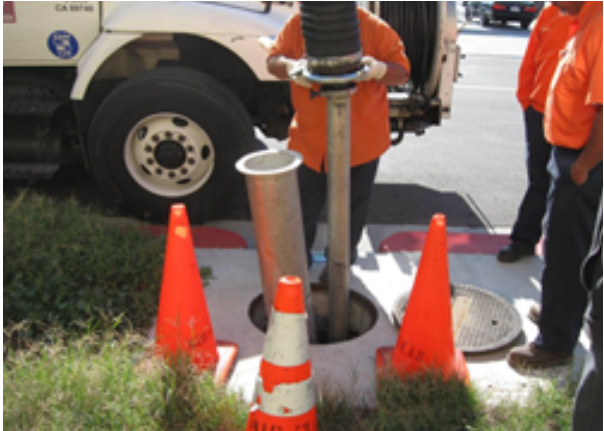
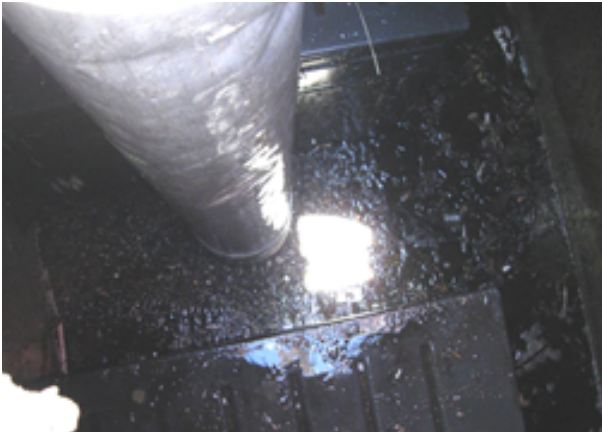
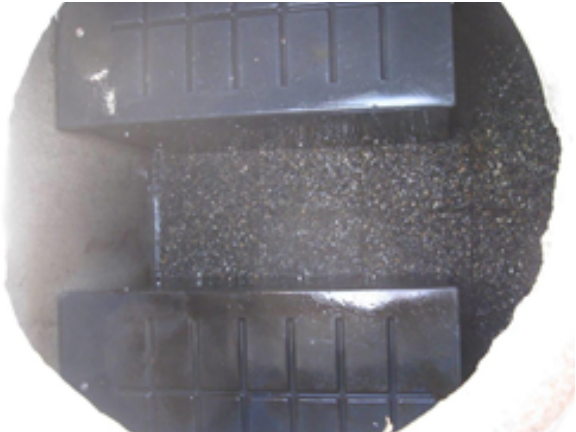
- 1. Remove access cover over pre-treatment chamber and position vacuum truck accordingly.
- 2. With a pressure washer, spray down pollutants accumulated on walls and pre-filter cartridges.
- 3. Vacuum out pre-treatment chamber and remove all accumulated pollutants including trash, debris, and sediments. Be sure to vacuum the floor until the pervious pavers are visible and clean.
- 4. If pre-filter cartridges require media replacement, continue to step 5. If not, replace access cover and move to step 11.

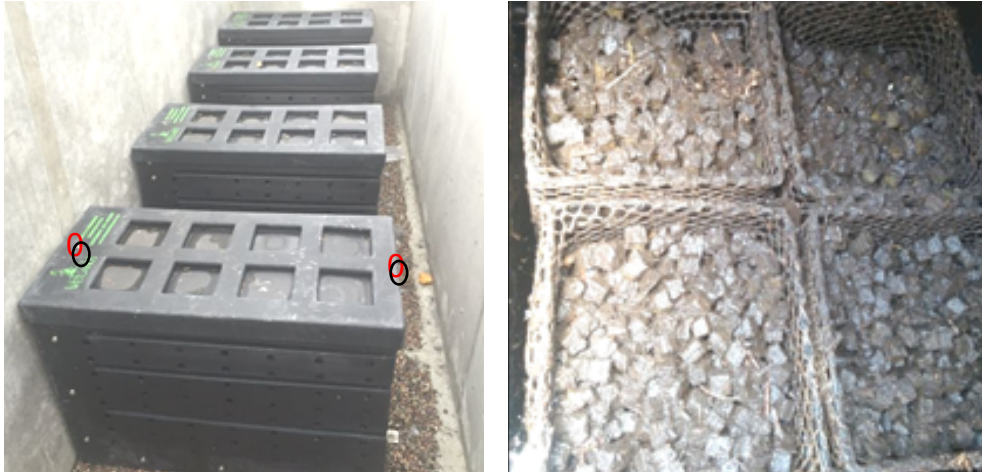
5. After successfully cleaning out the pre-treatment chamber (previous page) enter the pre-treatment chamber.
6. Unscrew the two bolts (circles shown below) holding the lid on each cartridge filter and remove lid.

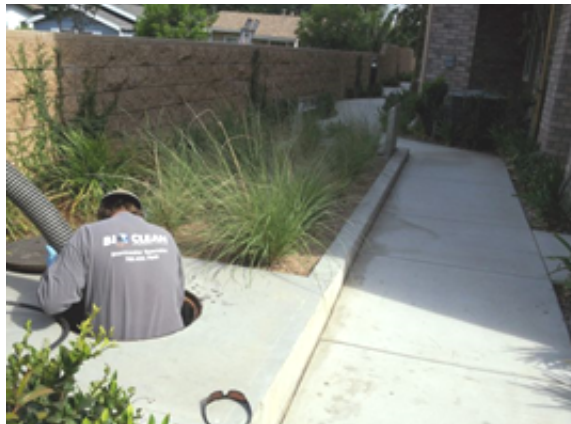
7. Place the vacuum hose over each individual media filter to suck out filter media.

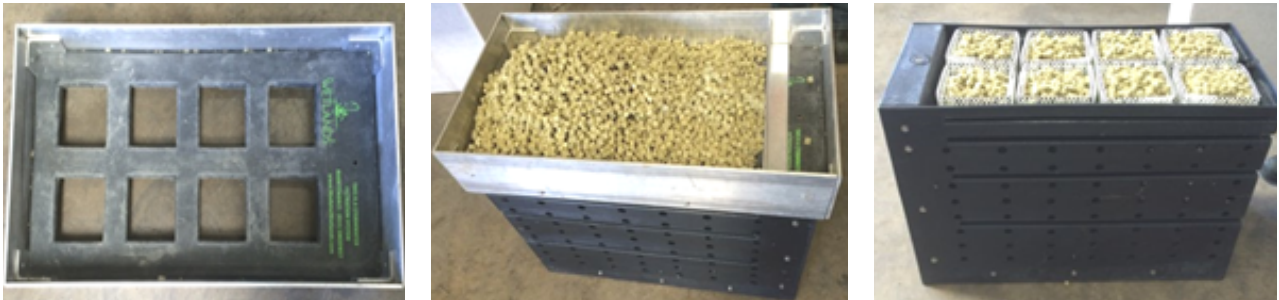
8. Once filter media has been sucked out, use a pressure washer to spray down the inside of the cartridge and it's media cages. Remove cleaned media cages and place to the side. Once removed, the vacuum hose can be inserted into the cartridge to vacuum out any remaining material near the bottom of the cartridge.
9. Reinstall media cages and fill with new media from the manufacturer or outside supplier. Manufacturer will provide specification of media and sources to purchase. Utilize the manufacture-provided refilling tray and place on top of the cartridge. Fill the tray with new bulk media and shake down into place. Using your hands, lightly compact the media into each filter cage. Once the cages are full, remove the refilling tray and replace the cartridge top, ensuring bolts are properly tightened.

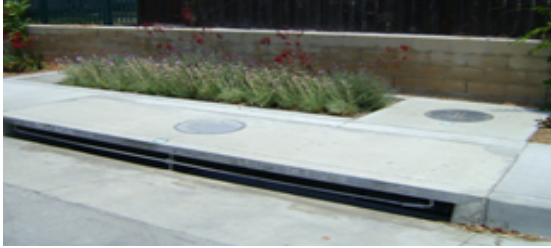
11. In general, the biofiltration chamber is maintenance-free with the exception of maintaining the vegetation. The Modular Wetlands Linear utilizes vegetation similar to surrounding landscape areas, therefore trim vegetation to match surrounding vegetation. If any plants have died, replace them with new ones.

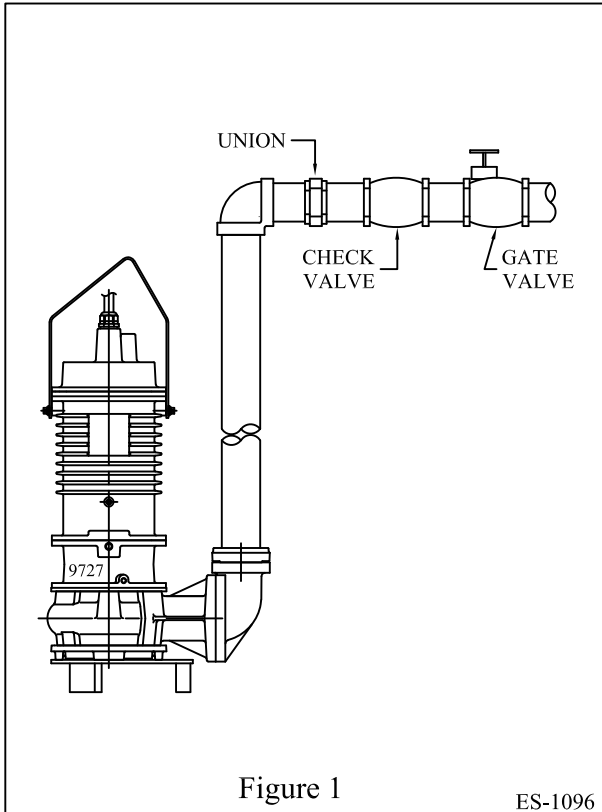
(Refer to Figure 1)

1. Piping should be as short as possible using a minimum number of fittings to avoid excessive friction loss.
2. Pipes should line up "naturally" with the pump discharge and should never be forced together.
3. Discharge piping must be supported by appropriate supports.
4. In a duplex installation, each pump must have its own check valve.

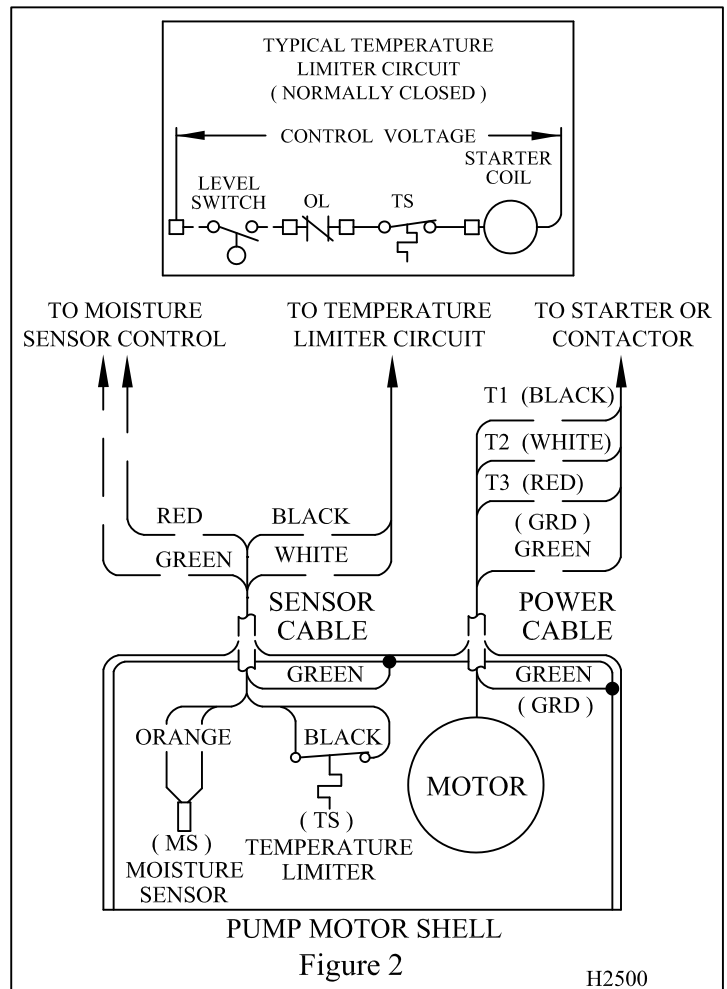
(Refer to Figure 2)

The pump is equipped with the moisture sensor and temperature limiter when this option is ordered. Connect the moisture sensor to the Weil Alarm-Test Panel as shown in Figure 2. Power supplied to the Alarm-Test Panel must be 115 volts, regardless of the voltage supplied to the pump motor.

Connect the temperature limiter into the pump motor starter control circuit in series with the liquid level control and the starter holding the coil, as shown in Figure 2.

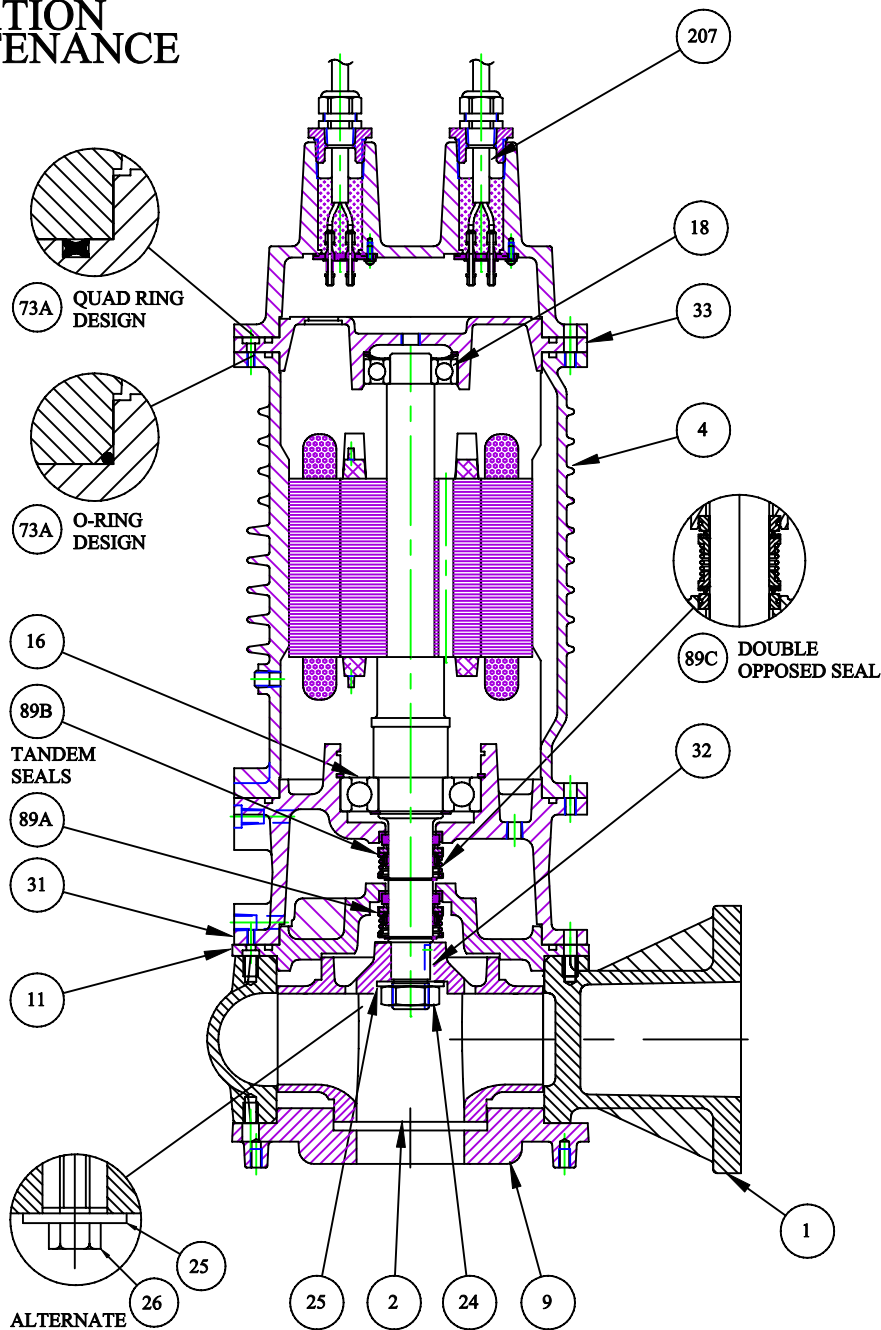
## Submersible Wastewater Pump

### PARTS BREAKDOWN

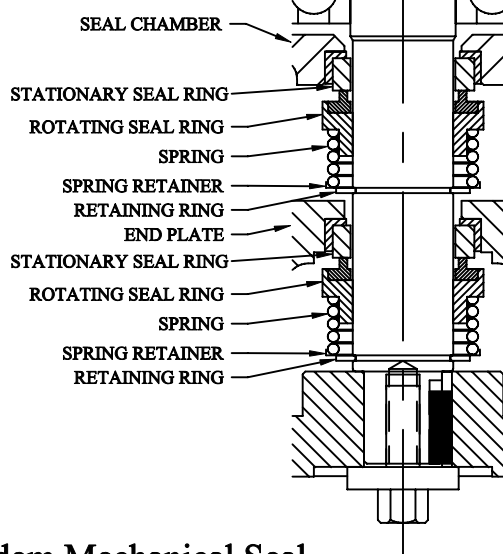
**Figure 1**

1. Remove the retaining ring from the shaft and remove the spring retainer and spring.
2. Slide the rotating seal ring off the shaft. **TAKE CARE NOT TO SCORE THE SHAFT.**
3. Remove the round head machine screws holding the end plate (11) to the seal chamber.

**Tandem Mechanical Seal Assembly**

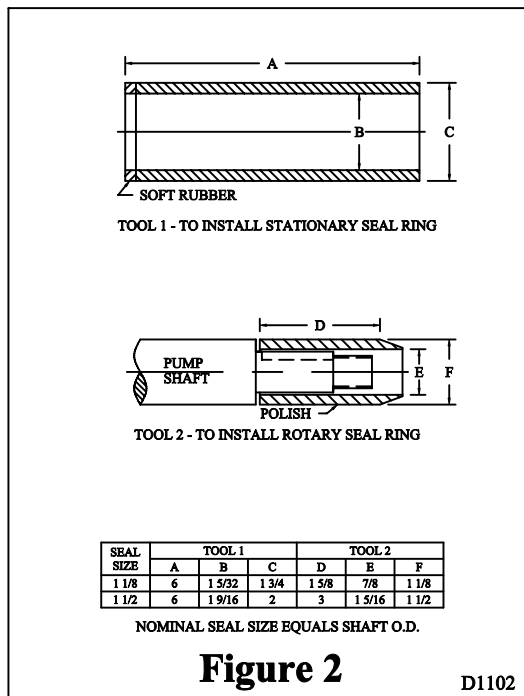
**Figure 2**

1. Check the replacement seal to ensure that it is the same type, shaft size and length as the original seal. **UPPER SEAL COMPONENTS AND LOWER SEAL COMPONENTS MUST NOT BE INTERCHANGED.**
2. Apply a thin coating of lubricating oil or glycerin to the outside surface of the rubber cup of the stationary seal ring. **TAKE CARE NOT TO MAR OR DAMAGE THE SEAL FACES.**
3. Position seal ring with its face toward the threaded end of the shaft. Gently press the seal ring into its seat using tool 1 shown in Figure 2. **APPLY EVEN PRESSURE TO SEAL FACE.** The seal is seated to its full depth when the rubber seating cup is flush with the surface of the seal chamber. **THE ROTATING SEAL RINGS AND THE STATIONARY SEAL RINGS MUST NOT BE INTERCHANGED.**

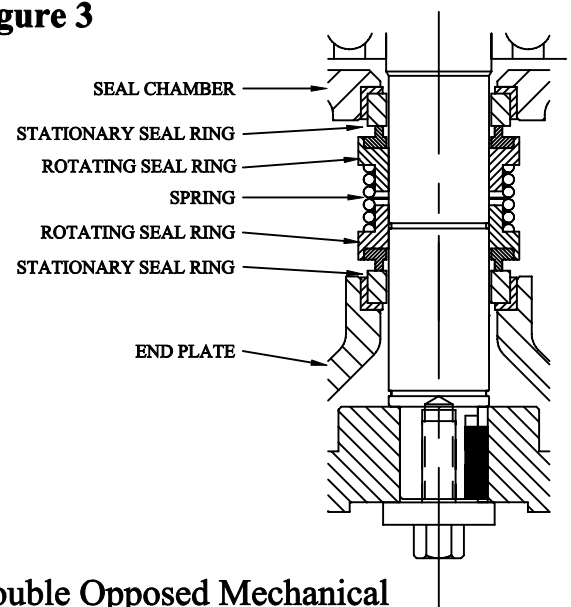
**Figure 3**

**Double Opposed Mechanical Seal Assembly**

**DISASSEMBLY - DOUBLE OPPOSED SEAL**  
(Refer to Figure 3)

**ASSEMBLY-DOUBLE OPPOSED SEAL**  
(Refer to Figure 3)
