# STORMWATER SITE PLAN REPORT

# STEP BY STEP EARLY LEARNING CENTER

C&A PROJ # 21-003

JULY 9, 2024

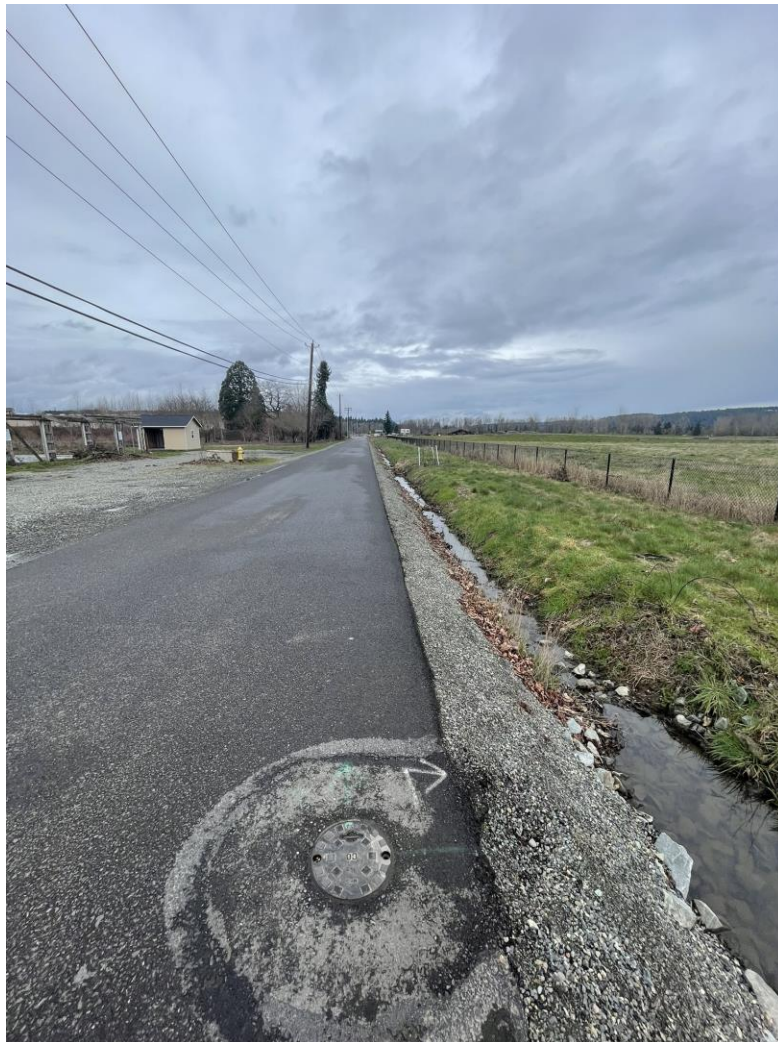
A photo looking north along 33<sup>rd</sup> Street SE from the project outfall is shown below.

The site discharges via culvert on the east side of 33<sup>rd</sup> Street SE and flows north for approximately 680–feet to the 5<sup>th</sup> Avenue SE intersection. There the ditch drains into a relatively new 24–inch diameter storm line that conveys runoff north for approximately 700–feet where to the 75<sup>th</sup> Street E intersection (3–way intersection). Runoff turns west in a 36–inch diameter line for approximately 30–feet. Then turns north again in a 42–inch line. Runoff generally continues in a 42–inch storm line until it discharges to the Puyallup River.

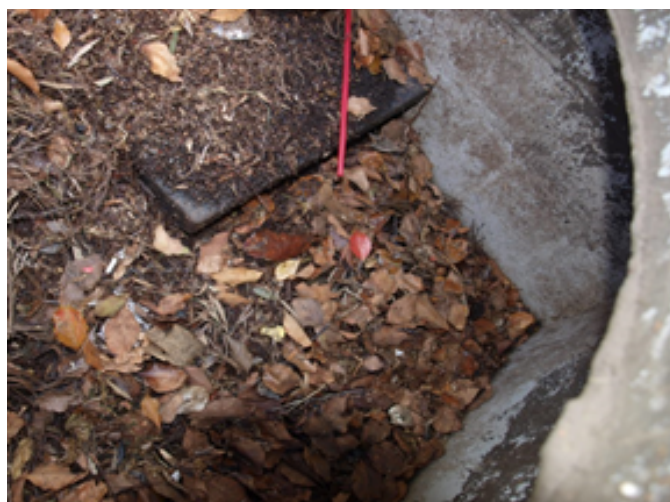
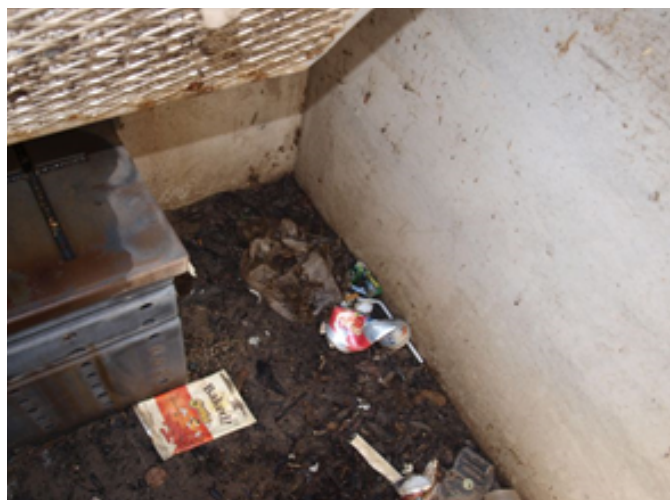
- Excessive accumulation of sediment in the pretreatment chamber of more than 6" in depth.
- Excessive accumulation of sediment on the BioMediaGREEN media housed within the pretreatment cartridges. The following chart shows photos of the condition of the BioMediaGREEN contained within the pre-filter cartridges. When media is more than 85% clogged, replacement is required.

- Excessive accumulation of sediment on the BioMediaGREEN media housed within the pretreatment cartridges. When media is more than 85% clogged, replacement is required. The darker the BioMediaGREEN, the more clogged it is and in need of replacement.

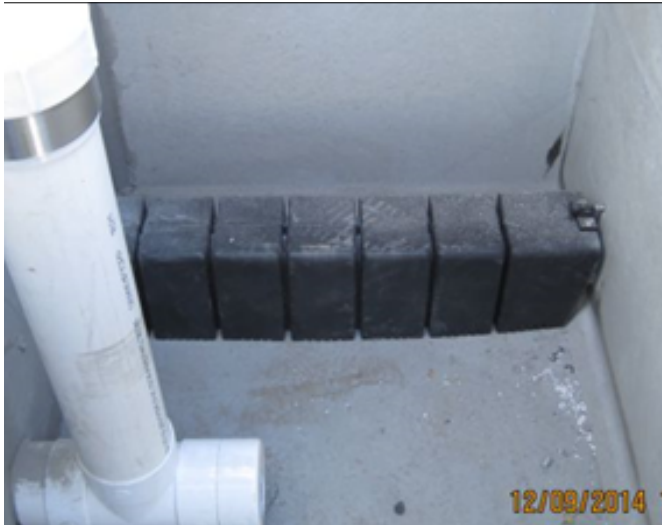
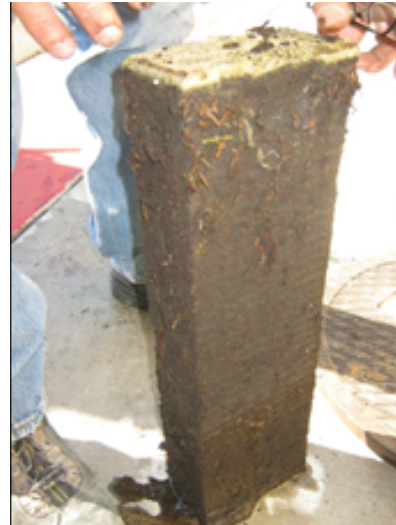
- Excessive accumulation of sediment on the BioMediaGREEN media housed within the drain down filter (California only - older models). The following photos show the condition of the BioMediaGREEN contained within the drain down filter. When media is more than 85% clogged, replacement is required.

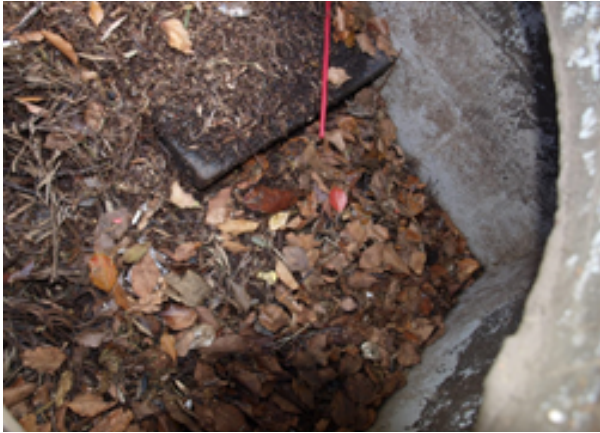
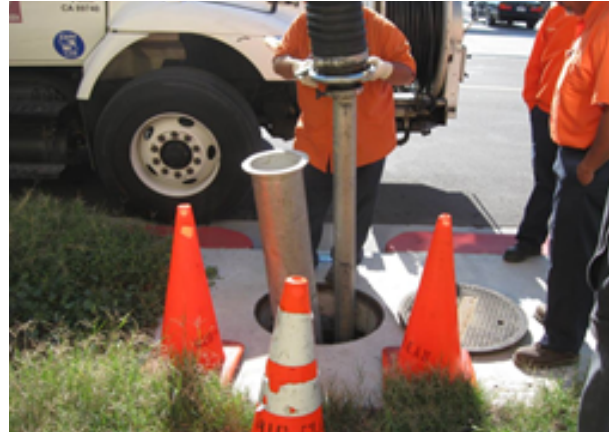
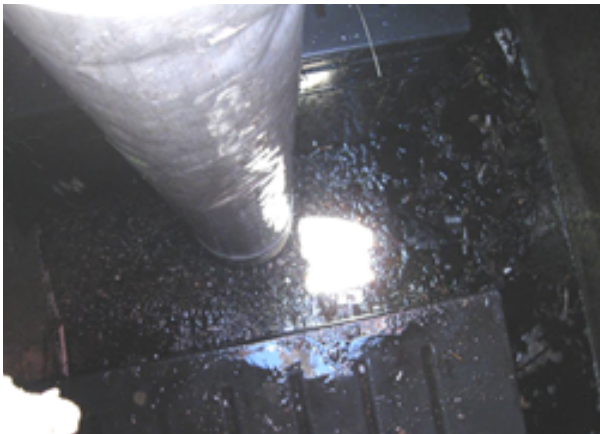
1. Remove access cover over pre-treatment chamber and position vacuum truck accordingly.
2. With a pressure washer, spray down pollutants accumulated on walls and pre-filter cartridges.
3. Vacuum out pre-treatment chamber and remove all accumulated pollutants including trash, debris, and sediments. Be sure to vacuum the floor until the pervious pavers are visible and clean.
4. If pre-filter cartridges require media replacement, continue to step 5. If not, replace access cover and move to step 11.

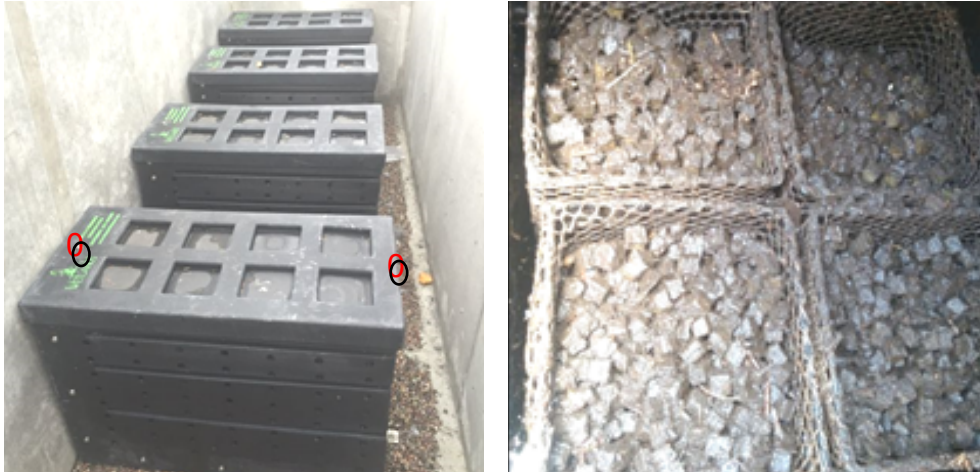
5. After successfully cleaning out the pre-treatment chamber (previous page) enter the pre-treatment chamber.
6. Unscrew the two bolts (circles shown below) holding the lid on each cartridge filter and remove lid.

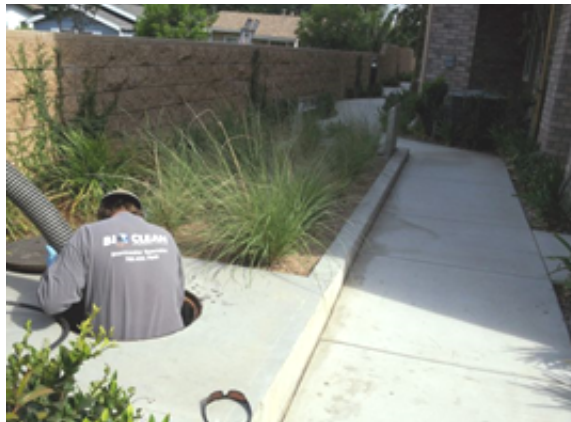
7. Place the vacuum hose over each individual media filter to suck out filter media.

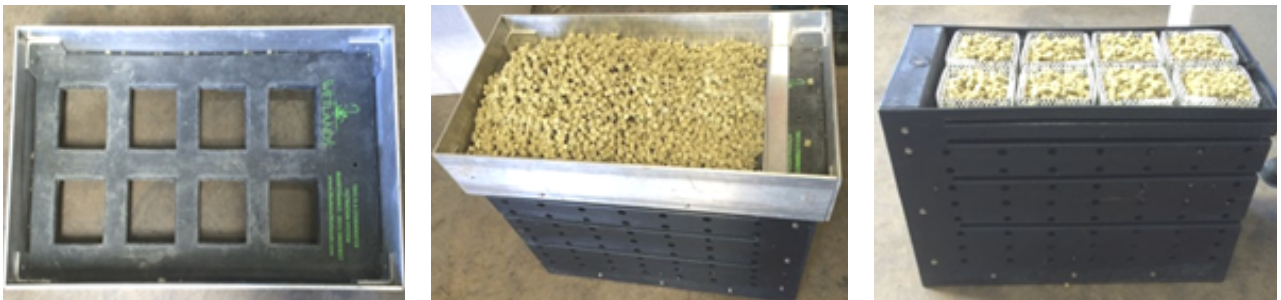
8. Once filter media has been sucked out, use a pressure washer to spray down the inside of the cartridge and it's media cages. Remove cleaned media cages and place to the side. Once removed, the vacuum hose can be inserted into the cartridge to vacuum out any remaining material near the bottom of the cartridge.
9. Reinstall media cages and fill with new media from the manufacturer or outside supplier. Manufacturer will provide specification of media and sources to purchase. Utilize the manufacture-provided refilling tray and place on top of the cartridge. Fill the tray with new bulk media and shake down into place. Using your hands, lightly compact the media into each filter cage. Once the cages are full, remove the refilling tray and replace the cartridge top, ensuring bolts are properly tightened.

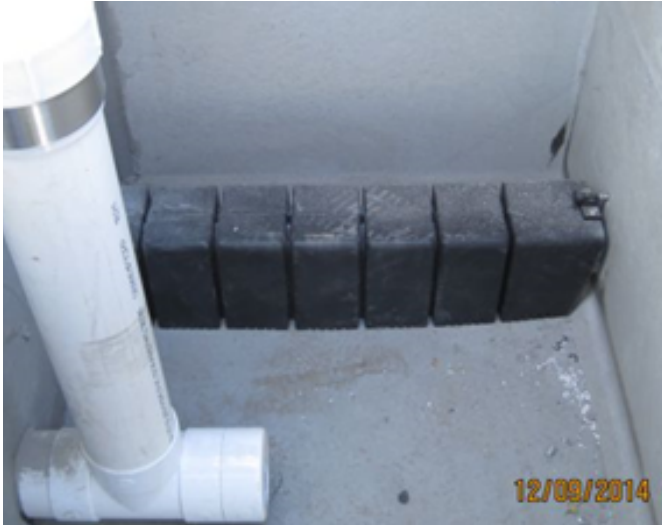
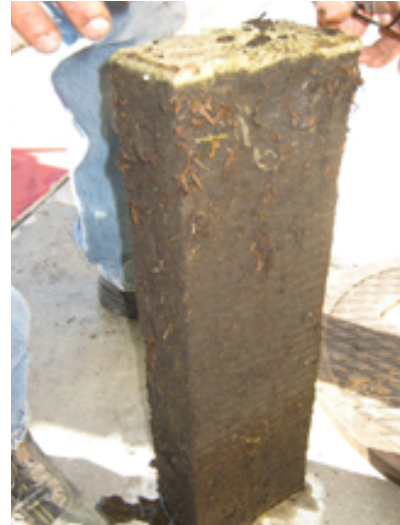
15. Remove access hatch or manhole cover over discharge chamber.
16. Enter chamber to gain access to the drain down filter. Unlock the locking mechanism and lift up drain down filter housing to remove used BioMediaGREEN filter block as shown below. *NOTE: Drain down filter is only found on units installed in California prior to 2023. If no drain down filter is present, skip steps 16 and 17.*
