STORMWATER SITE PLAN REPORT

STEP BY STEP EARLY LEARNING CENTER

C&A PROJ # 21-003

MARCH 21, 2025
PERMIT #PRCCP20241109

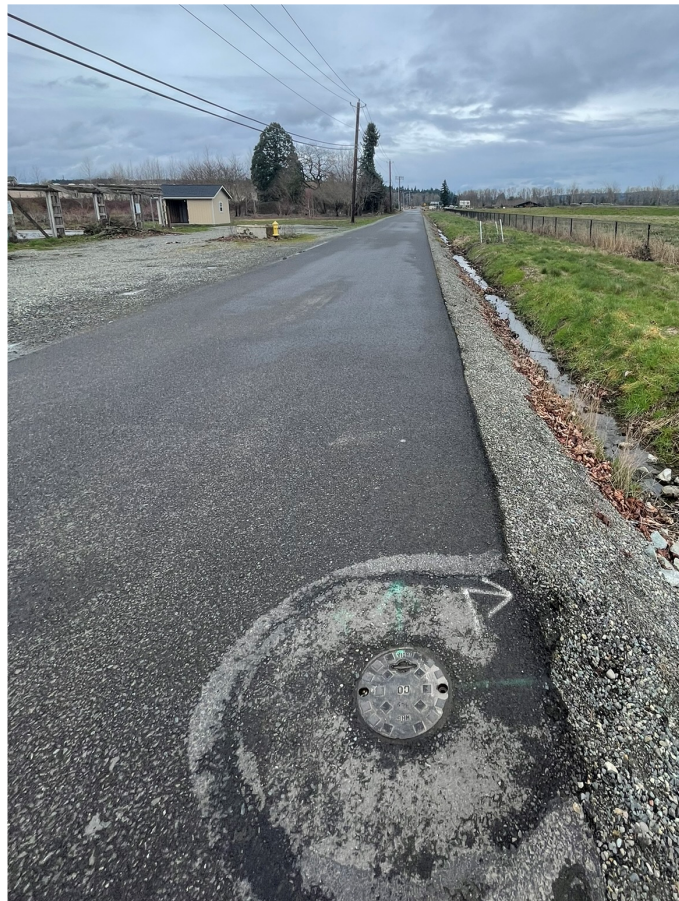
A photo looking north along 33rd Street SE from the project outfall is shown below.

The site discharges via culvert on the east side of 33rd Street SE and flows north for approximately 680–feet to the 5th Avenue SE intersection. There the ditch drains into a relatively new 24–inch diameter storm line that conveys runoff north for approximately 700–feet where to the 75th Street E intersection (3–way intersection). Runoff turns west in a 36–inch diameter line for 74th approximately 30–feet. Then turns north again in a 42–inch line. Runoff generally continues in a 42–inch storm line until it discharges to the Puyallup River.

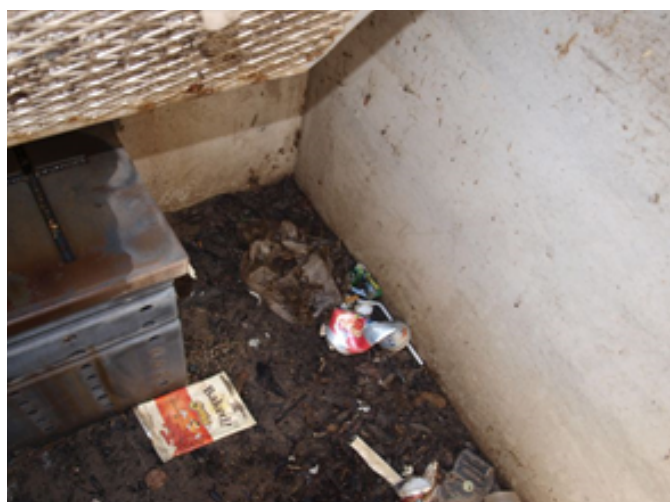
- Excessive accumulation of sediment in the pretreatment chamber of more than 6" in depth.
- Excessive accumulation of sediment on the BioMediaGREEN media housed within the pretreatment cartridges. The following chart shows photos of the condition of the BioMediaGREEN contained within the pre-filter cartridges. When media is more than 85% clogged, replacement is required.

- Excessive accumulation of sediment on the BioMediaGREEN media housed within the pretreatment cartridges. When media is more than 85% clogged, replacement is required. The darker the BioMediaGREEN, the more clogged it is and in need of replacement.

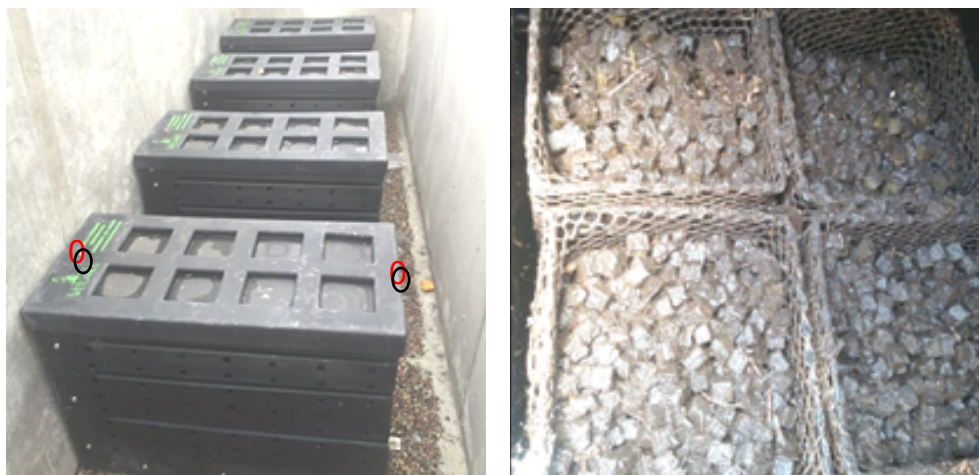
5. After successfully cleaning out the pre-treatment chamber (previous page) enter the pre-treatment chamber.
6. Unscrew the two bolts (circles shown below) holding the lid on each cartridge filter and remove lid.

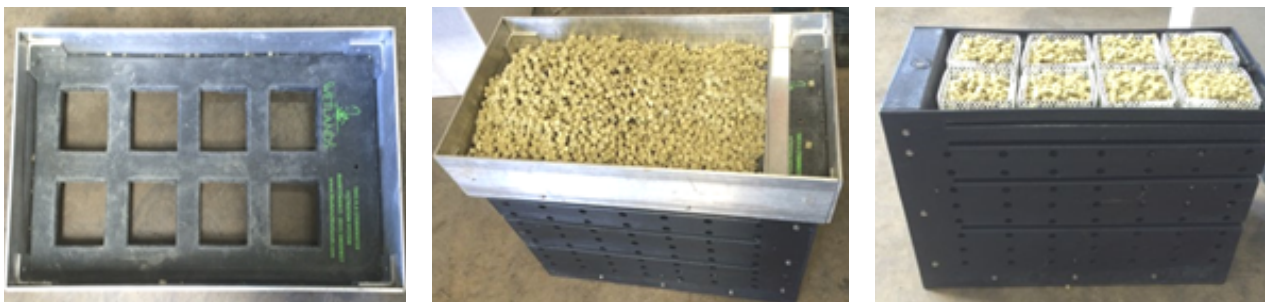
8. Once filter media has been sucked out, use a pressure washer to spray down the inside of the cartridge and it's media cages. Remove cleaned media cages and place to the side. Once removed, the vacuum hose can be inserted into the cartridge to vacuum out any remaining material near the bottom of the cartridge.
9. Reinstall media cages and fill with new media from the manufacturer or outside supplier. Manufacturer will provide specification of media and sources to purchase. Utilize the manufacture-provided refilling tray and place on top of the cartridge. Fill the tray with new bulk media and shake down into place. Using your hands, lightly compact the media into each filter cage. Once the cages are full, remove the refilling tray and replace the cartridge top, ensuring bolts are properly tightened.

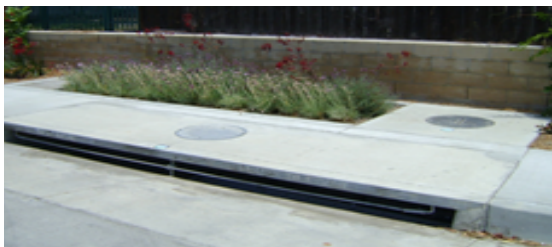
11. In general, the biofiltration chamber is maintenance-free with the exception of maintaining the vegetation. The Modular Wetlands Linear utilizes vegetation similar to surrounding landscape areas, therefore trim vegetation to match surrounding vegetation. If any plants have died, replace them with new ones.

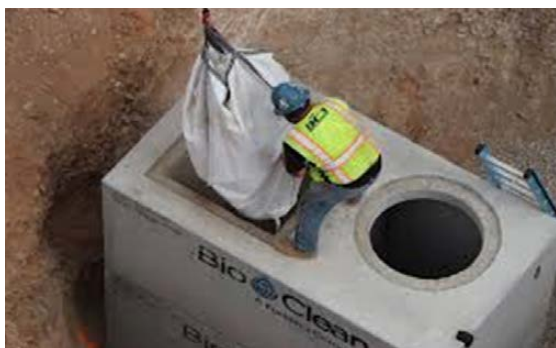
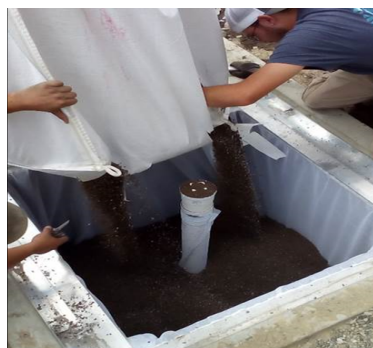
13. As with all biofilter systems, at some point the biofiltration media (WetlandMedia) will need to be replaced. Either because of physical clogging or sorptive exhaustion of the media ion exchange capacity (to remove dissolved metals and phosphorous). The general life of this media is 10 to 20 years based on site specific conditions and pollutant loading. Utilize the vacuum truck to vacuum out the media by placing the hose into the chamber. Once all the media is removed use the power washer to spray down all the netting on the outer metal cage. Inspect the netting for any damage or holes. If the netting is damaged it can be repaired or replaced with guidance by the manufacturer.

14. Contact one of Contech's Maintenance Team members at <https://www.conteches.com/maintenance> to order new WetlandMedia. The quantity of media needed can be determined by providing the model number and unit depth. Media will be provided in super sacks for easy installation. Each sack will weigh between 1000 and 2000 lbs. A lifting apparatus (backhoe, boom truck, or other) is recommended to position the super sack over the biofiltration chamber. Fill the media cages up to the same level as the old media. Replant with vegetation.

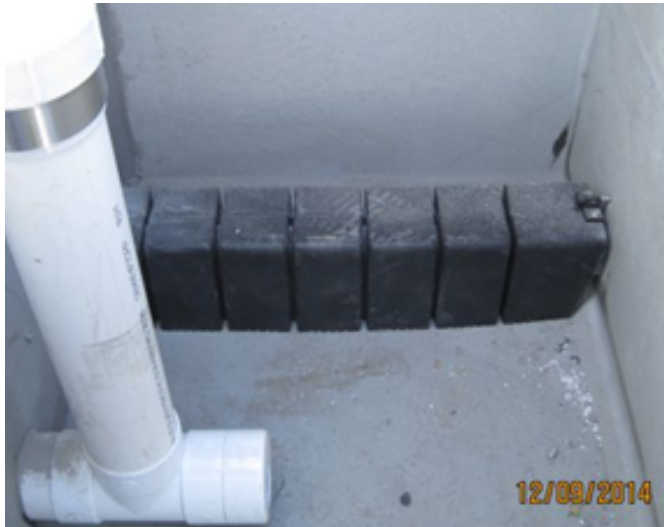
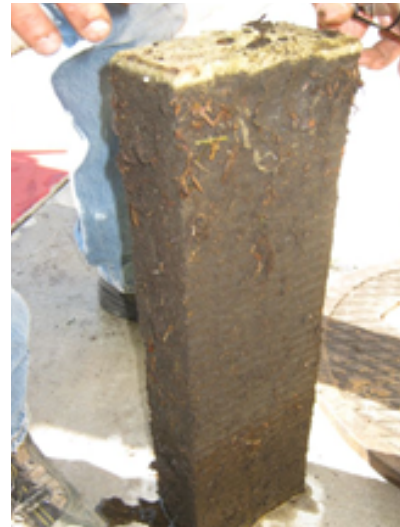
15. Remove access hatch or manhole cover over discharge chamber.
16. Enter chamber to gain access to the drain down filter. Unlock the locking mechanism and lift up drain down filter housing to remove used BioMediaGREEN filter block as shown below. *NOTE: Drain down filter is only found on units installed in California prior to 2023. If no drain down filter is present, skip steps 16 and 17.*

17. Insert a new BioMediaGREEN filter block and lock drain down filter housing back in place.
18. Replace access hatch or manhole cover over discharge chamber.
