300 BUILDING LARSON AUTO GROUP 300 RIVER ROAD, PUYALLUP, WA 98371

Drainage Report

MC# LARS0001 1/19/2022

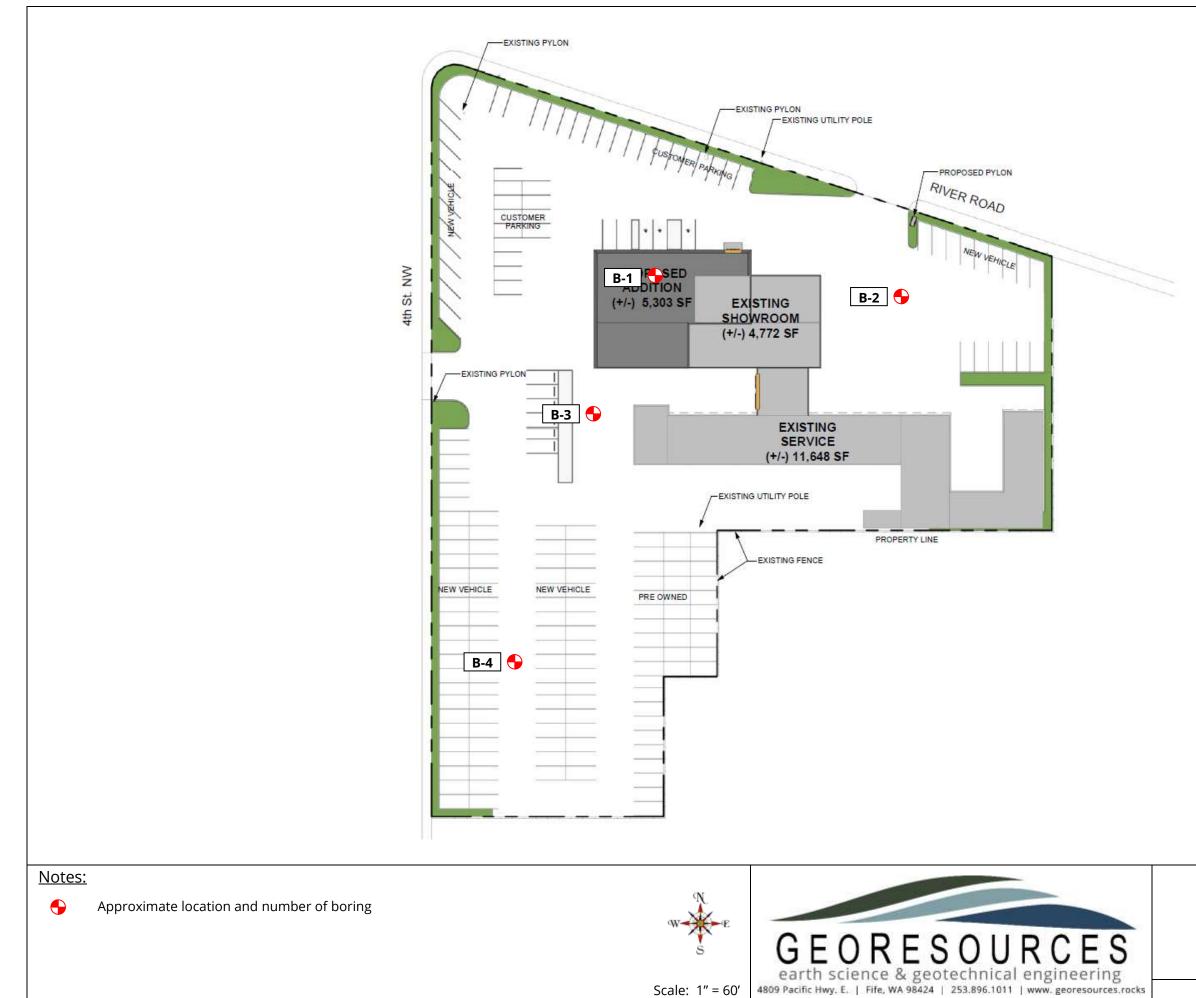
Site & Exploration Plan

Proposed Commercial Development 300 River Road Puyallup, Washington PN: 0420214010, 0420214027, 0420281154

Based on Pierce County GIS data and our site observations, the ground surface at the site gently slopes down to the north at inclinations of less than 2 percent. Total topographic relief across the site is on the order of 8 feet, and topographic relief across the project area is on the order of 4 feet. The site is paved. The existing site configuration and topography is shown on the Site Vicinity Map, Figure 3.

The approximate location of our exploration is shown on the attached Site & Exploration Plan, Figure 3. The locations indicated on Figure 3 were estimated based on taping and pacing from locatable site features. Our subsurface explorations indicate the subsurface conditions at specific locations only, as actual subsurface conditions can vary across the site. Furthermore, the nature and extent of any variation would not become evident until additional explorations are performed or until construction activities have begun. Surface elevations were interpolated based on available topographic information. As such, our boring locations and elevations should only be considered accurate to the degree implied by our measuring methods. The soils encountered were visually classified in accordance with the Unified Soil Classification System (USCS) and ASTM D: 2488. The USCS is included in Appendix A as Figure A-1, while the descriptive logs of our borings are included as Figures A-2 through A-5.

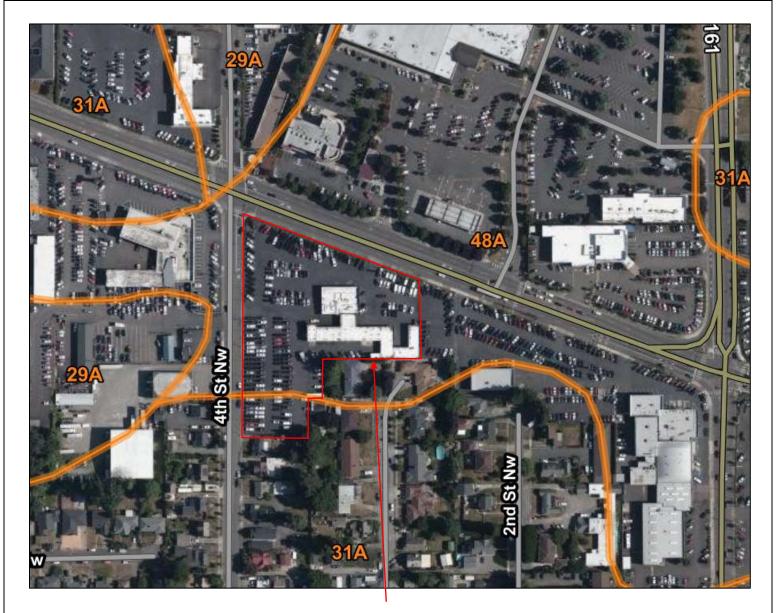
Figure 4

Map created from Web Soil Survey (http://websoilsurvey.sc.egov.usda.gov/App/WebSoilSurvey.aspx)

The USDA Natural Resource Conservation Survey (NRCS) Web Soil Survey maps most of the site as underlain by Xerothrents fill (48A) soils and the southwest portion of the site as underlain by Puyallup fine sandy loam (31A) soils. An excerpt from the NRCS soils map for the site area is included as Figure 4.

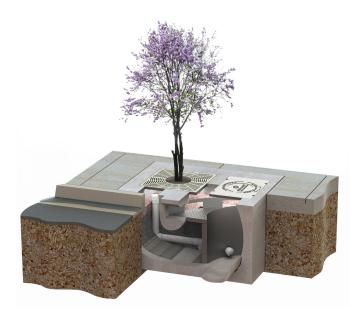
BioPod Tree Module

Natural, shredded hardwood mulch should be used in the BioPod. Timely replacement of the mulch layer according to the maintenance indicators described above should protect the biofiltration media below the mulch layer from clogging due to sediment accumulation. However, whenever the mulch is replaced, the BioPod should be visited 24 hours after the next major storm event to ensure that there is no standing water in the biofiltration chamber. Standing water indicates that the biofiltration media below the mulch layer is clogged and must be replaced. Please contact Oldcastle Infrastructure at (800) 579-8819 to purchase the proprietary StormMix[™] biofiltration media.
