**300 BUILDING
LARSON AUTO GROUP
300 RIVER ROAD, PUYALLUP, WA 98371**

Drainage Report

MC# LARS0001
Revision 1: 5/2/2022

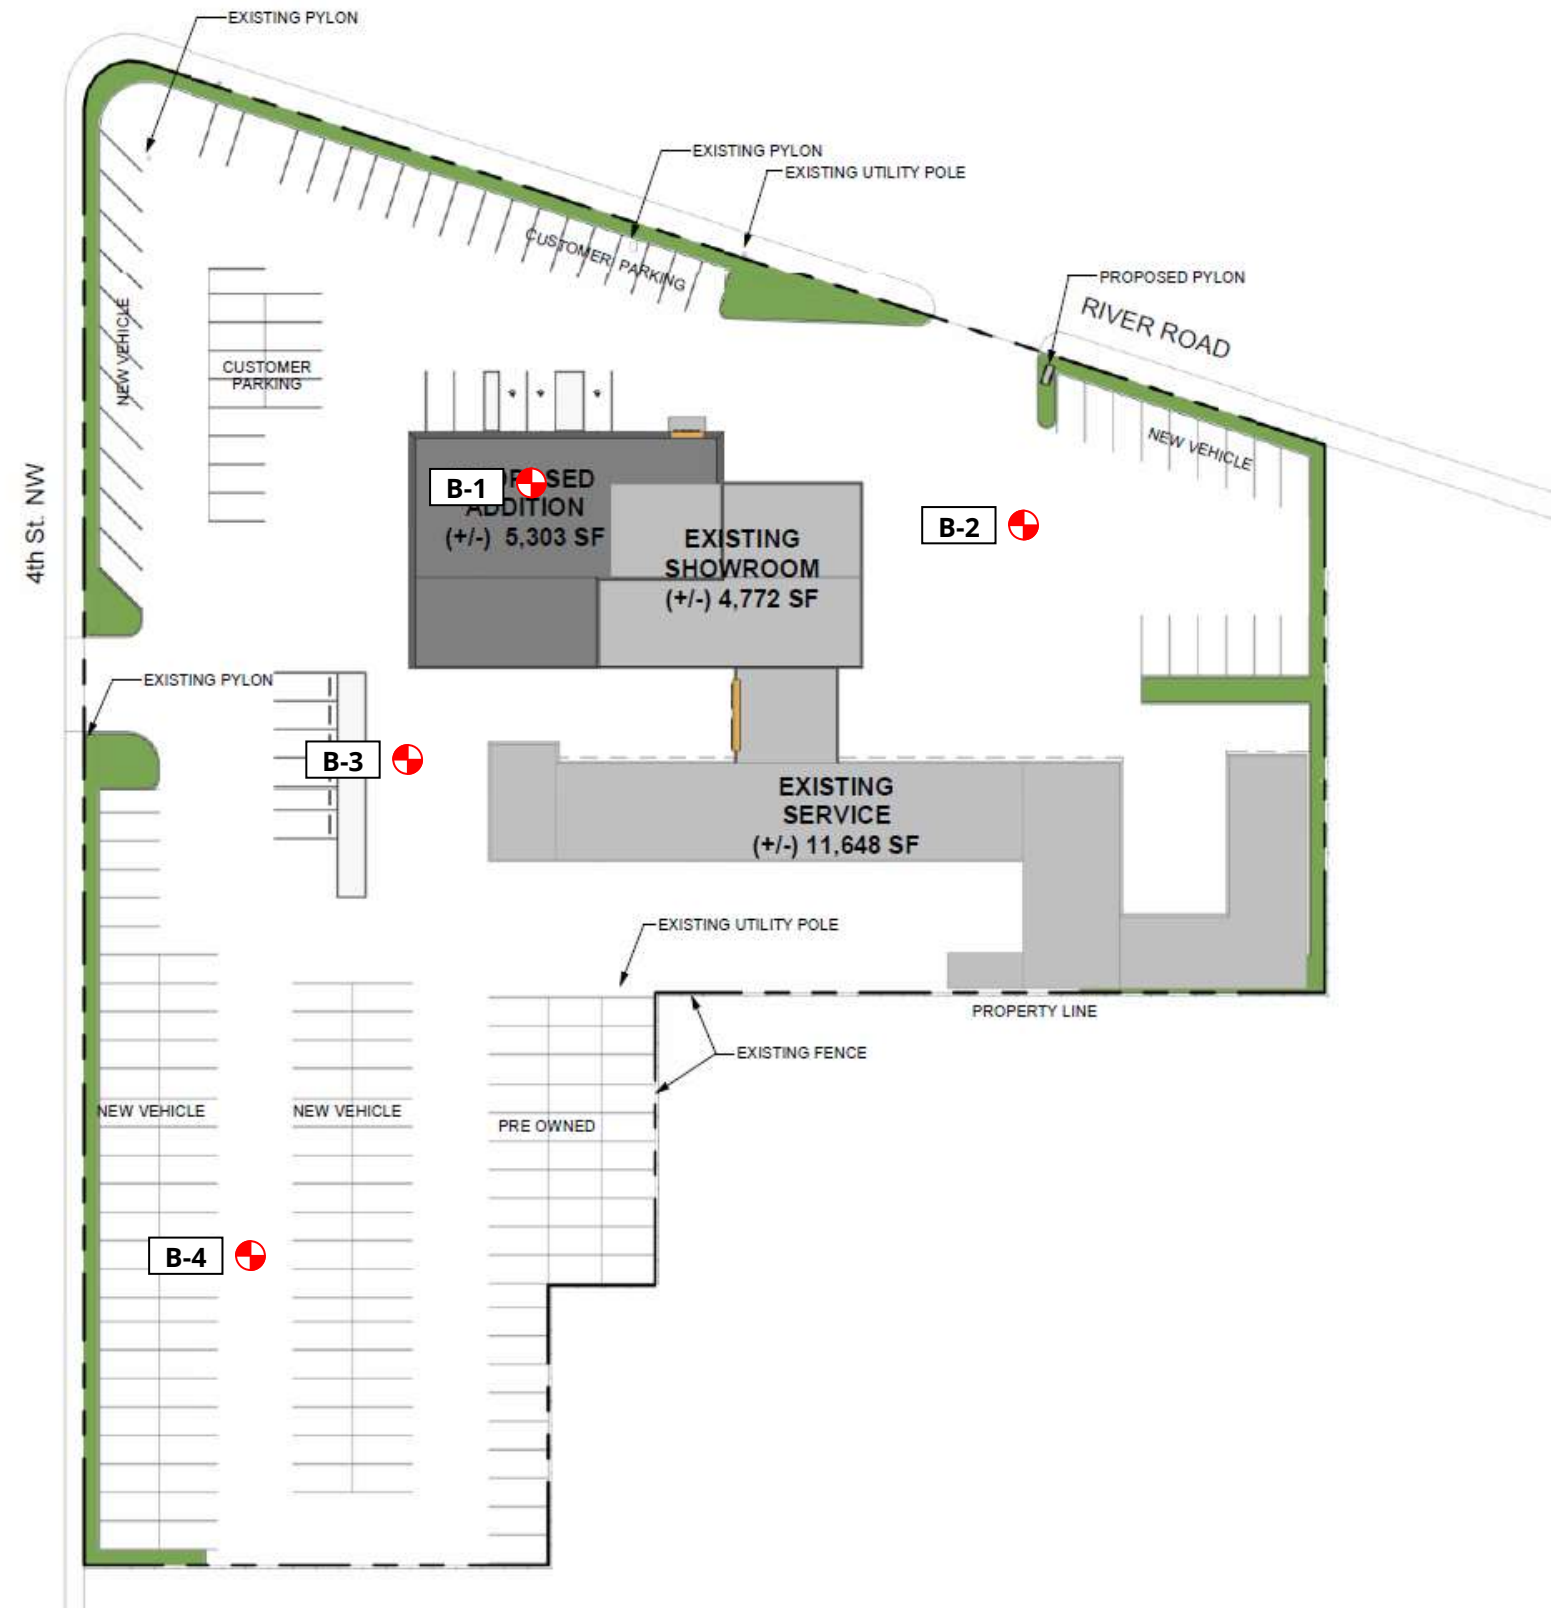
Site & Exploration Plan

Proposed Commercial Development
 300 River Road
 Puyallup, Washington
 PN: 0420214010, 0420214027, 0420281154

The approximate location of our exploration is shown on the attached Site & Exploration Plan, Figure 3. The locations indicated on Figure 3 were estimated based on taping and pacing from locatable site features. Our subsurface explorations indicate the subsurface conditions at specific locations only, as actual subsurface conditions can vary across the site. Furthermore, the nature and extent of any variation would not become evident until additional explorations are performed or until construction activities have begun. Surface elevations were interpolated based on available topographic information. As such, our boring locations and elevations should only be considered accurate to the degree implied by our measuring methods. The soils encountered were visually classified in accordance with the Unified Soil Classification System (USCS) and ASTM D: 2488. The USCS is included in Appendix A as Figure A-1, while the descriptive logs of our borings are included as Figures A-2 through A-5.
