# Structural Analysis Report AT&T

| Site Name | GOOD SAMARITAN |
| Site ID | WA6659 |
| Structure Type | Penthouse Wall |

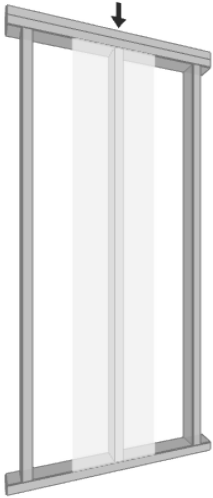
Level, Wall: Stud

**1 piece(s) 2 x 6 DF No.2 @ 16" OC**

Wall Height: 16'

Member Height: 15' 7 1/2"

O. C. Spacing: 16.00"

Drawing is Conceptual
